Microscopic structure changes of Malan loess after humidification in South Jingyang Plateau, China

Keywords Loess · Cement · Humidification collapse mechanism · Multi-level collapsibility

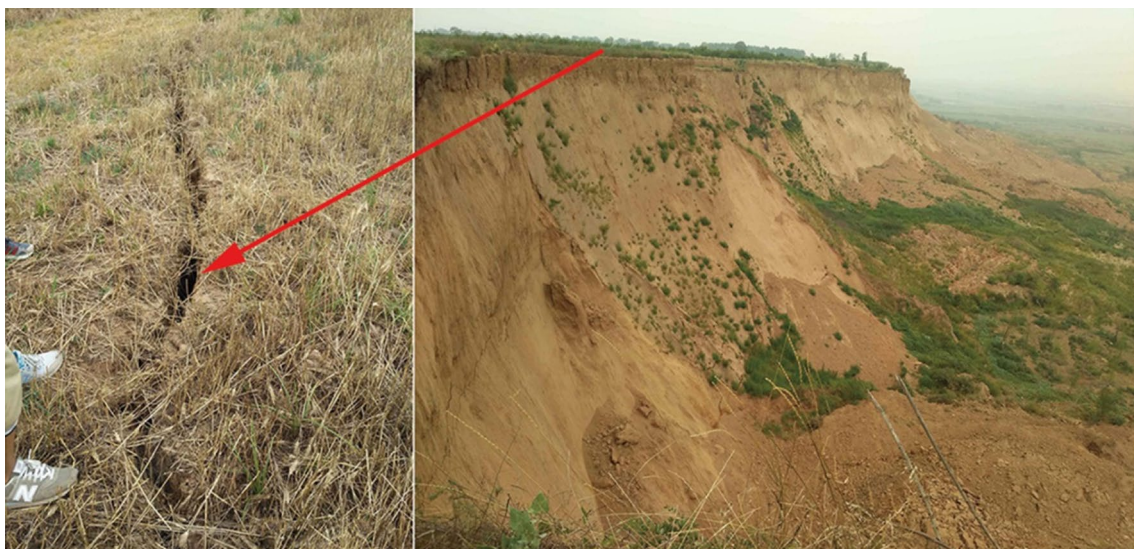
Fig. 2 Due to the irrigation, a large amount of water infiltrates into the farmland, resulting in uneven collapse of the land, and longitudinal cracks appear along the edge of the plateau, which reduce the slope stability, leading to the occurrence of landslides

a series of geological problems have occurred. For example, given perennial irrigation, cropland in this area already exhibits evidence collapsible phenomena, thus resulting in many longitudinal fractures along the river in the Loess Plateau. Such problems have led to the occurrence of a chain of landslides and have continuously reduced arable land as depicted in Fig. 2. The test site is an earth-fetching area. Figure 3 displays that the section of loess from Malan (L_1) to Lower Lishih (L_6) is completely exposed due to artificial cutting. The Malan loess obtained in this site is of Pleistocene age and Aeolian origin upon the earth fetching area.
