# Investigation of the ground movement due to underground mining at the Jinshandian Iron Mine in China

## Abstract

**Keywords** Underground mining · Sublevel caving · Ground movement · Movement and break angles · Horizontal stress · Discontinuity

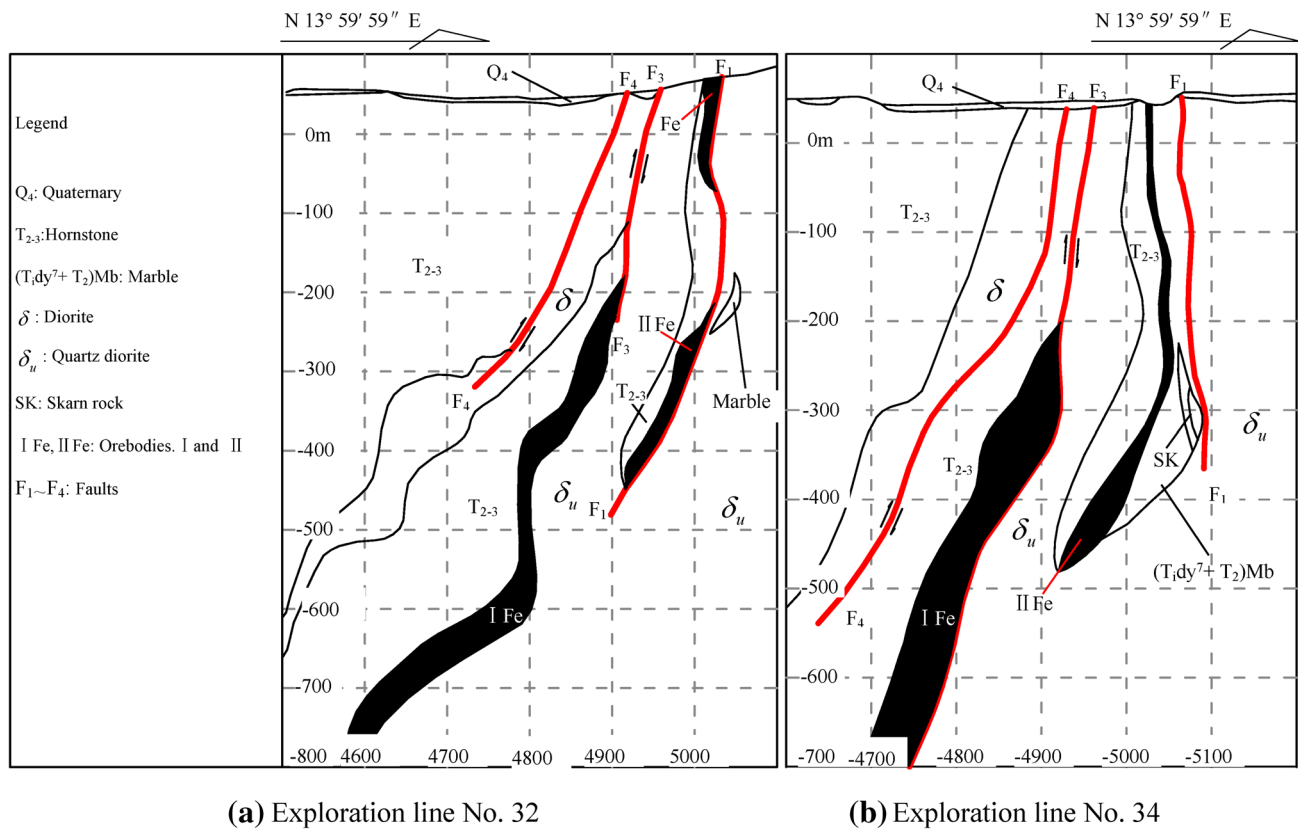
Fig. 2 Typical geological profiles

Four subparallel faults with strikes in an approximate E–W direction are found in the mining area (see Figs. 1 and 2). Their features can be summarized as follows:

From Figs. 1 and 2, it is clear that the overburden strata above orebody II are mainly comprised of marble, and that the discontinuity within the marble is quite developed. At the same time, karst cavities can be found in some local areas within the marble. Overall, the rock-mass quality of the marble falls in the poor range according to the RQD classification scheme. As the SLC method was adopted without sill pillars in the Jinshandian Iron Mine, the overburden strata were inevitably subjected to caving when the underground orebodies were extracted, and this would lead to the free displacement of the overburden strata. Due to the poor quality of the marble and presence of large-scale privately-mined voids in the overburden strata, the caving of the overburden strata would develop progressively towards the ground surface as the underground orebodies were excavated deeper and deeper.

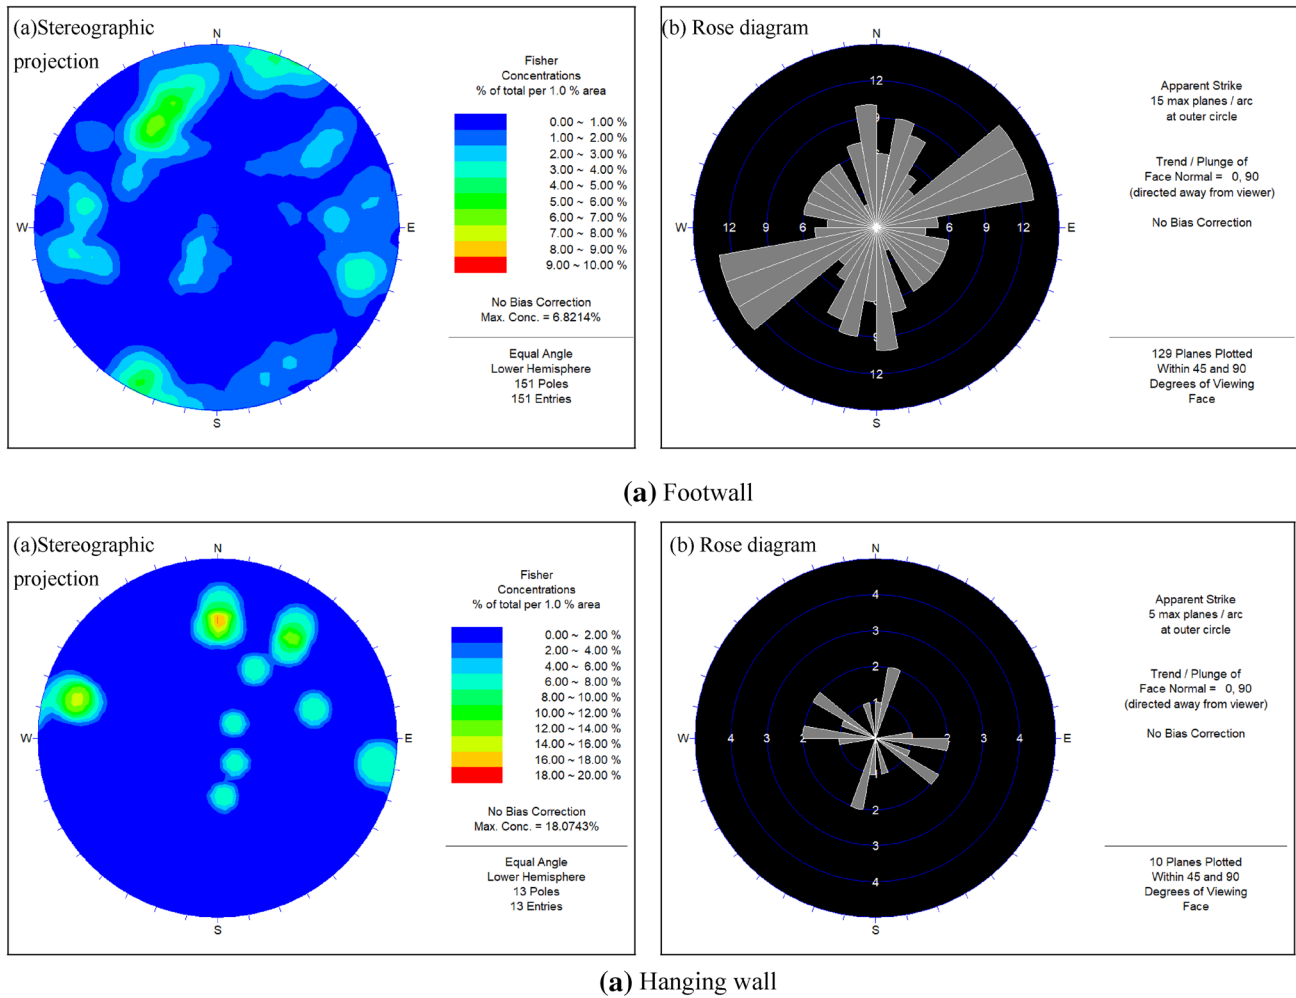
Fig. 3 Rose diagrams and stereographic projections for the discontinuities in the hanging wall (hornstone) and footwall (mainly quartz diorite)

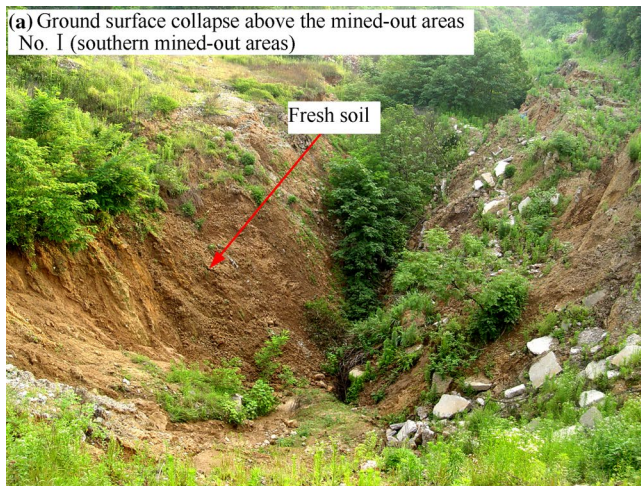
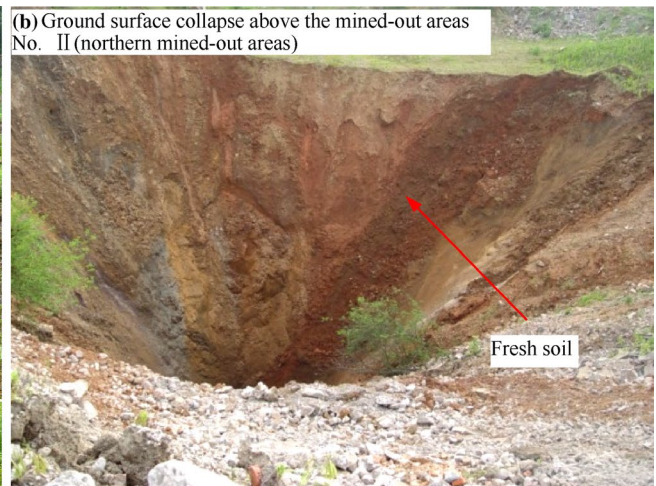
**Fig. 7** Ground surface collapses above the mined-out areas

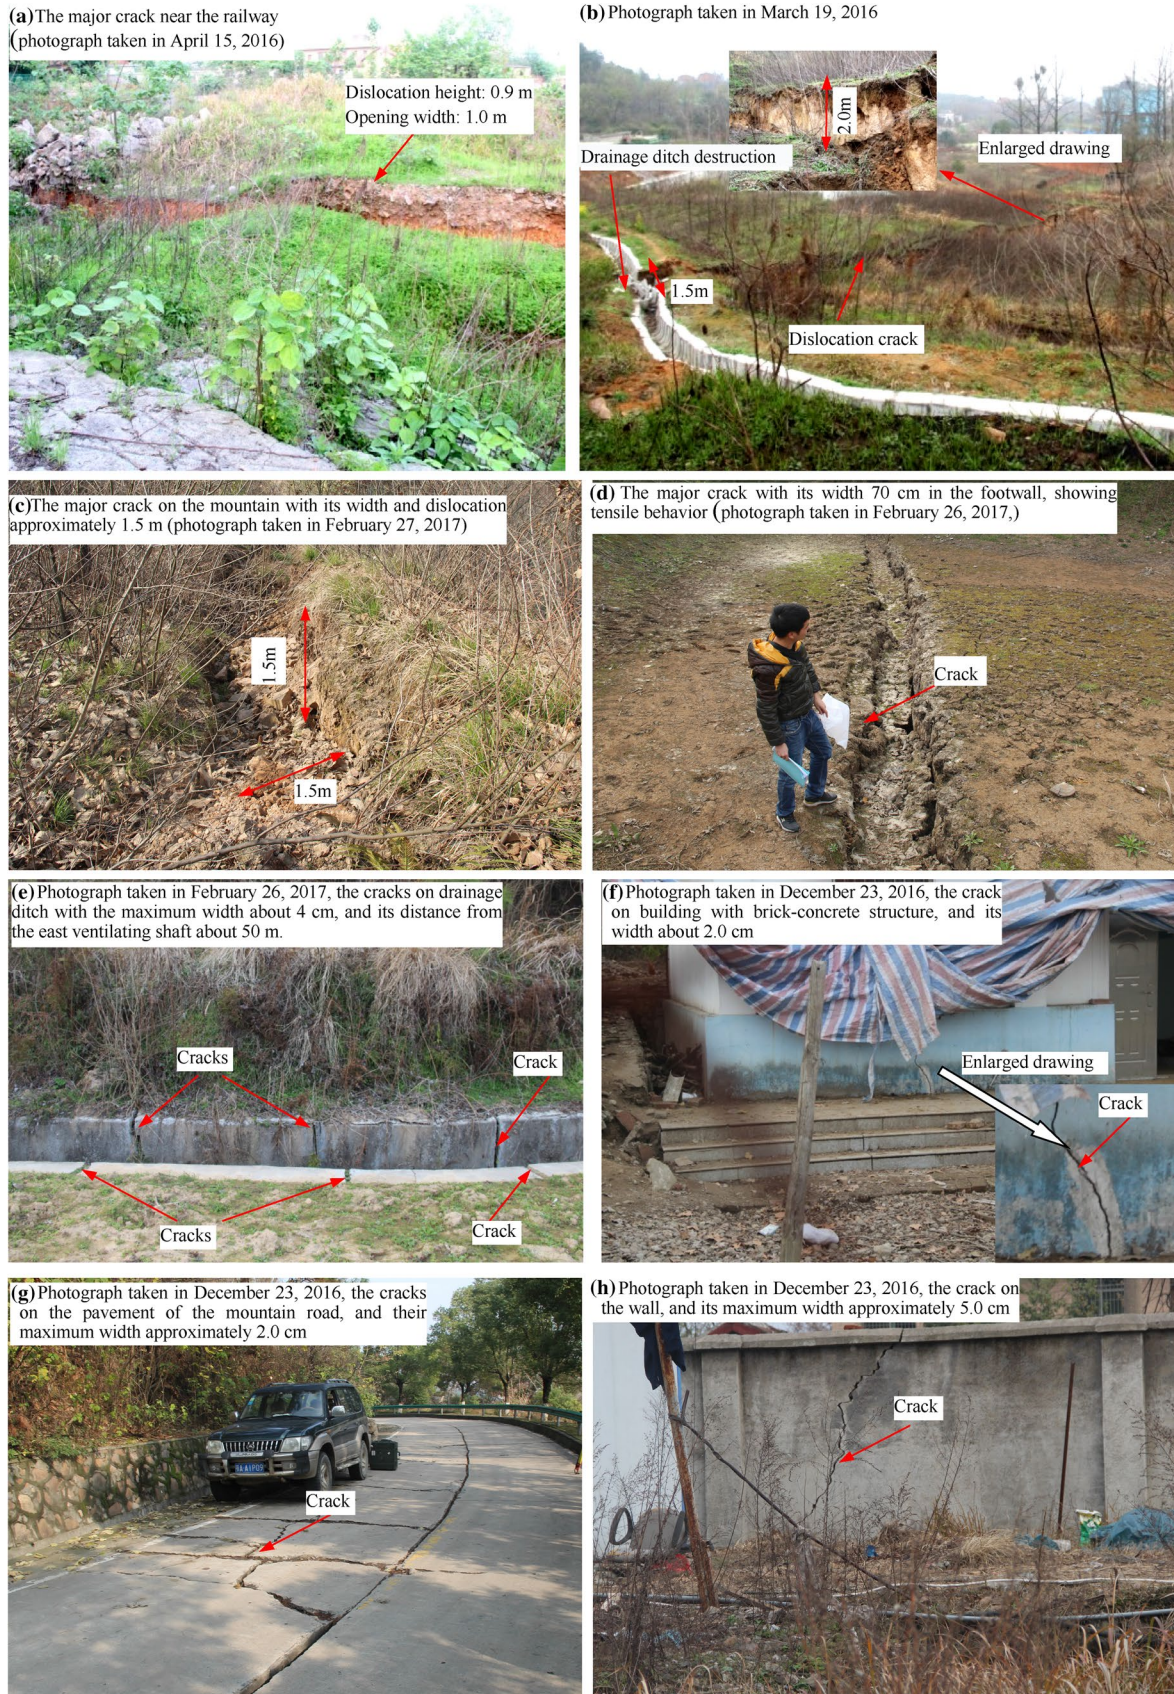
Fig. 8 The cracks on the ground surface, the buildings and facilities (the location of these cracks is seen in Fig. 6)

With the mining activities extending to greater depth, two field investigations of the ground surface cracks were specifically conducted in December 2014 (after ground surface collapse) and in December 2016 (Fig. 6): in the hanging wall, only a few ground surface cracks with a scattered spatial distribution were observed near the boundary of the mined voids (the maximum distance was about 80 m to the mined-out areas, see Fig. 8d), and their widths mostly range from 40 to 80 cm. However, in the footwall, many large ground surface cracks with significant dislocation and opening can

be found (Fig. 8a, b, c), and the dislocation displacement can reach approximately 2.0 m.

In these areas, two major cracks of length ~ 130 m can be found that intersect with the drainage ditch (Figs. 6 and 8b). Their strikes approximately lie in the direction N 70° W, and their dislocation and opening displacements amount to 2.0 m and 1.5 m, respectively. Meanwhile, a branched major crack was found in the western area near the mined-out region (with a strike of approximately N 30° E and length of about 80 m). Outside the branched major crack, a major crack was to be found with a length of about 100 m and dislocation and opening displacements that are both about 1.5 m (Figs. 6 and 8c). Its strike is generally parallel to the branched major crack. Moreover, the outermost major cracks are approximately 100 m from the boundary of the mined-out areas in the footwall. Regardless of the cracks in the hanging wall and those in the footwall, these cracks mostly show evident shearing behavior.

In many mining-affected areas it is often hard to find cracks in the ground surface. However, in this case, it was easy to see cracks in concrete pavements, brick-concrete structural facilities and buildings (see Fig. 8e–h). In general, these cracks are mostly ranged from 1 to 3 cm wide. More specifically, at ~ 50 m away from the east ventilating shaft, the widths of the cracks in the drainage ditch are of the order of 2 cm (Fig. 8e),

and the width of the crack in the subsidiary building of the backfill station is approximately 1.5 cm (Fig. 8f).

column-shaped rock masses began to slide and topple along them towards the mined-out areas. We refer to these areas as ‘sliding–toppling’ areas. At the present time, slippage and tensile phenomena can be readily observed at ground level near the major cracks (Fig. 8b, c).

According to the foregoing analysis, the excavation of the underground orebodies is clearly a vital factor influencing the movement of the ground in the footwall of the mine. Discontinuities within the surrounding rock mass can also significantly affect the behavior as they are geological defects. If there is a major discontinuity in the surrounding rock mass that has a strike that is generally parallel to the boundary of the mined voids, then rupture will preferentially occur along this major discontinuity. Therefore, the macroscopic deformation of the ground surface is such that the major dislocations and opening cracks are formed along the major discontinuities (see Fig. 8b, c). Hence, the presence

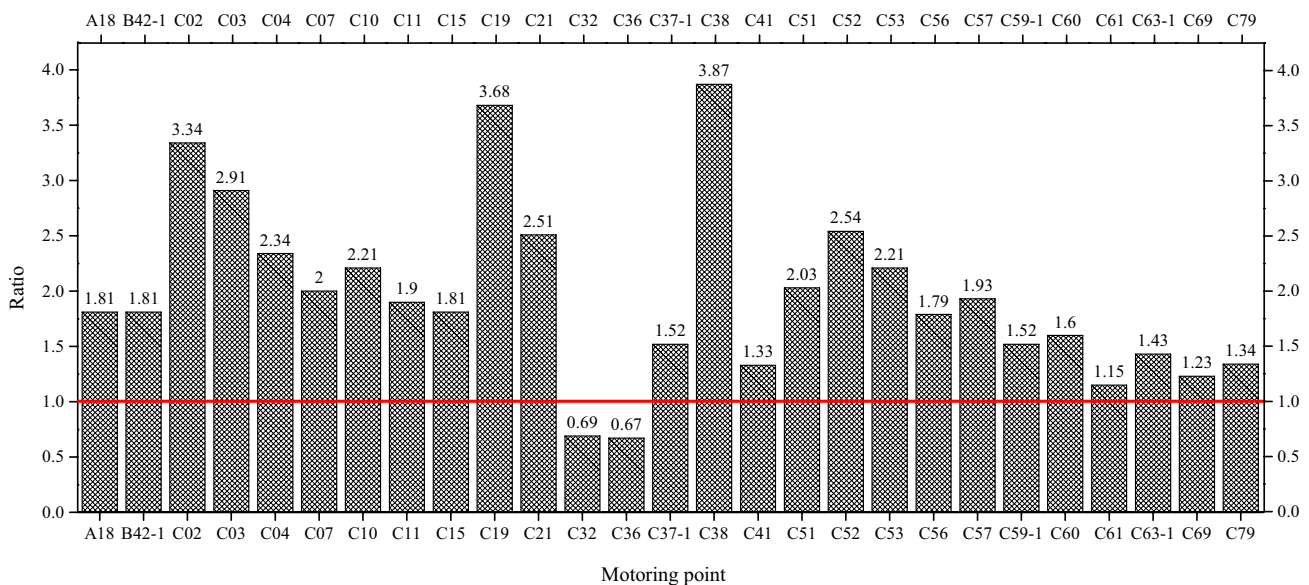
**Fig. 10** Ratio of the horizontal to vertical displacements from the monitoring points

As can be seen from Table 8 and Fig. 10, only a few monitoring points near the boundary of the mined voids are found to have HD/VD ratios of less than 1.00, i.e., monitoring points C32 (0.69) and C36 (0.67)). Therefore, this ratio is generally greater than 1.00 for the majority of the monitoring points (where it may reach up to 3.87). Moreover, the ratio gradually increases as the distance from the boundary of the mined voids increases. For example, in the southern part of the mining-affected area, the ratio increases in the sequence C69 (1.23) to C63-1 (1.43) to C21 (2.51) to C19 (3.68) as one moves away from the mined-out voids. This latter value is roughly three times that at C69.

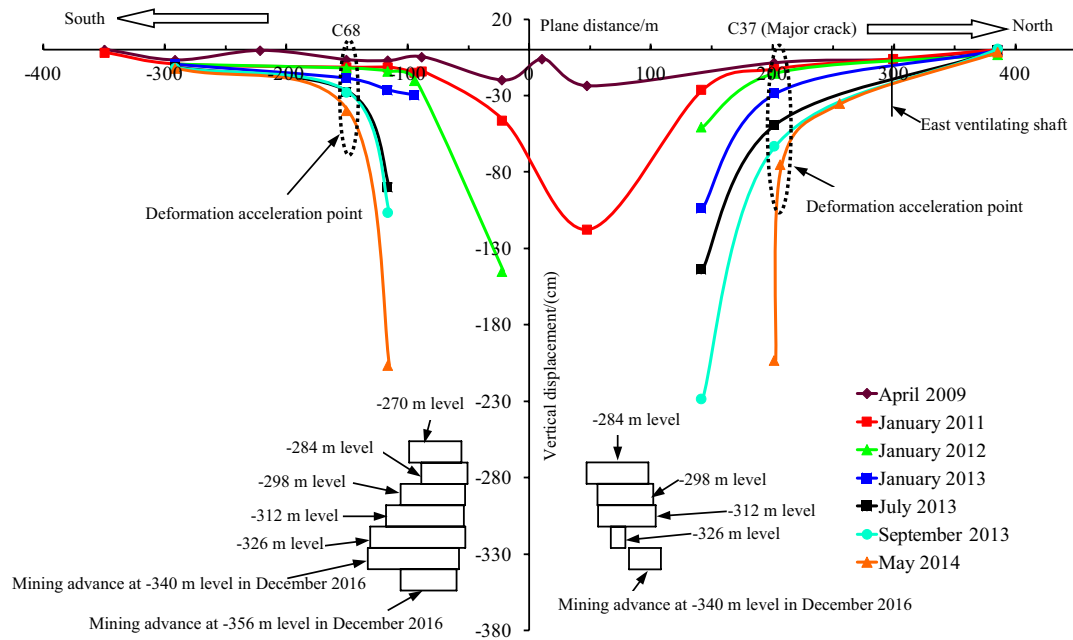
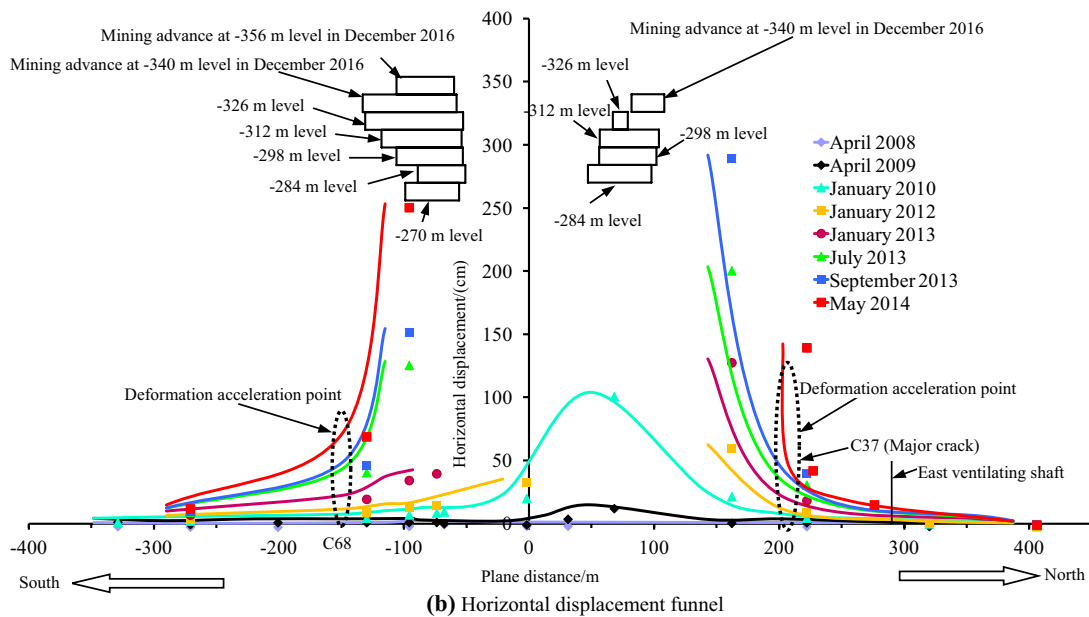
(a) Vertical displacement funnel

(b) Horizontal displacement funnel

Fig. 11 Vertical and horizontal displacement funnels at profile I

Similarly, in the southern mining area (i.e., south of the origin point O in the coordinate axis  $x$ , see Fig. 11a), a deformation acceleration point was found at monitoring point C68, and the vertical displacement was small in the southern part of the monitoring point C68. However, the vertical displacement rapidly accelerated in the northern part of monitoring point C68. For example, the rate of vertical displacement at monitoring point C14 changed from 0.28 mm/d (in December 2011) to 2.64 mm/d (in November 2013).

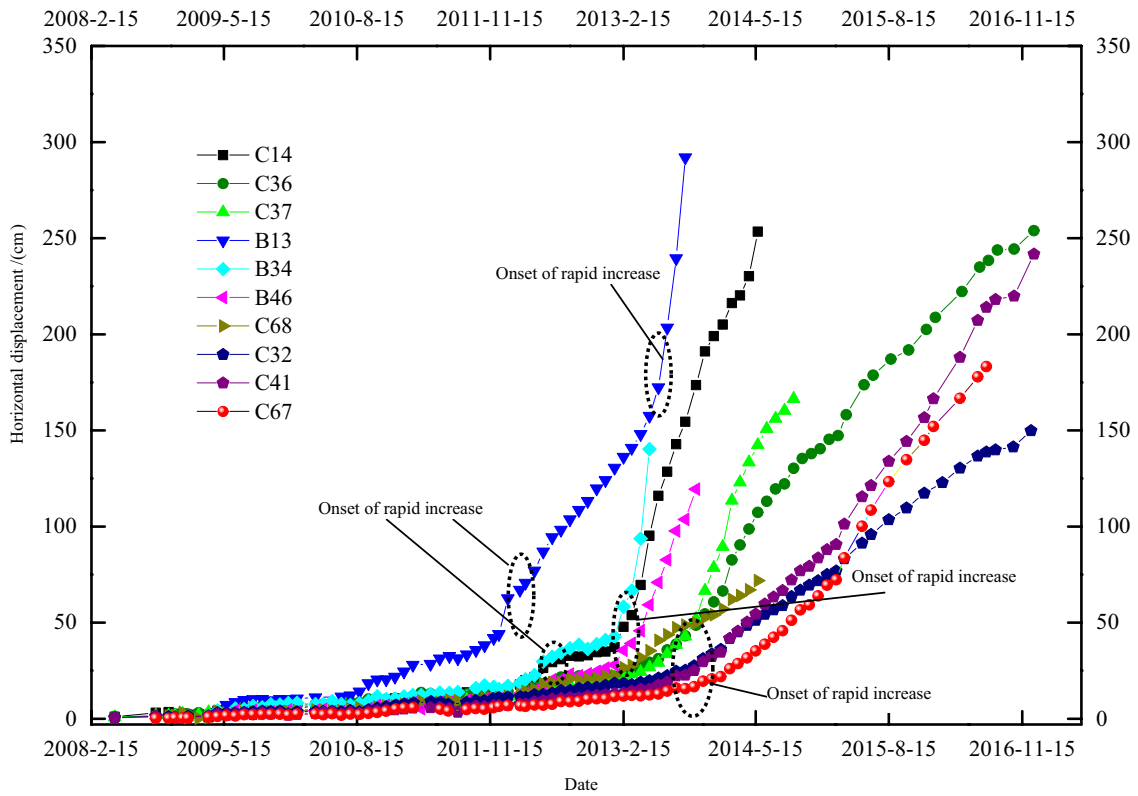
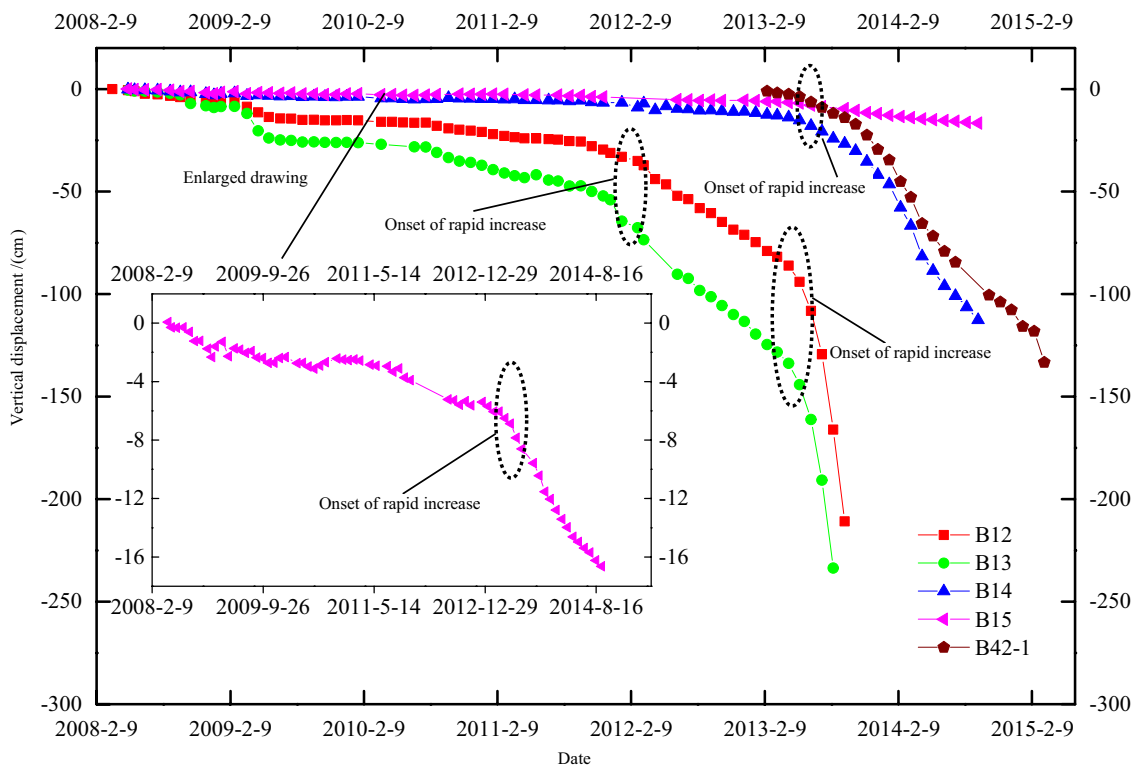
(a) Horizontal displacement

(b) Vertical displacement

Fig. 12 Displacement–time curve around the collapse pit

Figure 12 shows the horizontal and vertical displacements of the surface as a function of time. As can be seen, there are several, obvious, onset points at which the displacement rapidly increases in the area associated with the collapse. Xia et al. (2016) have reported observing several typical types of displacement–time curve at the Chengchao Iron-ore Mine in China, which they refer to as ‘folding’, ‘S’ and ‘linear’. Of these, the folding-type corresponds to the appearance of points marking the obvious onset of rapid changes in displacement. Thus, the displacement–time curves observed near the collapse pit in the Jinshandian Iron Ore Mine in this work can be seen to be of the folding-type.

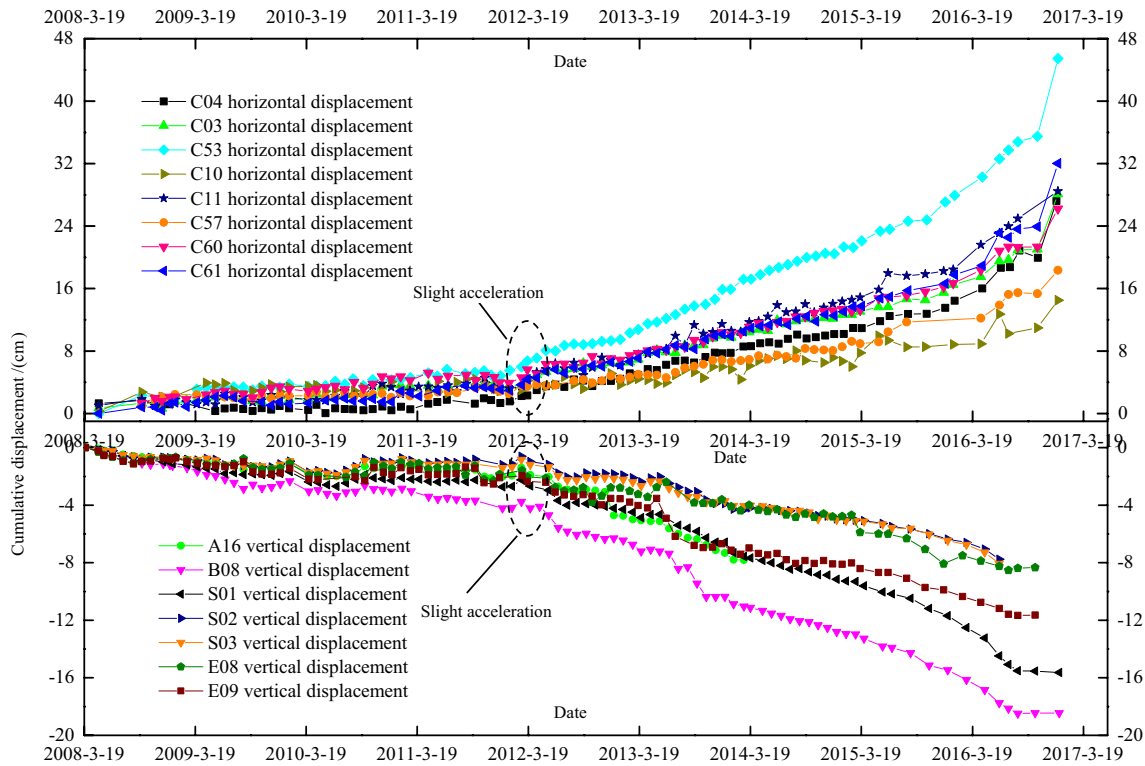
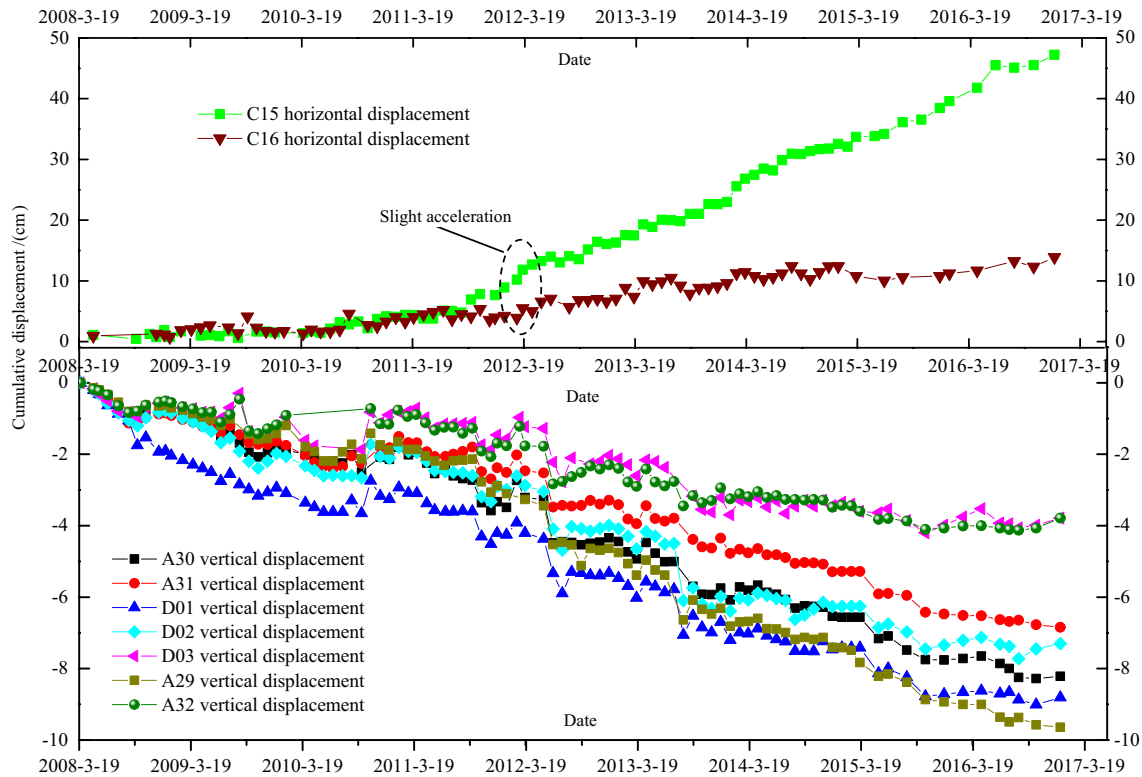
(a) Eastern part of the collapse pit

(b) Western part of the collapse pit

Fig. 13 Displacement–time curve around the eastern and western parts of the collapse pit

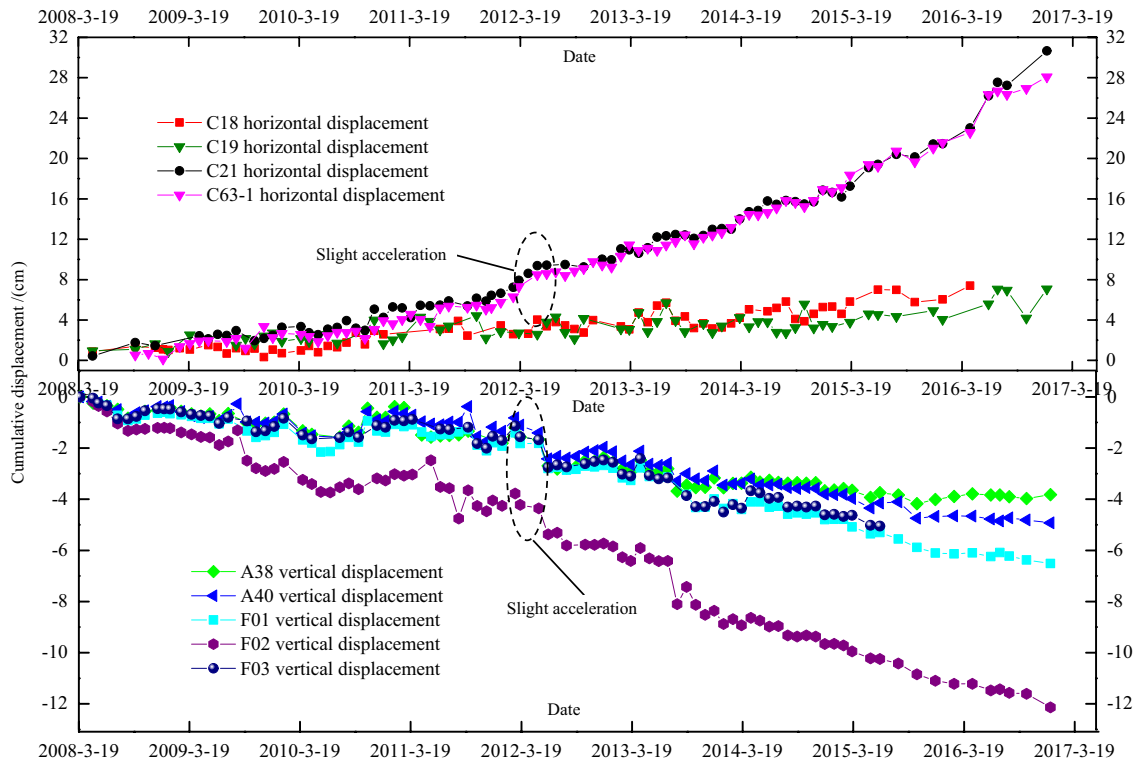
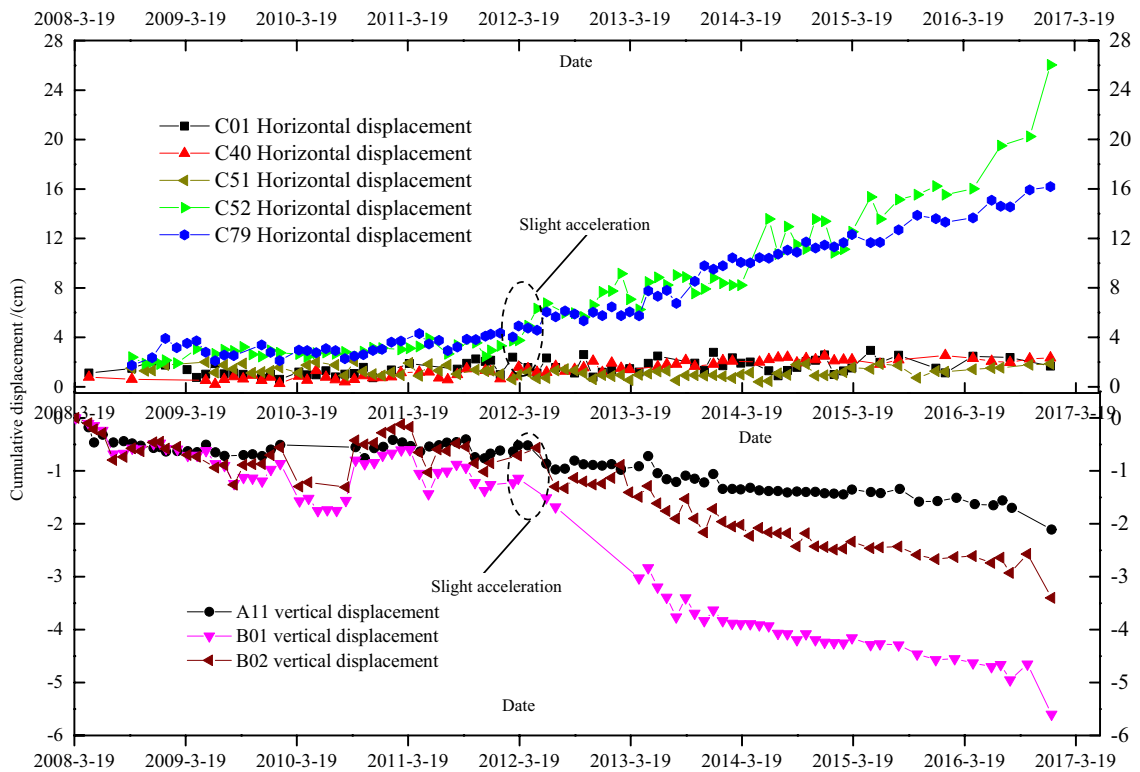
(a) Southern part of the collapse pit

(b) Northern part of the collapse pit

Fig. 14 Displacement–time curve around the southern and northern parts of the collapse pit

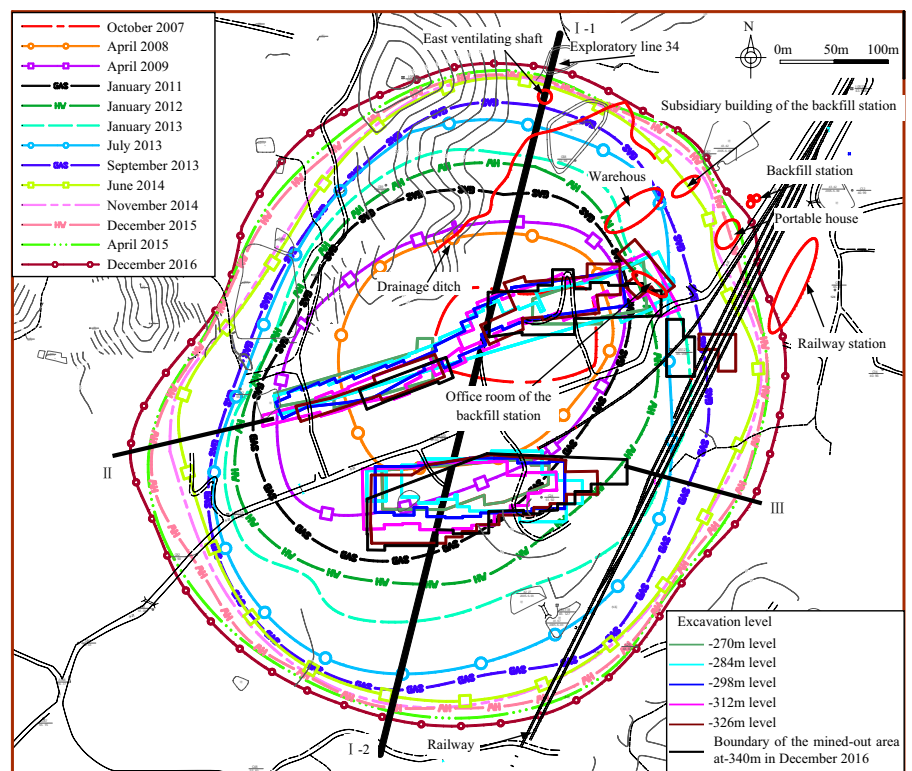
**Fig. 15** Distributions of the break and movement lines: April 2007 to December 2016

**(a)** Break line

**(b)** Movement line

Some regular patterns can be found in the mining-induced ground movement alluded to in Fig. 15, as follows:

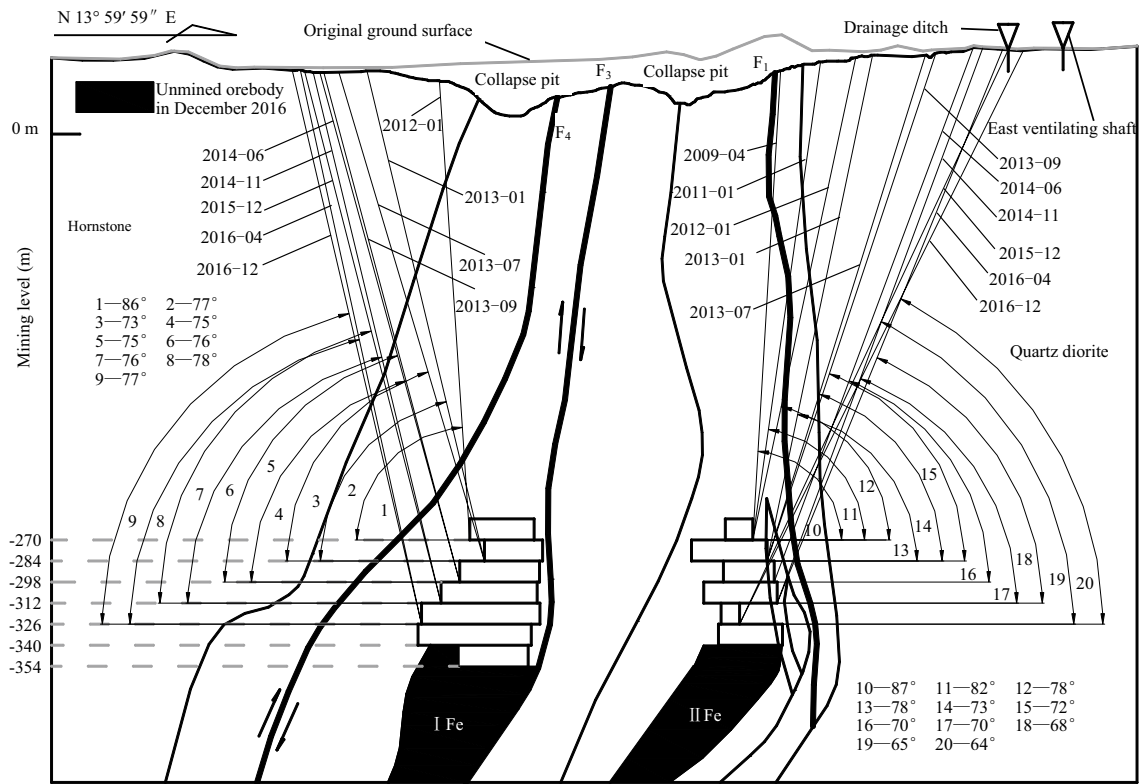
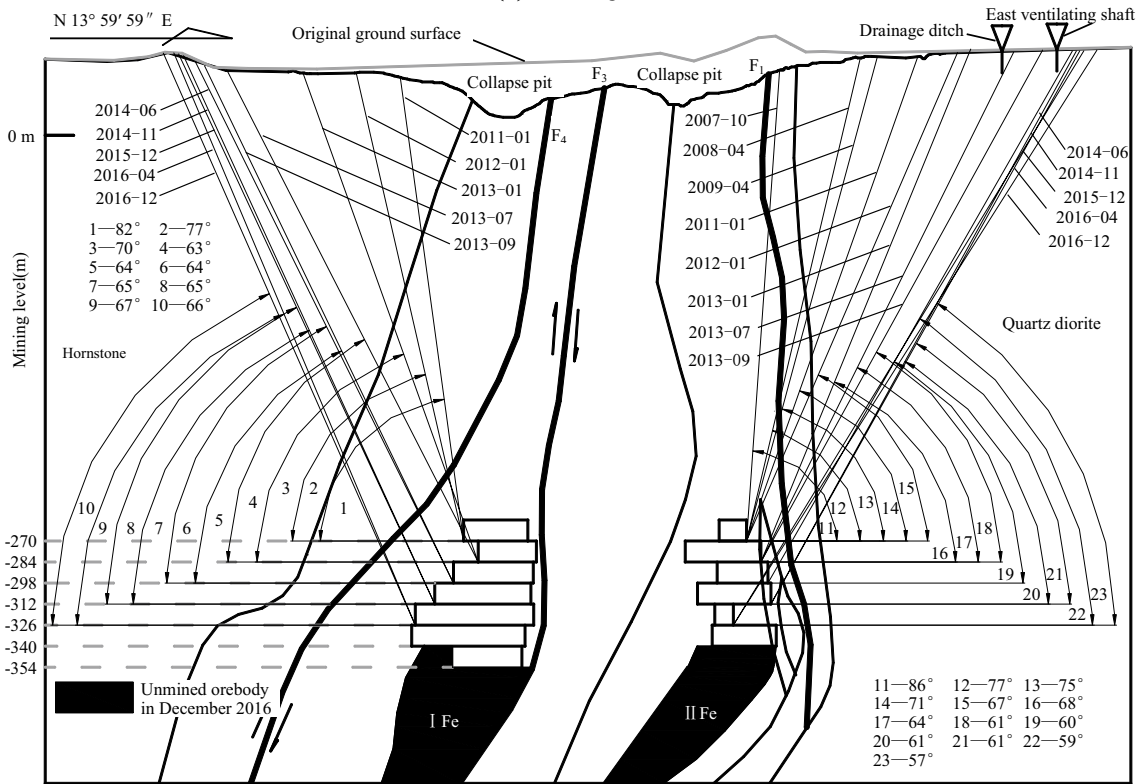
(a) Break angle

(b) Movement angle

Fig. 16 Distributions of break and movement angles: April 2007 to December 2016

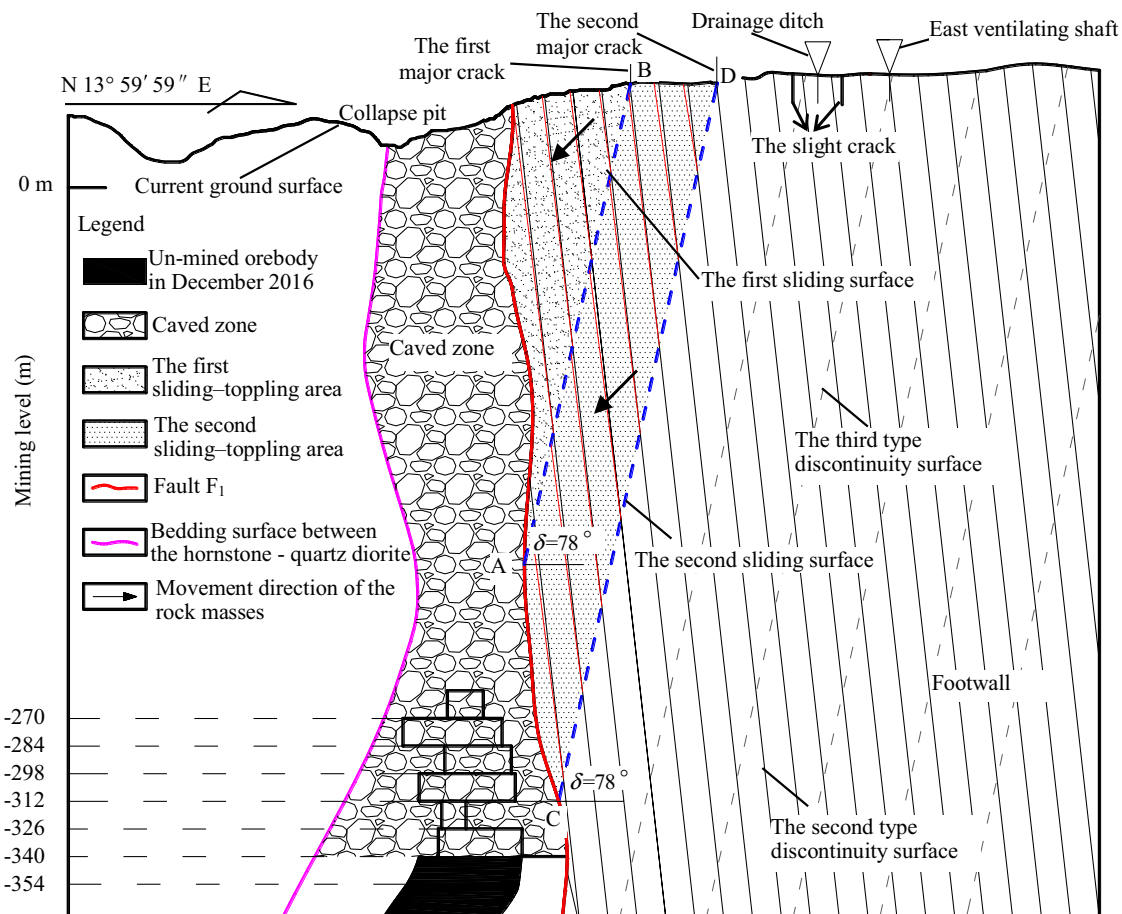
**Fig. 17** Ground movement of the rock masses surrounding the mined-out areas in the footwall ( $\delta$  refers to the dip angle of the sliding surface)

Clearly, the major cracks can be thought of as defining the locations of the sliding surfaces of the column-shaped rock masses (or overlapping column-shaped rock masses) at the ground-surface. The field investigations revealed that two major ground-surface cracks are to be found near exploration line 34. Therefore, there must be two obvious sliding surfaces in the rock masses surrounding the mined-out areas in this area (referred to as the first and second sliding surfaces, as the distance from the mined-out areas increases—see Fig. 17).
