# Characterization of El Kherba landslide triggered by the August 07, 2020, $M_w = 4.9$ Mila earthquake (Algeria) based on post-event field observations and ambient noise analysis

## Abstract

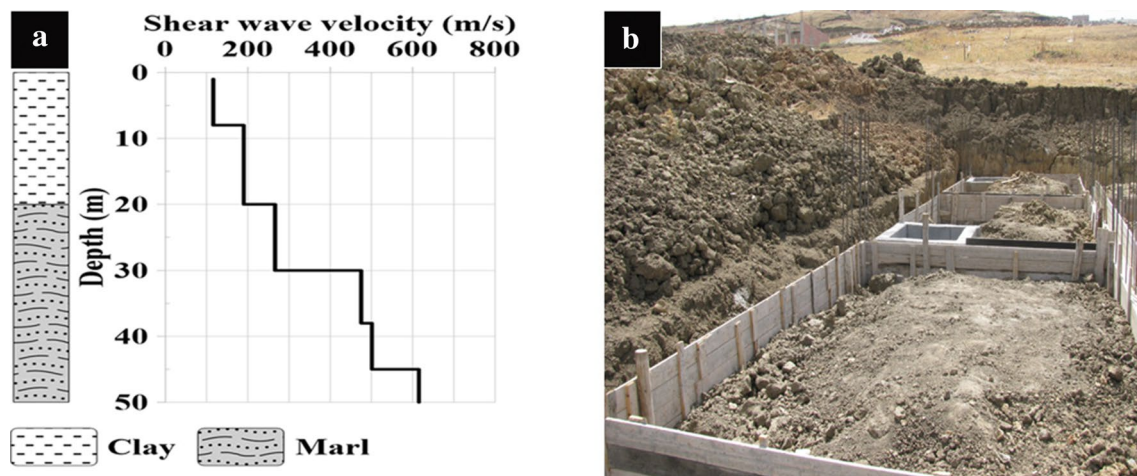
The preliminary results of an unpublished report of in situ and laboratory tests conducted by the National Laboratory for Housing and Construction (LNHC) for the entire Mila region, allowed the identification of two geotechnical units: a clay formation overlying marl bedrock (Zouaoui 2008) (Fig. 2a). The clay formation is sometimes described as silty or sandy for the first two meters, within which gypsum inclusions are found, and its thickness varies from 20 to 38 m. The upper most subsurface unit is characterized by shear velocities of about 100 m/s for depths ranging from 0 to 10 m and 170 m/s beyond 10 m. While density values

**Fig. 2** a Geotechnical model showing the variation of the shear wave velocity as a function of depth in the two lithological units, b photo taken in the landslide body, showing the anchoring of a new construction in the remoulded part of the clay layer

range from 1.5 to 1.7 ( $\text{KN/m}^3$ ), a water saturation higher than 87% and a plasticity index (PI) ranging from 35 to 40%. These geotechnical parameters indicate a low-density plastic soil, with a high water saturation percentage and swelling potential. The marl formation, situated at an average depth of 30 m, is considered in the current work as geotechnical bedrock since it has a shear velocity varying from 500 to 615 m/s, and a dry density between 1.93 and 2.1 ( $\text{KN/m}^3$ ). The latter formation is marked by a medium to low plasticity with PI ranging from 5 to 10%.

**Table 1** Surface of rupture depth ( $H_{rs}$ ) estimation from combining shear wave velocity from geotechnical model (Fig. 2) and soil frequency  $f_0$  from HVSR curves, using Eqs. (4) and (5)

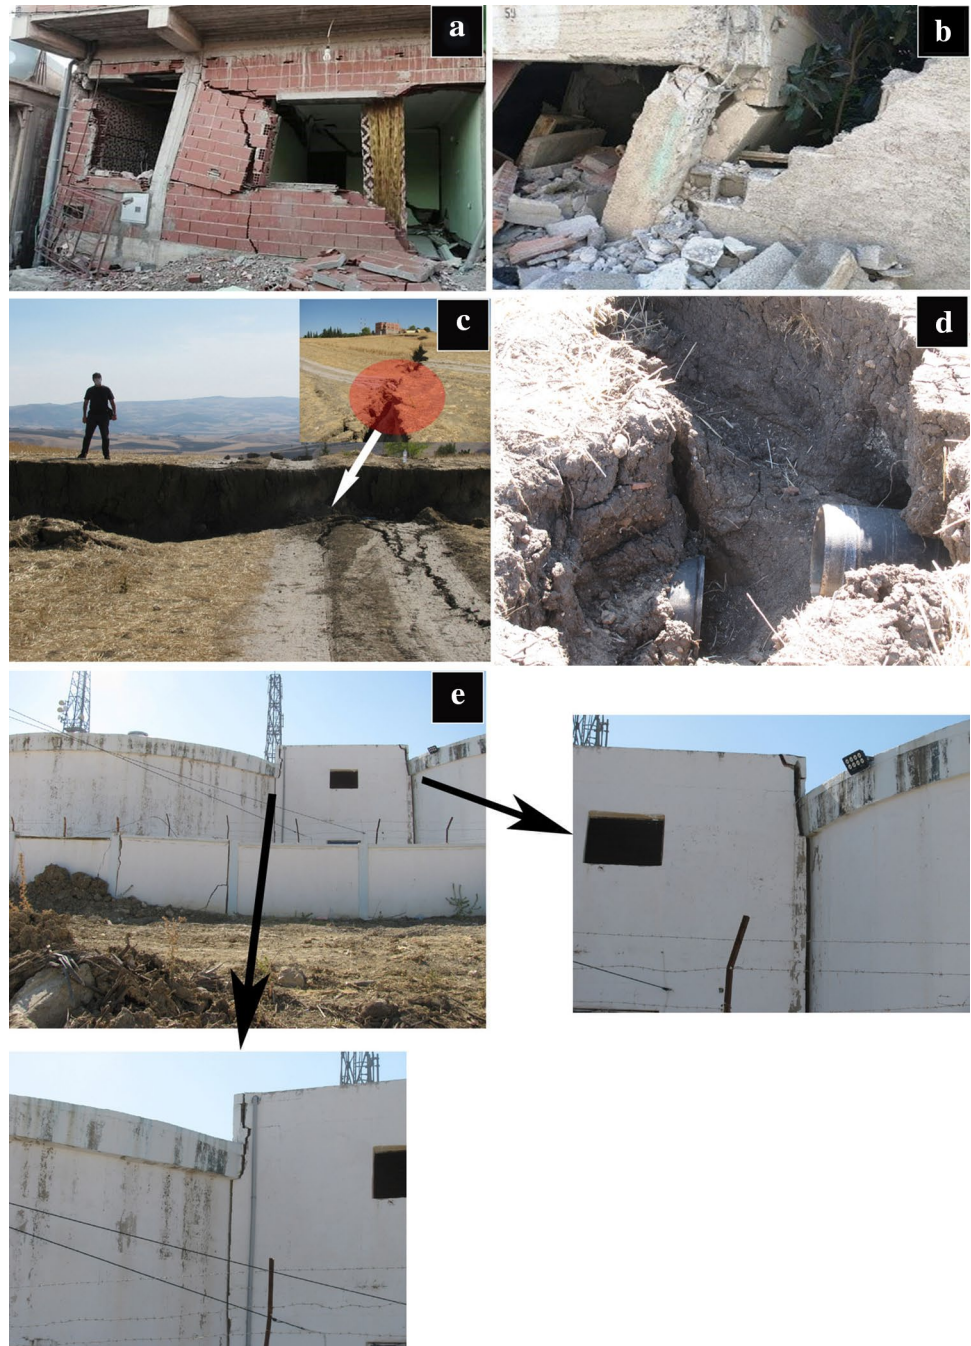
No effects (cracks or other damage) were reported directly after the earthquake. Nevertheless, it was only a few hours after the main shock that the cracks started to develop and propagate, resulting in toppled houses. Indeed, in all surveyed sites, the buildings were suffering from structural damage of varying degrees (Fig. 3a, b), resulting in a total collapse even the more recently built houses. Fortunately,

no casualties were reported. The landslide also caused road subsidence in some parts of the locality (Fig. 3c) and the failure of the sewer network (Fig. 3d). Plus, it caused serious damages to crucial structures like a water tower (Fig. 3e) located at the landslide's crown (Fig. 4a).

**Fig. 3** Photos **a, b** show the damage caused by the landslide to the structural elements of the houses, **c** Subsidence and horizontal displacement of a road, **d** Rupture of a sewer pipe, **e** cracks in the water tower and increase of the opening at the rupture joint

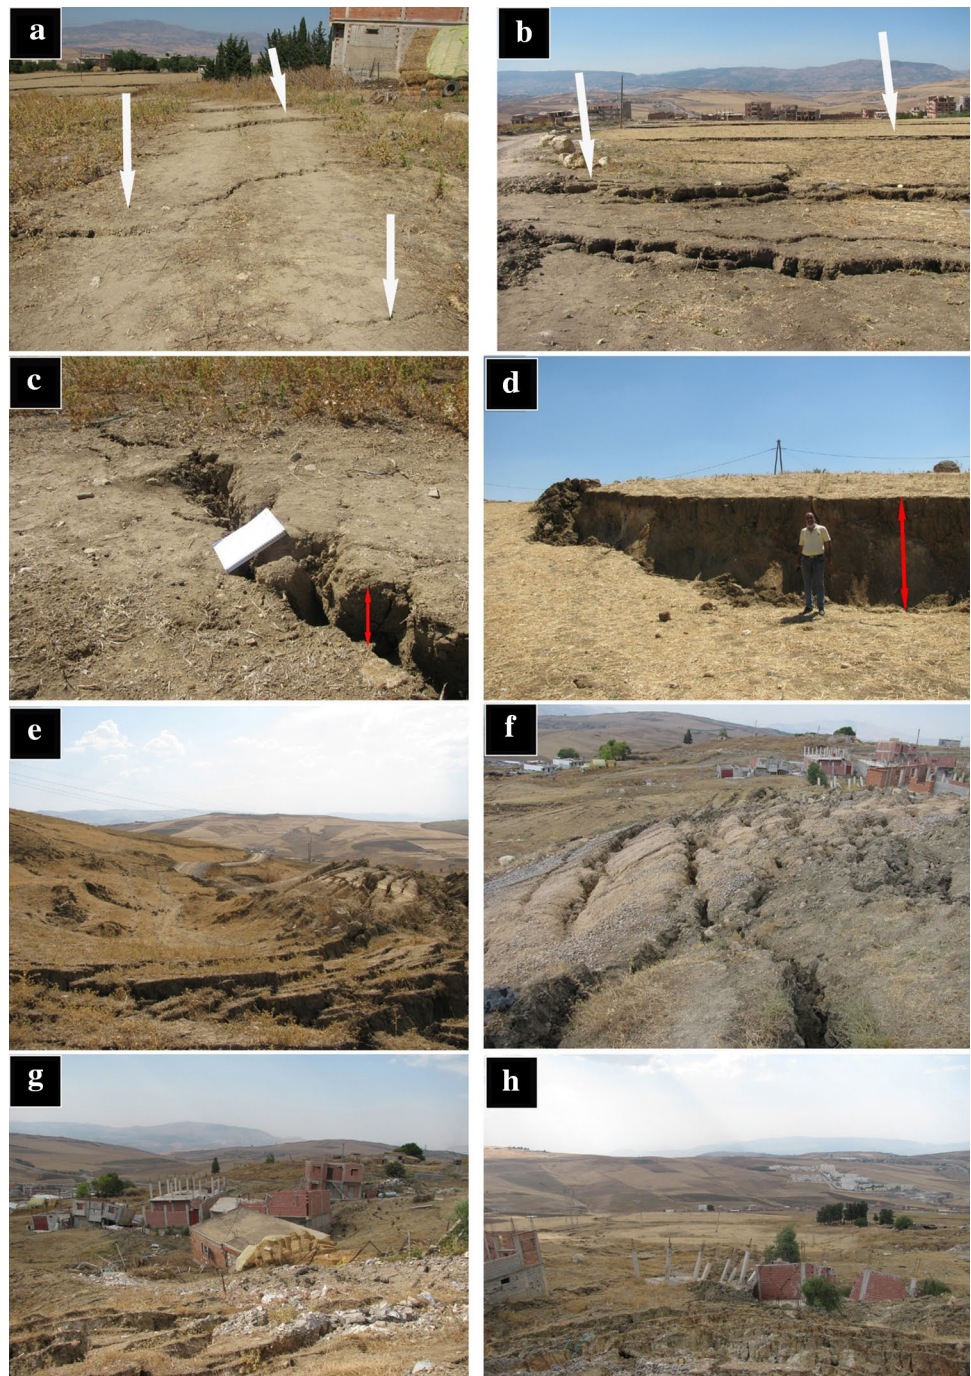
Further down, the main trends (i.e., N55 and N75) show significant fissures with lengths up to 200 m (Fig. 5b). They are observed continuously from uphill to downhill and are perpendicular to the main landslide direction (South to North). Also, they vary in width and depth of openings from few centimeters to few meters (Fig. 5c, d). The N25 and N135 directions mainly exist in the middle part of the landslide, as well as near its flanks. These cracks have a length of few meters, with openings ranging from few centimeters to few meters and few centimeters deep. The cracks of the N10 and N165 directions characterize the landslide flanks and tend to be parallel to them. Moreover, cracks of these trends are longer relative to the others. Some of these

cracks reached several hundred meters, with openings in upheaval zone form, reaching 6 m in width in some places. This is well illustrated in the eastern flank where a recently built house collapsed due to the development of such cracks, while at the western flank, there is a road that has undergone a vertical displacement of 2 m. A significant bulge of highly deformed material (accumulation zone) was created at the landslide foothill, as a result of the thrust exerted by sedimentary deposits. This corresponds to an upheaval zone (Fig. 5e, f) where cracks disseminated in all directions.

At the foot of the landslide, pronounced damage is clearly observed where buildings were tilted, torsioned, overturned, and in some instances totally destroyed (Fig. 5g, h).

**Fig. 5** Examples of fissures (white arrows) and scarps (red arrows) observed in the El Kherba locality: **a** An “en echelon” disposed fissures, **b** a long metric fissures that mark the landslide crown, **c**, **d** scarps with centimetric to metric vertical displacement, photos **e**, **f** taken in the foothill of the landslide showing the beading which is marked by an intense deformation, photos **g**, **h** showing the severity of the damage in the upheaval zone with houses that have undergone an inclination and torsions

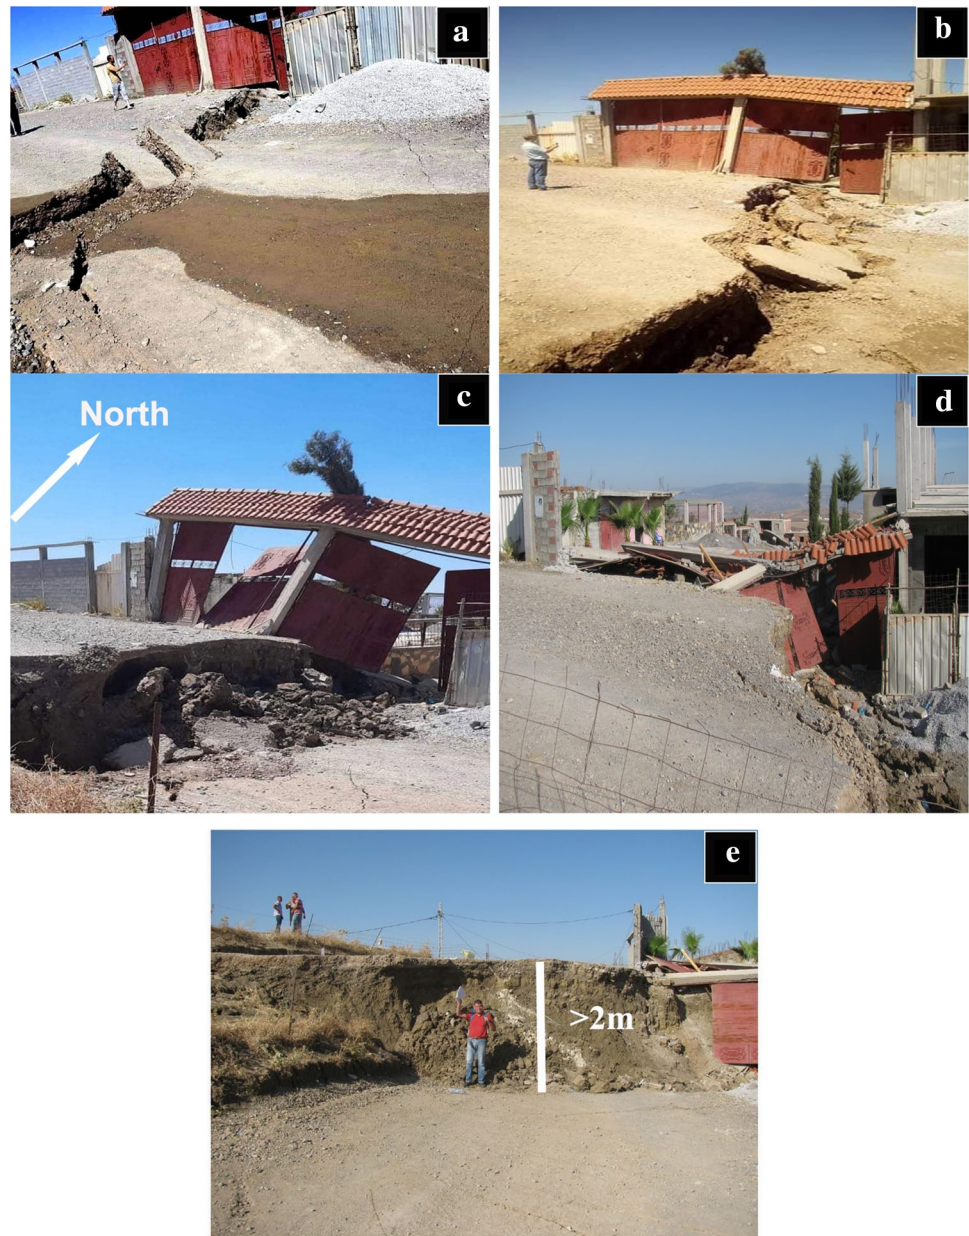
The spatio-temporal evolution of the landslide is well characterized by the development of landslide-related structures and cracks. Indeed, the buildings have undergone continuous deformation. At the western lateral limit, after the earthquake, the same day, a crack with a centimetric vertical throw appeared on the road pavement where two blocks were lifted and affected a house door

(Fig. 6a). The next day (August 8, 2020) the vertical displacement increased, the eastern compartment of the road pavement had settled and the two blocks were caught in the fissure (Fig. 6b), the eastern part of the door was tilted. On August 9, 2020 the vertical throw reached 1 m and the entire door was tilted northward (Fig. 6c). On August 11, 2020, the door collapsed and was buried in the ground (Fig. 6d). On that day, the vertical throw exceeded 2 m (Fig. 6e).

**Fig. 6** Evolution of a lateral scarp from a centimetric **a** to a metric **e** vertical displacement affecting an entrance gate that tipped and then was buried in the ground

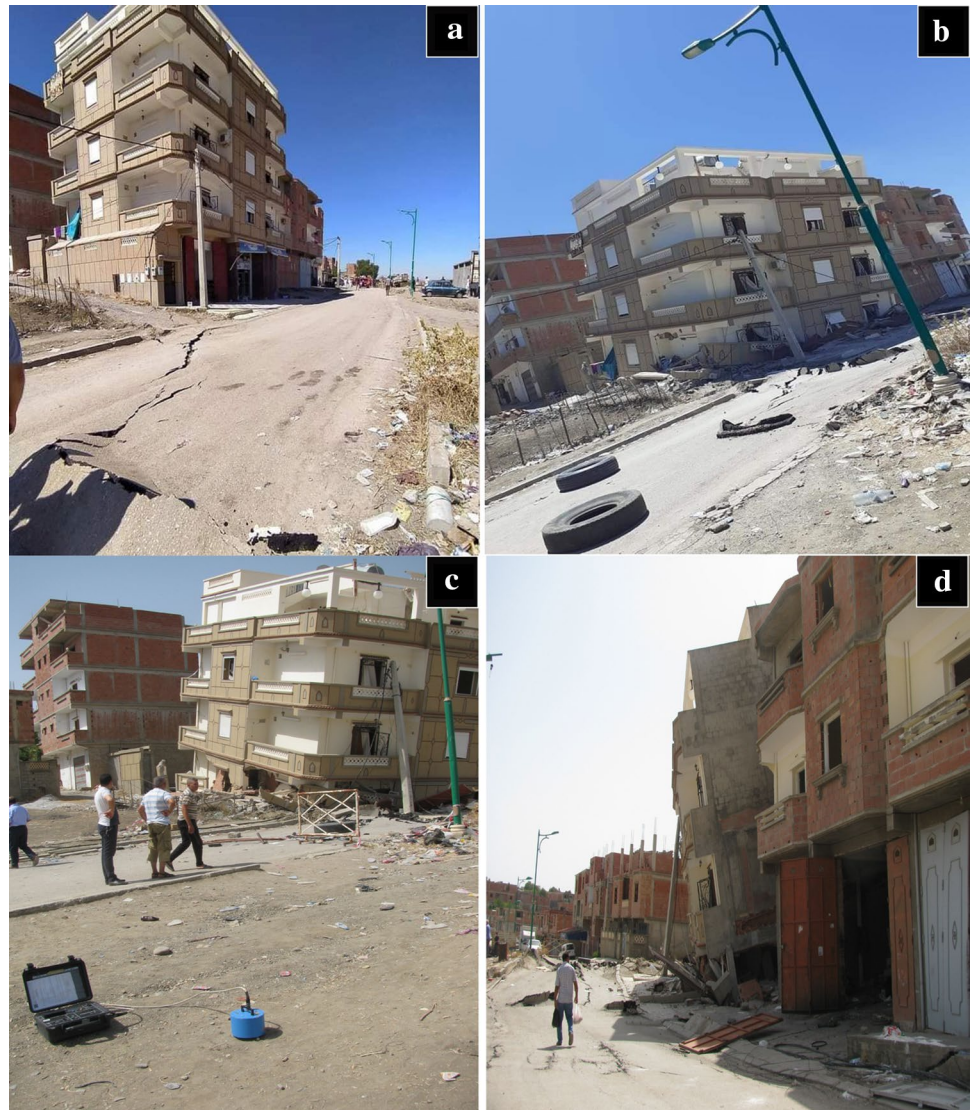
At the eastern flank of the landslide, further evidence illustrating the landslide evolution exists such as a crack that appeared in the pavement without affecting the surrounding building (Fig. 7a). The day after the earthquake, this building tilted northward, the first floor collapsed, and the second floor began to sink into the ground (Fig. 7b). On August 12, 2020, the first floor collapsed completely, and only the second, third, and fourth floors remained visible (Fig. 7c, d).

**Fig. 7** Example illustrating landslide evolution showing the tilting and sinking of a building

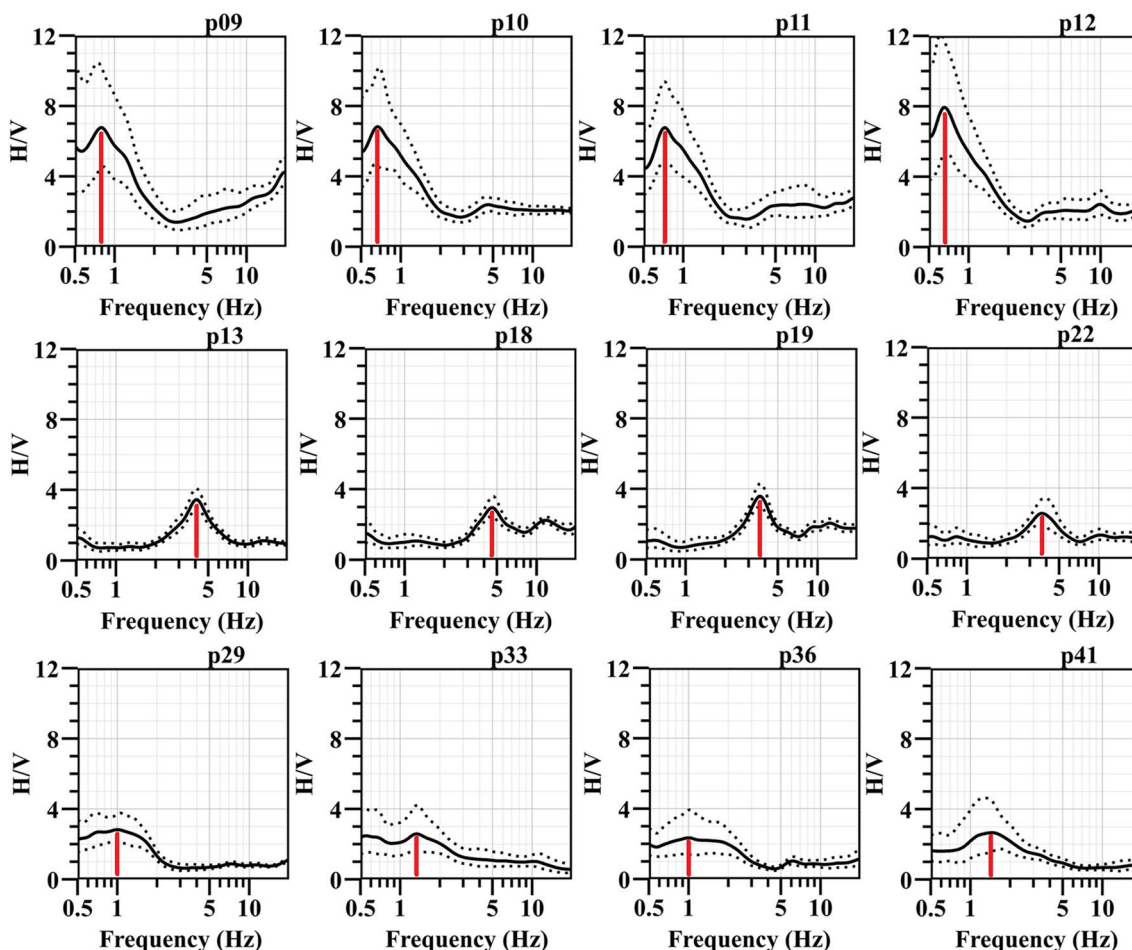
The HVSR curves obtained, over a frequency range from 0.5 to 20 Hz, show three distinct patterns. The HVSR curves in the stable part (sites P29, P33, P36, and P41) reveal peaks around 1–1.5 Hz that can be associated with the interface separating the marl and clay layers (Fig. 8).

The sites located on the landslide boundary (Fig. 8) (sites P09, P10, P11, and P12) present a distinct peak in low frequencies, from 0.6 to 0.8 Hz, marked by large amplitudes. Other peaks are also visible in the high frequencies, at about 5, 10 and 14 Hz, but with lower amplitude than those observed previously. Since these peaks are

**Fig. 8** HVSR curves obtained from an average of the horizontal components as a function of frequency (Black solid lines) at recording sites located in the landslide limit (first row) unstable zone (second

row) and stable zone (third row). The red line shows the main frequency of each frequency spectra

not visible on the stable part, this suggests the possibility that they may be associated with the presence of fractures at the landslide boundary and near the lateral scarps.

In the unstable part, the HVSR curves (Fig. 8) (sites P13, P18, P19, and P22) display a different pattern from the stable part, but similar to that near the landslide flanks, with entirely different features in high frequencies. Indeed, a very high amplitude peak appears at a frequency between 3 and 14 Hz. The interpretation of this observation, based on local geology, indicate that this peak is typical in the unstable part only, and may be associated solely with the soil remoulding. Indeed, the outcropping clay layer is excessively fractured and reveals an important decrease in its mechanical properties such as density and shear velocity. This could happen due to the mobilization of loosened materials (Kakhki et al. 2020), leading to a low-velocity contrast between the remoulded soil in the upper part and the undisturbed deep part below the surface of the rupture.

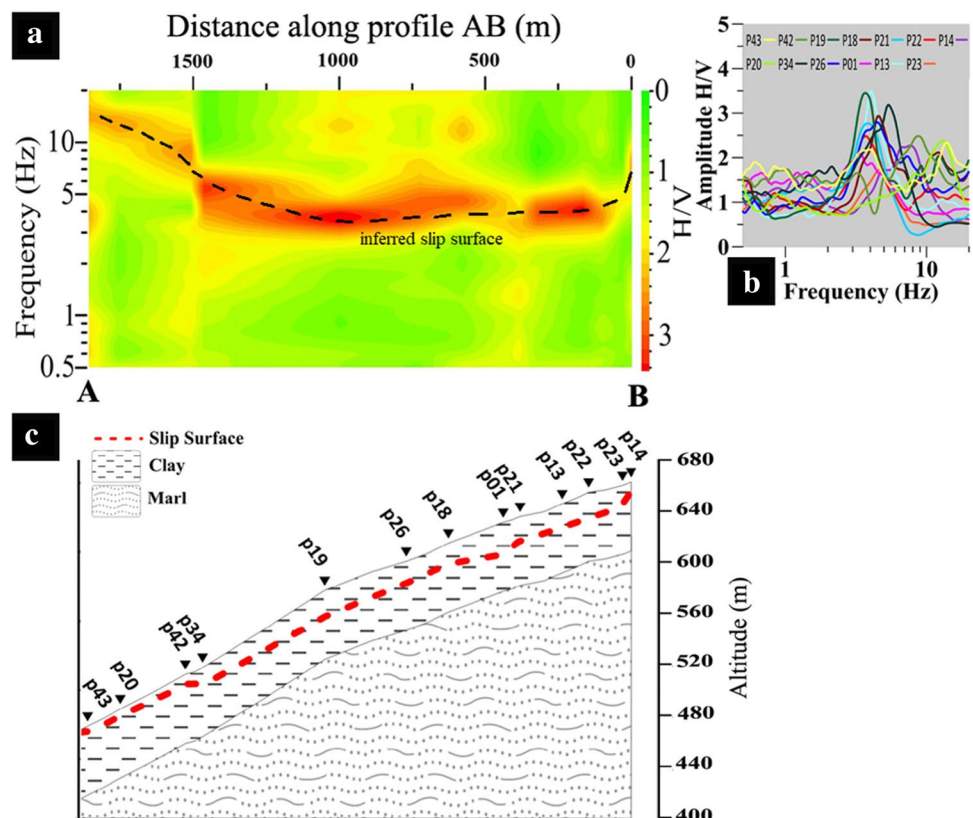
Along the AB profile (Fig. 4b), a 2-D profile (Fig. 9a) is obtained from the combination of all the HVSR spectra (Fig. 9b). The latter shows the spectral response over the entire slope, where an amplitude variation can be detected, suggesting that the fracture surface shape has changed. Subsequently, the average shear wave velocity obtained from the LNHC report coupled with the fundamental frequencies derived from HVSR curves enabled the

Based on the estimated depths, surface of rupture is mapped accurately along AB profile (Fig. 9c). The rupture surface may be located in the shallow clay layer at  $2.14 \pm 0.11$  m to  $8.35 \pm 2.68$  m (see Table 1). The depth variation is reflected by a significant shift in peak's frequency, associated with the landslide thickness decrease, and change in mechanical characteristics and soil properties induced by the landslide (Kakhki et al. 2020). Furthermore, water content plays an important role in triggering landslides. Indeed, a soil's water content above a certain threshold may reduce or diminish cohesion between the grains, which further leads to soil embrittlement.

**Fig. 9** a 2-D diagram obtained from the combination of all the noise measurements along the profile A–B as a function of distance and frequency. b HVSR curves at the recording sites located along the A–B profile in (Fig. 4b). c Geological cross-section along the A–B profile showing the estimated slip surface in red dashed lines
