# Experimental research on deformation failure process of roadway tunnel in fractured rock mass induced by mining excavation

## Abstract

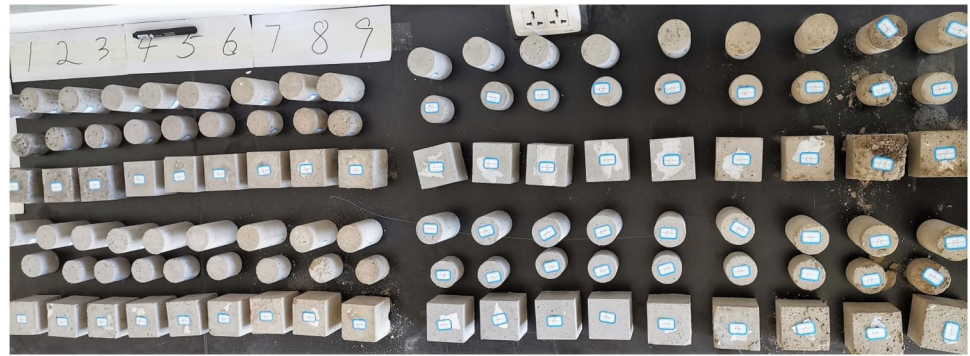
**Fig. 3** Parts of the samples (Li et al. 2020a, b, c)

A crucial part of a large-scale physical model test is quickly and accurately determining the ratio of similar materials. Most of the roadways in the study area are distributed in the marble rock mass on both sides of the ore body, and the physical and mechanical parameters of the intact marble rock and marble rock mass are shown in Table 2. River sand, cement, and gypsum were adopted as the raw materials to reduce the test cost, simplify the test procedures, and fully utilize the properties of raw materials. Then, a series of comparative tests with bone glue ratio and water–paste ratio as variables were conducted (Fig. 3). Experimental results indicate that the ratio A6 (river sand:cement = 4:1) and ratio C6 (river sand:cement:gypsum = 8:1:1) match intact marble and marble rock mass, as shown in Tables 2, 3 (Li et al. 2020a, b, c).

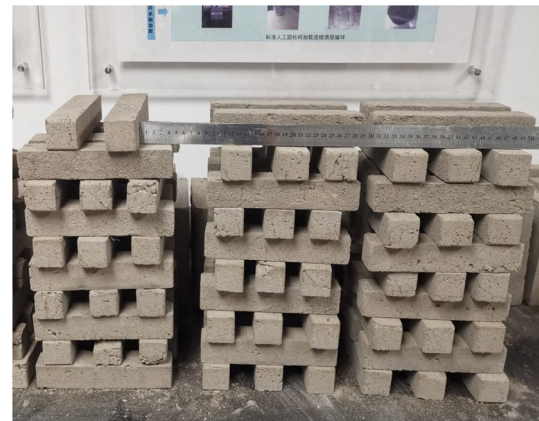
**Fig. 5** Building blocks

simulation theory. A polypropylene plastic mold, that is light and easy to demold, was made to save cost and realize mass production. After several steps including stirring, stuffing, scraping, stripping, and curing, the production of block is completed, and part of the building blocks is shown in Fig. 5.

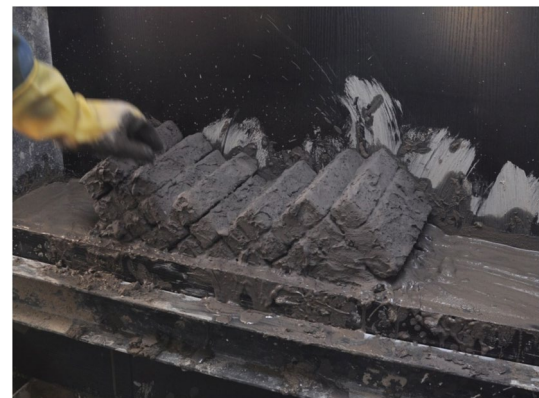
**Fig. 6** Model building process

Figure 6 shows the model building process. The outer surrounding of the model is made of similar material according to the parameters of the marble rock mass, which is compact and uniform. The material can effectively transfer stress and is conducive to observing the fracture development on the surrounding rock mass. The internal block of the model is made of similar material according to the intact marble rock, and the joints in the surrounding rock mass are clearly

visible, which can reproduce the structural characteristics of the prototype.

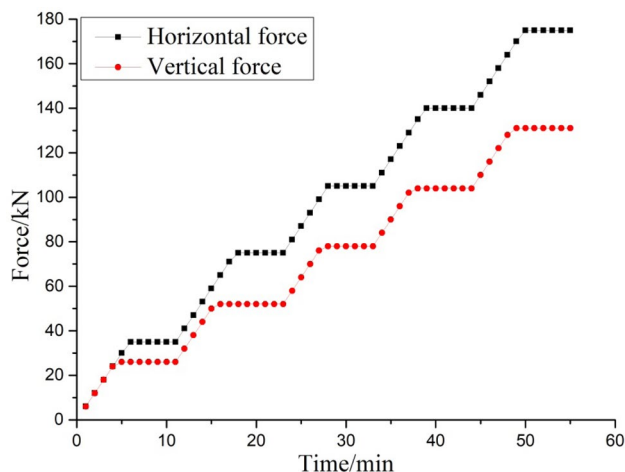
Fig. 10 Loading curves

According to the actual ground stress conditions in the study area, the horizontal and vertical ground stresses were set as 40 MPa and 30 MPa, respectively. Based on the similarity relation, the horizontal force was 175 kN, and the vertical force was 131 kN. Multi-stage loading was adopted, and the interval between the two adjacent loadings was five minutes. After the loading process finished, the force was maintained for about 10 min. When the stresses on each measuring point inside the model tended to be stable and balanced, the roadway was excavated. The loading speed was 0.1 kN/s, as shown in Fig. 10.
