The large deep-seated landslide induced by the March 12th, 2012 rainfall event in the city of Azazga, Northern Algeria: deformation characteristics and failure mechanisms

A rainfall-induced deep large landslide occurred on March 12, 2012, in the city of Azazga (Northern Algeria), causing heavy damages to residential buildings and public infrastructures. In this work, we investigate the inventory mapping, the deformation characteristics, the controlling factors, and the failure mechanisms of this landslide based on the field investigation, aerial photographs and satellite images interpretation, deep boreholes equipped with piezometers and inclinometers, as well as subsurface geophysical imaging by electric resistivity tomography (ERT). The obtained landslide inventory map shows that the landslide of March 2012 affected an area of 0.40 km². This landslide is considered as a partial reactivation of a large pre-existing one (0.606 km²), which represents 6.65% of the total urban area. Moreover, the analyses identified two types of causative factors: (1) the triggering factor related to the high intensity and antecedent rainfall as well as human activity through slope excavations and em

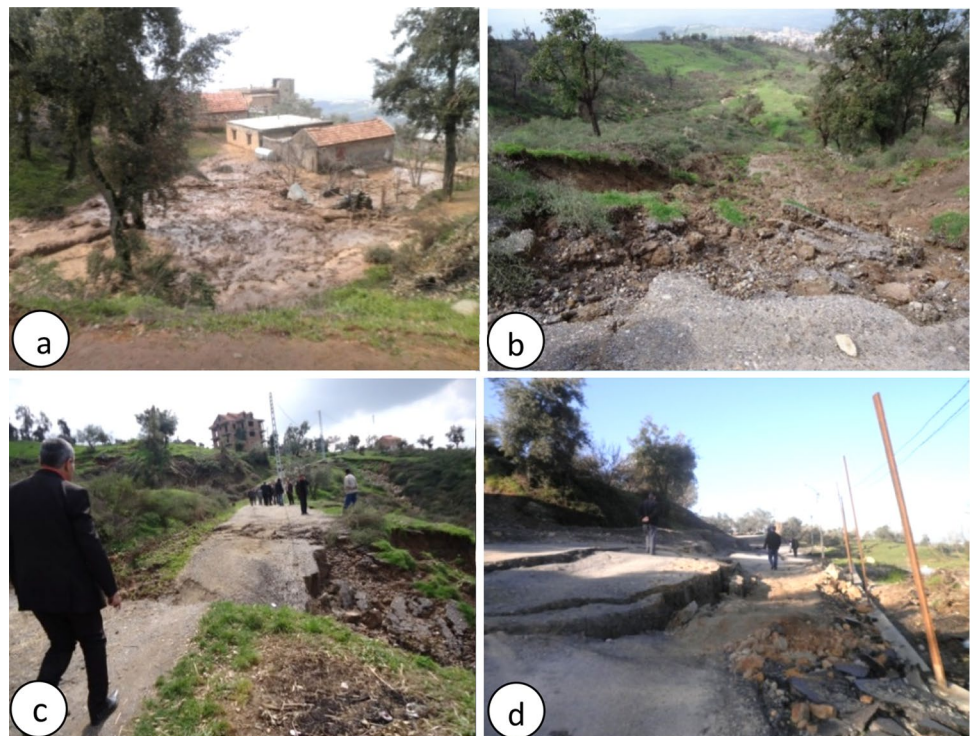
Fig. 1 Examples of different types of landslides induced by the March 12, 2012 rainfall event in the city of Azazga: **a** debris flow and damage to constructions in Agouni Guizem, southeast of the city, **b** debris flow along the Boulina river, south of the city, **c** damages of municipality road in the Agouni Guizem, **d** damage along national road RN 12 in Ighil Bouzel and Zen, north of the city

The heavy rainfall and snowfall of March 2012 triggered and reactivated various types of landslides, such as rock falls, rockslides, debris slides and debris flows within several sites of the urban area of Azazga, such as Tala Oukouchah, Zen, Ighil Bouzel, Agouni Guizem and Aït Bouhouni (Fig. 1). The slope movements have caused damage to roads, settlements of houses and public infrastructures over an area of about 2 km² (Fig. 2a).

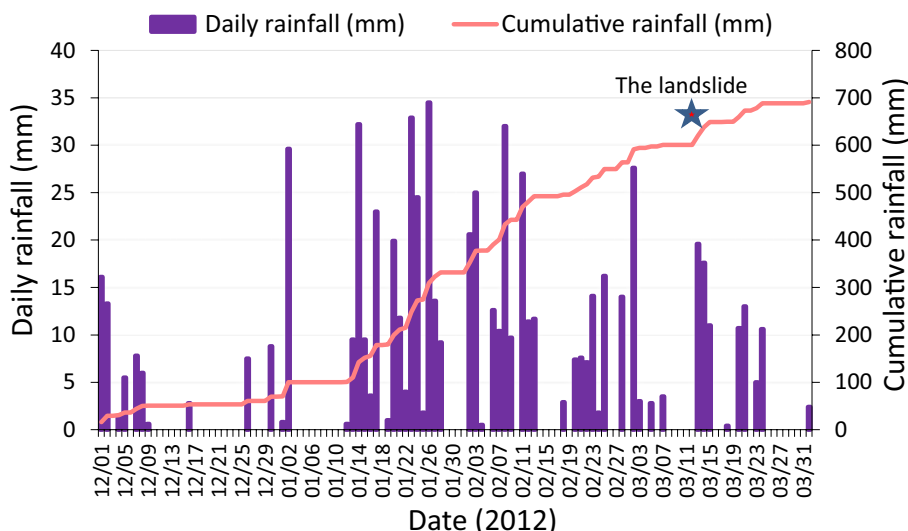
Fig. 5 Daily average and cumulative rainfall from December 1 to 30 of March 2012 at the Azazga Ecole meteorological station of Azazga city. The red star marks when the Ighil Bouzel landslide occurred

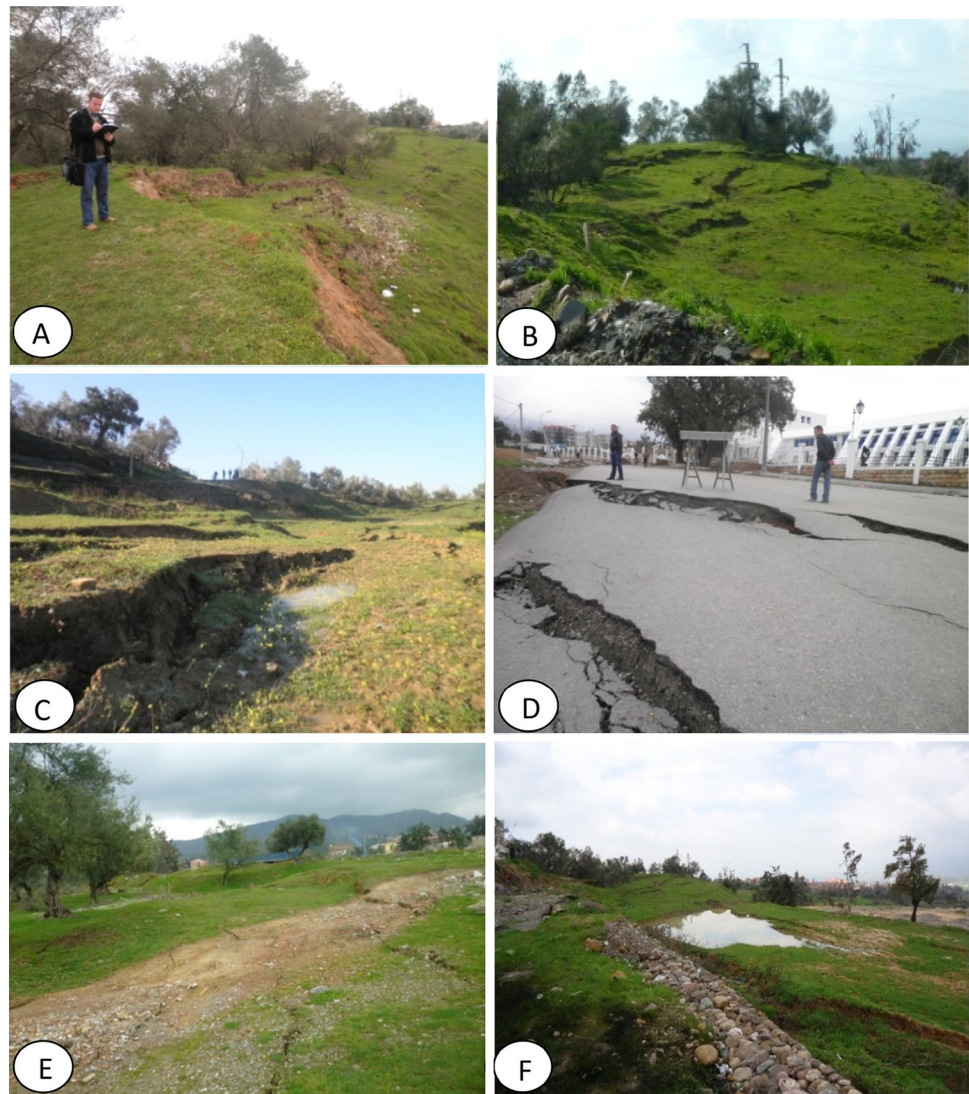
Fig. 7 Landslides deformation characteristics observed following heavy rainfall of 2012 in the vicinity of Ighil Bouzel (north of the city of Azazga): **a–c** scarps with an arched shape located at the medium section of the landslide body in the districts of Tala Oukouchah and Zen. **d** Scarps along the national road RN72 in the district of Ighil Bouzel, **e** tensile cracks located within the moving masses in the district of Ighil Bouzel and **f** collapse and stagnation of rainwater at the toe of the landslide. The locations of the photos taken (**a–h**) are shown in Fig. 9

of the photographs are marked in Fig. 9. Many parallel to subparallel tension cracks and fissures are developed as a characteristic of the traction deformation of blocks under high stresses. In the landslide body of the arcuate main scarp (Fig. 7a, b), minor scarps, fissures, depressions, minor landslides, continuous shear surface ground cracks and soil collapses have been observed. The landslide deformation intensified in the middle and the toe parts of the landslide with large cracks, reaching a maximum length of ~ 50 m and a width of ~ 50 cm. The cracks are also observed along the main national roads of RN 12 and RN 71. Tension cracks exhibit lengths ranging from 1 to 50 m, widths of 5 to 30 cm and vertical displacements of 10–60 cm (Fig. 7c, d). Field indices of instability with the inclination of olive trees, leaning of lamp posts, and walls are well observed. Along the flank of the medium section, continuous shear surfaces with lateral levees were observed as well as a centimeter to several meters long fissures and ground settlement (Fig. 7e, f) along the Aboud and Iazoughen waterways. The landslide

toe, sometimes tongue-shaped in plan, is often delineated by a gentle bulge in the ground surface and compression features (Fig. 7f).

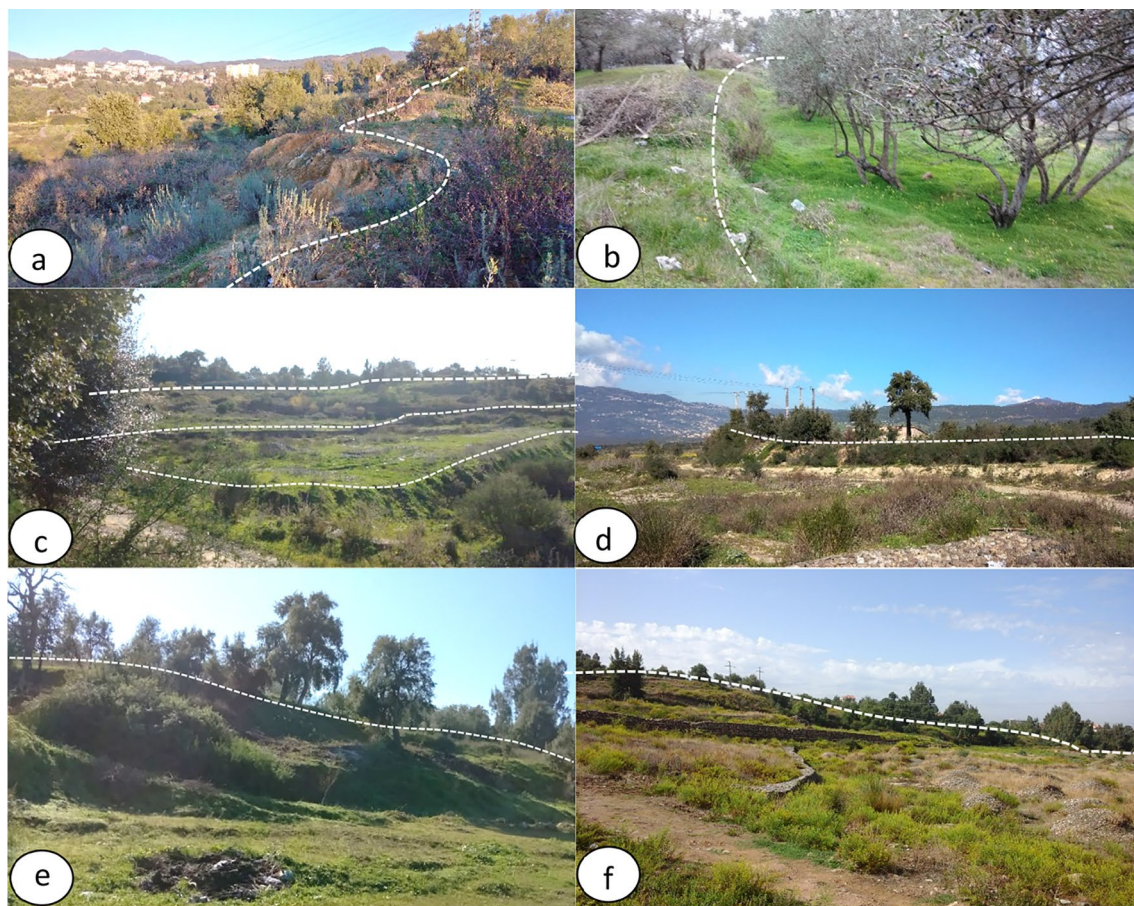
Fig. 8 Examples of ancient land instabilities indicating a mottled morphology with a series of bulges and long cliff-like scarps parallel to the general slope, counter slopes, old scarps, characteristic of low

stability slopes in the study area. The white dotted points are extend of long cliff, scarps, counter slopes and old scarps. The locations of the photographs (a–f) are shown in Fig. 9

Many field observations in and around the landslide zone revealed the existence of previous evidence of instabilities and indicate that the landslides induced by the March 2012 rainfall event constitute partial reactivations of pre-existing landslides. These land instabilities, known since February 1973, were reactivated, respectively, in April 1974, in March 1985, and in March 2012, always following an extended period of rainfall that characterized the winter season. Indeed, field observations showed a high morphological deformation characteristic of low stability slopes with counter slopes, double crests, counterscarps, old scarps and long cliff-like scarps parallel to the general slope trend that are evidence of ancient movements, as can be shown in Fig. 8a–f. This specific morphology is confirmation of

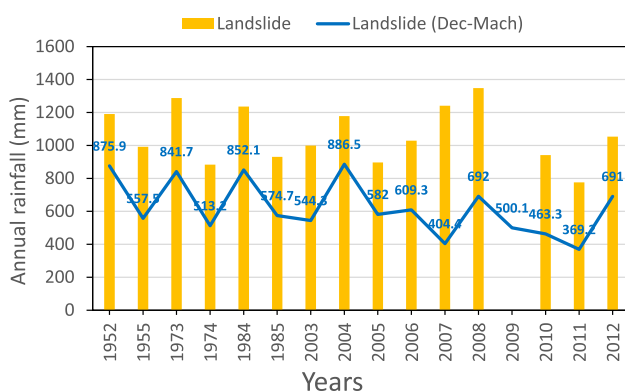
Fig. 10 Relationship between annually rainfalls and cumulative rainfall from December and March for each landslides event for the period of 1950–2014 (meteorological station of Azazga Ecole from ANRH 2019)

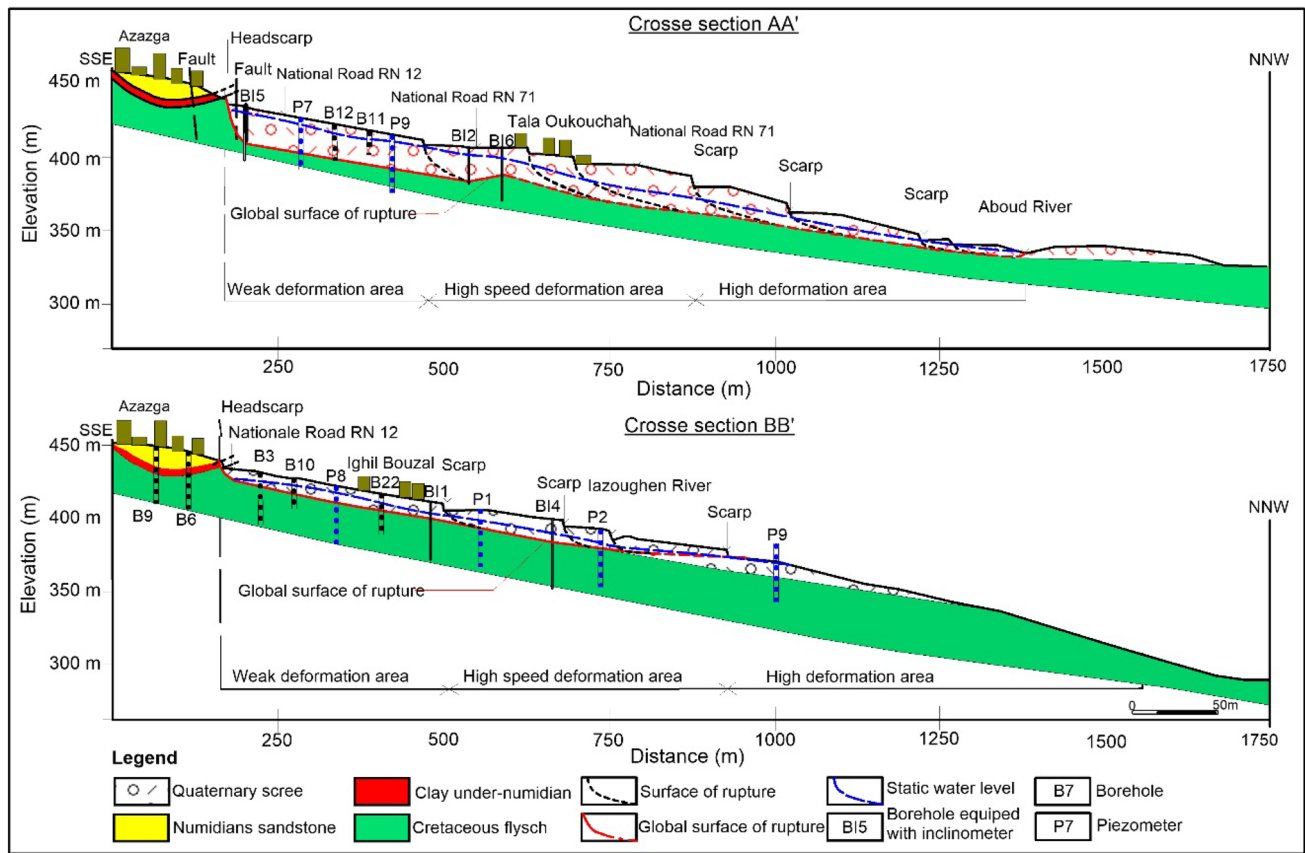
Fig. 12 Geological and hydrogeological cross-sections along the longitudinal profiles AA' and BB' (see Fig. 4 for the locations of the cross sections) in north–south direction performed from borehole,

piezometer and inclinometer illustrating the lithological structure with static water level and probable slide surfaces

cut into thin platelets at the surface and compact at depth. The depth of the flysch deposit varies between 3 and 31 m as shown in the cross sections AA' and BB' of Fig. 12. The depth decreases from the north to the south from 5 to 31 m and from the west to the east from 10 to 25 m; (2) The quaternary scree deposits that cover the Cretaceous flysch are made of sandstone blocks of different sizes embedded in clayey to sandy-clay deposits. Furthermore, the bedding structure of the lower rock slope, with a thin layer of clay beneath the sandstone, has a direct effect on the rock slope's instability due to the ease with which shear-sliding surfaces appear along weak interlayer interfaces. In addition, the lithological discontinuity between the permeable formations (scree) and the impermeable formations (flysch) constitutes a major hydrological discontinuity plane.

The analysis of the piezometric level map of the mean groundwater table for the high-water period (December–February) based on the inventory of 78 water points (13 piezometers, 4 sources and 60 wells) by using Kriging interpolation shows the presence of a continuous and generalized shallow groundwater with a piezometric level of the groundwater table at a depth ranging between 320 and 450 m and a static level ranging between 2.5 and 5 m (Fig. 14). This groundwater is contained in the quaternary sandy-silty cover formations (scree). The values of the static and piezometric levels of the groundwater table increase from the south to the north, indicating a water flow from the south toward the north and from the center toward the Iazoughen and Aboud rivers in the direction of the landslide (Fig. 12). Figure 12 illustrates the

lithological structure of the landslide and the groundwater table in the landslide zone.

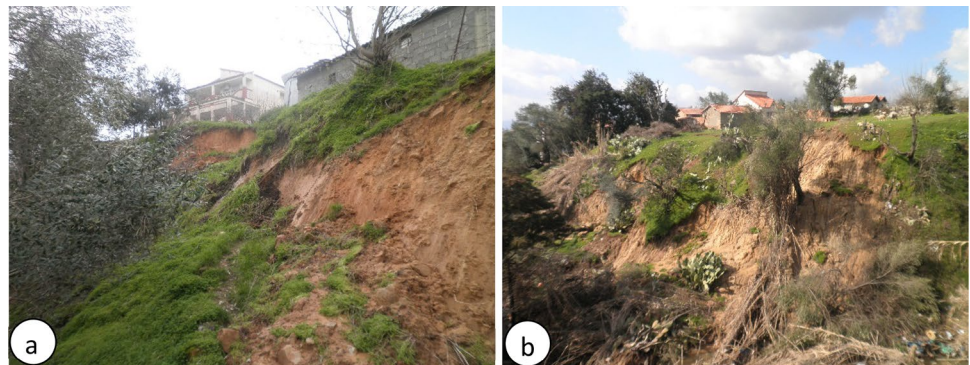
Fig. 13 Basal erosion and undercutting of the **a** lazoughen and **b** Aboud rivers torrents at the foot of the landslide area

undermining of the banks, which activates the dynamics of the slope and causes the removal of the abutment of the slope toe, as observed along the Iazoughen river during the heavy rainfall of March 2012 (Fig. 13).

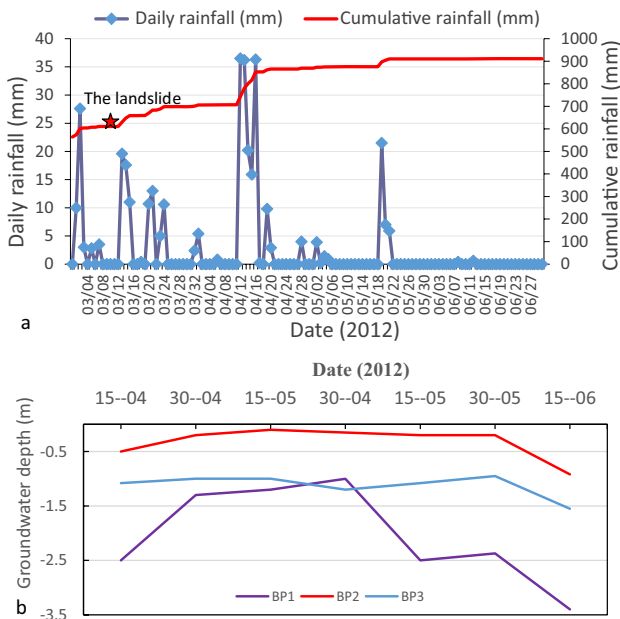
Fig. 15 Relationship between: **a** normal cumulative potential precipitation and **b** groundwater level fluctuations monitored by piezometers installed along the sliding plane for the period from April 4, 2012 to December 25, 2013

15 to June 15, 2012 (period of groundwater recharge). Low values of groundwater level are observed at the BP2 and BP3 piezometers (0.5–1 m) installed near the toe and body of the landslide, respectively, followed by BP3 values (1–3.4 m) installed at the head of the landslide. Our realistic results indicate that the low value of groundwater level corresponds to the period of groundwater recharge (April to June), then the value increases from June, which corresponds to the discharge period (Fig. 15). There is

a good relationship between normal cumulative precipitation (Fig. 15a) and groundwater level (Fig. 15b). The shallow depth of groundwater level is related to the saturation conditions caused by continual cumulative precipitation increasing the water content of the sliding mass, as observed during heavy rainfall events through sources, springs and wells (Fig. 16a, b) in the upstream part of the

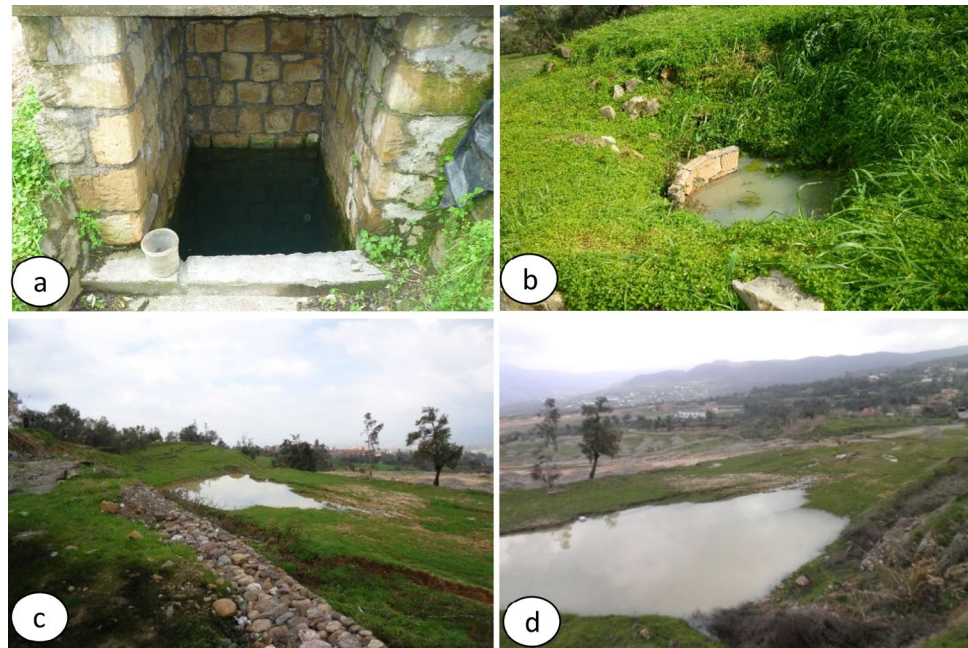
Fig. 16 Observed groundwater table in the study area: **a, b** wells and water spring showing the surface water level during wet periods in the upstream part of the landslide, **c, d** Groundwater discharge at the landslide toe after the 12, March 2012 rainfall event
