# Runnels Reverse Mega-pool Expansion and Improve Marsh Resiliency in the Great Marsh, Massachusetts (USA)

J. Grant McKown<sup>1</sup> · David M. Burdick<sup>2</sup> · Gregg E. Moore<sup>3</sup> · Christopher R. Peter<sup>4</sup> · Andrew R. Payne<sup>5</sup> · Jennifer L. Gibson<sup>3</sup>

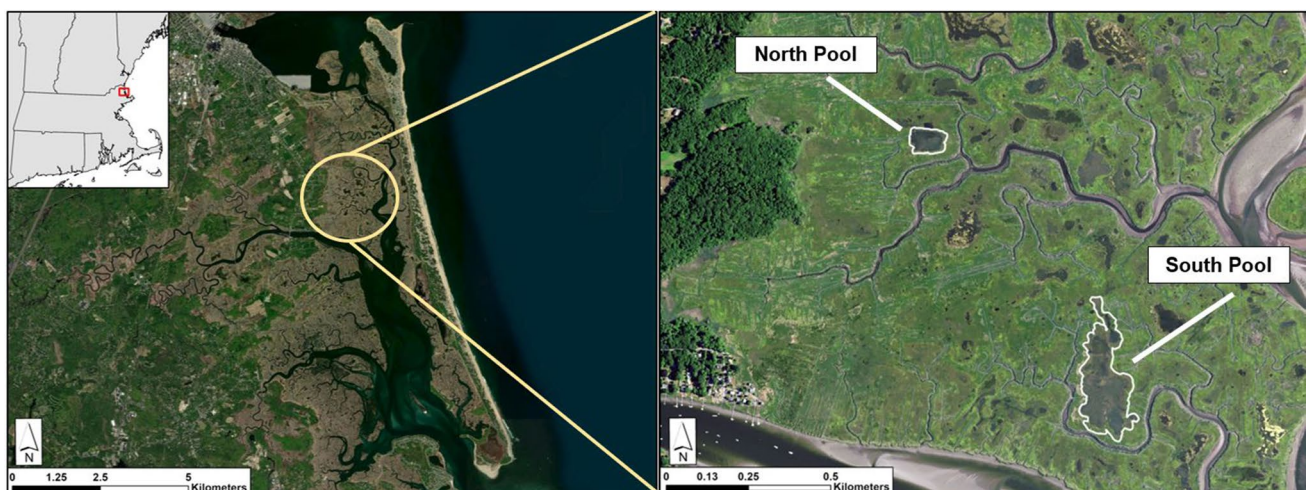
**Fig. 1** **Left:** Site map of study area in the Parker River National Wildlife Refuge (Newbury, Massachusetts). **Right:** North and south pools are outlined in white

The study site, hereafter referred to as Pine Island Marsh, is located within the Great Marsh system and Parker River National Wildlife Refuge (Newbury, MA) between the Parker River and Pine Island Creek (Fig. 1—Left). Pine Island Marsh is a 191-ha salt marsh platform dissected by three major tidal creeks, numerous smaller order creeks, and artificial drainage ditches (density = 149 m ha<sup>-1</sup>). The system is mesotidal with a mean tidal range of 2.64 m (NOAA Gauge 8,441,241). The system is considered sediment deficient for long-term salt marsh stability (Cavatorta et al. 2003; Langston et al. 2020) with median suspended sediment concentrations of 15 mg L<sup>-1</sup> and approaching 40 mg L<sup>-1</sup> near the mouth of the estuary (Hopkinson et al. 2018). The three major rivers of the system (Rowley, Ipswich, and Parker Rivers) are dammed upstream, limiting the sediment supply. Average salt marsh elevation gain rates ranged from 3.5 mm yr<sup>-1</sup> in the high marsh platform to 9.5 mm yr<sup>-1</sup> in the low marsh compared to recorded SLR rate of 4.8 mm yr<sup>-1</sup> (Langston et al. 2020). The vegetation community is comprised of low marsh on tidal creek and ditch banks of tall

North (42.7700, -70.8295) and south pools (42.7631, -70.8231) were selected for restoration using runnels based on recent dieback of halophyte graminoids, buildup of drifted algal mats, shoreline soil slumping, relict agricultural features (e.g., embankments and ditches), and proximity to hydrologic pathways for runnel construction (Fig. 1 – Right). In 2014, one year before runnel construction, the north and south pools had dimensions of 0.60 ha and 3.52 ha with perimeters of 327 m and 1536 m, respectively, and varying nearshore depths of 15 – 20 cm. Runnels approximately 30 cm width and 15 cm depth were constructed in the Spring of 2015 from the edge of the pool to the nearest hydrologic pathway with lengths ranging 60 – 200 cm (Fig. 2). A post driver and angle iron were used to compact the marsh to the appropriate dimensions. One runnel was constructed at the north pool and two at the south pool to compensate for its size and tidal prism (Fig. 3). We cut the runnels to set the pools on a drainage trajectory whereby the dimensions of the runnel would expand to eventually equalize with the pool's tidal prism.

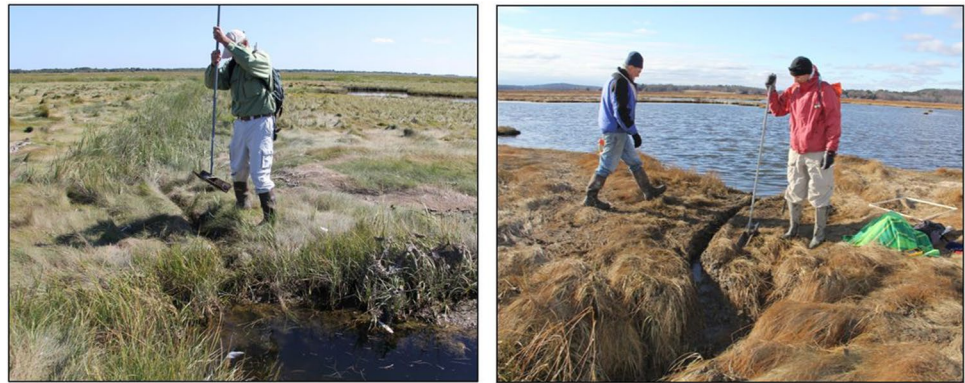
**Fig. 2** **Left:** Creation of runnel by compacting the marsh surface using a handheld tamping tool at the north pool site in 2015. Runnel connected an existing ditch to the expanding pool. **Right:** Runnel at the south pool site in 2015 after construction. Runnels were created with dimensions of approximately 30 cm width - 15 cm depth and lengths of 60 – 200 cm

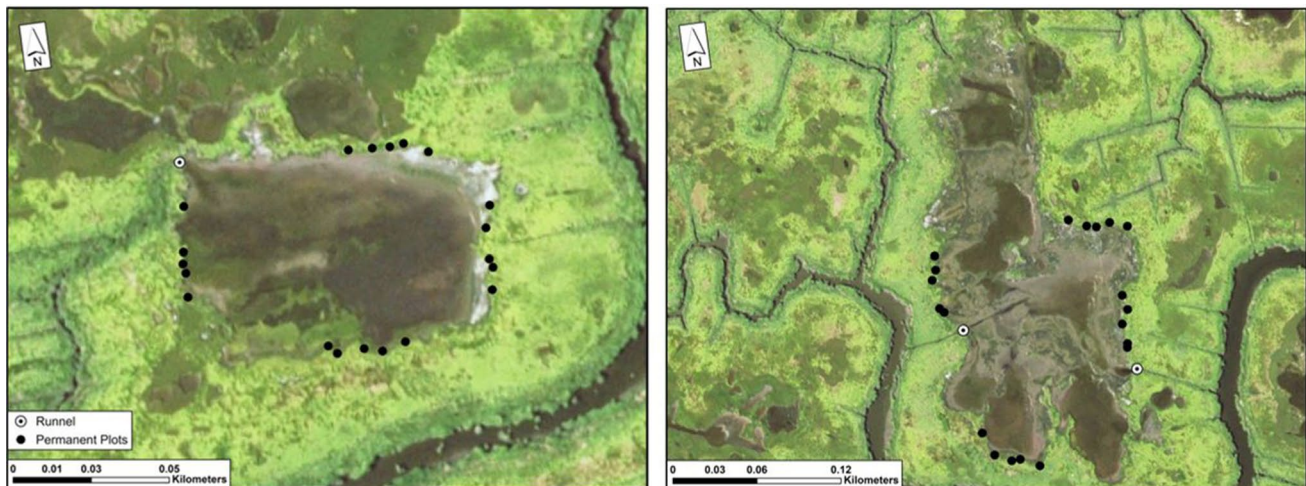
**Fig. 3** Field sampling design and runnel construction (white) for north and south pools. Permanent plots (black) consist of paired salt marsh platform edge and pool plots

completed in Summer 2015, Summer 2016, Fall 2018, and Fall 2021. Elevation was monitored in Spring 2015, Summer 2016, and Fall 2021. Transects parallel to the pool edge were established in Spring of 2015 on four sides of each pool to monitor the recovery of the vegetation and elevation following runnel construction (Fig. 3). Five pairs of permanent vegetation plots were randomly located along each 30 m transect with at least 3 m between plots. Each location consisted of a pair of 0.5 m<sup>2</sup> plots with one on the salt marsh platform edge and the second immediately adjacent in the pool ( $n = 40$  per pool site).

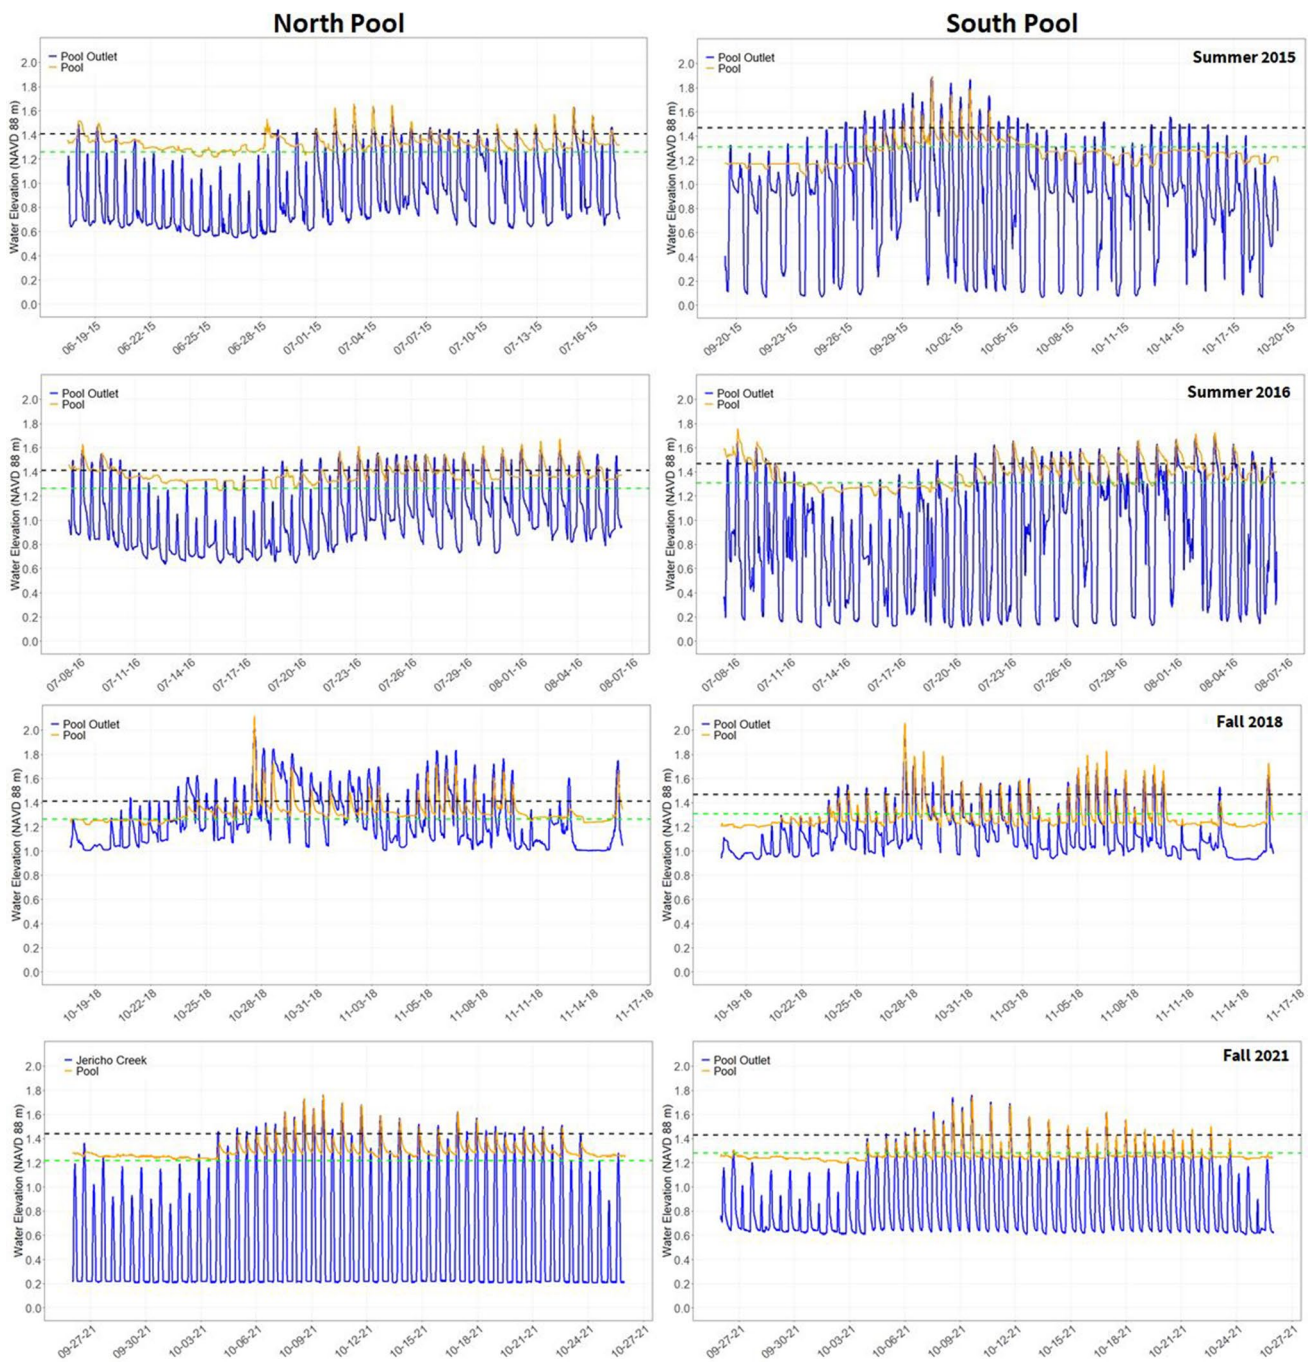
**Fig. 4** Water level elevations for hydrologic channel (blue) and pool (orange) water level recorders in Summer/Fall 2015 (after runnel construction), Summer 2016, Fall 2018, and Fall 2021. The north pool

is shown on left and south pool on the right. The average salt marsh platform elevation (black dashed line) and pool elevation (green dashed line) are shown for each site

The efficacy of the runnels to drain both pools after high tides improved during the first three years post-restoration and diverged after 2018 (Table 1). Although pre-restoration

monitoring was not completed for hydrology, it was assumed that the pools remained flooded permanently based on field observation and lack of outlet. The percent flood duration time, a proxy for the ability of the pool to drain after high tides, declined by 25% and 76% for the north and south pools, respectively, by 2018. The timing and high tide elevation of the tides between the channels and both pools converged between 2015 – 2018. While pools still took longer to drain than channels, lags in drainage diminished over time (Fig. 4). The runnel for the north pool became clogged with vigorous *S. alterniflora* growth and sediment sometime after 2018. Drainage through the north runnel had decreased and lagged substantially after high tides in 2021, creating permanent flooded conditions in the pool. The surrounding marsh platform continued to benefit, however, as the flooding duration decreased from 10% of the monitoring period in 2015 to 5% in 2021. In the south pool, flooding duration continued to decline to 13% by 2021 and saturation of the marsh platform remained relatively low and unchanged by the end of the monitoring period.

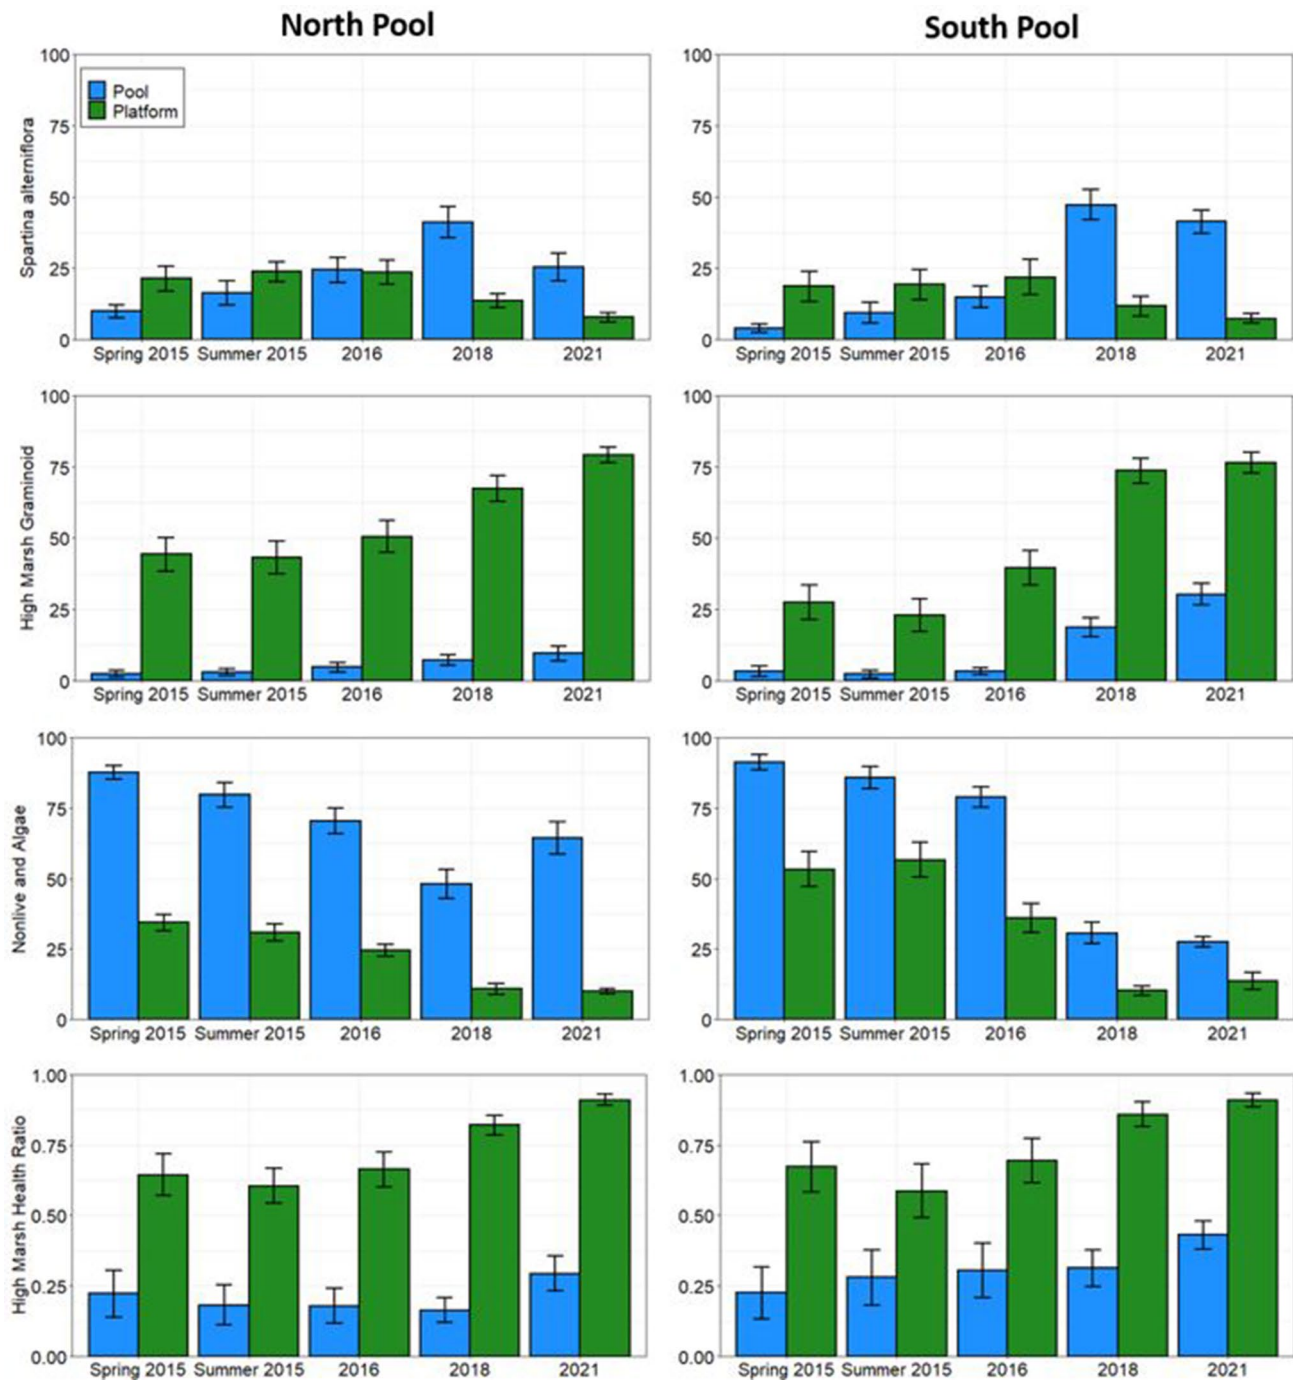
**Fig. 5** Vegetation metrics of *Spartina alterniflora* cover, high marsh graminoid cover, and non-live and algae cover in the North (**Left**) and South (**Right**) pool sites. Error bars are + standard error

The vegetation communities of the pools and platforms were set on a trajectory of recovery and improved health and required 3 – 4 years to differentiate from pre-restoration conditions (Fig. 5, Online Resource 1). In the pool habitat, percent cover of *S. alterniflora* cover increased by 31% north and 37% south and high marsh graminoid cover, the aggregate of *S. patens*, *D. spicata*, and *J. gerardii*, increased 7% north and 27% south while the drained bare areas declined by 21% north and 63% south from pre-restoration conditions to 2021. *S. alterniflora* cover peaked in Fall 2018 for the north pool and subsequently was reduced by 39% in 2021 as non-live cover increased by 21%. In the south pool habitat,

*S. alterniflora* cover declined by half between 2018 – 2021 and was predominantly replaced by high marsh graminoid cover. The non-live cover continued to decline in the same timeframe, resulting in a total loss of 64% since restoration.

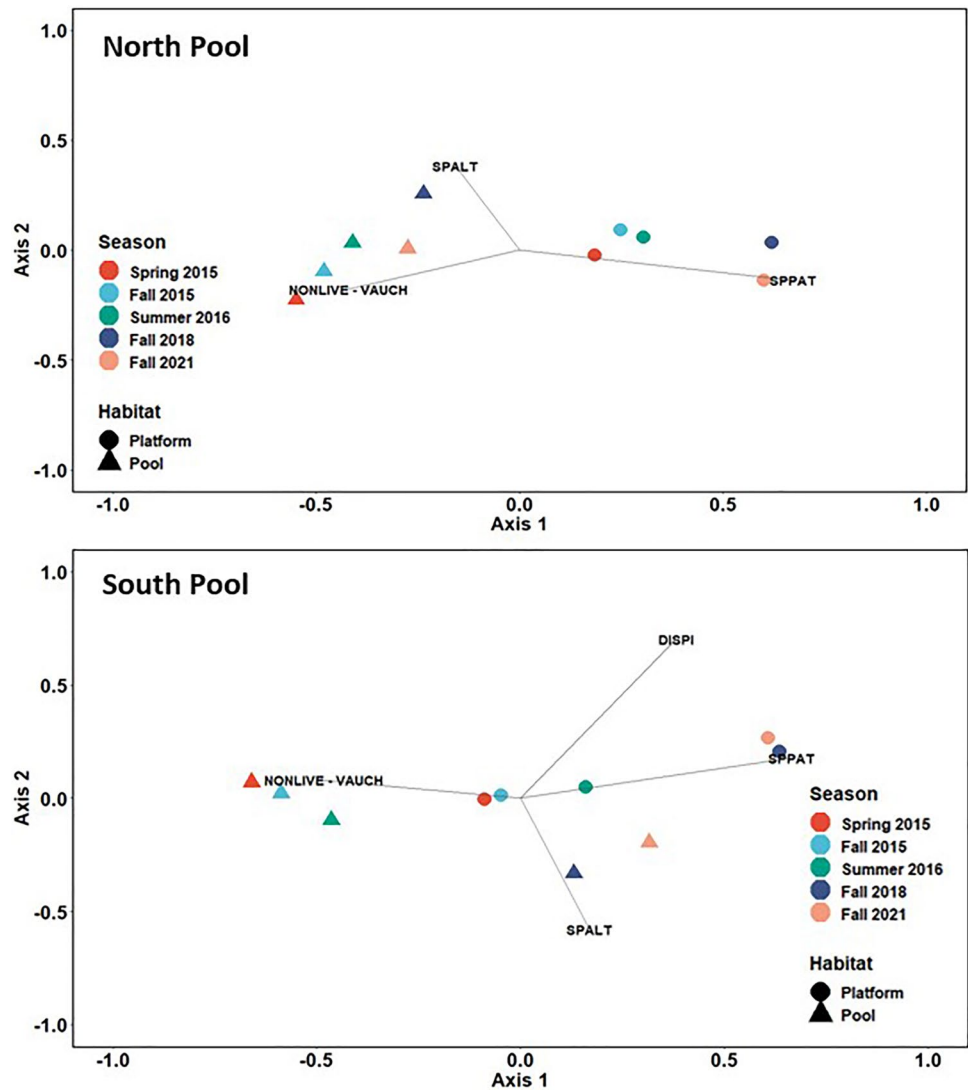
**Fig. 6** Non-metric multidimensional scaling ordination (NMDS) north pool (Top) and south pool (Bottom) for the mean locations of each habitat and season. Vegetation species that were highly and significantly correlated ( $r^2 > 20\%$ ,  $p < 0.05$ ) are overlain in main NMDSs. Species abbreviations are DISPI = *Distichlis spicata*, SPALT = *Spartina alterniflora*, SPPAT = *S. patens*, NONLIVE – VAUCH = Non-live Cover

Two-dimensional NMDS ordinations found divergent recoveries of the vegetation community between the north (stress = 7.2) and south pools (stress = 12.8; Fig. 6). The low stress values (< 15) suggest the NMDS ordinations are useful at interpreting and understanding the vegetation community (McCune and Grace 2002). At the north pool site, the pool plots remained relatively stagnant over time, associated with non-live ( $r^2 = 0.90$ ; correlation regression with NMDS) and *S. alterniflora* cover ( $r^2 = 0.92$ ). Dissimilarity between pre-restoration conditions increased through 2018 ( $R = 0.501$ ,  $p < 0.001$ ), although the vegetation community partially reverted in 2021 ( $R = 0.199$ ; Table 2). At the south pool site (Fig. 6), the pool plots progressed towards a vegetation community with greater *S. patens* cover ( $r^2 = 0.71$ ) and less non-live cover ( $r^2 = 0.87$ ), resembling the vegetation of the platform plots in 2016. The vegetation community only required two full growing seasons to differentiate from Spring 2015 conditions ( $R = 0.147$ ,  $p = 0.003$ ) and progressed towards high marsh habitat through 2021 ( $R = 0.939$ ). SIMPER analyses indicated that *S. alterniflora* and non-live cover drove dissimilarity in the pools over time (Table 3), indicating the vegetation community mainly improved through the colonization of the low marsh grass.

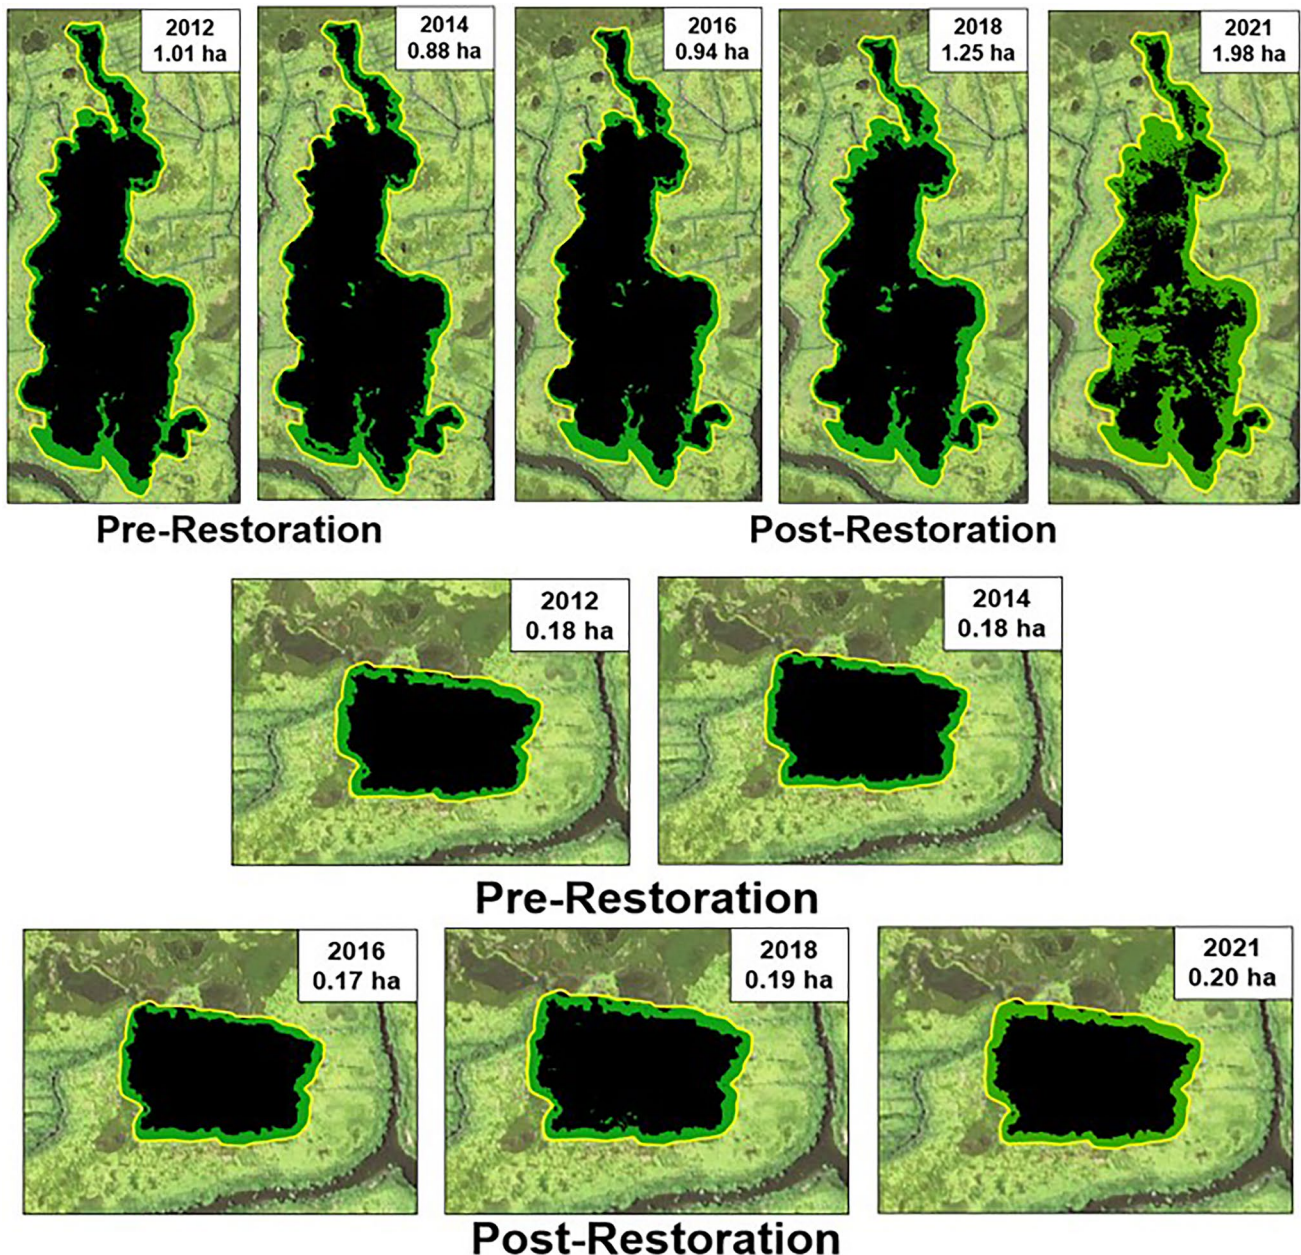
**Fig. 7** Remote sensing analysis of south (**Top**) and north pools (**Bottom**). Runnel construction took place in Spring 2015. National Agriculture Imagery Program aerial imagery of 2018 is background for all

panels. Vegetated areas are shown in green and unvegetated areas in black. The 5 m buffer of the pool outline is shown in yellow

of 2% (0.003 ha) and 12% (0.12 ha) of vegetated marsh area in the north and south pools, respectively (Fig. 7, Table 5). In the south pool, vegetation gains were restricted along the perimeter of the pool between 2015 – 2018 resulting in gains of 42% (0.37 ha) of vegetated area since 2014. Between 2018 – 2021, however, vegetation greatly expanded into the interior of the pool, resulting in total gains of 124% (1.10 ha) since 2014. In the north pool, vegetation expansion was minor since restoration with an increase of 13% (0.02 ha). Revegetation was consistent along the entire pool perimeter including the emergence of several patches within the southern pool interior by 2021. It should be noted that two non-hydrologically connected pools just north of the north pool continued to expand and these unvegetated areas were measured within the 5 m buffer, interfering with the estimate of vegetation recovery.
