Railway Slope Monitoring Based on Dual-Parameter FBG Sensor

Abstract: A large number of slopes appear along the line during railway construction, which will pose a threat to railway safety operation. Slope monitoring plays an important role in ensuring the safety of railway operation. Aiming at the difficulties of sensor multiplexing, low accuracy, and large disturbance by trains, this paper proposes a railway slope monitoring method based on integrated fusion detection of inclination and vibration. Instability and failure characteristics of the K3 slope in Shuohuang Railway and dynamic characteristics under the excitation of the train load are analyzed by the finite element method (FEM) analysis. Based on the above analysis, a slope monitoring system is established utilizing the self-developed dual-parameter fiber Bragg grating (FBG) sensor. The monitoring data of the past four years show that the slope is in a relatively stable state at present. The monitoring data are consistent with the results of the FEM. The feasibility of the damage identification method based on inclination and vibration characteristics is verified, which provides a new method for railway slope monitoring.

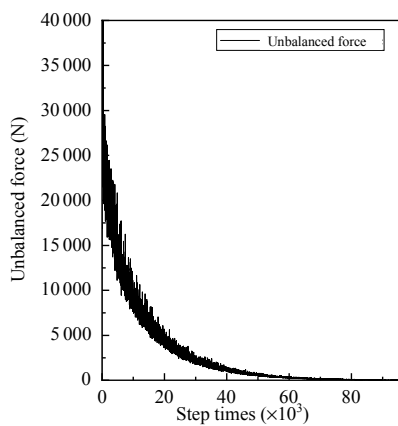
Fig. 3 Unbalanced force of the slope.

Under the dead weight stress, the unbalanced force of the model is calculated, and the maximum unbalanced force of the system is less than 1×10^{-5} N after the model runs for 8000 steps. As shown in Fig. 3, the calculation converges, and the system is considered to be in equilibrium at this time, indicating that the loess slope is stable as a whole. By using the strength reduction method, the

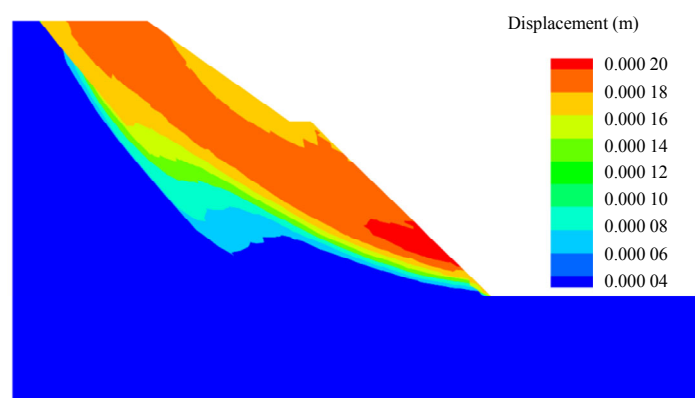
Fig. 4 Displacement of slope at the critical state of stability.

cohesion and friction angle of the material are reduced, and the deformation of the slope when it enters the limit equilibrium state is shown in Fig. 4 (the material properties of the slope are shown in Table 1). As shown in the figure, it can be seen that a penetrating slip plane is formed from the toe to the top of the slope. The reduction factor (slope safety factor) at this time is 1.32.

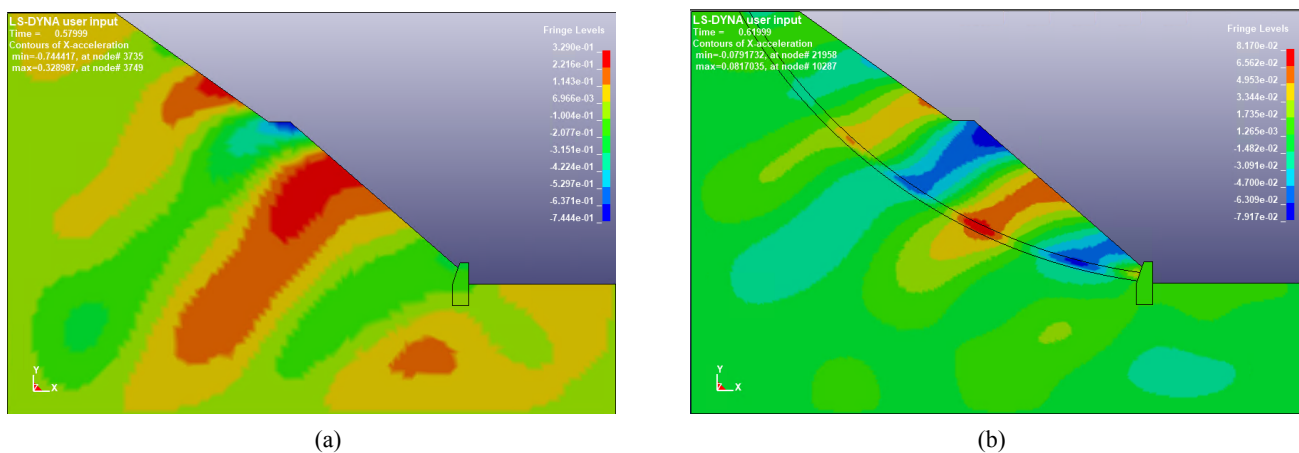
Fig. 8 Acceleration cloud map of the slope model: (a) normal model 0.58 s and (b) defect model 0.635 s.

is shown in Fig. 8. As shown in Fig. 8, the acceleration distribution gradient is consistent with the propagation direction of the vibration wave, and the closer it is to the slope surface, the greater the acceleration peak value is. In the

model with a weak layer, there is an obvious boundary at the weak layer of acceleration, which is caused by the obvious attenuation of acceleration when it passes through the weak layer.

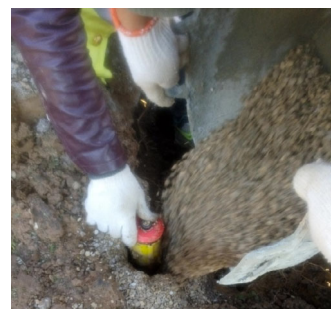
Fig. 11 Backfilling of the borehole.

Under the influence of the scouring effect of the drilling rig circulating mud and hole collapse, the diameter of the borehole is usually larger than that of the drill bit, which leads to the actual amount of the backfill material far exceeding the calculated amount. Therefore, if the backfill amount is less than the calculated amount, it can be determined that the backfill is not dense. The drilling depth of the borehole is about 20 m, and the pipe running depth is 18.5 m. The theoretical backfill material is 0.14 m^3 , and the actual material is nearly 1 m^3 . This is not only the factor of the borehole diameter scouring and hole collapse, but also the gravel backfilling into the internal cracks of the slope through which the borehole passes.

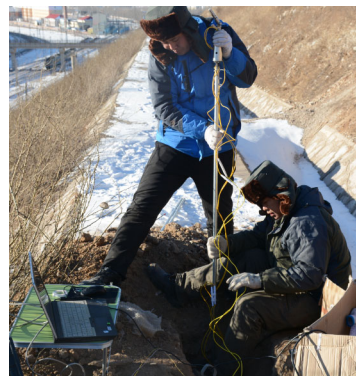
Fig. 12 Installation photo of the FBG sensors.

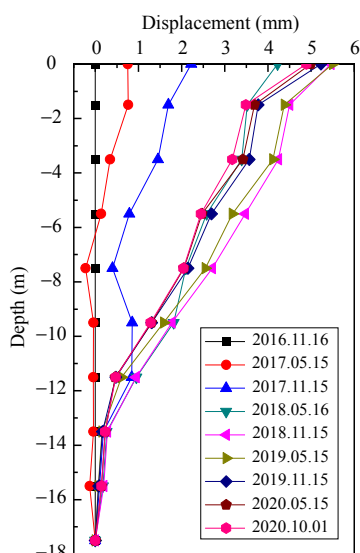
Fig. 13 Time-varying curve of the displacement in the primary slope.

The monitoring system was installed in November 2016, and the monitoring data of internal deformation of the slope are shown in Figs. 13 and 14. It can be seen that from November 2016 to August 2018, during the slope deformation stage, the internal displacement of the slope gradually increased, the maximum displacement was about 5.7 mm, and the average deformation rate was 3.25 mm/y. After August 2018, the slope basically turned into a stable period, and the internal displacement basically did not change. The reason for slope deformation may be that a large amount of slurry leaked during drilling and stored inside the slope, which led to a decrease in the loess strength inside the slope and even the collapse of loess, thus causing the internal deformation of the slope. With time, the moisture inside the soil gradually migrated and dissipated, the stability of the soil gradually recovered, and the internal deformation rate of the

slope gradually decreased until it reached a stable state. From Fig. 13, it can be seen that the deformation size of the slope turns at 11.5 m, and the deformation is larger at the position above 11.5 m. As far as the whole slope is concerned, there is no obvious slip surface on the slope.

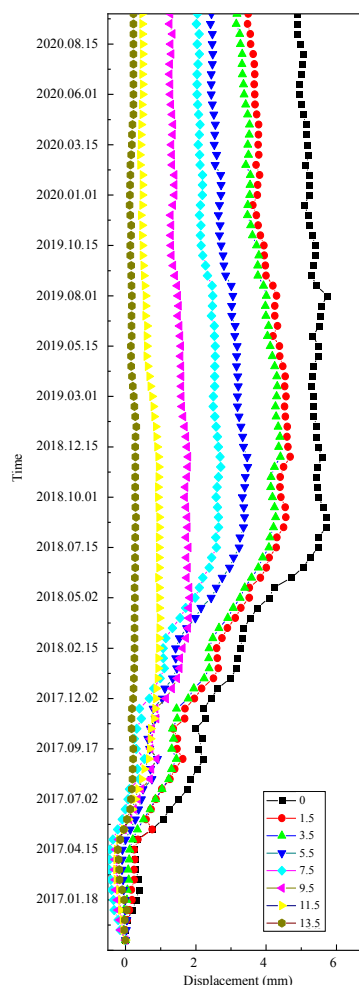
Fig. 14 Time-varying curve of the displacement in the primary slope.

It should be noted that the 13.5 m depth sensor of the slope failed in January 2017, and the 17.5 m depth sensor failed in May 2020. After the sensor fails, when calculating the deep deformation of the slope, the deformation at the position of the sensor is calculated according to the effective deformation before the sensor fails.

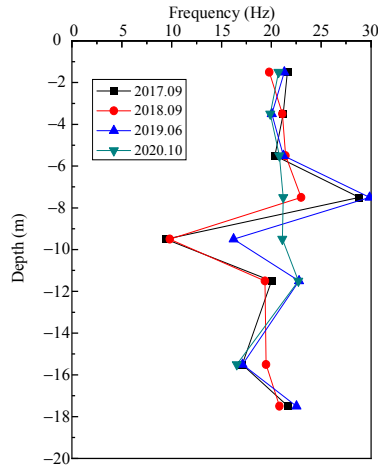
Fig. 15 Strongest frequency of each measuring point in the slope.

Under the excitation of the train, the strongest excitation frequency of each measuring point on the slope at different time points is shown in Fig. 15. As shown in the figure, the strongest frequency at the depth of 7.5 m decreases with time, with a variation range of 21.19 Hz–28.82 Hz and a frequency fluctuation range of about 7.63 Hz. The strongest frequency at the depth of 9.5 m on the slope increases with time, with a variation range of 9.42 Hz–21.08 Hz and a frequency fluctuation range of about 11.66 Hz. The strongest response frequency of other measuring points under the excitation of the train does not change obviously and is the strongest. Under the excitation of the train, the vibration amplitude of each measuring point on the slope is

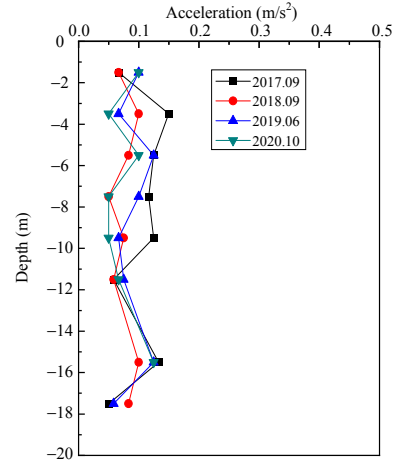
Fig. 16 Peak acceleration of each measuring point in the slope.

shown in Fig. 16. As shown in the figure, the amplitude change is not obvious, which also shows
