Time–frequency and wavelet-based study of an old steel truss bridge before and after retrofitting

Suresh Kumar Walia¹ · Raj Kumar Patel² · Hemant Kumar Vinayak¹ · Raman Parti¹

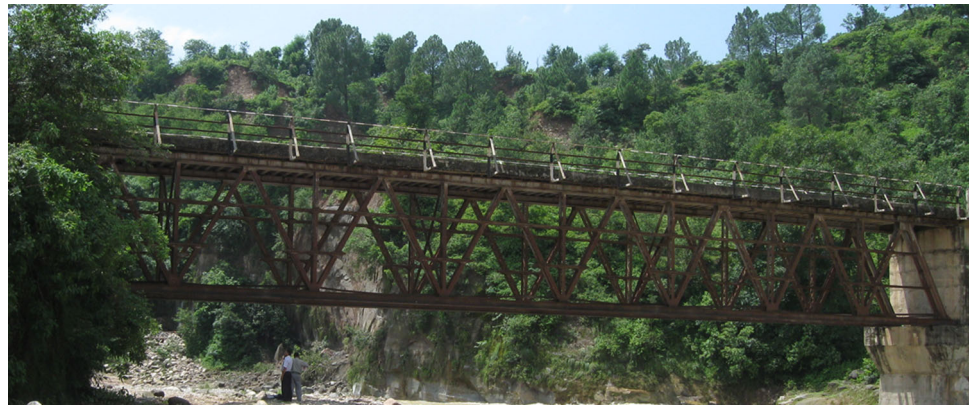
Fig. 1 Steel truss bridge of span 47.90 m over Bathu Khad

The bridge considered for experimentation had been constructed on the National Highway 20 on Bander Khad near the village Samloti Himachal Pradesh, India by the British Company named as Dorman Long & Company Limited, Middlesbrough, England in the year 1920 (Fig. 1).

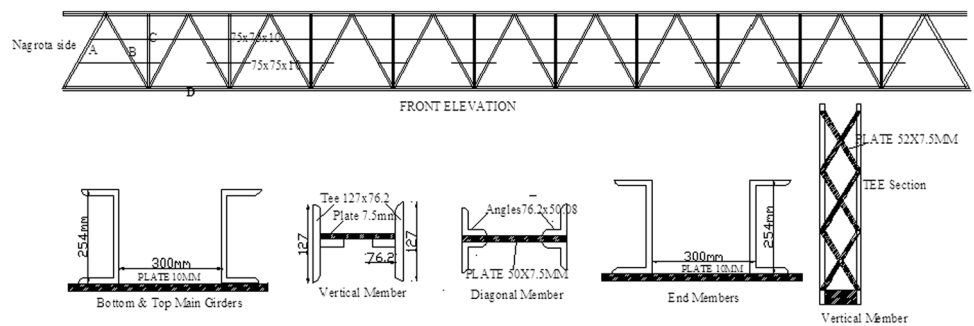
Fig. 2 As-built drawings of steel truss bridge

As-built drawing and design data were not available, an extensive investigative program was chalked out, comprising preparation of the as-built drawings at the site, development of analytical model to obtain the baseline structural parameter, and conduct of field tests to obtain the present status of the bridge [23].

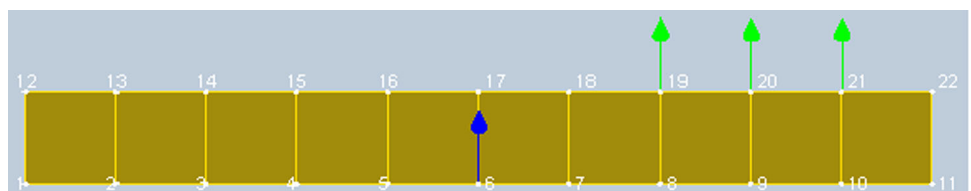
Fig. 3 Typical sensor location of one of setup on the bridge

To obtain the distributed response of the structure, sensors were placed on bottom nodes at the intersection point of the vertical and diagonal members in the vertical direction of motion on both the trusses of the bridge. In a single set, four sensors were used for the measurement. Thus, vertical acceleration time histories at 22 locations were measured in six sets. Each sensor location has been identified with unique nodal coordinate number. Figure 3 shows the detail of the placement of the sensors position on the bridge with the nodes named as $n1, n2, \dots, n11$ on the downstream, and $n12, n13, \dots, n22$ on the upstream. One accelerometer has been used as reference sensor. The measurement of the node in the bridge was carried out along the vertical direction. The direction of the installed acceleration pick up was accounted for during the analysis of the data.

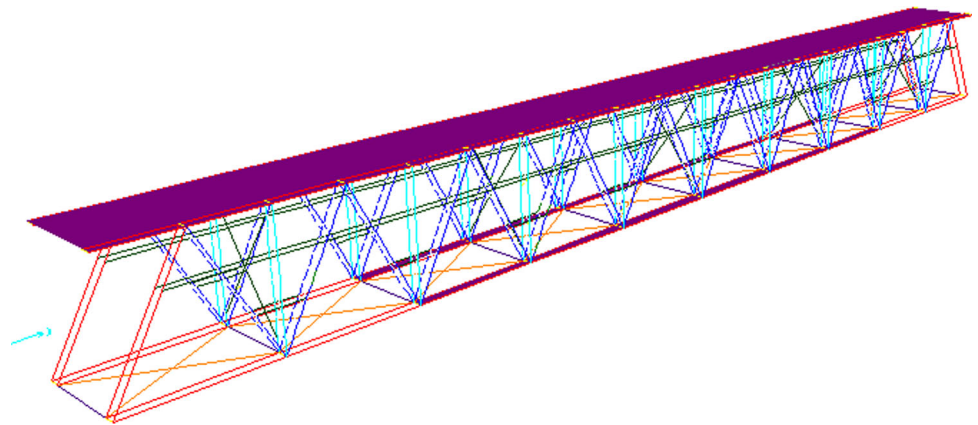
Fig. 4 As-built analytical model of 47.50 m deck-type steel truss bridge

This bridge is simply supported with a hinge support at one end and roller support at the other end. The bridge is having a span of 47.5 m with 10 equidistant panels of 4.75 m each. The deck of the bridge is made up of corrugated metal sheets of 8 mm thickness with overlay of bituminous premix carpet of 40 mm thickness as wearing coat. The vertical members and diagonal members are made up of built-up section as in Fig. 2. The members of the trusses have been joined with rivet connections. The structural modal parameters were determined through the analytical model of the bridge generated in SAP2000 [24] as per the built-up drawing of the bridge to achieve the maximum possible accuracy in the analytical model (Fig. 4). The analytical frequencies of the bridge obtained are 4.50, 10.86 and 17.79 Hz for the first, the second and the third mode, respectively, in the vertical plane of the bridge.

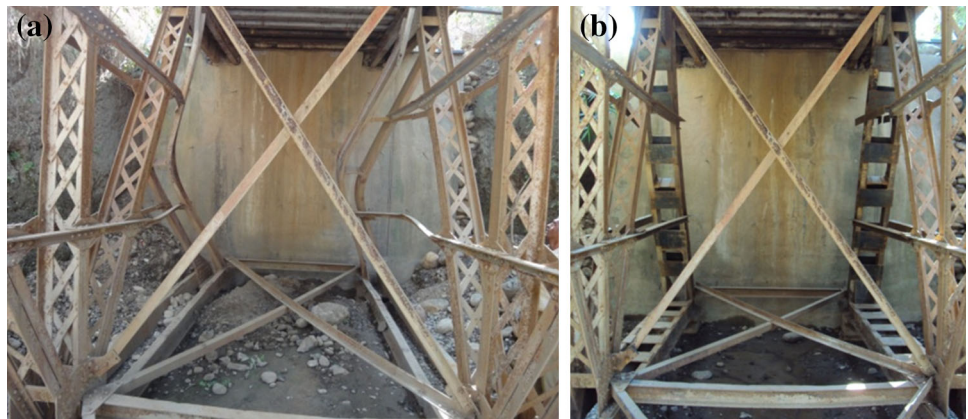
Fig. 5 Bottom and end members **a** before retrofitting **b** after retrofitting

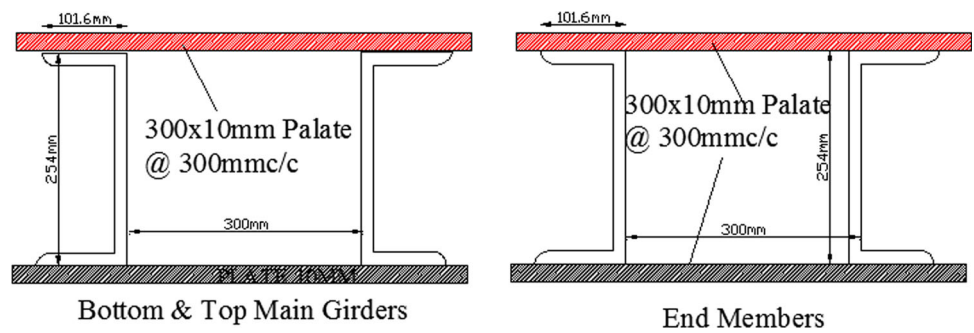
Fig. 6 Retrofitted sections

The bottom longitudinal members were straightened and stiffened with steel plate of $300 \times 300 \times 10$ mm size as shown in Fig. 6. However, the replacement of damaged deck plates and retrofitting of top longitudinal member is still pending, and owner agency is on the Job.

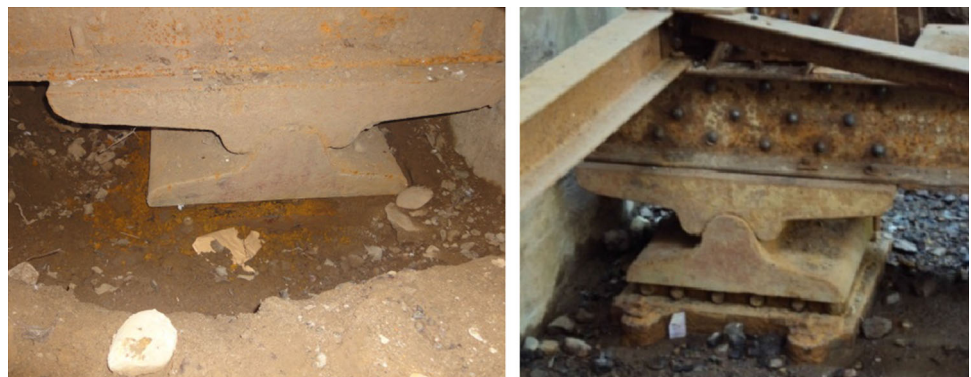
Fig. 7 Bearings before retrofitting and after retrofitting

The roller bearing acted as fixed support since the soil has been filled in the rollers. The load was relieved from the bearings by jacking the superstructure, and a temporary support system was introduced. Since Rocker and rollers were in good condition, the same bearings were used after clearing the soil deposits. The rollers of bearings were reset at correct alignment. The base plate was replaced with new

one. Figure 7 shows the status of bearings before and after retrofitting.

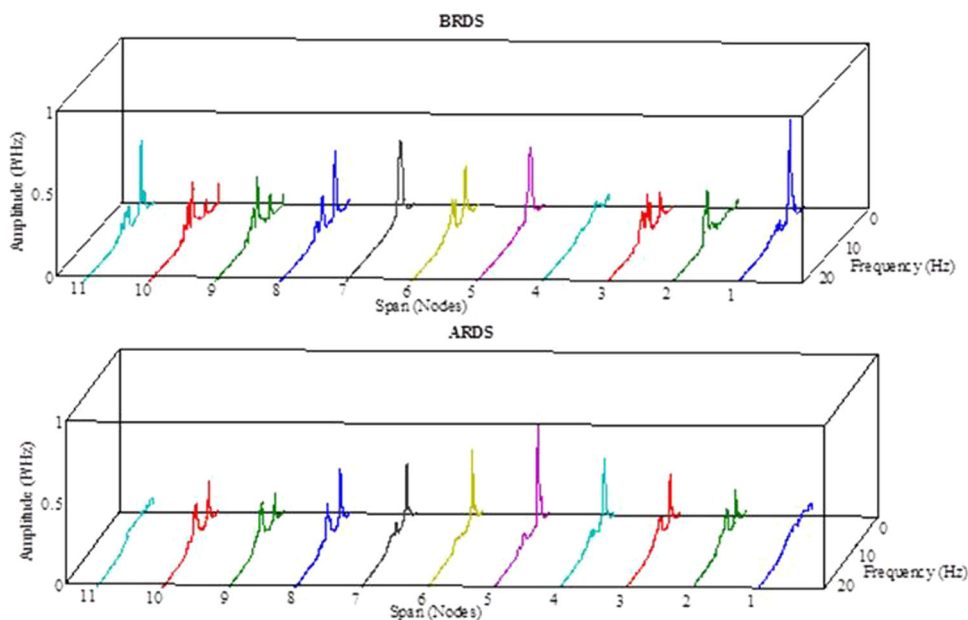
Fig. 8 Power spectral densities of Nagrota Bridge **a** before retrofitting **b** after retrofitting for the downstream truss

The PSDs of different nodes for the downstream and the upstream trusses before and after retrofitting are shown in

Figs. 8 and 9, respectively. It is observed that before retrofitting, node 4 did not vibrate as desired since this node did not generate the expected the first and the second modal frequencies. Similarly, node 21 is damaged because the node is not able to generate the modal frequency with desired amplitude. Such nonparticipation of the node in vibration of the structure is due to the flexibility introduced in the joint, thus, making the joint to be designated as damage joints. The modal frequencies were observed at the bearings indicating that the supports were not working as anticipated.

It has been observed from Fig. 8b that after retrofitting, nodes 4, 9, and 10 showed significant improvement in PSD curve. It means that the joints are intact and are able to generate the first mode. After retrofitting, nodes 1, 11, 12, and 22 do not show any nodal frequency because these

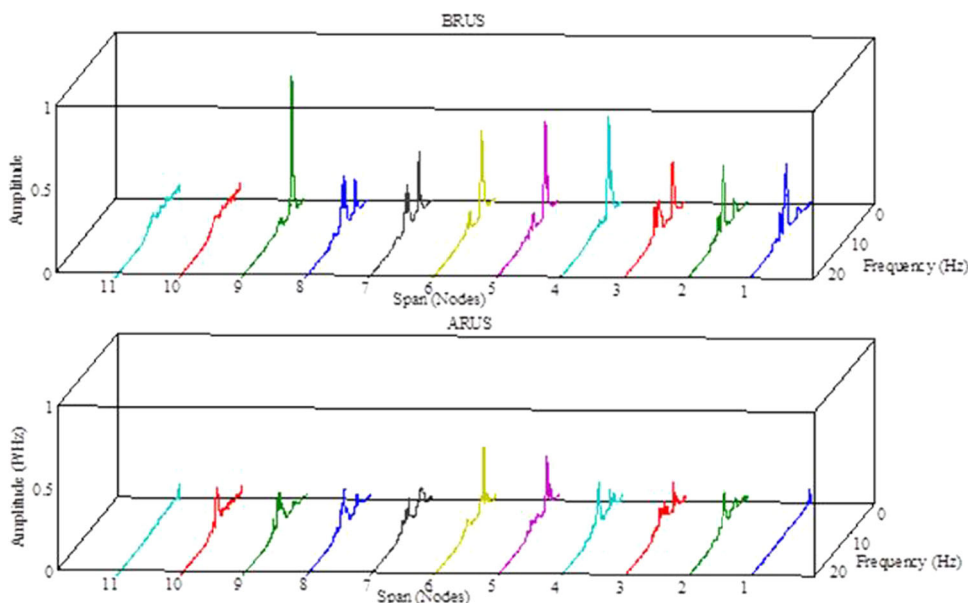
Fig. 9 Power spectral densities of Nagrota Bridge **a** before retrofitting **b** after retrofitting for the upstream truss

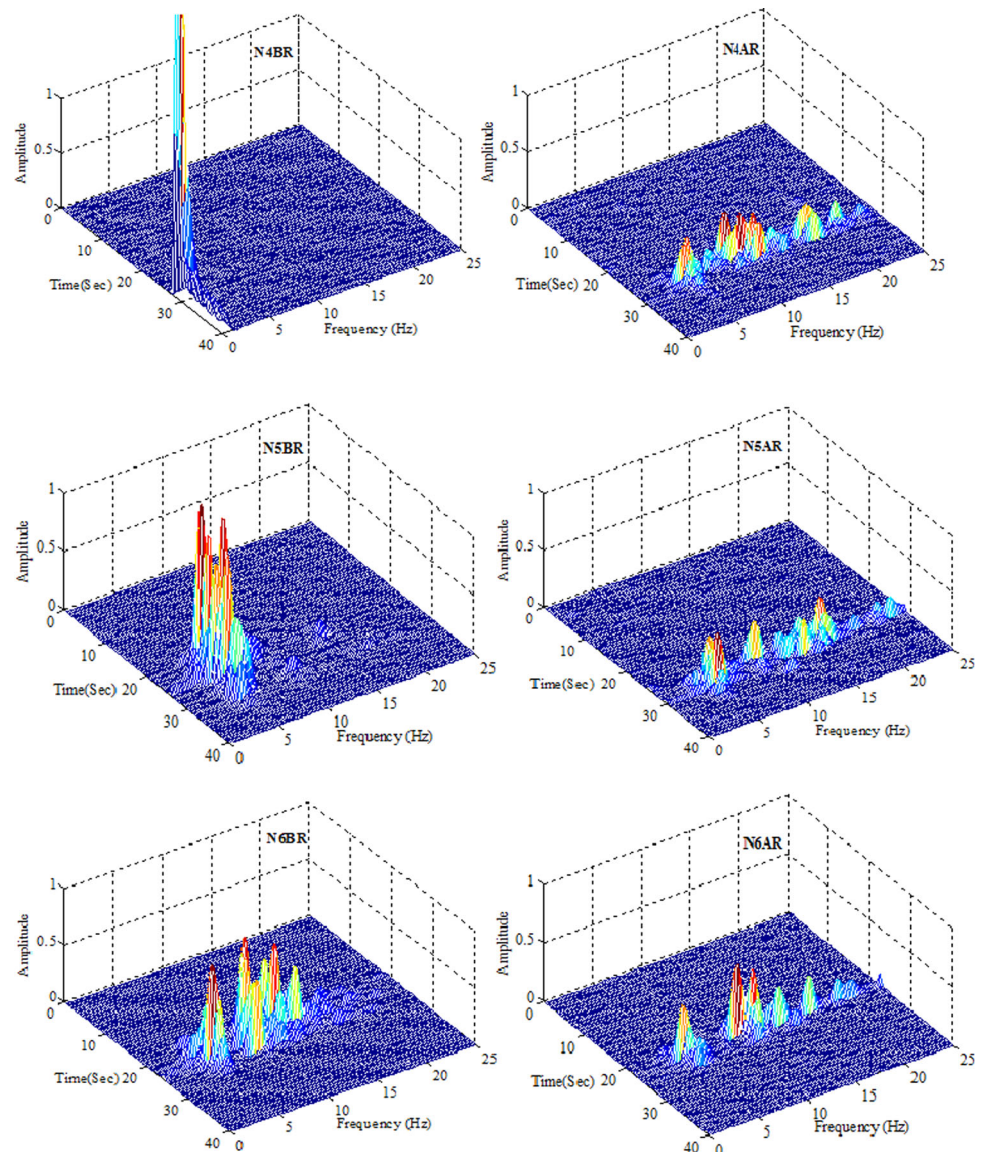
Fig. 10 STFTs of node numbers from 1 to 11 before and after retrofitting for the downstream truss

Therefore, the deficiencies in the nodal joints of the trusses along the span were further substantiated with the STFT. Time-dependent variation of joints can further be studied through the determination of frequency content of the random process [33]. The variation in the frequency content with time at different nodes of the structural member reflects the undesired flexibility at the nodes due to nonexcitation at particular structural frequency. The STFTs of the nodal responses before retrofitting were compared to the responses after retrofitting. The reduced excitation of the structural frequency bridge response after retrofitting of the nodal joints revealed the intactness of the bridge. Further, the distributed extraction of the bridge response at the target nodes revealed the nodal sensitivity after retrofitting. In the downstream truss (Fig. 10), nodes 1 and 11 before retrofitting generated nodal frequencies, but after retrofitting, both the nodes 1 and 11 did not generate modal response of a flexible joint, which showed that before retrofitting, supports were defective.

In the downstream truss, node 4 is damaged because it does not generate mode shapes before retrofitting, and after retrofitting, all the three mode shapes have been generated. Before retrofitting, node 5 and node 7 generated the first mode shape and did not generate the second and third mode shapes. After retrofitting, node 5 and node 7 generated all the mode shapes which are also evident in PSD. The Figs. 10 and 11 also show the degree of inappropriateness in the behavior of nodes, especially node 5 and node 7 as for longer time duration, the nodes vibrated at the fundamental structural frequency. The joints that are referred to as damage joint due to the induced nodal flexibility does not offer any stiffness and subsequently does not participate in generating the nodal frequency. The mode shape coefficients of the flexible nodes are amplified and shows undesired higher mode shape of the structure. In general,

the proper mode shapes have not been generated before retrofitting, and after retrofitting, the joints are intact and generated proper mode shapes.

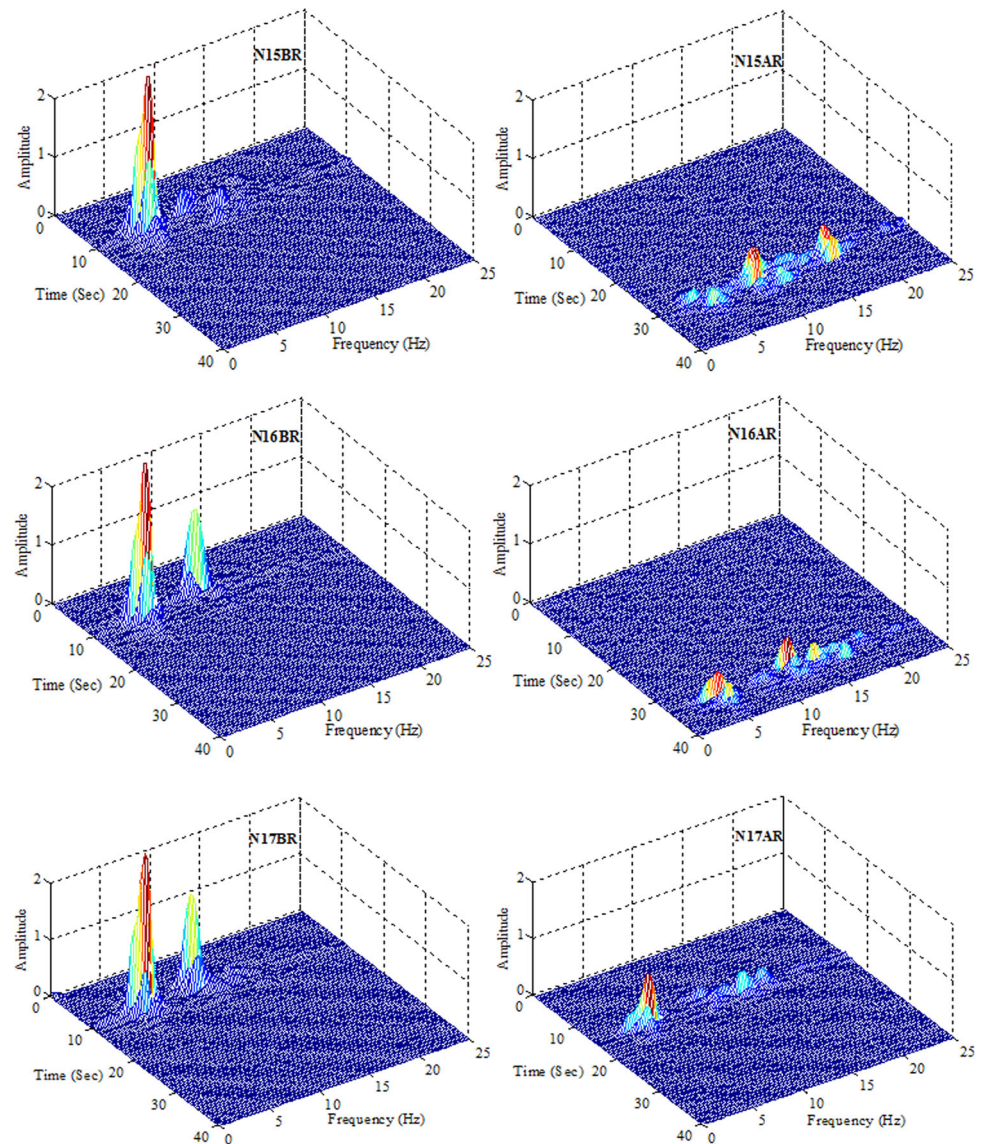
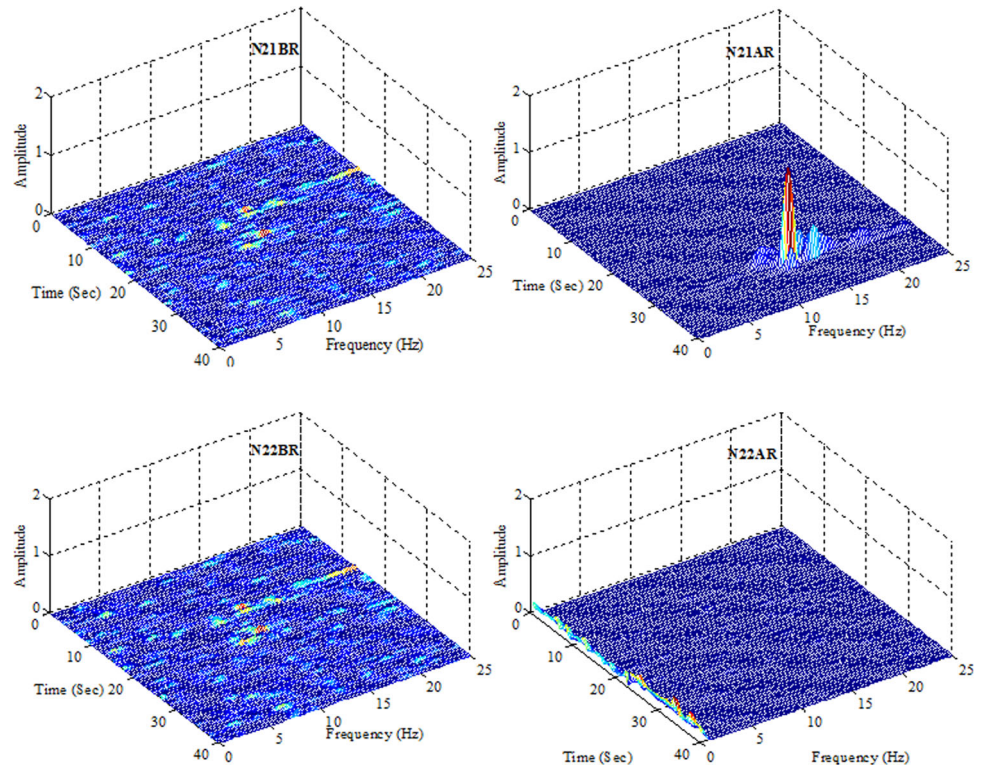
Fig. 11 STFTs of node numbers from 1 to 11 before and after retrofitting for the upstream truss

In the upstream truss (Fig. 11), after retrofitting, both the supports, i.e., nodes 12 and 22, behaved perfectly and showed improvement in the bearing of the bridge. Before retrofitting, most of the nodes showed higher amplitude of the modal frequencies compared to those after retrofitting revealing that nodal joints are more flexible before retrofitting. The amplitude of STFT shows how the frequency evolves over the time and also distribution of power among the frequency content of the STFT spectrum. Higher amplitude of a particular frequency shows higher power in a particular frequency along with the reduced distribution of power across the other frequency content. In the present study, higher STFT amplitude for a particular frequency

before retrofiting reflected concentration of the power and nonparticipation of other frequency mode shape due to lack of power. However, after retrofiting, the joint behavior changed and the uniform power distribution to the different frequency mode led to the reduced STFT amplitude w.r.t the situation before retrofiting. STFT at nodal point 21 before retrofiting does not generate any mode shape coefficient because this node acted as support as this joint had settled down. After retrofiting, this node generates the second and the third mode shapes.

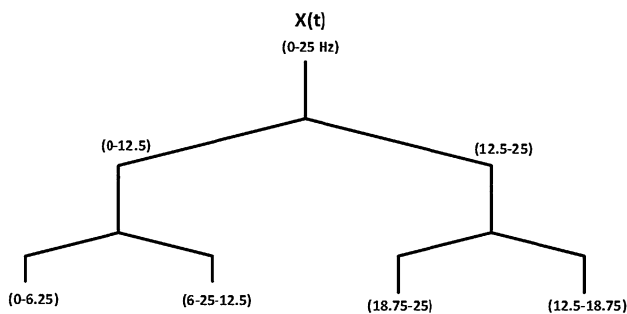
Fig. 14 Two-level wavelet packet decomposition tree

window length hence not adopted for further interpretation [36]. The Daubechies family db10 is used as a mother wavelet for wavelet packet analysis. The level of decomposition should be determined so that fundamental natural frequencies are separated into each wavelet packet. It is suggested to choose the wavelet packet of the frequency band that includes natural frequencies corresponding to fundamental modes. It is postulated that fundamental modes are more influenced by component damage than higher modes. Hence, in WPT the recorded signal is decomposed up to two levels and reconstructed because the frequency of interest was achieved up to this level. At level two, four components of the original signal are obtained with different frequency band (Fig. 14).

Figure 14 schematically illustrates a WPT-based decomposition process, where a two level WPT produces a total four sub-bands. The enhanced signal decomposition capability makes WPT an attractive tool for detecting and differentiating transient elements with high-frequency characteristics.
