Post-earthquake controls and damage detection through structural health monitoring: applications in l'Aquila

Filippo Lorenzoni¹ · Mauro Caldon¹ · Francesca da Porto¹ · Claudio Modena¹ · Takayoshi Aoki²

Abstract

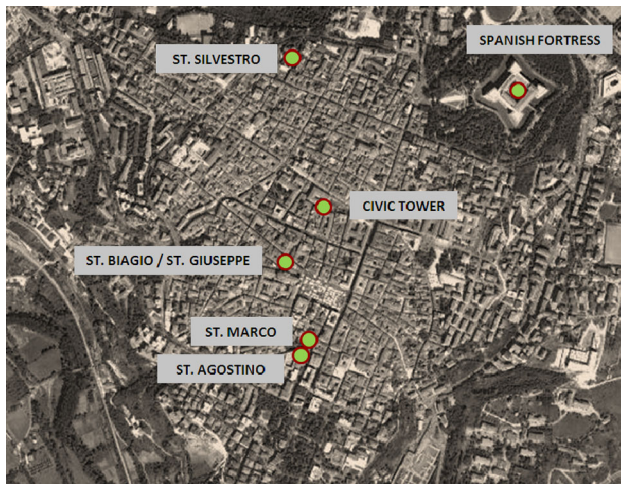
Fig. 1 L'Aquila structural health monitoring (SHM) network installed after the earthquake

Some major monuments were soon equipped with SHM systems in order to control the progression or stationariness of the damage pattern already assessed. In a second step, further systems were applied on other CH buildings, also during the stabilization works execution, in order to appraise the effectiveness of the interventions carried out, or to denounce their inadequacy. In this framework, a small network of SHM systems (Fig. 1) was set up by the Department of Civil, Architectural and Environmental Engineering and the Nagoya City University, whose data—also containing several after-shocks records—will constitute a sound database for investigation in the field of CH structures response and strengthening procedures.

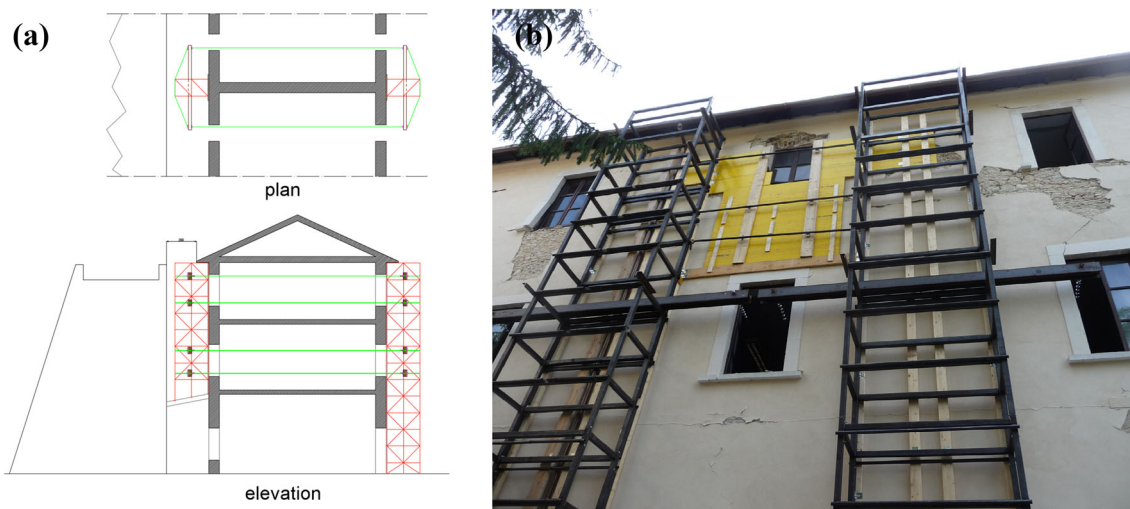
Fig. 4 Provisional interventions carried out on SE and SW wings: connection of the internal and external façades by means of steel cables and frames

The two façades of the North-West part showed a greater resistance to the overturning mechanism; there are no large detachments of the floors from the perimeter walls. In fact, in this area of the fortress a system of tie rods connecting the perimeter walls had been inserted before the earthquake. This intervention was effective and avoided collapses and irreversible damages to the structure. The structural stability was provided by relying on the remaining strength of the resisting elements, e.g. by connecting the internal and external façades of the damaged wings by means of stainless steel cables (Fig. 4), in order to avoid the observed

overturning mechanisms evolution, especially taking into account that non-negligible aftershocks occurred for several months. In the South-East wing, it was necessary to rebuild the roof, by using hollow section steel trusses and a light covering structure made of wood. The substitution of the original wooden structure of the roof with a heavy and stiff reinforced concrete structure, without any strengthening interventions on the underlying masonry walls, caused the collapse of the upper part of the façade. In the South-West wing steel frames were positioned in contrast to the external and internal façades before tensioning the cables.

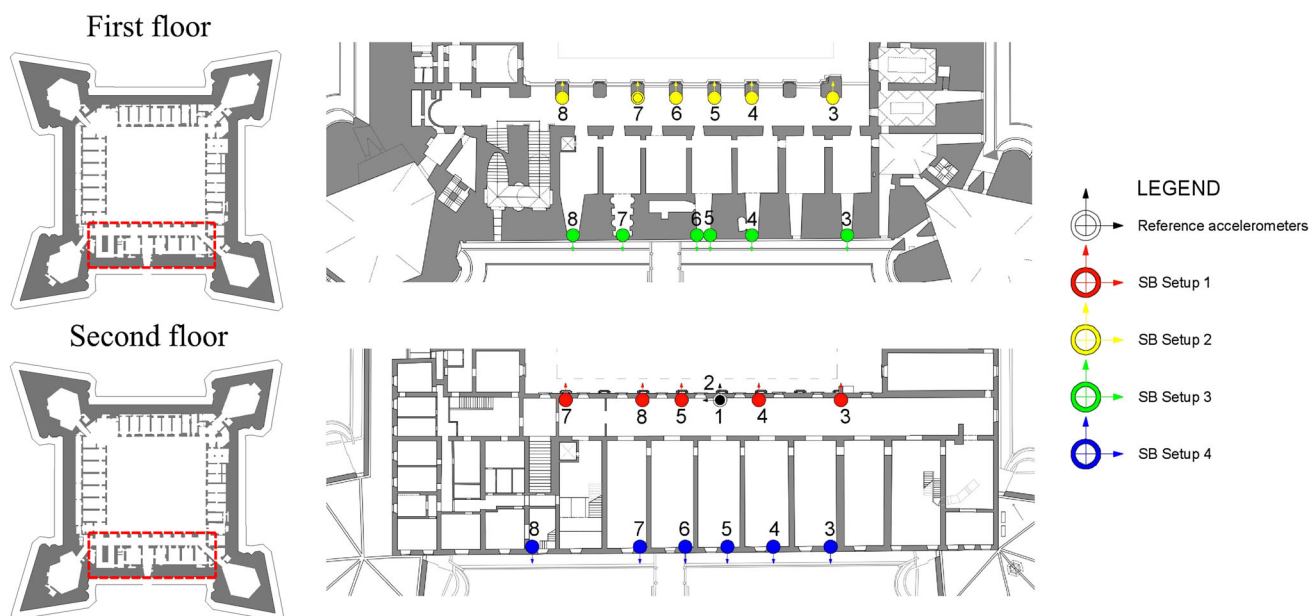
Fig. 5 Layout of the uniaxial accelerometers for the four setups (S1-red, S2-yellow, S3-green and S4-blue) used for the execution of AVT on the first (a) and second (b) floors of the monument (colour figure online)

Five configuration setups were performed with 27 points of acquisition (Fig. 5), using high sensitivity piezoelectric seismic accelerometers. For each setup, no more than eight sensors were used, including two fixed reference sensors, arranged in two directions (X and Y) parallel to the ground and perpendicular to each other (channels 1 and 2 at the second floor). Acceleration transducers were placed along

the out-of-plane direction on both sides of the wing. The records concentrated mainly on the perimeter walls as the aim was to investigate any dissimilar dynamic behaviour of the two façades due to the heavy state of damage of the structure. For each setup three records (65'536 points each) were acquired with a sampling rate of 100 SPS (samples per second).

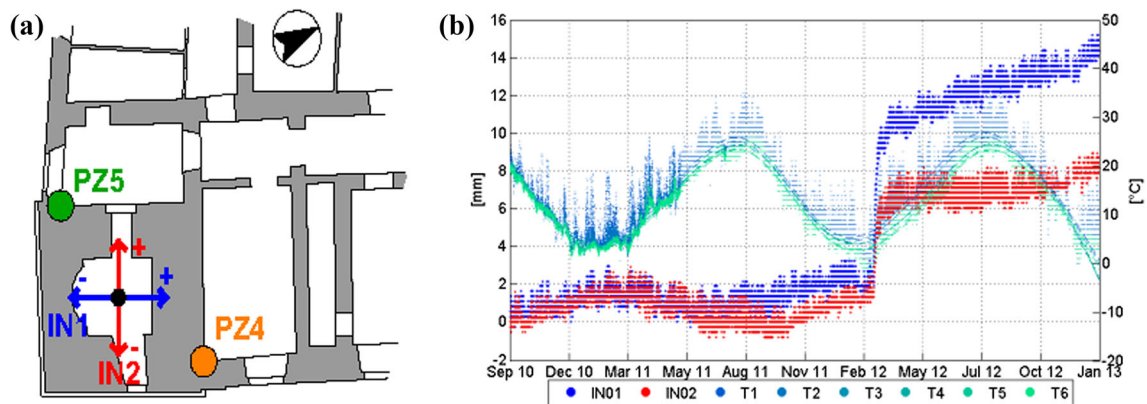
Fig. 14 Static monitoring of the Civic Tower: **a** layout of inclinometers (IN1 and IN2) and displacement transducers (PZ4 and PZ5); **b** top tower displacements recorded by inclinometers along N-S (IN1-blue) and E-W (IN2-red) directions [26] (colour figure online)

In February 2012 the equilibrium conditions of the tower underwent a significant change due to a slight

rotation/displacement of the tower toward the palace, as recorded both by the inclinometer (Fig. 14b) and by the displacement transducers placed at the tower-palace interface, in correspondence to the big lesion that separate the two structures.
