Ambient vibration test and numerical investigation on the St. Giuliano church in Poggio Picenze (L'Aquila, Italy)

Keywords Monumental constructions · Masonry structure · Seismic vulnerability · Ambient vibration test · FEM model

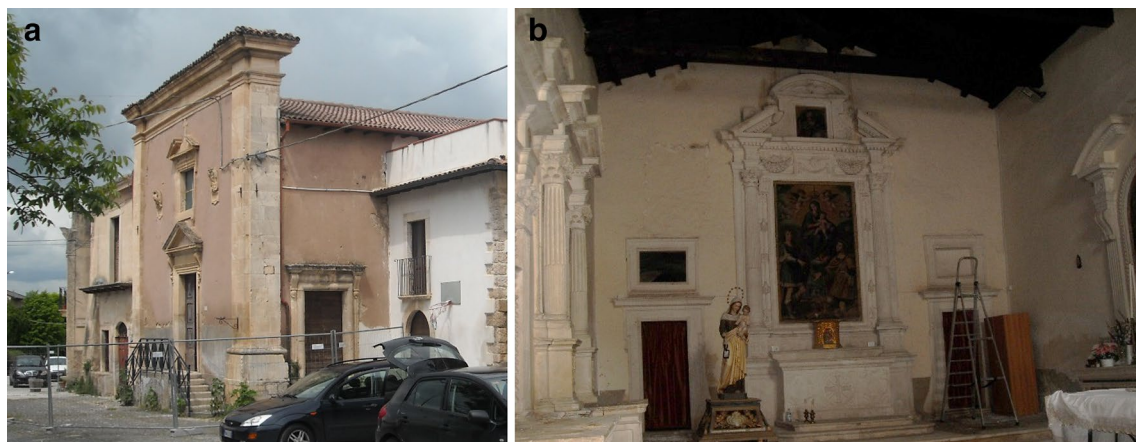
Fig. 2 St. Giuliano church: internal (a) and external (b) views

The construction of the St. Giuliano church (Fig. 2) dates back to the early fifteenth century. The stone crest on the façade shows the date of 1589, where previously there was a small hospital remained in use until 1447.

The church has a single rectangular nave with timber beams covered by terracotta flooring of recent workmanship. The nave has a major altar and side altars of fine workmanship with newsstands of different shapes. Externally the church has a plastered façade with a horizontal

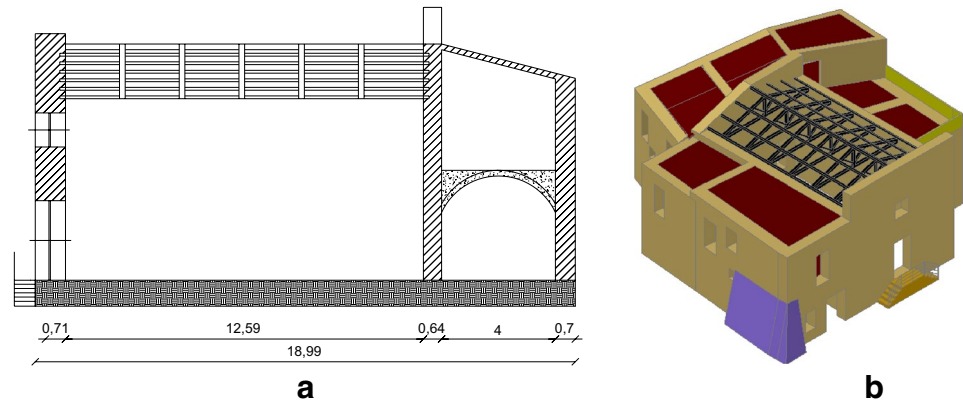
Fig. 4 Geometrical features of the St. Giuliano church: longitudinal section (a) and 3D drawing of the entire building aggregate (b)

The main vertical structure of the church consists of sack local stone masonry walls surmounted by a timber pitched roof (Fig. 4b). The walls, which have a thickness

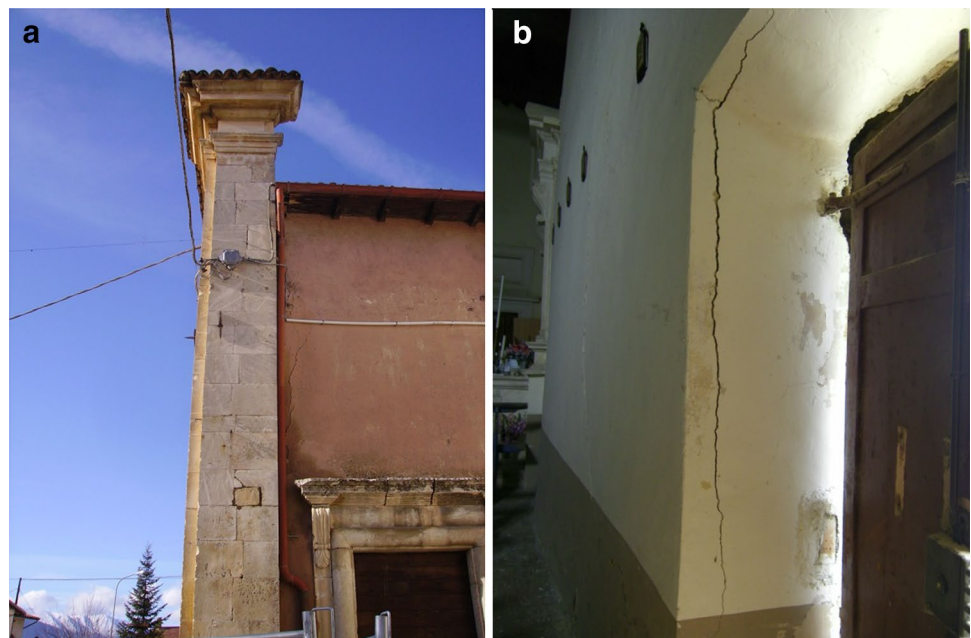
Fig. 5 Incipient overturning of the main façade (a) and horizontal bending mechanism of one of the longitudinal walls (b) of the church

of 70 cm, are covered by the lime mortar plaster. The main façade contains elegant architectural decorations typical of the Romanesque—Aquilano style. Due to the earthquake, this façade showed an out-of-plane overturning mechanism, which produced some cracks in the intersection zones with longitudinal walls. In addition, shear and vertical in-plane cracks have been detected on the façade wall. Another damage also concerns the church longitudinal wall on the right side of the entrance, which has suffered a horizontal bending mechanism triggered by the thrust of the first level vaults of the neighbouring building. Finally, some minor cracks into arches and vaults have been detected. The pictures of the main damages identified after earthquake are reported in Fig. 5.

Parameters that have influenced the described failure mechanisms of the masonry wall are certainly the high slenderness, its deficient boundary conditions and low resistances of both bricks and mortar joints.

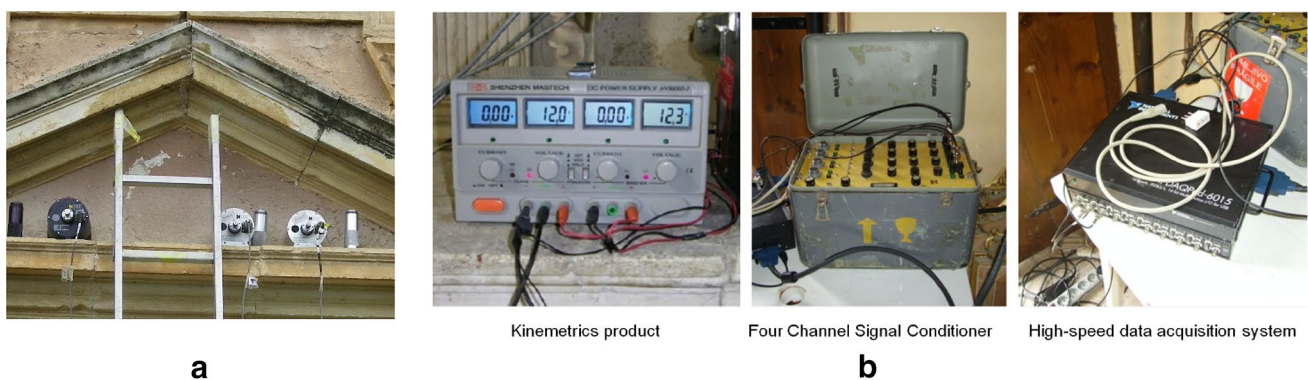
Fig. 6 The used seismometers (ranger type) (a) and the equipment for AVT (b)

The instrumentations used by the IZIIS laboratory members to carry out the ambient vibration test included the following equipments: three SS-1 Ranger seismometers (Fig. 6a), kinemetrics product for ambient vibration measurements and a four-channel signal conditioner for filtering and amplifying the measured signals (Fig. 6b).

The Ranger seismometers are widely recognized as excellent short-period field instruments. They have small size, high sensitivity, adjustable natural period and rugged water-tight construction. In addition, these tools can be used as vertical or horizontal seismometers by simple adjustment of the mass centring spring. The used seismometer type is a “moving coil” style acceleration transducer. The coil is stationary, however, while the strong permanent magnet serves as the seismic inertial mass. The mass is supported and constrained by annular springs at the top and bottom of the moving magnet. In vertical position, the unit, which has a weight of about 5 kg, has a diameter of 305 mm and a height of 140 mm. The basic natural period is of 0.35 s, but it is extended to 1 s or more by means of small rod magnets that surround the periphery of the mass, interacting with its magnetic field.

For amplification and simultaneous control of the seismometers, the signal conditioning model SC-1, also manufactured by Kinemetrics, was used. Four channels of ambient vibrations are recorded to allow for satisfactory resolution in low-frequency regions of the power spectra and the transfer functions. This four-channel frequency analyzer covers a frequency range from 0.02 to 25.6 Hz and allows for a complete frequency analysis of the signals obtaining both amplitude and phase spectra. In particular, the data sets consisted of records of velocity signals with duration of 1000 s and the sampling frequency was 200 Hz.

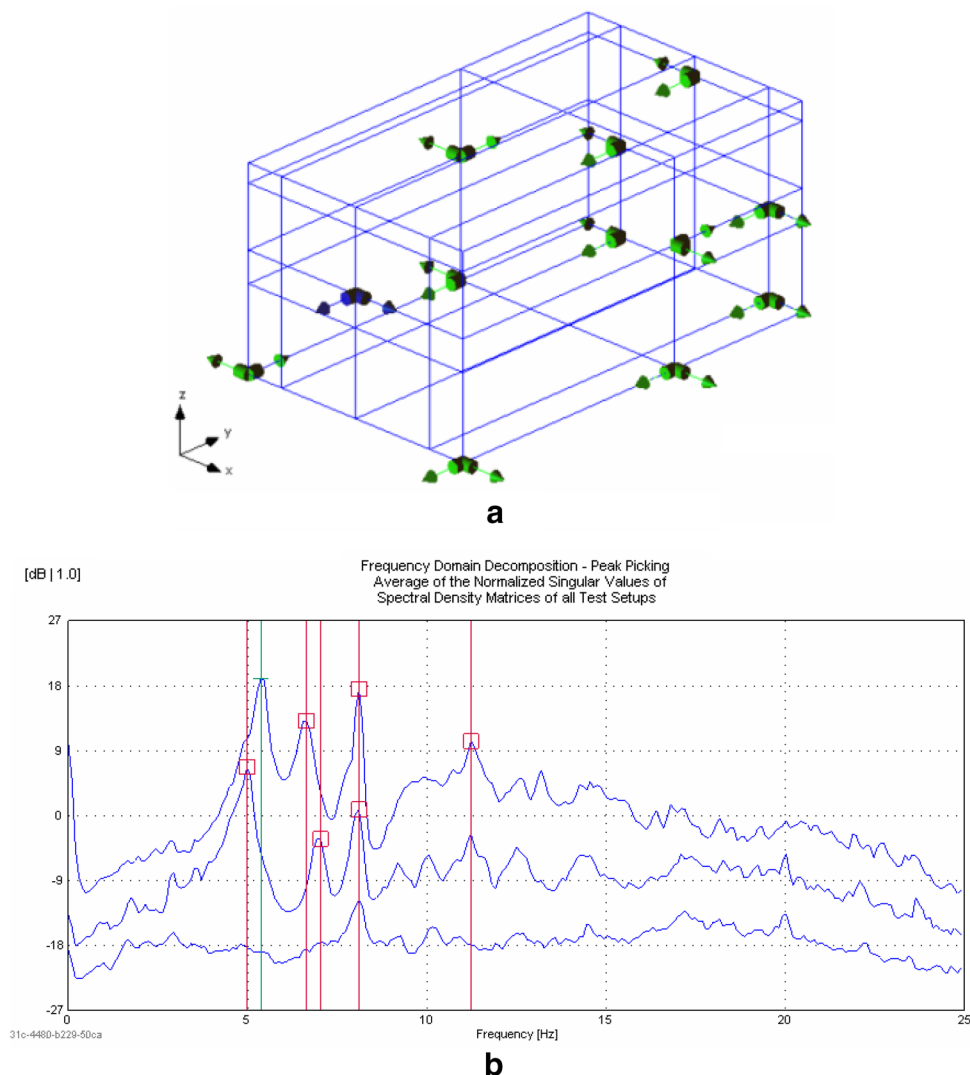
Fig. 7 Test setup (a) and dominant frequencies (b)

The structure of St. Giuliano church was measured in 11 different points to assess its dynamic properties. Measurement points were placed at different positions along the church height, by exploiting the presence of altars, gables and openings, in order to reconstruct the modal vibration shapes as precise as possible. They are indicated in green in Fig. 7a, where also the reference point (RP) with blue colour is highlighted. Four vibration modes, corresponding to the main modal vibration shapes related to the actual damage state of the construction, were identified from the analysis of the complete set of data representative of the entire construction.

The peak-picking of dominating frequencies in the obtained spectrum is depicted in Fig. 7b, where it is apparent that only the three lower peaks on the first SV line (SV1)

have been “picked”, while the other peaks (on SV1 and SV2) can be conceivably associated with local modes.

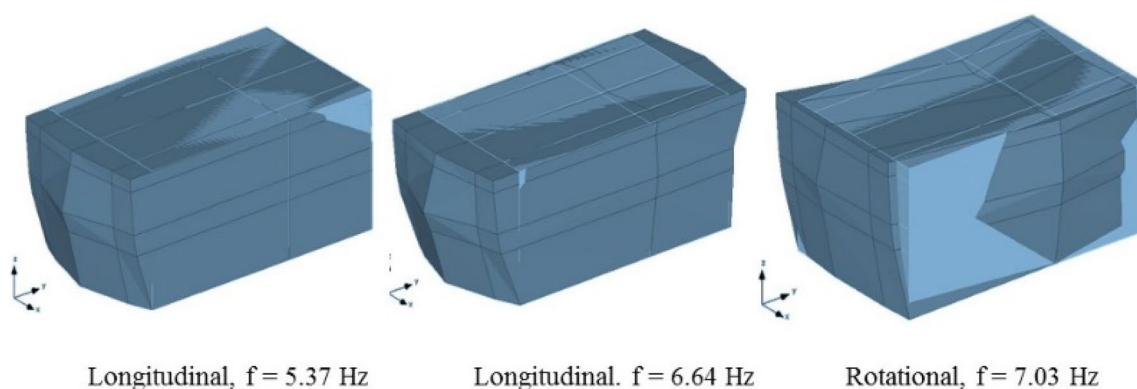
Fig. 8 Experimental mode vibration shapes

As shown in Fig. 8, the vibration mode shapes are characterized by the main frequencies of 5.37 Hz and 6.64 Hz, where the structure moves in longitudinal direction with dominant separation of the façade wall, and the frequency of 7.03 Hz, in which the torsion effect is noticeable as a result of the influence of the neighbouring connected structures, which give rise to a building compound characterized by in-plane and in-elevation structural irregularities. Moreover, in the previously mentioned torsion vibration mode, it is also noticed the horizontal bending mechanism of the longitudinal masonry wall detected after the occurred 2009 earthquake.

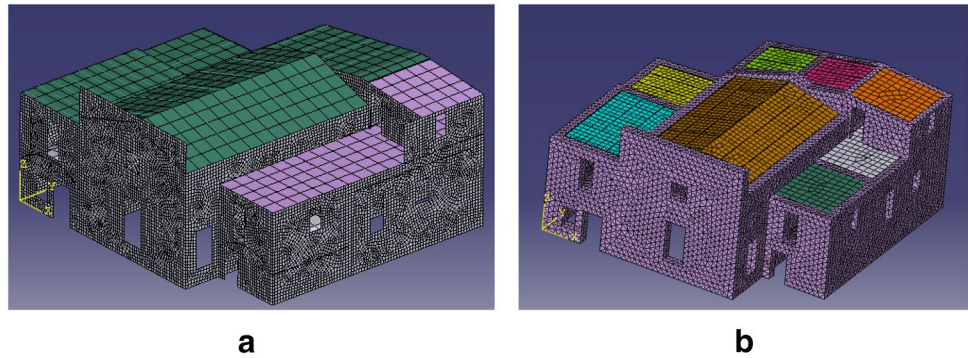
Fig. 9 The ABAQUS FEM model: with brick and shell elements (a), with brick elements only (b)

About the choice of finite element types (step 1), the examined masonry structure has been partitioned by means of tetrahedral 3D brick (C3D4, 4-node linear tetrahedron) elements. For roofing structural systems, instead, timber trusses and beams have been modelled with truss elements, while different techniques have been used to model the timber planking. In particular, in a first phase all the roofing planking components have been modelled as shell elements (Fig. 9a); subsequently, they have been modelled as brick elements (Fig. 9b).

The preliminary analyses have evidenced that the best model is that with all brick elements, since it does not consider the shell–brick interactions, which can lead to both solution convergence problems and significant analysis times. So, this FEM model based on brick elements only has been selected to perform subsequent analyses.
