# Monitoring and evaluation of bridges: lessons from the Polcevera Viaduct collapse in Italy

## Abstract

**Keywords** Monitoring of bridges · Evaluation of bridges · Maintenance · Existing bridges

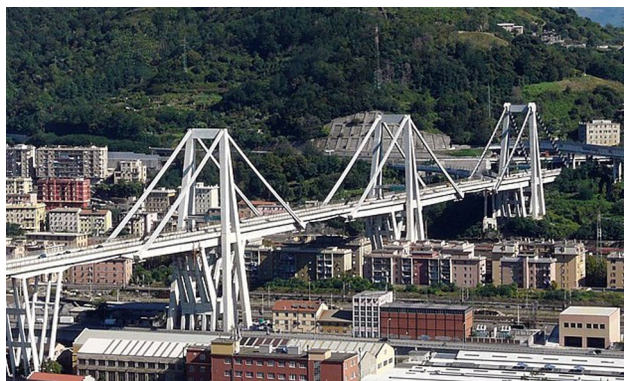
**Fig. 1** The Polcevera Viaduct before the collapse of the first balanced system on the left (namely pier 9)

Designed by Riccardo Morandi, one of the most famous bridge designers of all time, the main part of the viaduct was composed of three balanced systems, referred to as piers 9, 10 and 11, respectively, shown in Figs. 1 and 2 and connected by buffer beams. The failure occurred in pier 9 at the first balanced system on the west side (left in Fig. 1). Piecing together the failure dynamics of the bridge after the collapse was a difficult task. The most credible hypothesis about the dynamics of failure was the rupture of the first cable-stay, near the seaside. Only recently, this hypothesis seems to have been confirmed by a video, which was not available before. Lack of the cable-stay support resulted in collapse

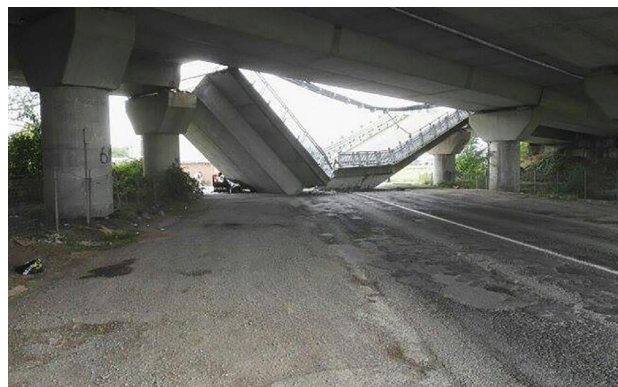
**Fig. 4** The viaduct collapsed at Fossano, Italy

on October 28th, 2016, while a truck carrying steel coils was passing, and the viaduct on the Fossano ring road (Fig. 4), suddenly collapsed on April 17th, 2017, in the absence of travelling loads. These are just two recent cases in Italy.

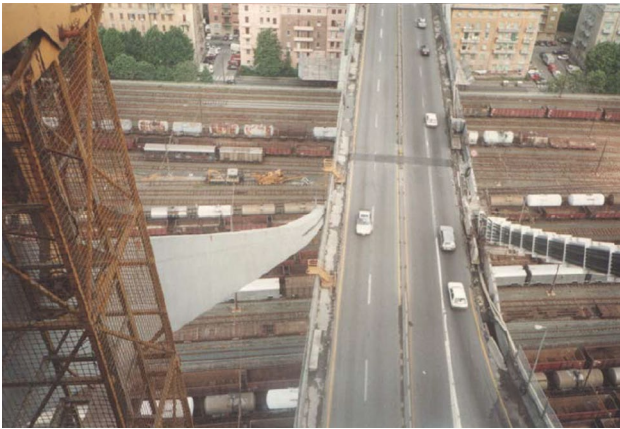
Fig. 5 Polcevera Viaduct: new strands on pier 11 [2]

As pointed out by Nuti et al. [2] failures of structures are often tragic events. Sadly, they represent an opportunity to improve our understanding about safety and reliability of structures. The Authors present a review of the Polcevera Bridge collapse and its history. They focused their attention on the monitoring to assess the performance decay due to corrosion (Fig. 5).

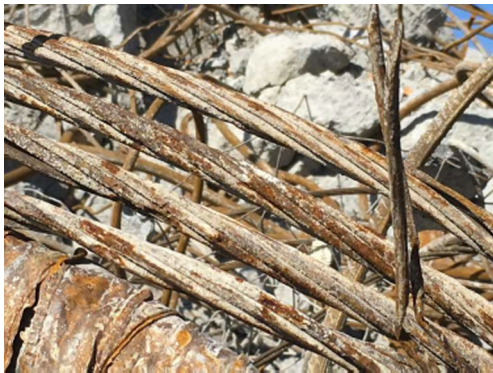
Fig. 6 Polcevera Viaduct: pitting corrosion of prestressing tendons [3]

Morgese et al. [3] demonstrated that the collapse of the Polcevera Viaduct could have been prevented with a proper real-time structural health monitoring. The authors tried to estimate the remaining service life for the bridge in the absence of structural health monitoring. They concluded that basic engineering principles may provide the backing to estimate the remaining life of the bridge. Based on the combined effects of fatigue and corrosion of the cable stays, they estimated the collapse of the bridge to have occurred in 2016 (Fig. 6).

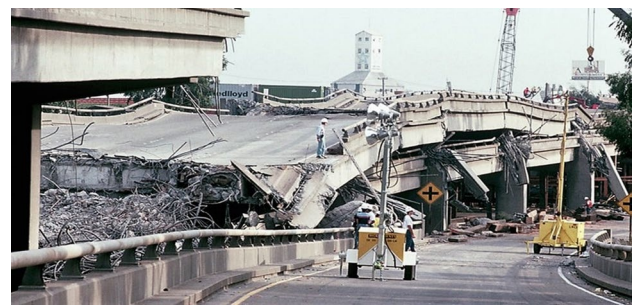
Fig. 8 Cypress Street Viaduct collapse [5]

Bontempi [5] explains the aspects related to structural robustness. Bontempi first introduces the concept of structural integrity and then considers how it varies in time, accounting for the different kinds of progressive collapses (Fig. 8). The analysis is carried out from a practical point of view, as needed by designers.

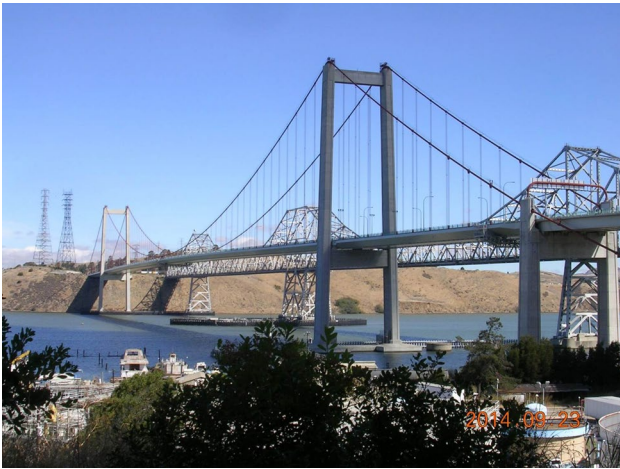
**Fig. 9** The two parallel Carquinez Strait Bridges [6]

The behaviour of the suspension bridge in Carquinez, CA (Fig. 9), during the Mw6.0 August 2014 South Napa, CA earthquake is analysed by Çelebi et al. [6]. They use data from an extensive array of accelerometers that recorded the earthquake-excited motions and identified the dynamic characteristics. These are compared with previous studies, which used ambient data of the deck only plus mathematical models.

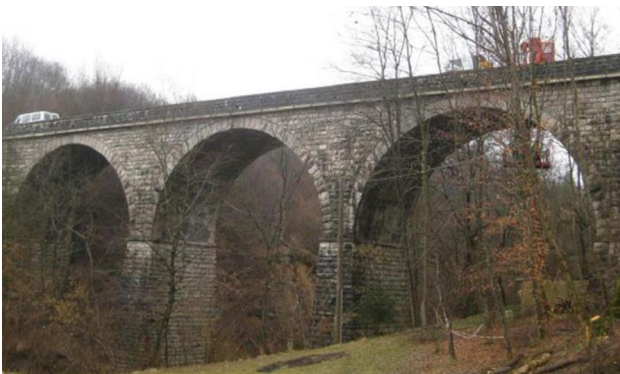
**Fig. 10** View of the Gresal Bridge [7]

Lorenzoni et al. [7] focused the attention on the evaluation of damping using operational modal analysis. Damping is usually affected by higher uncertainties, even when resonance frequencies and modal shapes have been correctly identified. They report the results of ambient and free-vibration tests performed on five different typologies of road and railway bridges and conclude that the

estimation of modal damping return to be more reliable for flexible structures and when SHM and free-vibration data are available (Fig. 10).

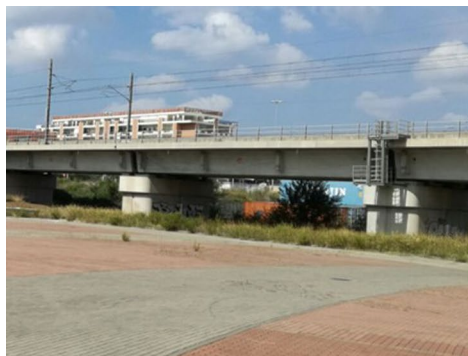
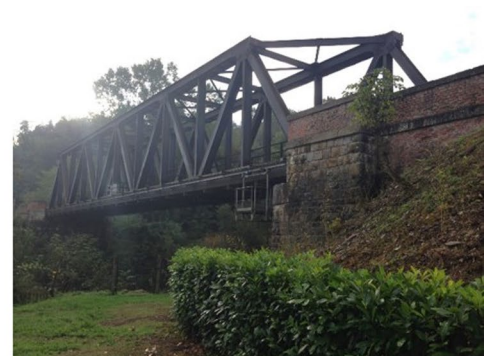
**Fig. 11** The two railway bridges [8]

Gattulli et al. [8] analyzed data acquired in operational condition on steel and concrete railway bridges belonging to the Italian network and highlighted dissipative sources and features (Fig. 11). They proposed a non-proportional damping index as a basis to determine the influence of different sources of non-proportionality in the damping matrix and justified the high value of damping observed in specific experimental campaigns.

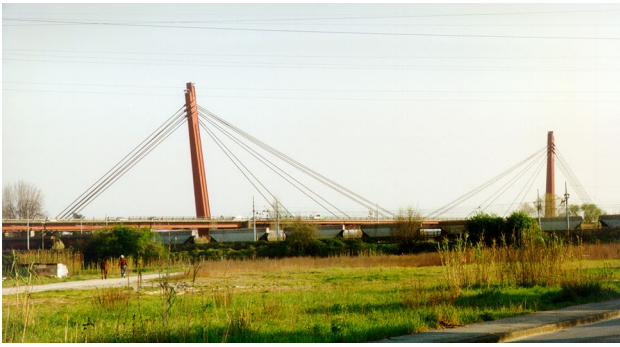
**Fig. 12** The Indiano Cable-Stayed Bridge, Florence, Italy [9]

The results of an experimental dynamic analysis and structural modeling of one of the longest bridges in Italy, the Indiano Cable-Stayed Bridge in Florence (Fig. 12), are presented by Clemente et al. [9]. Ambient and traffic-induced vibration tests were carried out, which allowed performing the system identification by means of a finite element model. This model was used to evaluate the effects of the static and seismic loads.

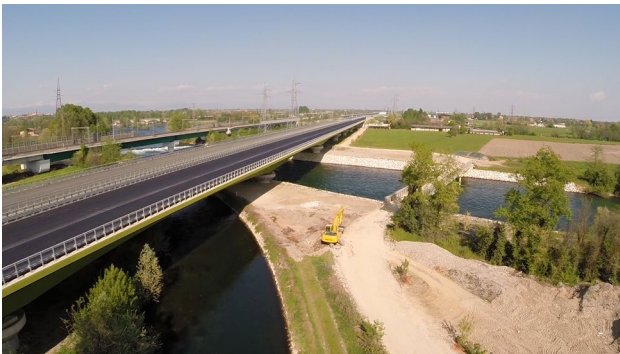
**Fig. 13** View of the Adda Viaduct [10]

Marcheggiani et al. [10] presented the results of static and dynamic testing of a multi span bridge, which was opened to traffic in 2014 (Fig. 13). The results of an operational modal analysis are compared with those of a numerical model, pointing out that the dynamic load test can supplement the static load tests for the structural evaluation of bridges, both new and existing ones.

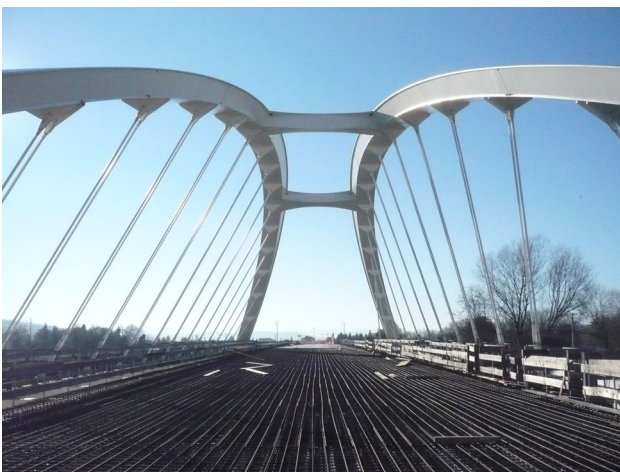
**Fig. 14** The bridge on the Potenza river [11]

Gara et al. [11] presented the results of an experimental campaign carried out during the construction of a base-isolated bridge across the Potenza river in central Italy (Fig. 14). Impact load tests were carried out on hangers and on other tie elements, as well as ambient vibration tests. Test results were compared with the numerical analysis to evaluate consistency between the design and the real structure at different construction stages.

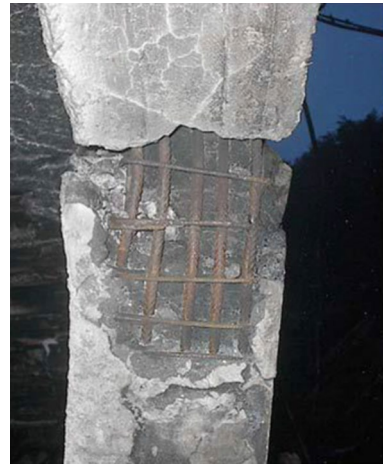
**Fig. 15** Damage on RC structural elements caused by the earthquake of Santa Venerina in 2002 [12]

The importance of the vertical component of seismic acceleration for bridges and viaducts is pointed out by Falsone et al. [12]. They show that their analysis is fundamental for collapse prevention of girder bridges subjected to near-fault earthquakes, also with reference to unseating failure and damage to piers and abutments (Fig. 15).

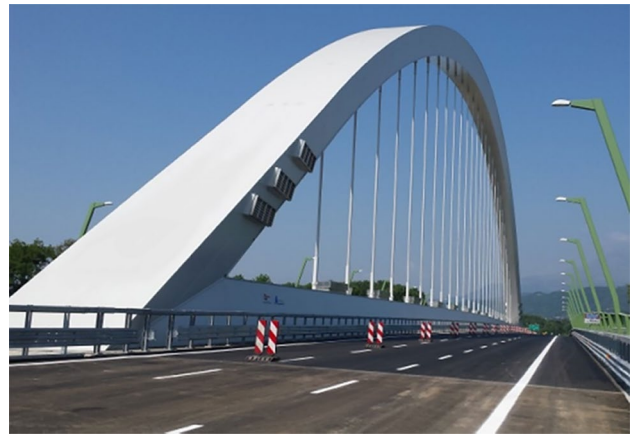
**Fig. 16** General view of the suspended arch steel bridge [13]

Chiaia et al. [13] illustrate the application of an active monitoring system on a 250 m suspended arch steel bridge using sensors of different types (Fig. 16). They point out that the estimation of dynamic characteristics is influenced by several factors, among these the effects of temperature.
