Fibre optic sensing of ageing railway infrastructure enhanced with statistical shape analysis

Haris Alexakis^{1,2} · F. Din-Houn Lau³ · Matthew J. DeJong⁴

2 Case study: the Marsh Lane Bridge

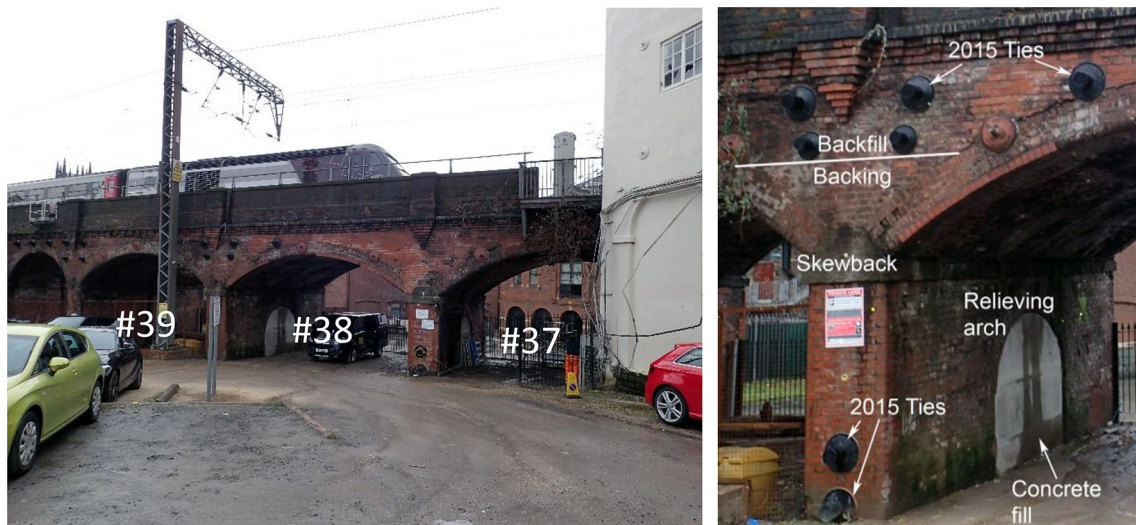
Fig. 1 Left—Northern view of the Marsh Lane Viaduct in Leeds, UK. Right—Closer view of the pier between Arches 38 and 39, showing the 2015 retrofit

The bridge appears significantly damaged due to the increase of the operational train loads over the last decades and due to environmental effects. For this reason, it was repaired in 2015 by filling the relieving arches of the piers with concrete and installing steel ties to arrest the transverse movements of the piers and spandrel walls, as shown in Fig. 1-right. Figure 2 is the plan view of the bridge showing with red lines the main cracks observed under the arches. The most severe damages are concentrated over the relieving arches at the centre of the piers due to a spreading

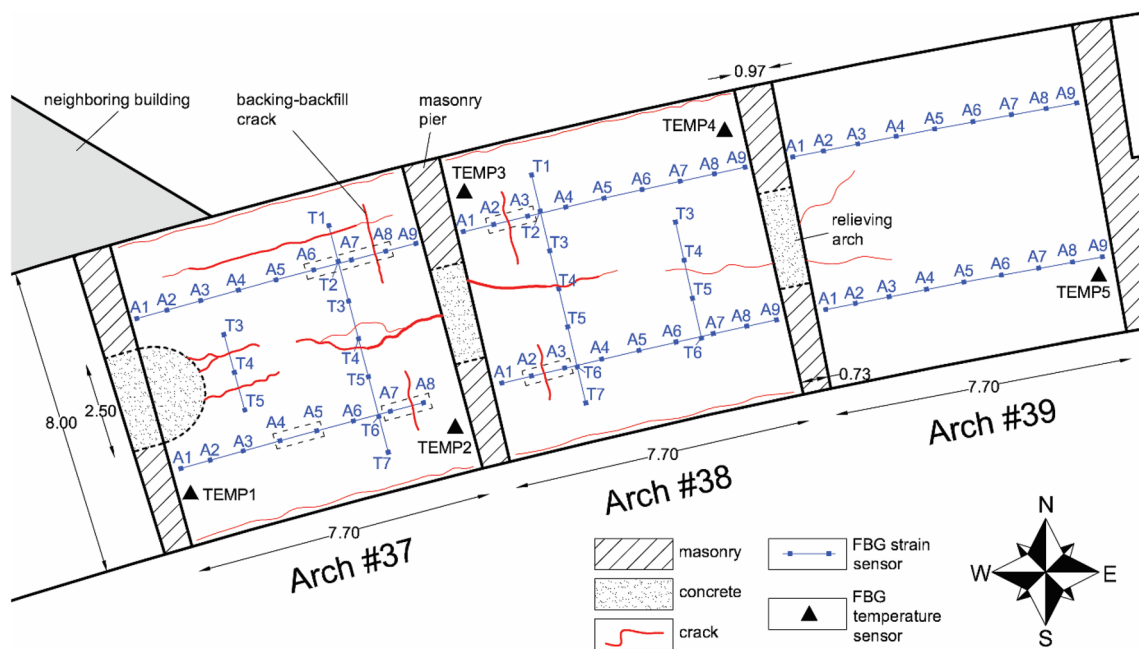
Fig. 2 Plan view of the investigated section of the bridge, showing the main damages and location of the fibre Bragg grating network

mechanism that forces the relieving arch keystone to descend and the pier walls to bow outwards [18]. The pier between Arches 37 and 38 is surrounded by transverse cracks at the level where the backing meets the backfill material (see Fig. 1-right). These cracks are due to the intense out-of-plane rocking response of the pier under train loading before the 2015 retrofit [18]. In the longitudinal direction, separation cracks between the spandrel walls and the arch barrels are observed in Arches 37 and 38 as well as a longitudinal crack in Arch 37 develops below the North railway track.

In July 2016, a few months after the bridge repair, a network of FBG strain sensors was installed underneath Arches 37 and 38, allowing for the detailed study of their dynamic deformation [18]. In November, 2017, this proof-of-concept, temporary monitoring installation was replaced by a permanent FBG monitoring installation [19–21] underneath Arches 37, 38 and 39, shown in Fig. 2, to assess the long-term effectiveness of the 2015 retrofitting intervention and to monitor bridge deterioration. In Fig. 2, the blue lines along the longitudinal and transverse direction of the bridge

correspond to the FBG network of strain sensors and the black triangles to FBG temperature sensors.

The FBG network shown in Fig. 2 comprises: 47 strain sensors in the longitudinal direction; 17 strain sensors in the transverse direction; 4 sensors attached to steel wires that

connect the springings of Arch 37 and Arch 39, which are located underneath the longitudinal strain sensors arrays, to measure variations in arch span (see also Fig. 4-top); and lastly, 5 temperature sensors.

The analysis identifies five locations where the dynamic strain has notably increased over the two year monitoring period. The locations are indicated with dashed boxes, both in Figs. 2 and 5, which correspond to sensors 37NA6A7-37NA7A8, 38NA2A3, 37SA4A5, 37SA7A8, and 38SA2A3. In other words, the dynamic deformation has increased in all four symmetric quarter span locations around the Arch 37–38 pier, where the transverse cracks are observed, together with the South keystone area of the most severely damaged Arch 37.

In the following statistical analysis we consider the FBG data from sensors 37NA6A7 and 38NA3A4. Sensor 37NA6A7 is located at the 1/3 of the Arch 37 span at the North side of the bridge (see Fig. 2). This is one of the five locations where an amplification of the dynamic strain has been identified in [20], as discussed in the previous Sect. 38NA3A4 is its symmetric location in Arch 38, at the 1/3 of the arch span (see Fig. 2), where no significant variations in the dynamic strain was observed [20].

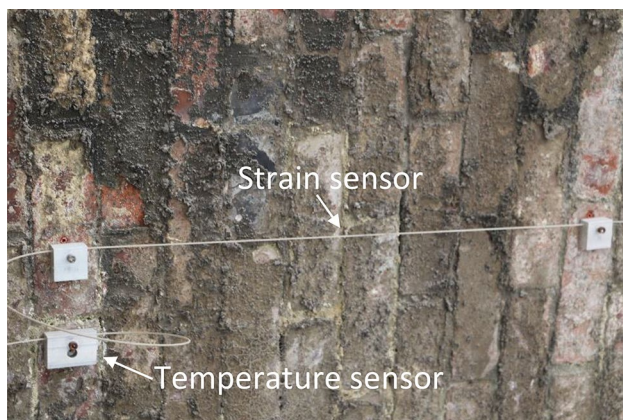
Fig. 3 Fibre Bragg grating strain and temperature sensor

A close view of the FBG strain and temperature sensors is offered in Fig. 3. In the case of strain sensors, the fibre optic cable is pre-tensioned and the Bragg gratings are located between aluminium clamps. In that way, every FBG sensor measures strain variation between two fixed points, which are about 1 m apart.

The FBG temperature sensor developed for this study (see Fig. 3-bottom left) consists of two machined rectangle aluminium plates with a tight groove fitted around the cable, screwed together. The clamps are long enough to transfer strain due to thermal expansion of the aluminium, while the cable that exits the clamp is loose to omit any influence of structural deformation.

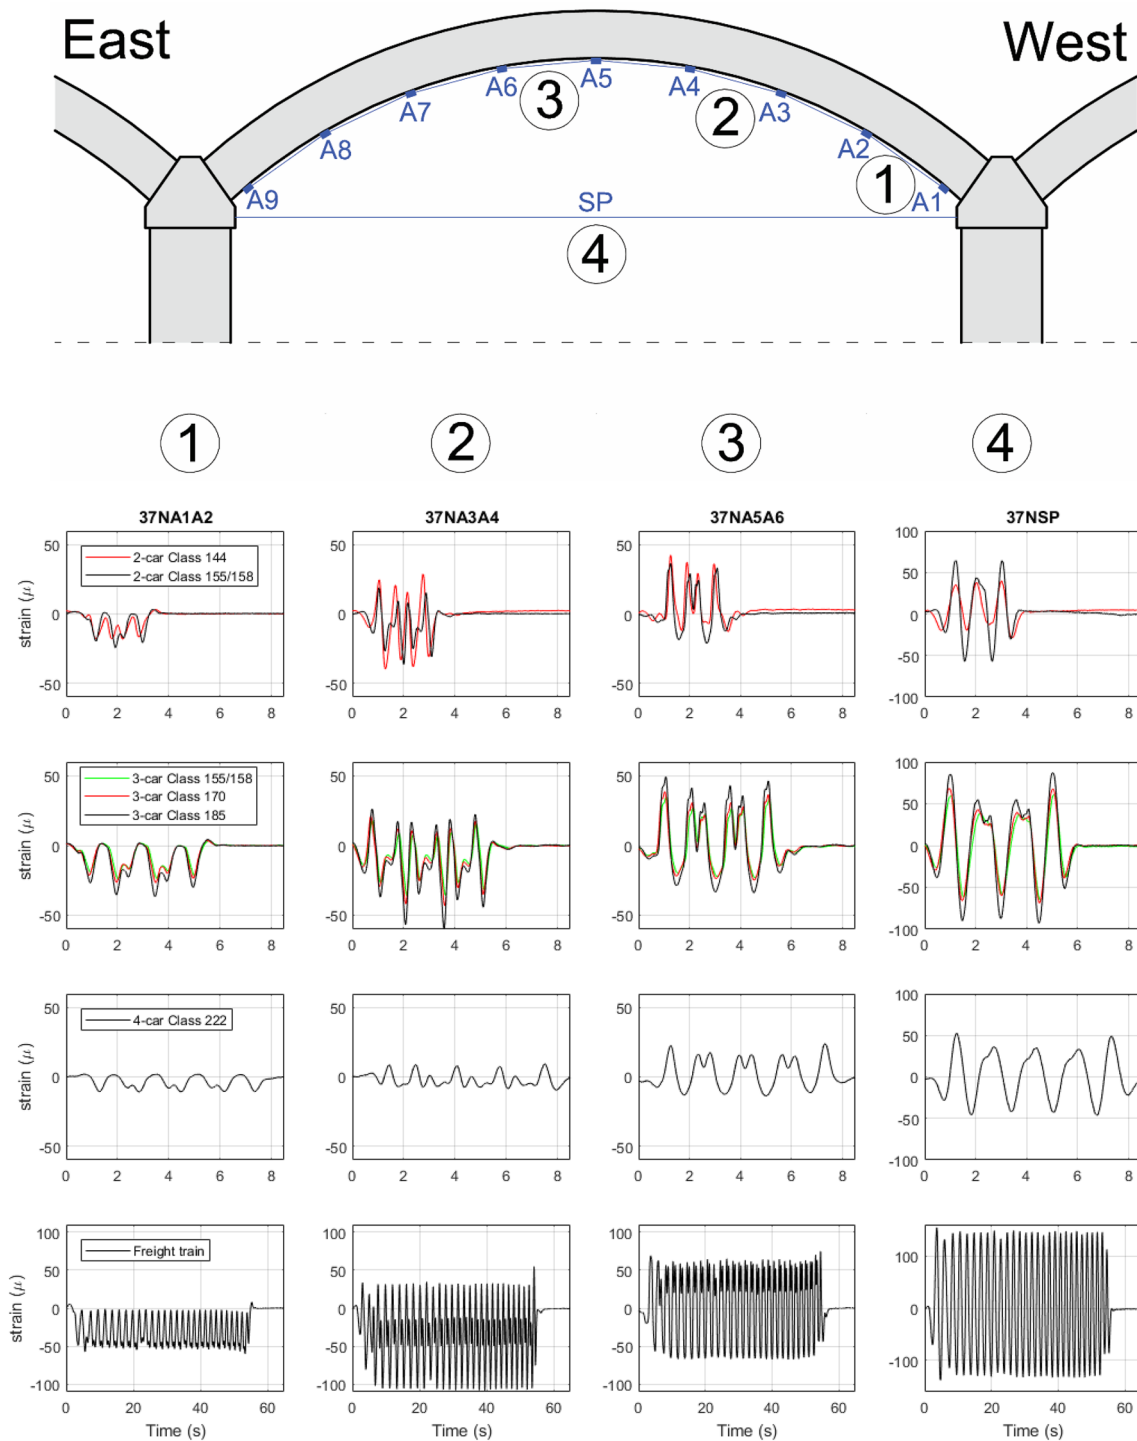
Fig. 4 FBG strain signals at four bridge location for the most common

Figure 4 offers an overview of the bridge response and the various shapes of FBG signals under the most common train loadings. Figure 4-top presents schematically a typical strain sensor array on the North side of the bridge in the

longitudinal direction. Four sensors are numbered, which correspond to the four columns of the graphs in Fig. 4. Locations 1, 2 and 3 correspond to the strain sensor between clamps A1 and A2 (near the arch springing), clamps A3 and A4 (near the quarter span), and A5 and A6 (near the half span), respectively. Location 4 corresponds to the sensor

that measures strain of the steel wire which connects the arch springings, measuring the dynamic variation of the arch span.

The signals presented in Fig. 4 are for the sensor array on the North side of Arch 37, which is the most severely damaged arch. In particular, the first column corresponds to sensor 37NA1A2, the second to 37NA3A4, the third to 37NA5A6 and the fourth to 37NSP. In all plots, the trains are heading towards the East, using the North track. The first row of graphs corresponds to the most common type of passenger trains with two cars that cross the bridge, which are the Class 144 (red line) and Class 155/158 (black line). The second row corresponds to passenger trains with 3 cars, which are the Class 155/158 (green line), Class 170 (red line) and Class 185 (black line). The third row corresponds to the most common passenger train with 4 cars, which is the Class 222. There are more types of passenger trains crossing the bridge, but these signals represent the vast majority of the data. The most common train type is the 3-carriage Class 185, which represents approximately the 50% of the records.

The graphs in the three first columns and three first rows have the same scale to allow direct comparison. All signals represent trains with approximately the same velocity. Negative values of the relative strain correspond to contraction and positive to expansion. Moving from location 1 to location 3, the response gradually changes from fully compressive at the springings to mostly tensile at the keystone. The passenger trains with 3 cars, and especially the most frequent train Class 185, cause the largest dynamic deformation. In the last column, the 37NSP sensor measures strain variations of the steel wire connecting the springings, and the response tends to be symmetric, with the negative and positive values corresponding to span closing and opening. The last row offers an example of a heavy multi-wagon freight train.

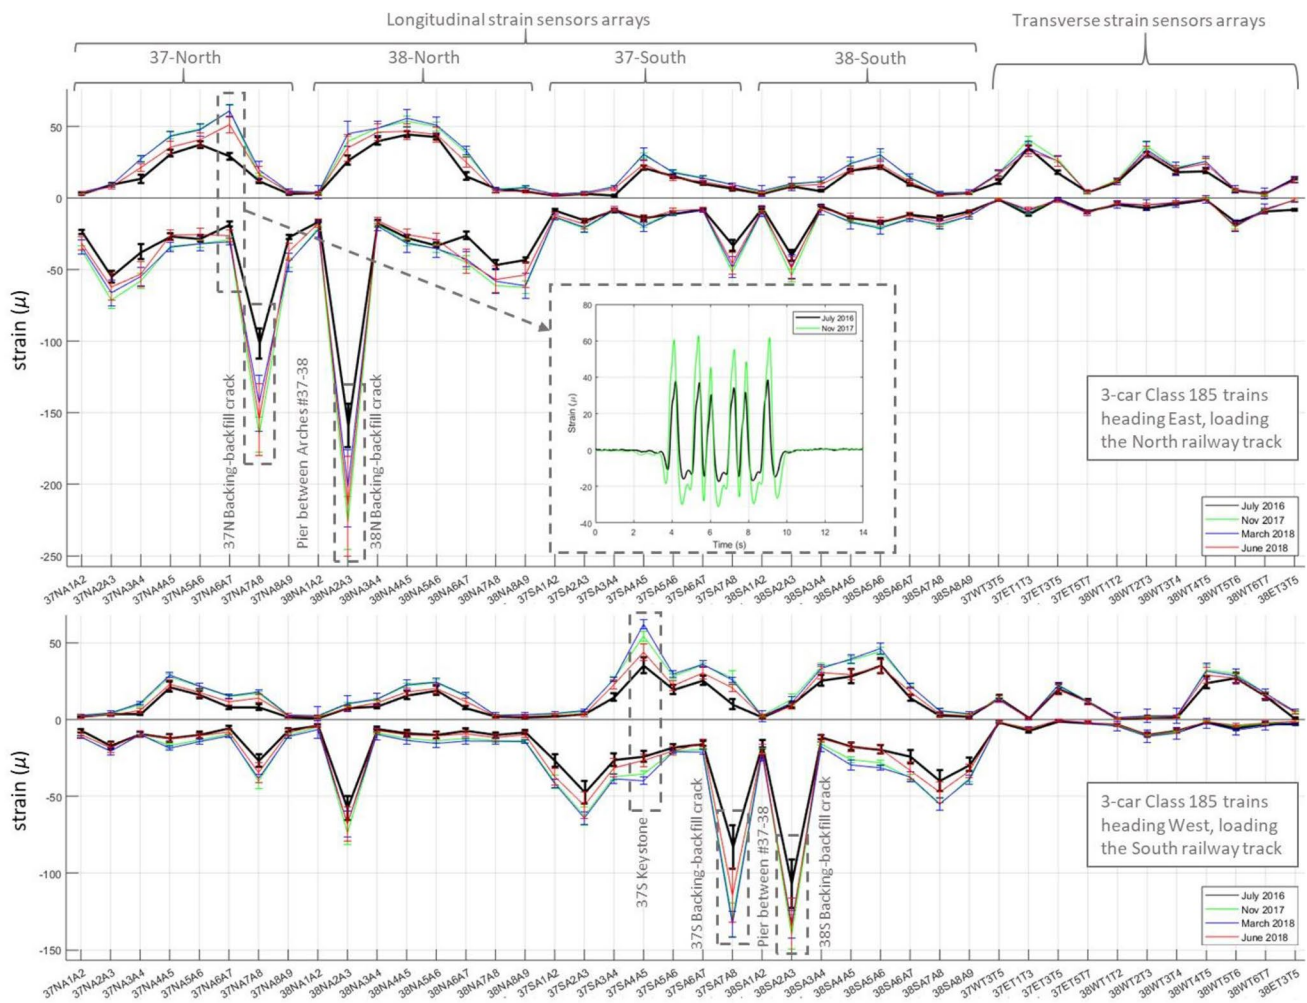
Fig. 5 Mean value and standard deviation of the maximum and minimum peaks of FBG signals for 42 sensors underneath Arches 37 and 38, for the Class-185 3-carriage train that is heading East (top graph) and West (bottom graph)

Apart from these five cases highlighted in Figs. 2 and 5, the response remained consistent in all other sensor locations (see Fig. 5). In particular, a uniform seasonal pattern was observed, which was further studied in a subsequent work by the authors [21]. The work shows that temperature and dynamic strain are linearly related. When temperature increases, the bridge dynamic deformation decreases uniformly in the longitudinal direction. In the transverse direction, where the thermal expansion is not constrained, the decrease is smaller. However, the increase in dynamic strain at the five identified locations is beyond what can be explained by temperature variation.

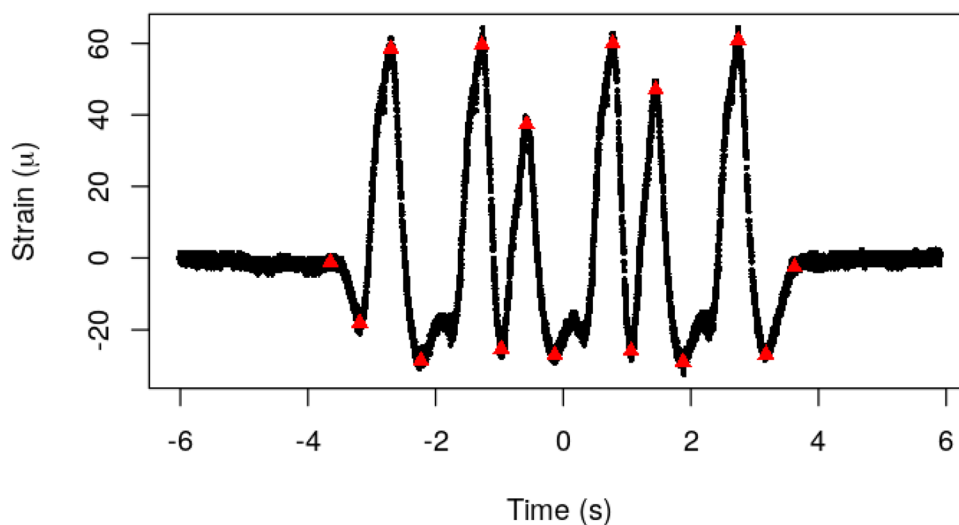
Fig. 6 FBG sensor data (centred) for a single train passage event at 37NA6A7. Triangle points represent landmarks

We shall mathematically denote the landmarks as a matrix $X \in \mathbb{R}^{15 \times 2}$, where X_{j1} and X_{j2} correspond to the time (x) and microstrain (y) coordinate of the j th landmark. The matrix X is called a configuration matrix.

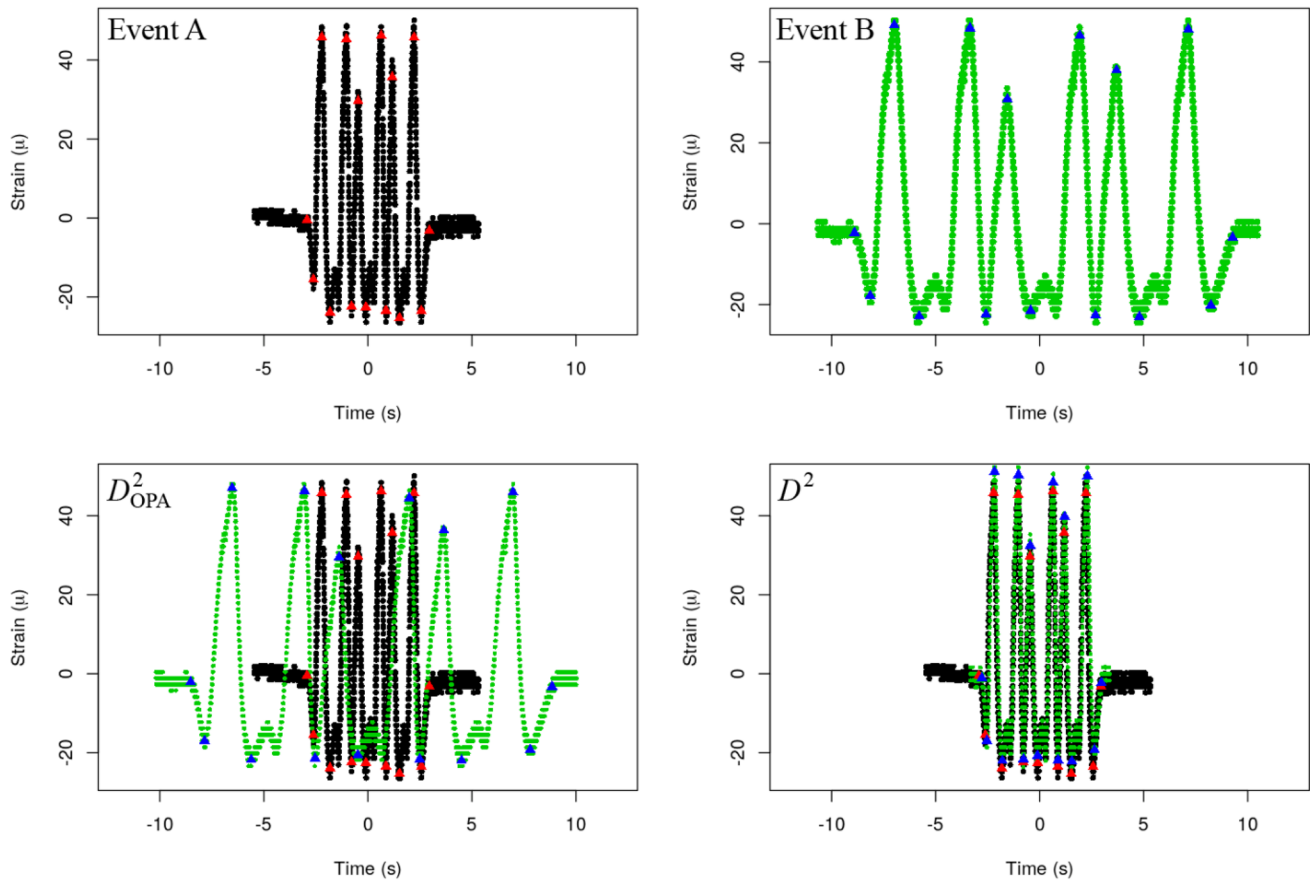
Fig. 7 Illustration of transformation B (top right) onto A (top left). Transformed version of B using D^2_{OPA} and D^2 are presented bottom left and right respectively

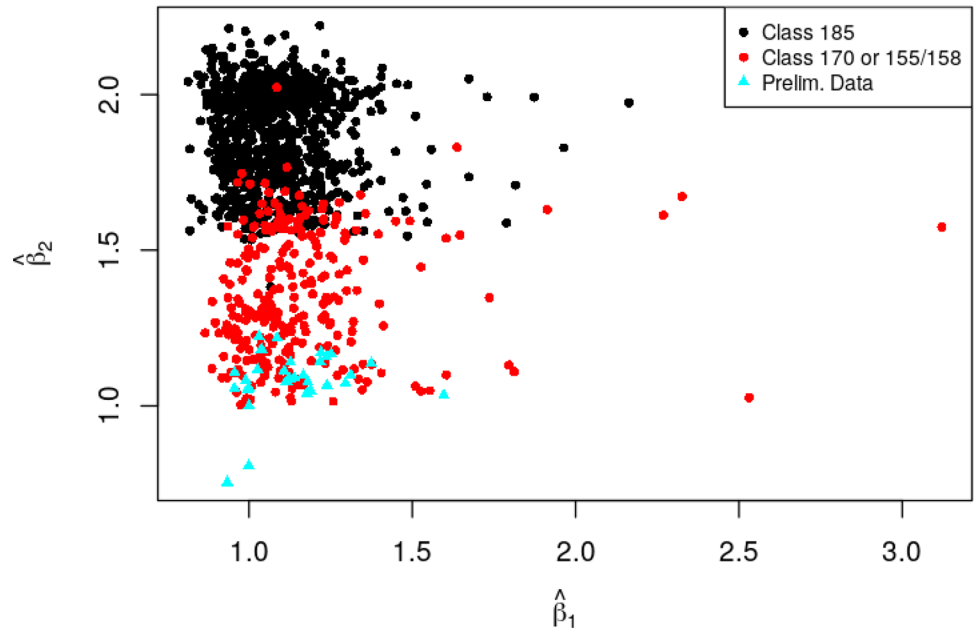
Fig. 8 Estimates of $\hat{\beta}_1$ and $\hat{\beta}_2$ for train passage events at sensor 37NA6A7

Figure 8 displays the estimates of $\hat{\beta}_1$ and $\hat{\beta}_2$ for all train passage events at sensor location 37NA6A7. The data from the preliminary FBG installation in July 2016 are shown

separately from the permanent FBG installation, after November 2017. Data from the preliminary installation do not contain information from temperature sensors, as in the permanent installation. Note that there is a 16 months gap between the two installations. The data from the permanent installation, after November 2017, have been grouped to Class 185 and non-Class 185 (i.e. Class 170 or Class 155/158), as discussed previously. There is not a discernible correlation between $\hat{\beta}_1$ and $\hat{\beta}_2$. In other words, train speeds (over the limited range of speeds measured) do not seem to affect the level of dynamic deformation at 37NA6A7. Similar observations can be made in the other sensor locations.

It is expected that most of the 31 train passage events (2016 preliminary data) correspond to the most frequent Class 185 train. With this in mind, there is a clear shift in $\hat{\beta}_2$ between the 2016 preliminary events and the remaining values. This will be examined separately in Sect. 4.3. By omitting for now the 2016 preliminary data, in Fig. 10 we see a clear trend, with $\hat{\beta}_2$ decreasing with temperature. Further, there seems to be various levels of the trend – more precisely, there seems to be a three different linear relationships exhibited in the data. The statistical relationship between $\hat{\beta}_2$ and temperature may be modelled by for example a linear model. However, if the different groups are not accounted for in the data will lead to inflated variation in the parameter estimates. Therefore, before fitting a model, we start by investigating the different groups exhibited by the data. The groups seem to correspond to a large extent with the different train classes. Before modelling the data, we first consider

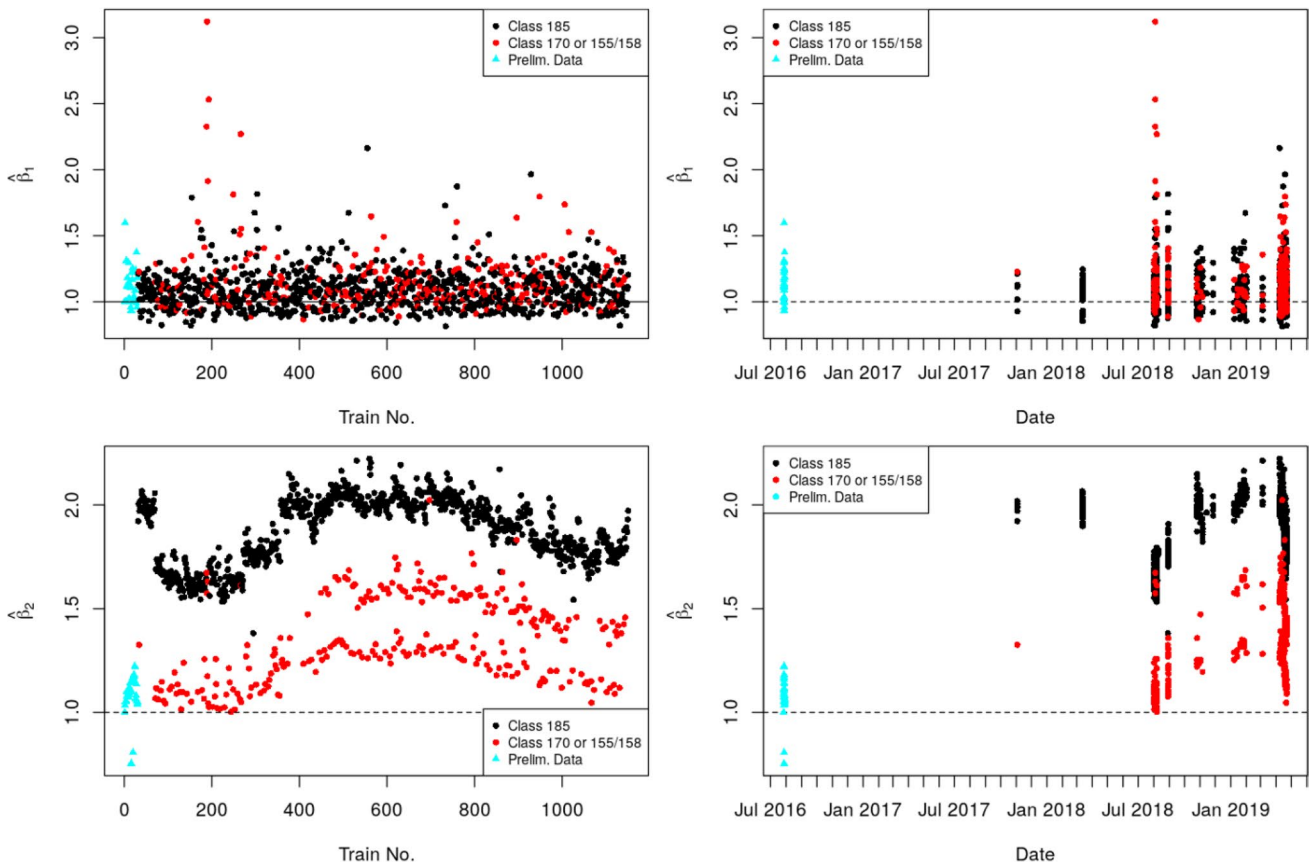
Fig. 9 Estimates of $\hat{\beta}_1$ (top row) and $\hat{\beta}_2$ (bottom row) for chronologically ordered train passage events at sensor 37NA6A7

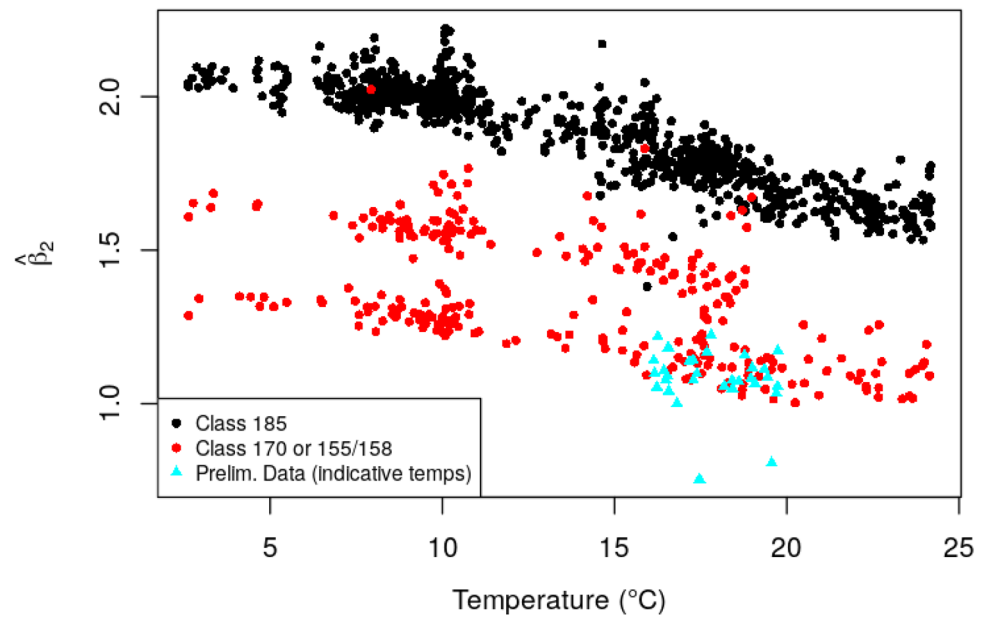
Fig. 10 Estimates of $\hat{\beta}_2$ against temperature for train passage events at sensor 37NA6A7

constructing a classifier that can be used to predict train classes based on the $\hat{\beta}_2$ value and temperature of an event.

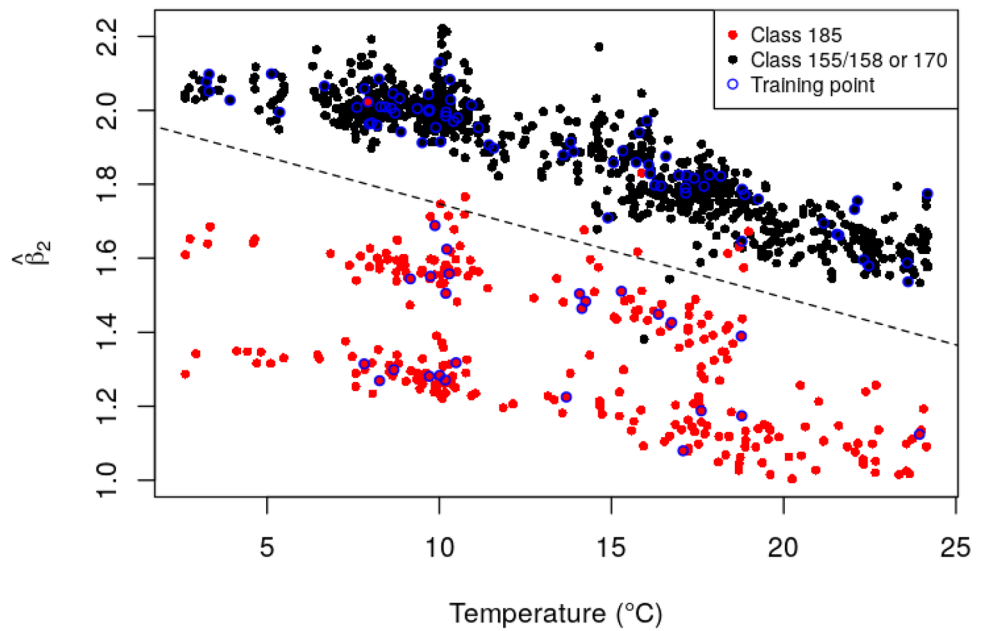
Fig. 11 SVM results. Maximum margin hyperplane (dashed black line), training datapoints

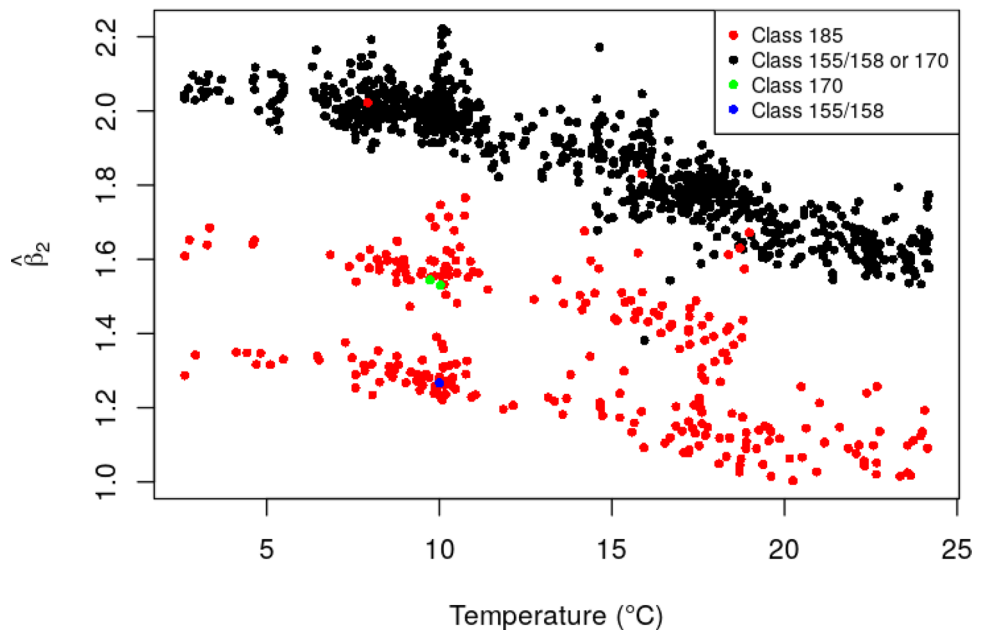
Fig. 12 Estimates of $\hat{\beta}_2$ against temperature for train passage events at sensor 37NA6A7, with train subclasses

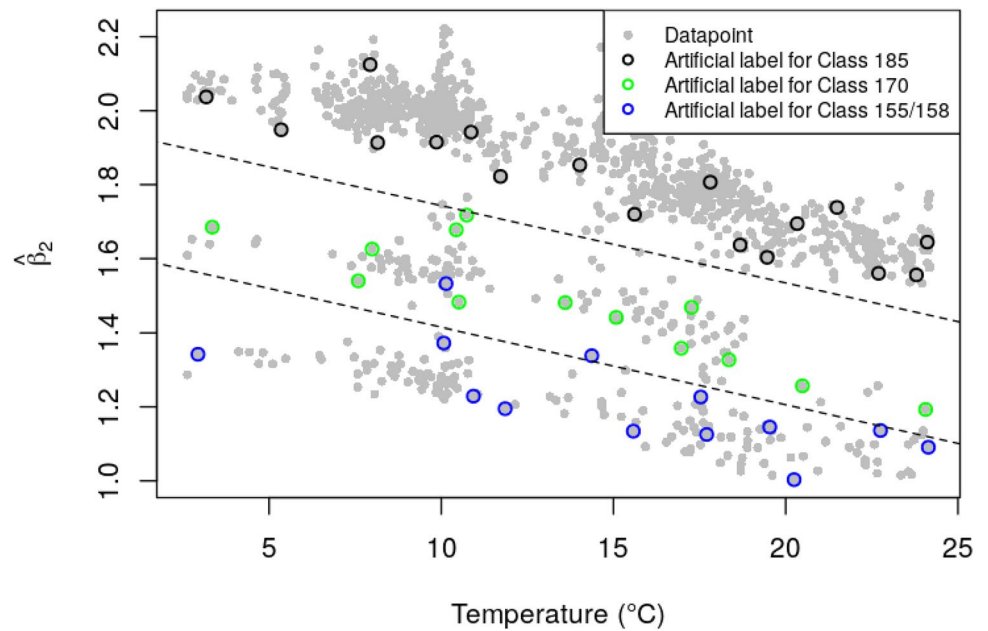
Fig. 13 SVM results using train subclasses. Data are represented by the grey points. Circled points are those datapoints used to train the SVM. The dotted lines represent the hyperplanes that separate the class predictions of the SVM method

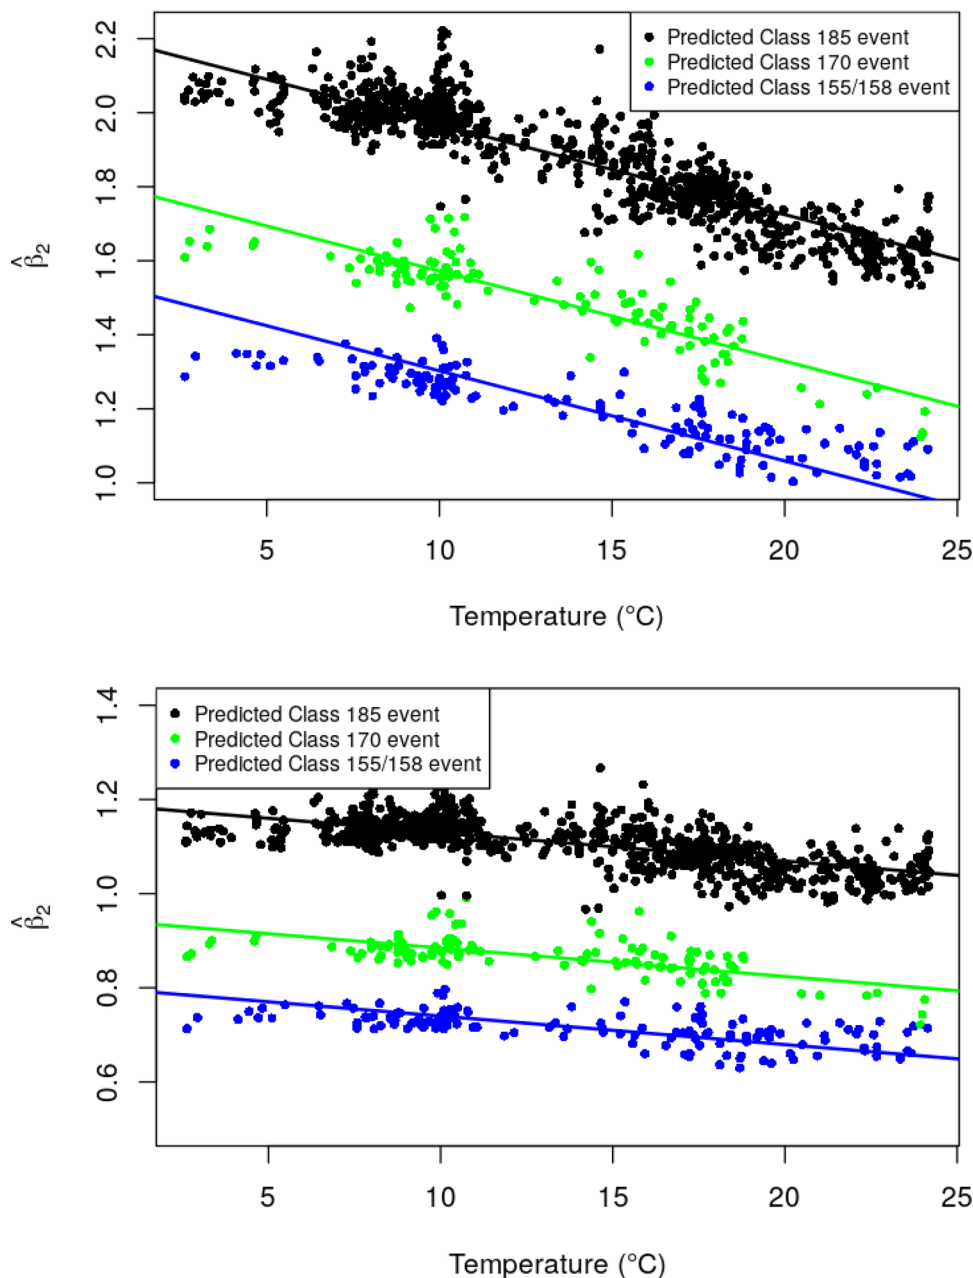
Fig. 14 Top: Expected $\hat{\beta}_2$ value (lines) given temperature and train class given by the fitted linear model of Eq. (7) using data from sensor location 37NA6A7. The train classes are the predicted classes given by the SVM. Bottom: Fitted linear model to estimates of $\hat{\beta}_2$, from 37NA6A7, and temperature data with train classes from sensor location 38NA3A4

$\hat{\beta}_2$ given the temperature and train class, is represented in Fig. 14-top.

The interpretation of the estimated parameters of fitted model is as follows: There is an $\hat{\alpha}_2 = 0.396$ decrease in relative strain between Class 185 and 170 train events; further there is an $\hat{\alpha}_3 = 0.6655$ decrease from Class 185 to Class 155/158 train events.

It is noted that some dispersion of data points around the fitted curves in Fig. 14 is expected. This is because not all trains of the same class are identical, and their exact

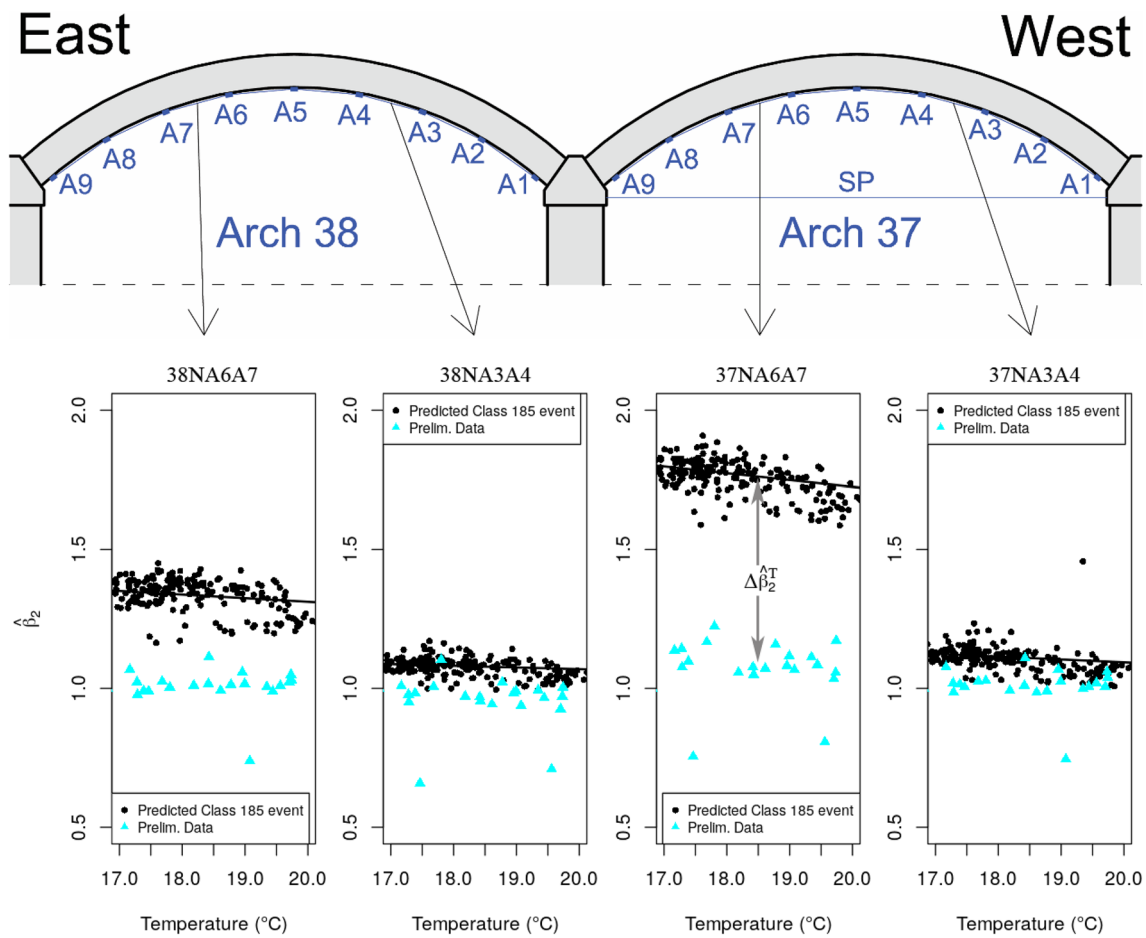
Fig. 15 Comparison between the $\hat{\beta}_2$ estimates for the 2016 preliminary events and the predicted Class-185 curve from SSA and SVM in four sensor locations

For instance, in the most severely damaged arch of the bridge, Arch 37, location 37NA3A4 shows a slight deviation between the preliminary and predicted $\hat{\beta}_2$ equal to 0.095, or 9.5%, which corresponds to change in the peak-to-peak amplitude dynamic strain equal to $9.5\% \bar{\epsilon}_0 = 6.75 \mu\epsilon \approx 78.296 \mu\epsilon - 72.071 \mu\epsilon$. In other words, the mean peak-to-peak amplitude of the recorded events from the permanent installation, appears amplified by approximately $7 \mu\epsilon$. Note that this identified change is in order comparable to the low signal noise of the FBGs ($\pm 2 \mu\epsilon$). Slight deviations may exist due to incompatibility of the temperature data, or because not all the preliminary events are from Class 185 trains. In another location of Arch

37, 37NA6A7, the biggest $\hat{\beta}_2$ deviation among the four sensors is observed, equal to 0.682, or 68.2%, while the peak-to-peak amplitude appears amplified by 68.2% $\bar{\epsilon}_o = 31.89 \mu\epsilon$. This observation is in agreement with previous findings [20].
