Raindrop Erosion of Composite Materials: Some Views on the Effect of Bending Stress on Erosion Mechanisms

Abstract

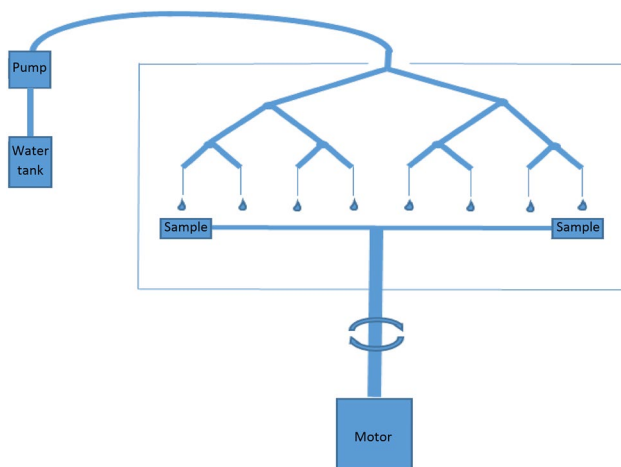
Fig. 2 Line drawing of experimental rig

The type of rig used for this experiment was a whirl arm rig shown in Figs. 1 and 2. It involves a motor spinning a shaft which is connected to a central hub to which two samples are connected at a radius from the centre. At the circumference of the swing arm includes needles which provide

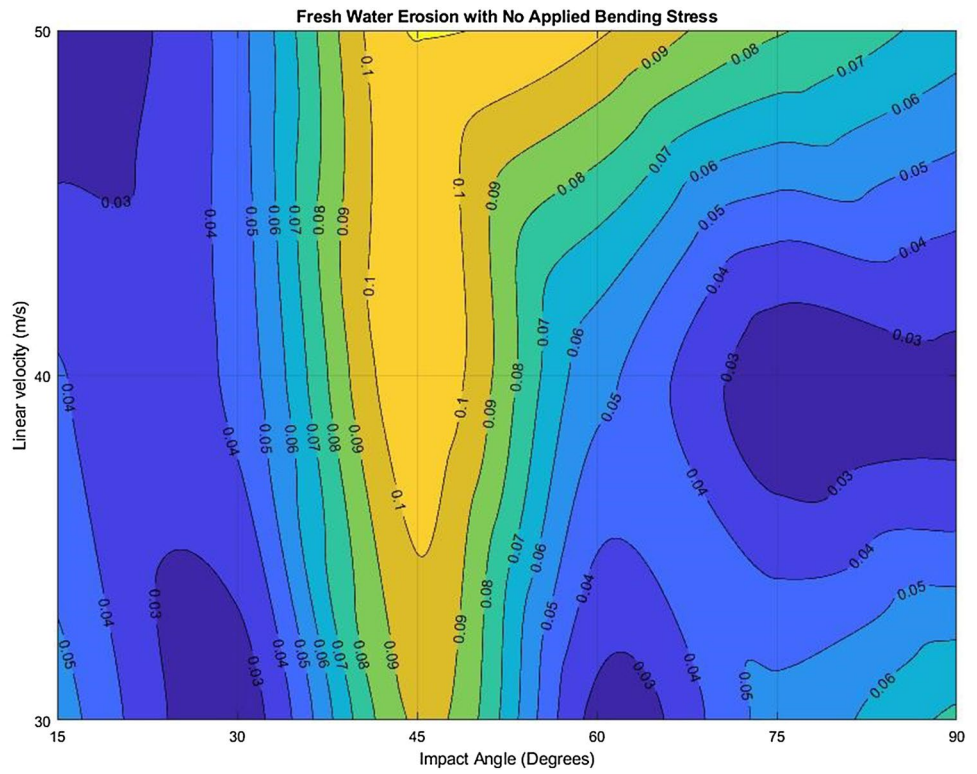
Fig. 3 Percentage mass loss of fresh water erosion with no applied bending stress

The first experiment that was conducted was fresh water with no applied stress. From Fig. 3 the conditions that yielded the most erosion was at the maximum speed of 50 ms^{-1} and at droplet angle of 45° with a mass loss of 0.11%. From the wear map it is very distinguishable where the transition between negligible erosion to relatively high erosion occurs. This has been observed within the literature [15]. This is theorised to be the threshold number of droplets on the surface of the material sufficient to weaken it significantly to initiate erosion. This behaviour was observed with the majority of all the experiments tested. This was also observed in the SEM images of the samples as the erosion was concentrated in the areas where the fibres were closest to the surface and hence the top layer of epoxy was the thinnest (Figs. 7 and 8).

The wear map from this experiment, Fig. 3, can also be visualised as a line graph shown in Fig. 9. From this graph it can be concluded that the material is neither experiencing fully ductile or fully brittle properties as the impact angle with the most erosion is 45° . This can be explained as G10 epoxy glass is a composite material involving a brittle glass fibre with a ductile matrix binding the fibres together. The surface features evident on the eroded samples are more in common with ductile gauging or ploughing type features rather than the fracturing or localised shattering that is

in Figs. 3, 5, 9 and 12 which is consistent with the literature [16]. However when the sample is stressed it varies from this pattern.

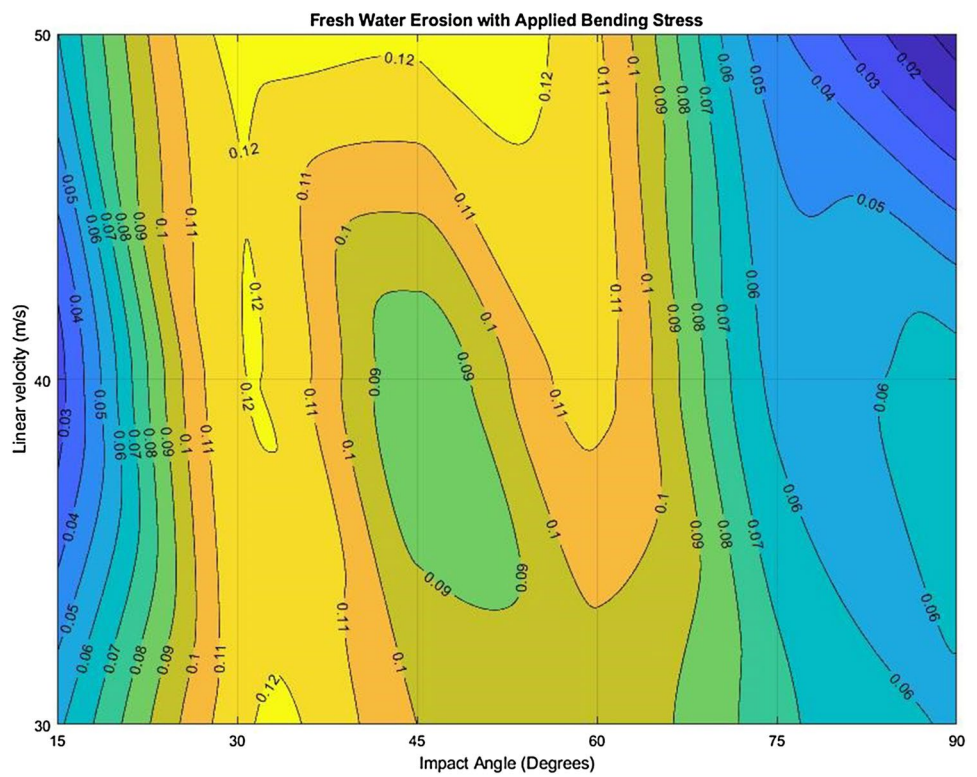
Fig. 4 Percentage mass loss of fresh water erosion with an applied bending stress

From the wear maps in Figs. 4 and 6 a slightly unusual pattern occurred over the different impact angles. Instead of peaking at one impact angle this experiment showed two peaks which was not as expected.

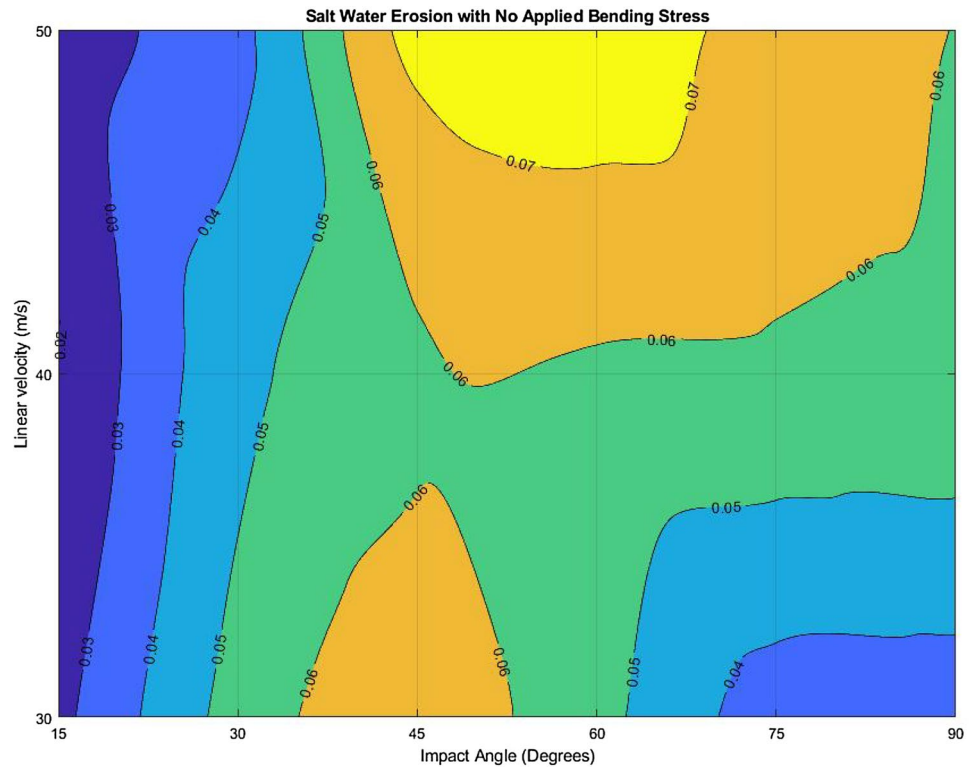
Fig. 5 Percentage mass loss of salt water erosion with no applied bending stress

The maximum mass loss during this experiment was experienced at 50 ms^{-1} at 60° with a total loss of 0.077%; this can be seen in the wear map, Fig. 5. The difference in mass loss between the fresh water and salt water mass loss is not overly substantial as there will be some salt crystals remaining in the sample. From the wear map of the salt water testing (Fig. 5) a line graph can be constructed (Fig. 12). These results show neither fully “ductile” nor “brittle” erosion behaviour [16] as described in the literature in a similar fashion to the result exposed in fresh water.

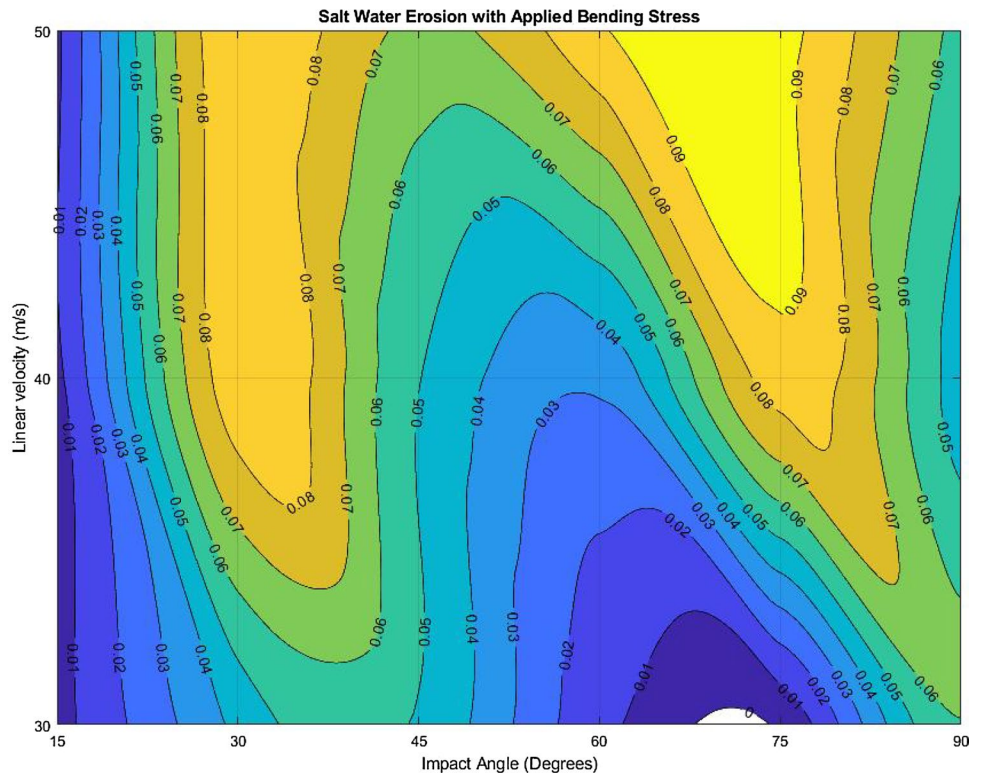
Fig. 6 Percentage mass loss of salt water erosion with an applied bending stress

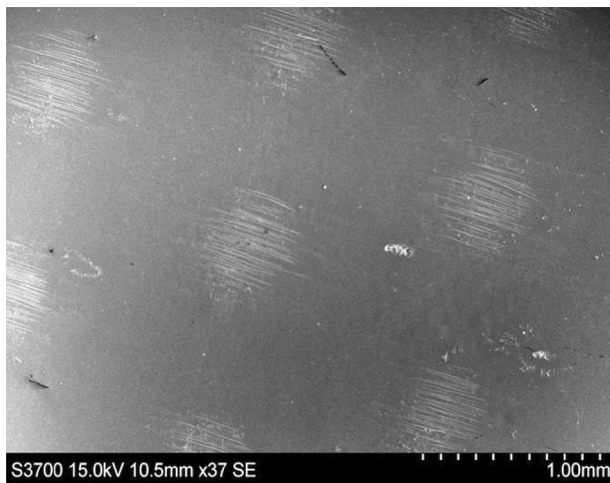
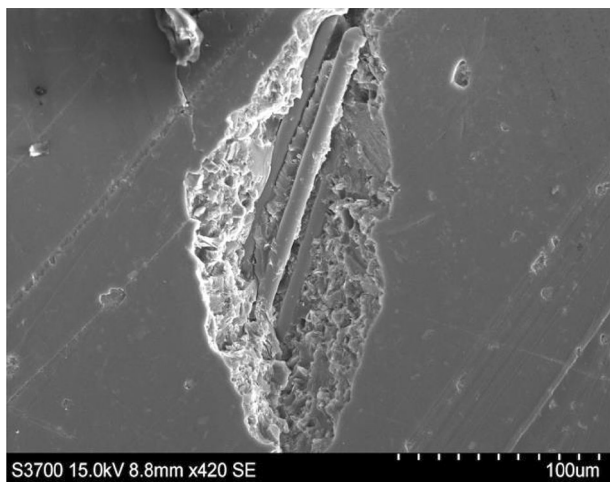
Fig. 7 SEM image of fresh water erosion on an unstressed sample at 30 ms^{-1} , 45°

Fig. 8 SEM image of fresh water erosion on an unstressed sample at 40 ms^{-1} at 30°

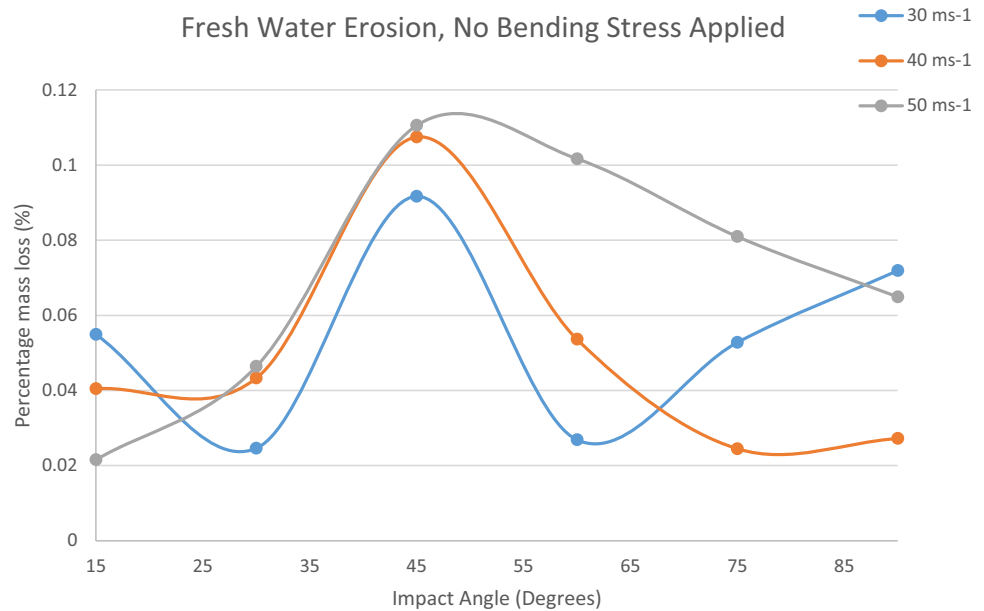
Fig. 9 Line graph of fresh water erosion with no bending stress

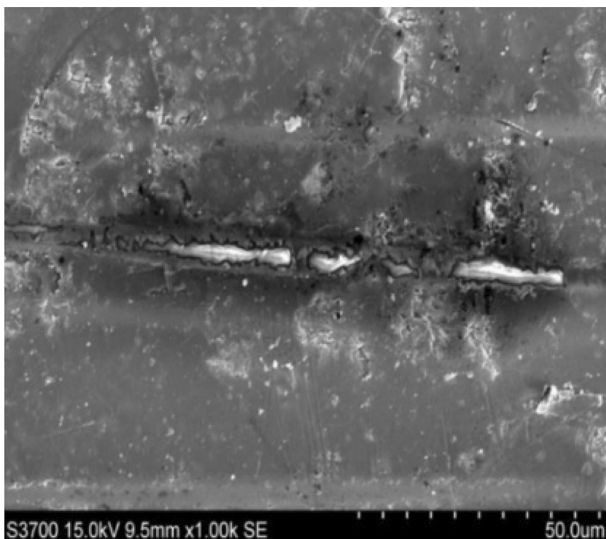
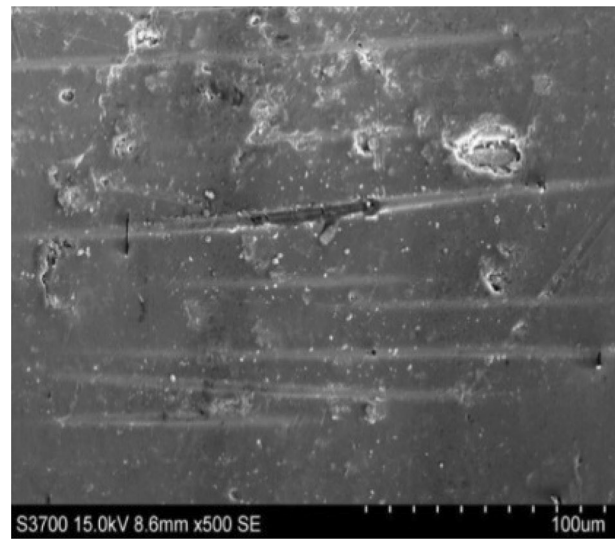
Fig. 10 SEM image of Salt water erosion on unstressed sample at 50 ms^{-1} , 30°

Fig. 11 SEM image of salt water erosion on an unstressed sample at 50 ms^{-1} , 45°

The second experiment that was conducted was with 3.5% salt water solution to simulate the effects of sea water on wind turbine blades under the same parameters to which the fresh water was tested. This was to determine if offshore wind turbines are eroding differently to those on shore. The Figs. 10 and 11 depict the erosion occurring to an extent where the glass fibres on the surface are exposed.

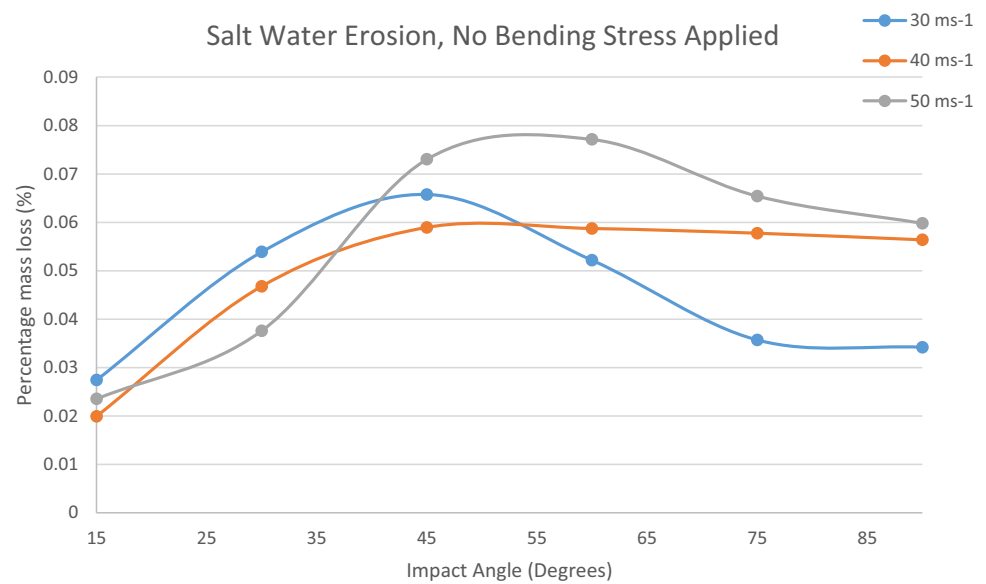
Fig. 12 Line graph of salt water erosion with no bending stress

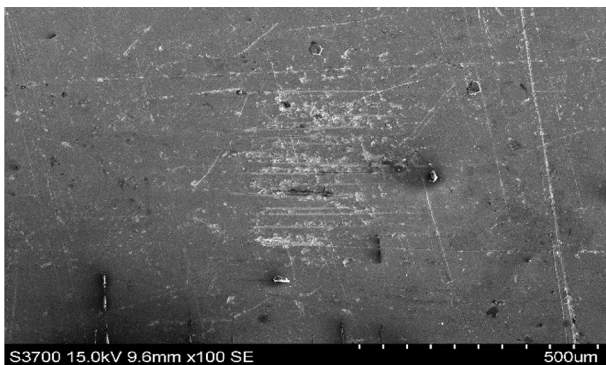
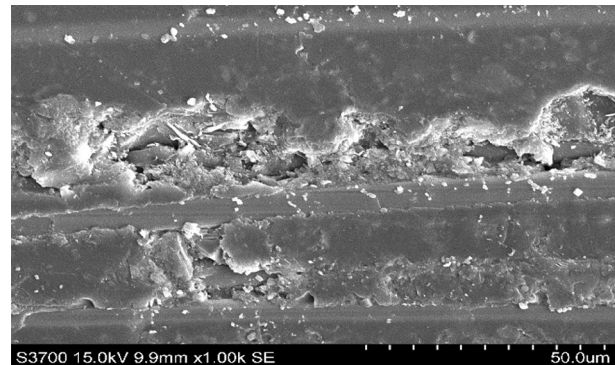
Fig. 13 SEM image of fresh water erosion on a stressed sample at 50 ms⁻¹, 30°

Fig. 14 SEM image of salt water erosion on a stressed sample at 50 ms⁻¹, 45°

The maximum mass loss was at 50 ms^{-1} at 30 and 45° with a 0.12% mass loss, this can be observed in the wear map in Fig. 5. This mass loss can be seen in the SEM images in Figs. 13 and 14 as the top layer of epoxy is eroded to the

point where the fibres closest to the surface are exposed. The erosion is accelerated in this region due to the surface being slightly rougher at this point and the ploughing mechanism of the water droplet seems to have more effect on the surface by removing material. This is also observed in the optical microscope images of the unstressed sample (Figs. 15 and 16) as the point at which the fibres are closest to the surface show a greater dark area. This possibly implies that there is excessive pitting and erosion in the material.

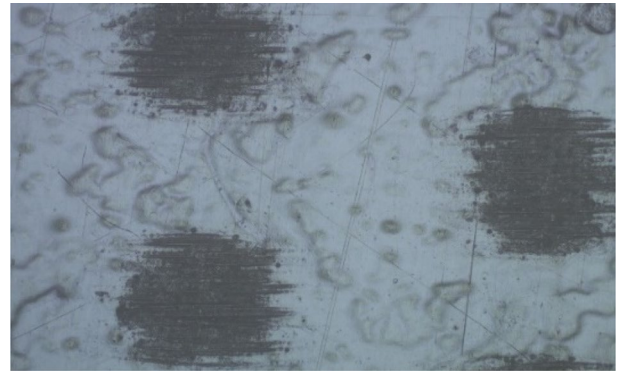
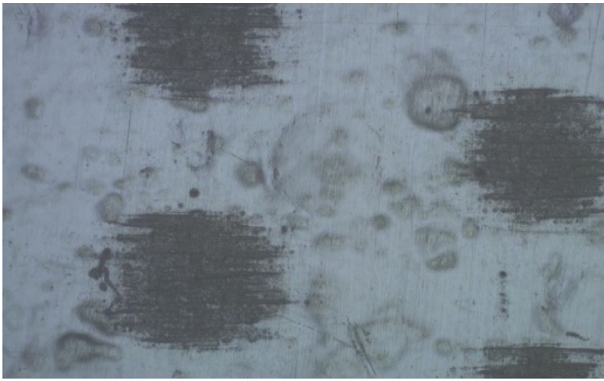
Fig. 15 Optical microscope image of unstressed sample at 50 ms^{-1} , 30°

Fig. 16 Optical microscope image of unstressed Sample at 50 ms^{-1} , 45°

The stressed samples showed different surface features in the optical microscope images as a circular ridge formation; this was not present in the optical microscope images of the unstressed samples (shown in Figs. 15 and 16). It is postulated that this is the result of the stresses on the material. The feature can be observed in the Figs. 17, 18 and 19.

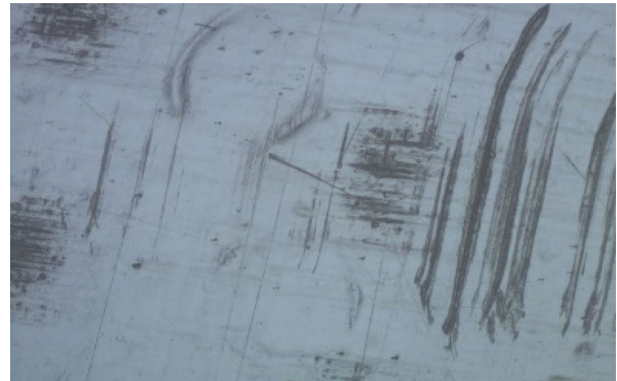
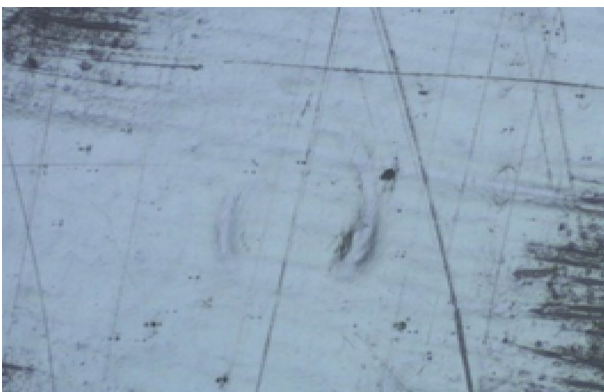
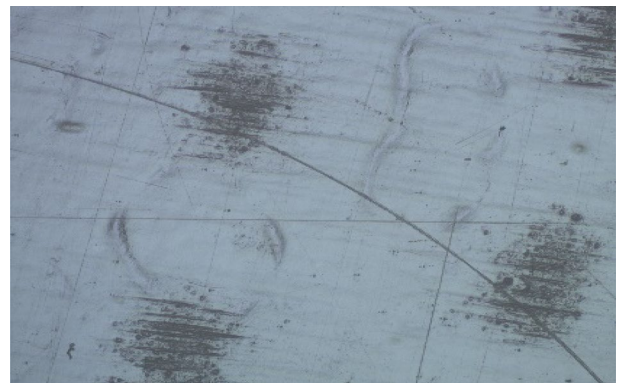
Fig. 18 Optical microscope image of stressed sample at 50 ms^{-1} , 45°

Fig. 17 Optical microscope image of stressed sample at 50 ms^{-1} at 60°

Fig. 19 Optical microscope image of stressed sample at 40 ms^{-1} , 45°

It is assumed these features are associated with plastic deformations of the top surface due to the impact of a water droplets which can be termed SICD (Surface Impact Circular Deformation). In Fig. 17 there is a crack in the top surface to the right of the SICD; this was assumed to result from the stresses which would have occurred during the formation of the SICD. This crack could explain the slightly higher magnitude mass loss in the stress tests compared to the unstressed tests as this crack is liable to increase the erosion rate resulting in the glass fibres being at an increased risk of erosion which would lead to considerably more mass loss.

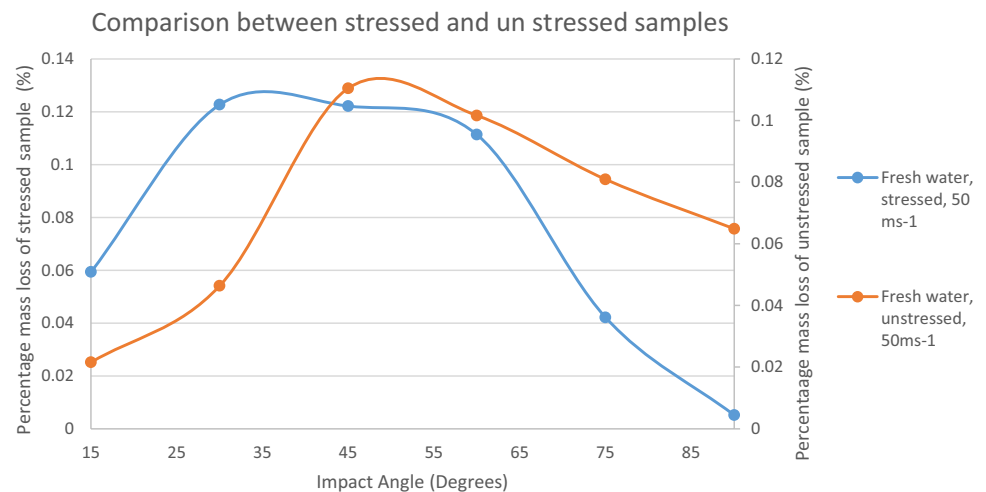
Fig. 21 Comparison of erosion between the stressed and unstressed samples

A comparison between an unstressed and stressed sample can be shown in the line graph (Fig. 21), illustrating 50 ms^{-1} using fresh water as the erosive medium.

From this graph (Fig. 21), the stressed sample experiences high erosion over a larger range of impact angles and experiences erosion past threshold at lower angles of impact. Therefore, it can be deemed that the stressed sample is more susceptible to erosion than the unstressed sample. It is postulated that the stressed sample is experiencing a larger crossover between abrasion and brittle/fatigue erosion which allows the top surface of the material to be likely impeded and have fibre exposure. This behavioural change when stressed is theorised to be due to the additional stress from the droplet impact causing plastic deformation (as all stresses are additive). The graph suggests the sample is now behaving in a more “ductile” than “brittle” manner due to the slight shift to the left. This change could be due to the polymer (which is the more ductile portion of the material)
