# Pitting Corrosion Behavior of F304 Stainless Steel Under the Exposure of Ferric Chloride Solution

Present paper deals with an experimental investigation of pitting corrosion of forged 304 stainless steel. Material is exposed to ferric chloride solution to investigate the effect of pitting corrosion. This material is known to provide structural strength with improved toughness and ductility. A number of experiments were carried out on F304 SS under ferric chloride solution by putting it for three different time durations of 8 h, 16 h, and 24 h. The results specify that pit formation increases over time. During experimentation, the number of pits, pit depth, corrosion rate, weight loss, and average pit depth have been measured. Microstructural characterization and surface roughness tests were carried out on the chemically exposed surface to understand the growth of pitting corrosion. Fractographic images high-end microscopy showed that the ferric chloride solution initiates the pitting of 304 austenite stainless steel. Furthermore, the exposure leads to the formation of a number of small pits that coalesce together to form cracks that appear at the bottom of the pit. It was also c

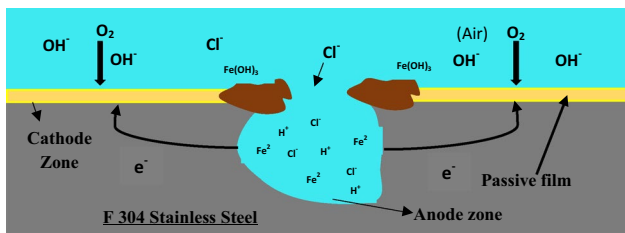
Fig. 1 Deep growth mechanism during pitting corrosion

surroundings by hydrolysis reactions (from 4 to 46), leading to an increase in corroded area [16]. Figure 1 depicts a deep growth of pitting corrosion exposed in a chloride environment. It consists of two regions (anode and cathode) as shown. The deep structure of material where pitting is formed is known as an anode region.

These anodic regions are very small as compared to cathode zone produced on the diffused interface which is adequate to electron loss and forms the pitting direction. It was observed that the passive film turns into more critical in nature when it is exposed to the solution of ferric chloride.

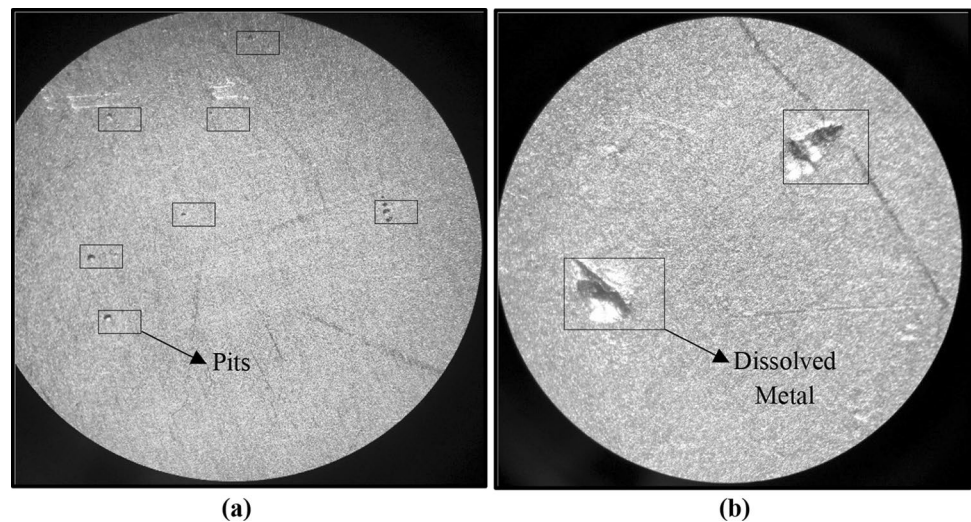
**Fig. 2** Optical image of corroded specimen at 22 °C **a** 8 h and **b** 16 h

The first specimen was put under corrosion test for the duration of 8 h at a temperature of 22 °C. The specimen having a total surface area of 22 (cm<sup>2</sup>) was prepared with 220 grit and 420 grit emery paper. Figure 2a shows the specimen 1 at  $\times 20$  magnification observed under an optical microscope after the exposure of 8 h, and no significant pits have been observed. But the total number of minor pits observed was seventeen. The average pit depth was 0.2410 (mm) as determined with the help of pit depth gauge.

The observed corrosion rate was 0.0011 (g/cm<sup>2</sup>). Specimen 1 is kept under corrosion test for two different time durations of 8 h and 16 h at temperature 22 °C, respectively. Surface morphology was studied at  $\times 20$  magnification using an optical microscope. The average pit depth was measured using a pit depth gauge. Additionally, in a similar way for a different set of experiments were also carried out at different time durations and temperature. During these experimentations, a significant amount of pits has been observed on the surface of the specimen. Moreover, microstructures of all the fine specimens are shown in Figs. 2, 3, 4, 5, and 6 distinctly. Table 3 shows the analysis of the results of all experiments. The result was obtained in combination with the rise of temperature, and the degree of erosion appeared to be more. Hence, the higher temperatures and the start of corrosion will be found higher [22]. For specimen 1 and 2, the corrosion rate increased with increasing the exposure time at room temperature. Moreover, while increasing the degree of temperature solution caused by

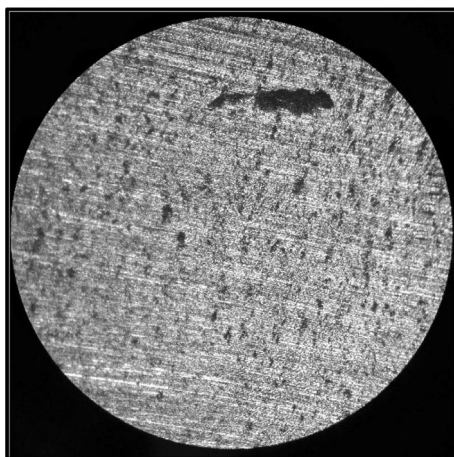
**Fig. 3** Optical image of corroded specimen at 22 °C, 24 h

Experiments were carried out on five different specimens kept under a corrosive environment at different temperature and time durations as shown in Table 2. The surface of the specimens was prepared with 220 grit and 420 grit emery paper. During the entire process, eight parameters were investigated as shown in Table 3. After experiments, the specimens were observed under an optical microscope of Leica. The formation of pits is shown in Figs. 2, 3, 4, 5, and 6, respectively.

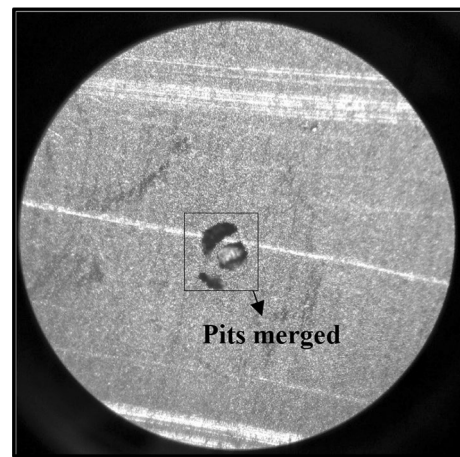
**Fig. 4** Optical image of corroded specimen at 50 °C, 24 h

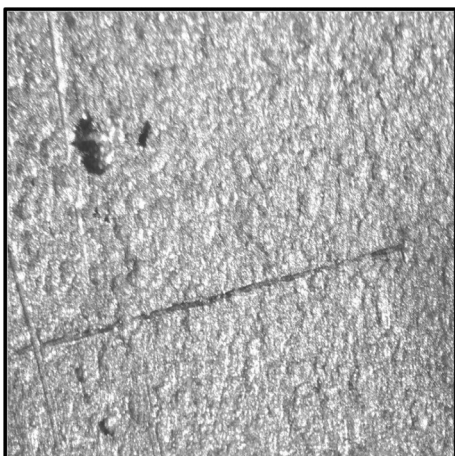
Fig. 5 Optical image of corroded specimen at 5 °C, 12 h

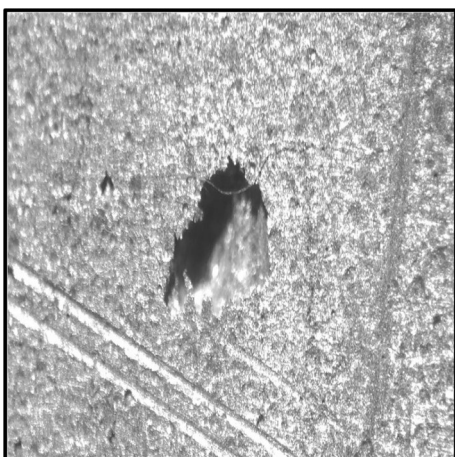
Fig. 6 Optical image of corroded specimen at 5 °C, 24 h

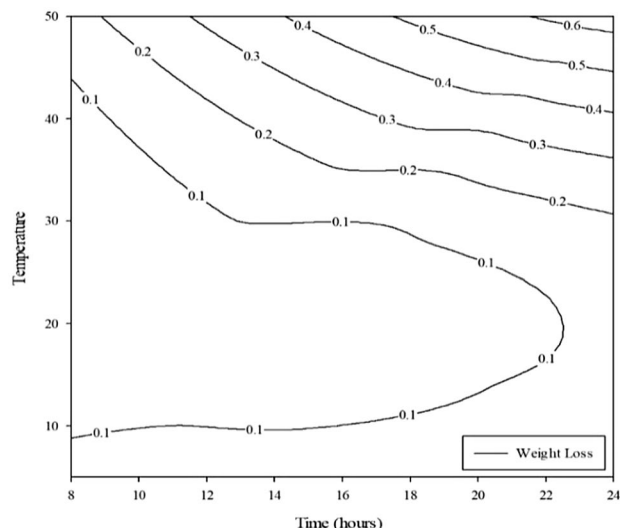
Fig. 7 Weight loss (g) of corroded specimen with respect to time (h) and temperature (°C)

Figure 7 shows that weight loss of the material is a function of temperature. Contour shows that the weight loss

increases with an increase in exposure time and becomes independent of time duration if kept at a fixed concentration of the solution. For instance, at a temperature of 30 °C for a time duration of 13 h, weight (wt) loss is found to be 0.1 g, but it becomes 0.2 g while the temperature is increased to

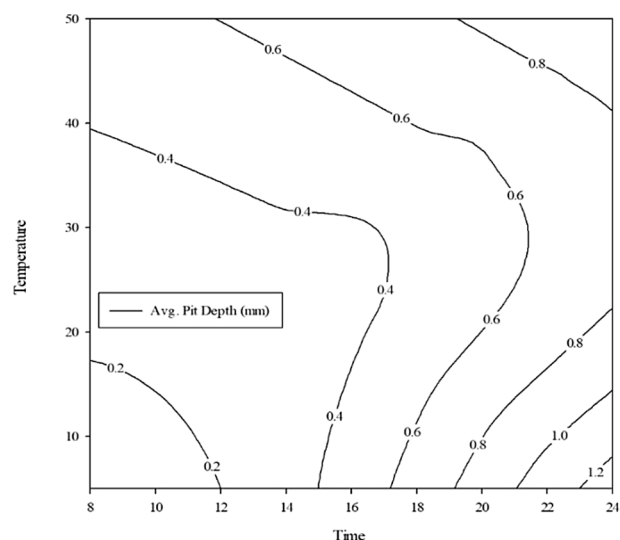
Fig. 8 Avg. pit depth (mm) of corroded specimen with respect to time (h) and temperature (°C)

40 °C and still kept for 13 h. Figure 8 shows that average pit depth is a function of both time and temperature. Contours show that average pit depth increases with an increase in both time and temperature.

For instance, at fixed temperature of 20 °C constant horizontal direction shows that pit depth increases with an increase in time, whereas vertical direction shows that pit depth increases with an increase in temperature also. It can be observed from temperature–time–corrosion rate plot in Fig. 9 that resistance to pitting by austenite stainless steel 304 reduces with the increase in corrosion rate, i.e., at lower temperatures (5 °C), corrosion rate is higher in comparison with room temperature (22 °C) and elevated temperatures (50 °C). This signifies the surface of F304 stainless steel dissolves more at low temperature. However, Fig. 9 shows that corrosion rate is a function of temperature only. It is independent of time at fixed temperature for fixed time

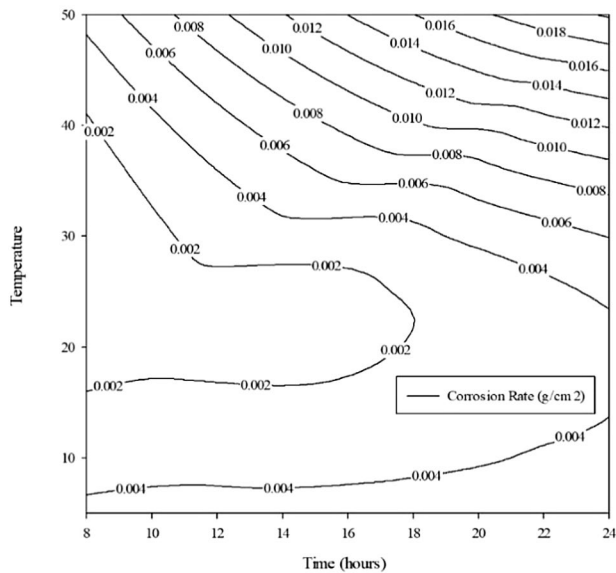
**Fig. 9** Corrosion rate ( $\text{g}/\text{cm}^2$ ) of corroded specimen with respect to time (h) and temperature ( $^{\circ}\text{C}$ )

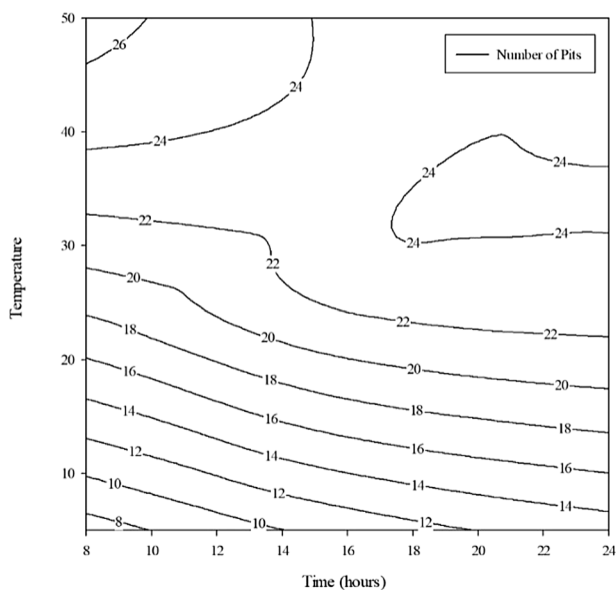
**Fig. 10** No. of pits of corroded specimen with respect to time (h) and temperature ( $^{\circ}\text{C}$ )

duration. Similar relation can be seen in Fig. 10 which shows the number of pits increases with an increase in temperature. Contours show that for every fixed time duration, the number of pits increases.

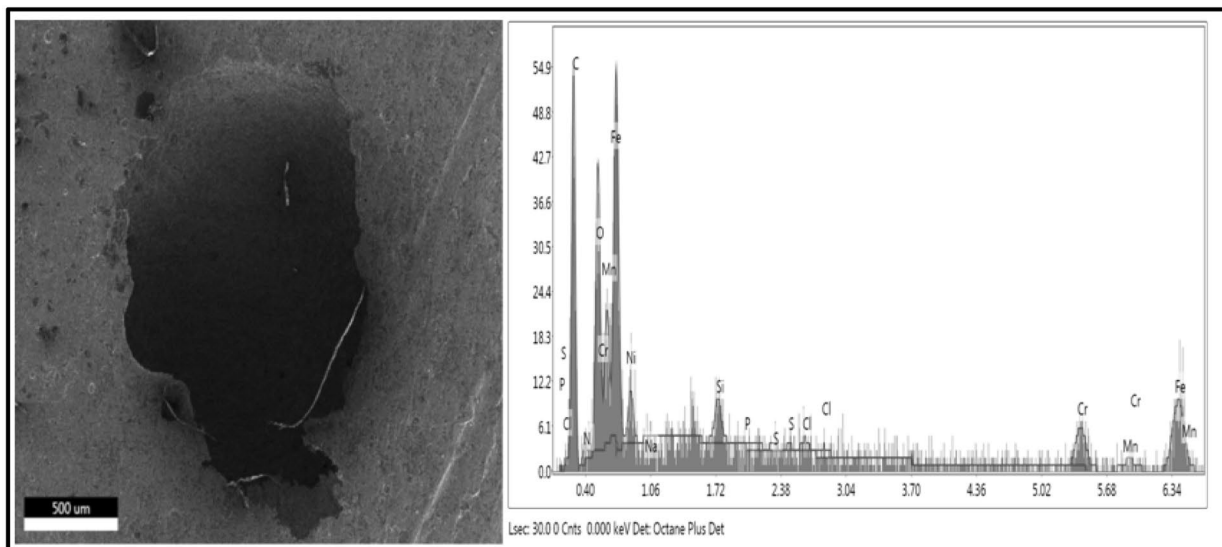
Elements	C K	N K	O K	Fe L	Ni L	Si K	P K	S K	Cl K	Cr K	Mn K
<b>Weight %</b>	26.91	1.60	8.47	34.07	4.38	1.93	0.38	0.35	1.13	22.85	6.41
<b>Atomic %</b>	60.24	3.07	13.67	16.40	2.00	1.84	0.33	0.29	0.86	11.82	3.14

Fig. 12 EDX image of specimen exposure at temperature 5 °C and time 24 h and the results of EDX analysis of F304 stainless steel

The corroded specimens corresponding to temperature of  $5^{\circ}\text{C}$ ,  $22^{\circ}\text{C}$ , and  $50^{\circ}\text{C}$  kept for an exposure time of 24 h were analyzed using (Energy Dispersive X-Ray) EDX. Equivalent weight percent and atomic percent values as obtained from EDX analysis are given in Table 5 with respective spectra. The ferric chloride inclusion attacks the localized sites and initiates the pit formation. The pit location was identified to find out the varying composition of F304 stainless steel exposed under the ferric chloride solution. Figure 12 shows an EDX analysis of specimen at temperature  $5^{\circ}\text{C}$  and exposure time of 24 h. The results confirm

exposed region as a composition of chloride ion near the pit surface which is 1.13 wt%.

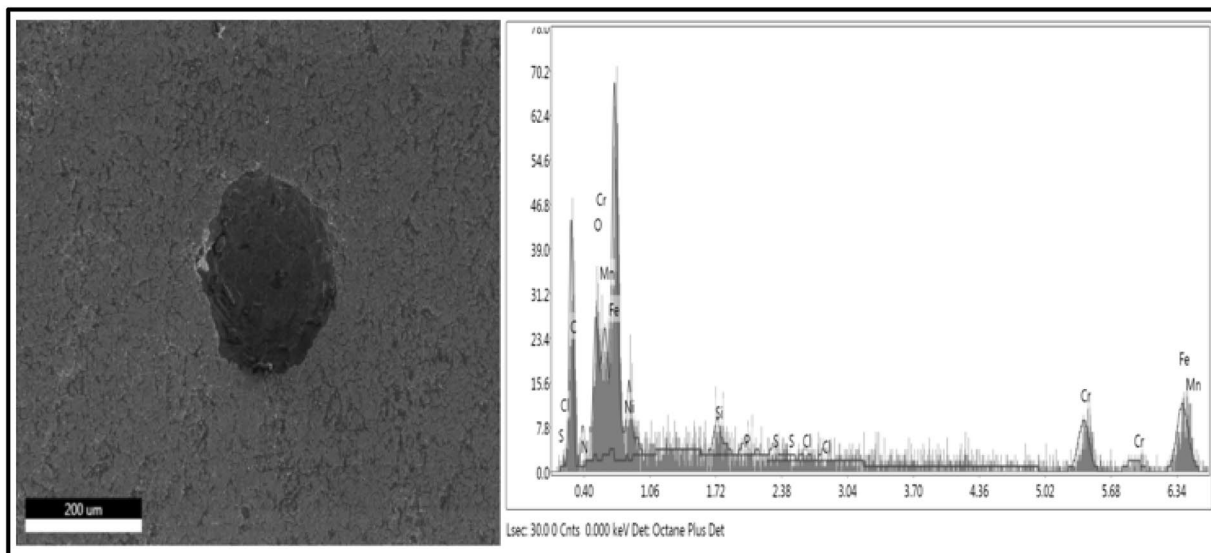
Elements	C K	N K	O K	Fe L	Ni L	Si K	P K	S K	Cl K	Cr K	Mn K
<b>Weight %</b>	16.75	3.73	4.52	31.29	5.45	1.55	0.95	0.90	0.88	27.03	6.95
<b>Atomic %</b>	41.24	7.87	<b>8.36</b>	<b>16.57</b>	2.75	1.63	0.91	0.83	0.74	15.37	3.74

Fig. 13 EDX image of specimen exposure at temperature 22 °C and time 24 h and the results of EDX analysis of F304 stainless steel

Furthermore, Fig. 13 shows the observed result of EDX analysis of the second specimen exposed in 22 °C for 24 h. Figure 14 represents EDX spectrum of specimen exposure at temperature 50 °C for 24 h. High chloride content has been observed at 50 °C which was 1.65 wt% of total weight wt%. The increased temperature gradually increases the concentration of chloride around the pit surface.

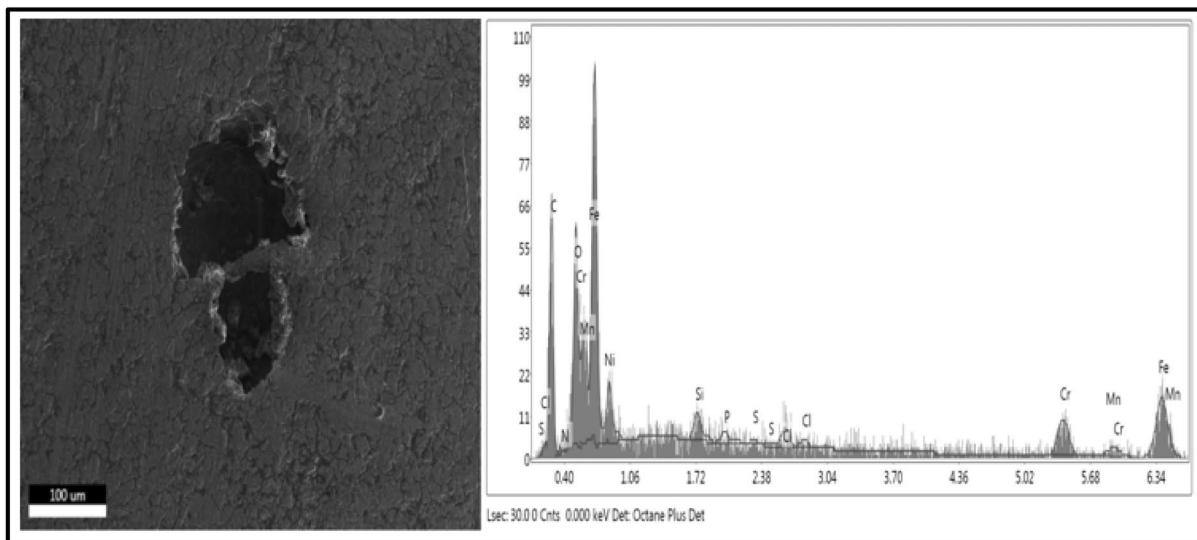
Elements	C K	N K	O K	Fe L	Ni L	Si K	P K	S K	Cl K	Cr K	Mn K
Weight %	18.86	1.43	6.89	37.32	4.95	1.24	0.71	0.38	1.65	21.36	5.21
Atomic %	45.04	2.93	12.34	19.17	2.42	1.27	0.66	0.34	1.34	11.78	2.72

Fig. 14 EDX analysis of F304 stainless steel of specimen exposed at temperature 50 °C for 24 h

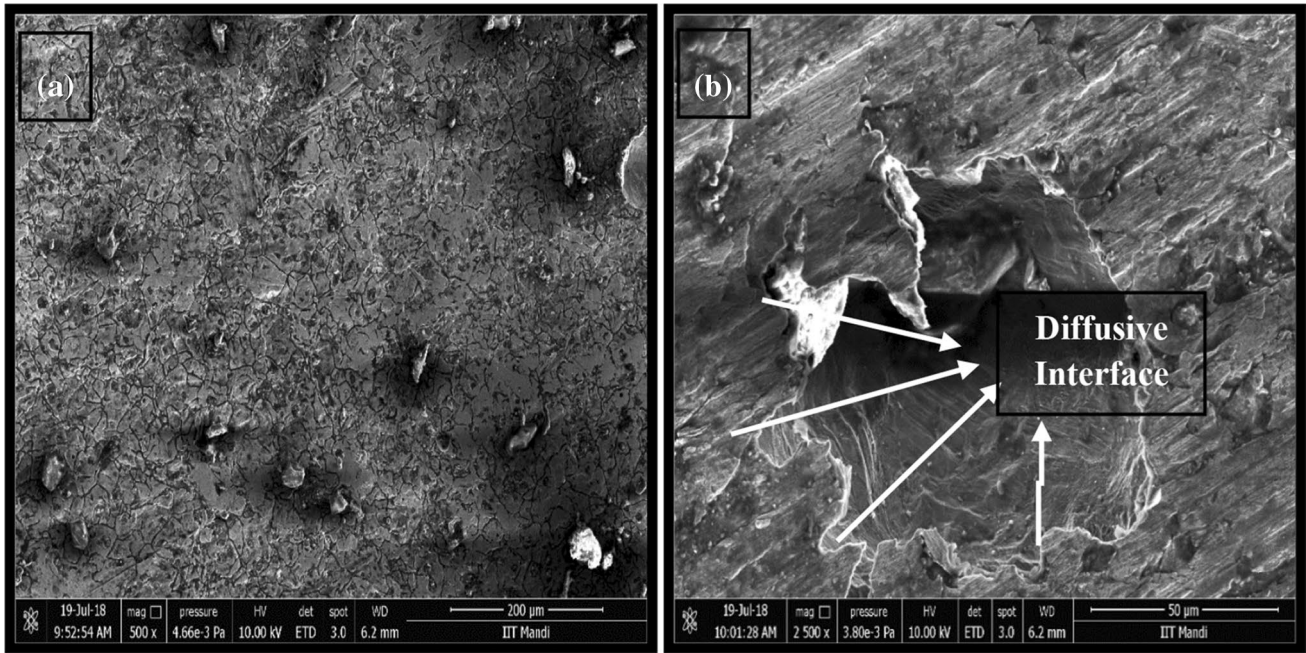
Fig. 16 SEM images of F 304 stainless steel at 5 °C and exposed under 12 h

The pit surface morphologies of corroded specimens at different magnifications have been observed. Figure 16a depicts

the surface of the F304 stainless steel alloy exposed under 12 h at 5 °C. It was found that in Fig. 16a, the surface of the exposed steel becomes brittle which helps to develop a tiny amount of cracks/pits throughout the surface. Figure 16b

shows the hemispherical pit size being developed on the surface of alloy. The pit bottom has large opened surface. As shown in Fig. 16b, a small number of cracks and crack-like topographies can be seen nearby the pit boundary. Figure 17 reveals the surface morphology of the alloy exposed in chemical solution at the temperature of 5 °C and time 24 h

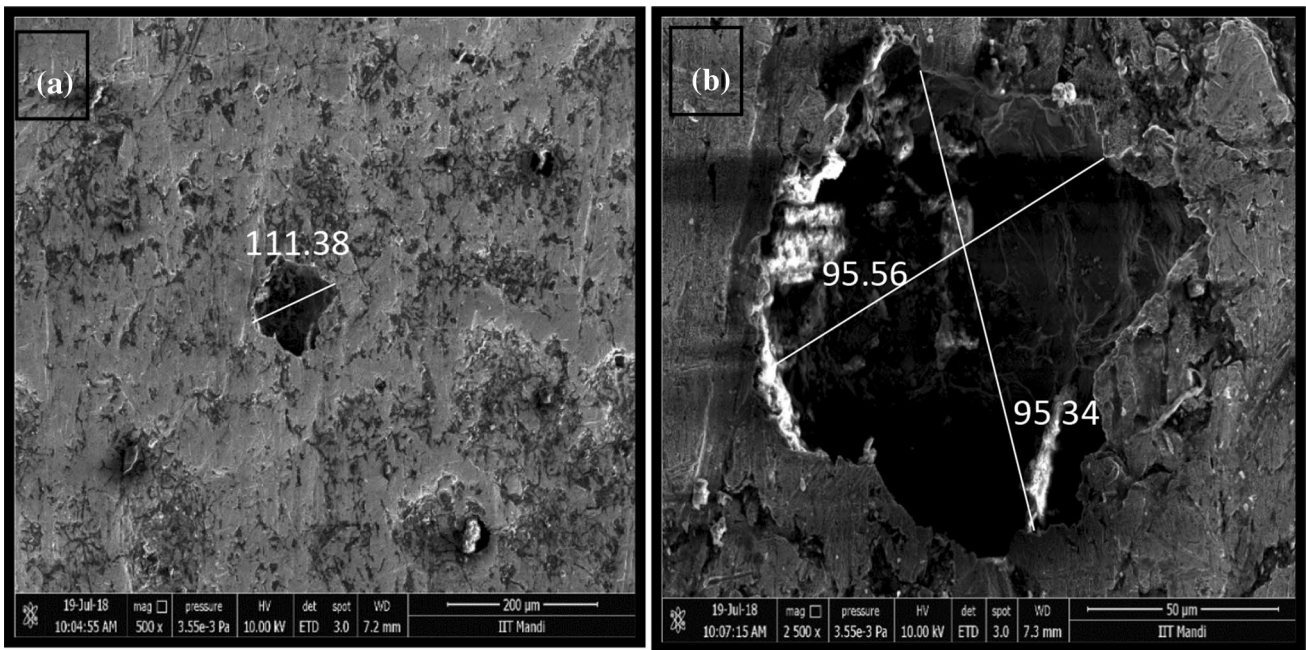
Fig. 17 SEM morphology of stainless steel alloy exposed at 5 °C under 24 h

which (a) expressed the surface of the corroded alloy and (b) represented the hemispherical pit geometry. The distance of 95.56 μm and 95.34 μm was calculated by using software “Imagej”.

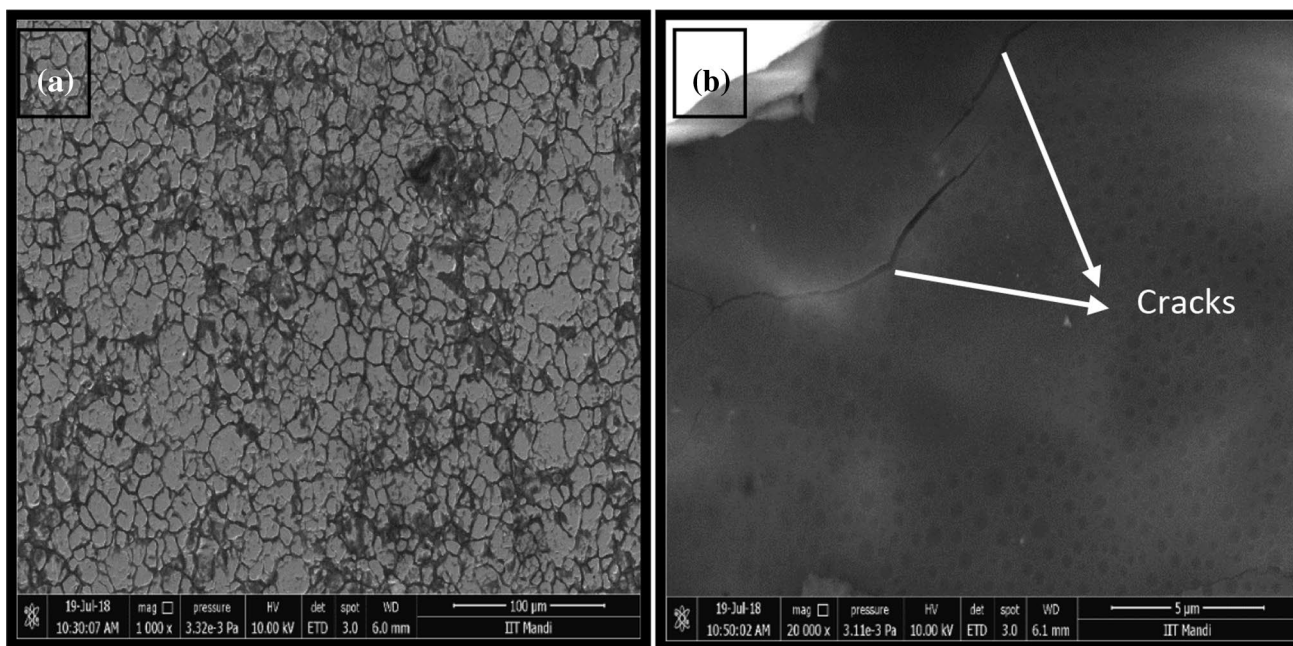
Fig. 18 SEM image of alloy exposed at the temperature of 22 °C and 16 h

the localized crack and then start to propagate. Figure 18c shows the small cracks at the pit bottom site, and it was most likely to crack easily. The small amount of inclusion was found at the bit bottom which will act as an electrolyte and increase material degradation. Figure 19a shows the pit geometry of hemispherical type and (b) represents inclusion at the surface of pit bottom. In most of the cases,

this inclusion also helps to initiate the more pit at the surface of pit bottom. Further, SEM image also revealed that the corrosion cracking has initiated from the pit base and from the intergranular corroded area. The surface texture of the exposed specimens formed corrosion layer after 12 h (at 5 °C), 24 h (at 5 °C), 16 h (at 22 °C), and 24 h (at 22 °C), respectively. Figure 18a shows the corrosion

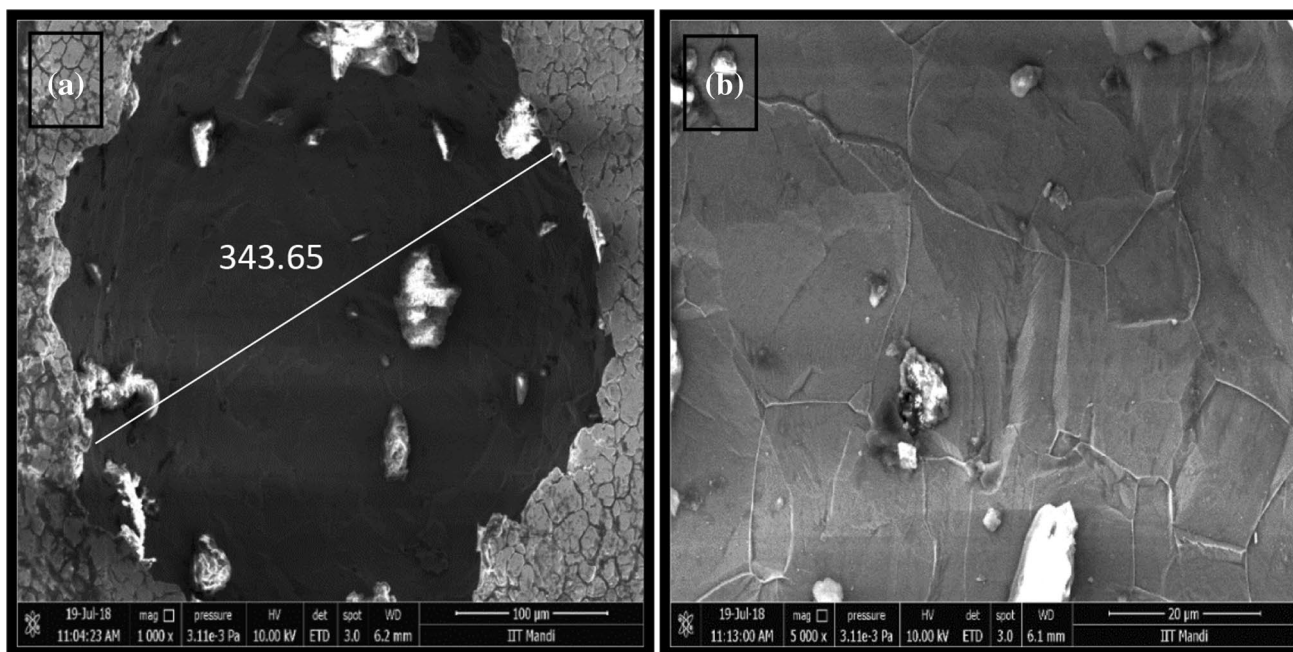
Fig. 19 SEM images of alloy exposed at a temperature of 22 °C and 24 h

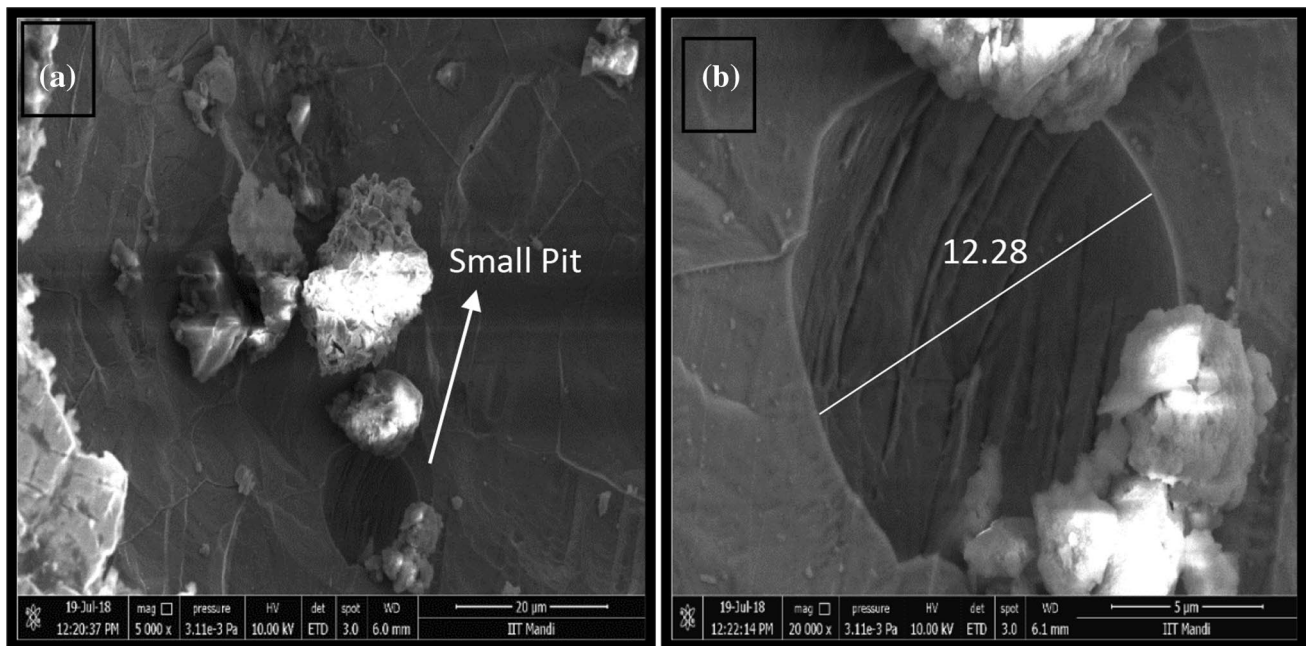
**Fig. 20** SEM images of alloy exposed at the temperature 50 °C and 24 h

Usually, the material degradation was more inside the pitting surface. Therefore, the internal surface of pit is more corrosive in nature and the pit tries to meet together through inside the pitting surface. Figure 20b also represents that the pit was trying to damage the material from inside the alloy. It has been revealed that Mn has a strong attraction to sulfur to proceed extremely stable MnS inclusions and, as a consequence, it typically seems to proceed these sulfides within austenite stainless steel microstructure. Stainless steel assessed here confirms the existence of manganese sulfide inclusions which allows revealing the different mechanism of Mn action with respect to corrosion rate.
