The Effects of Corrosion Problems on the Performance of Oil Wells Operated with Electrical Submersible Pumps: Lessons Learned

Abstract

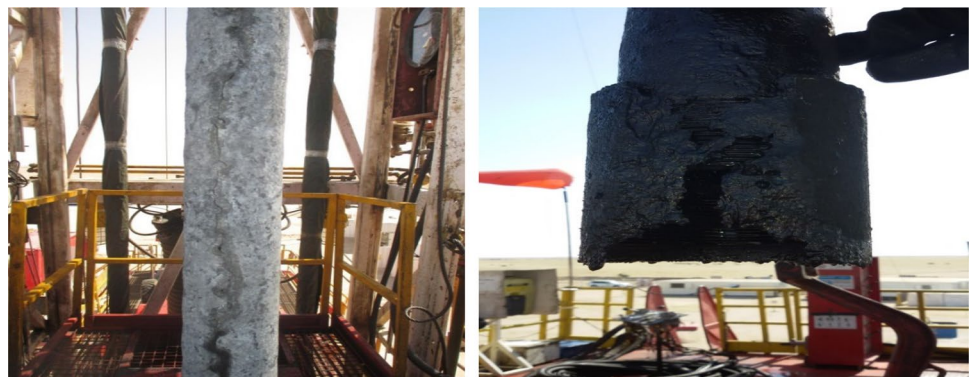
Fig. 5 Production tubing (2 7/8 in; N-80; 6.5 lb/ft), an example the effect of hydrogen corrosion on production tubing string

the metal, there are blisters on the surface. When the rupture is examined under the microscope, cracking occurs during the crystal groups. This is true for low temperatures. However, at high temperature, the cracks are at the limits of the crystals. At high temperatures, hydrogen reacts with iron carbide forming methane whose particles are large and cannot escape out the metal pores. This creates high pressure within the metal, which leads to cracking.

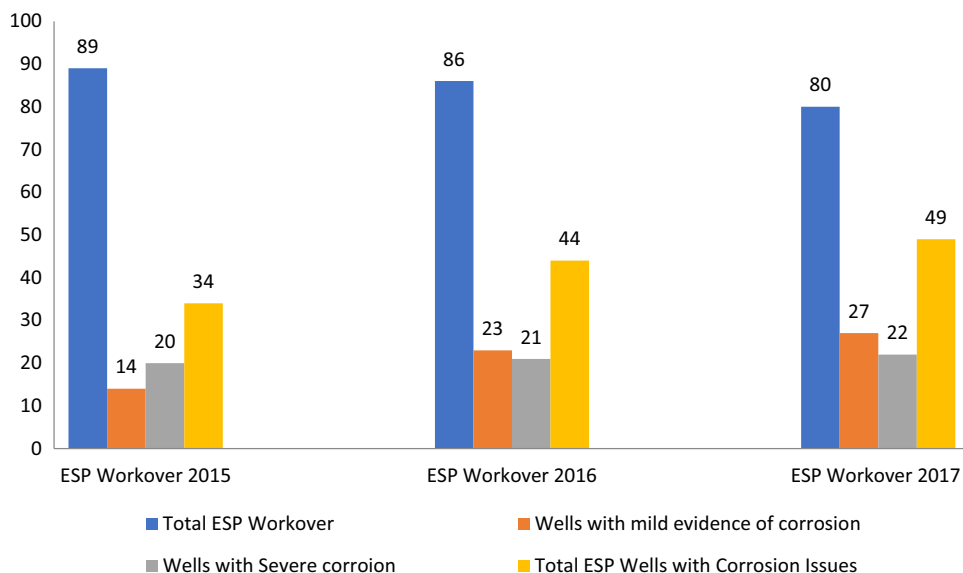
Fig. 7 ESP corrosion damage during (2015–2017) reported by the inspection process of pulled tubings

In 2015, 89 electrical submersible pumps (ESP) were installed or replaced in production wells. 28 of these ESPs found that the corrosion rate in the production tubing was low to medium as shown in Fig. 7. However, other 20 of these ESPs found that the corrosion rate in the production tubing was severe. On the other hand, 9 ESPs were failed

In 2016, 86 electrical submersible pumps were installed or replaced for production wells. 23 of which found that the corrosion rate in the production tubing was light to medium as shown in Fig. 7. However, 21 of them found that the corrosion rate was severe. On the other hand, 9 ESPs were failed due to the induced holes in the production tubings which are carbon steel L80 type.

In 2017, 80 electrical submersible pumps ESP were installed or replaced for production wells. 27 of which found that the corrosion rate in the production tubing was light to medium as shown in Fig. 7. 22 of them found that the corrosion rate was severe. 13 submersible electric pumps failed due to the induced holes in the L80 production tube.
