# Erodibility characteristics and slope stability analysis of geological units prone to erosion in Udi area, southeast Nigeria

## Abstract

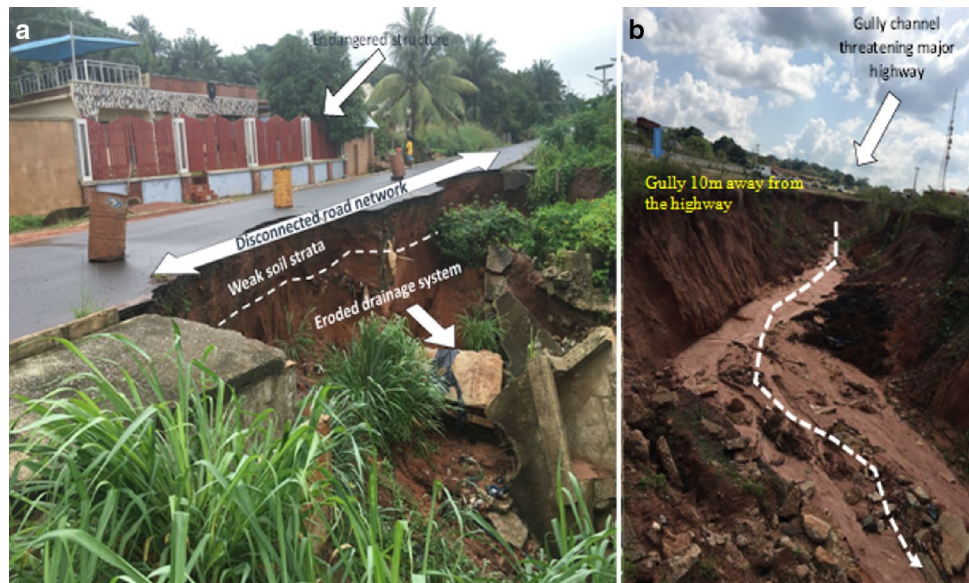
**Fig. 1 a, b** Developing gully channels destroying and threatening engineering structures in Udi province

Land degradation, as a result of soil erosion, is one of the major geologic hazards threatening many lives and properties in different parts of Nigeria (Igwe and Egbueri 2018; Egbueri and Igwe 2020). The most critical part of this menace is the formation of rills and gullies. Gullying has caused several environmental damages in this region. Such environmental problems caused by gullying in Udi include loss of agricultural lands and natural vegetation, loss of residential apartments, destruction of engineering structures like roads and drainage channels, and disruption of wildlife ecosystem (Figs. 1 and 2). Being geomorphic processes, rill and gully

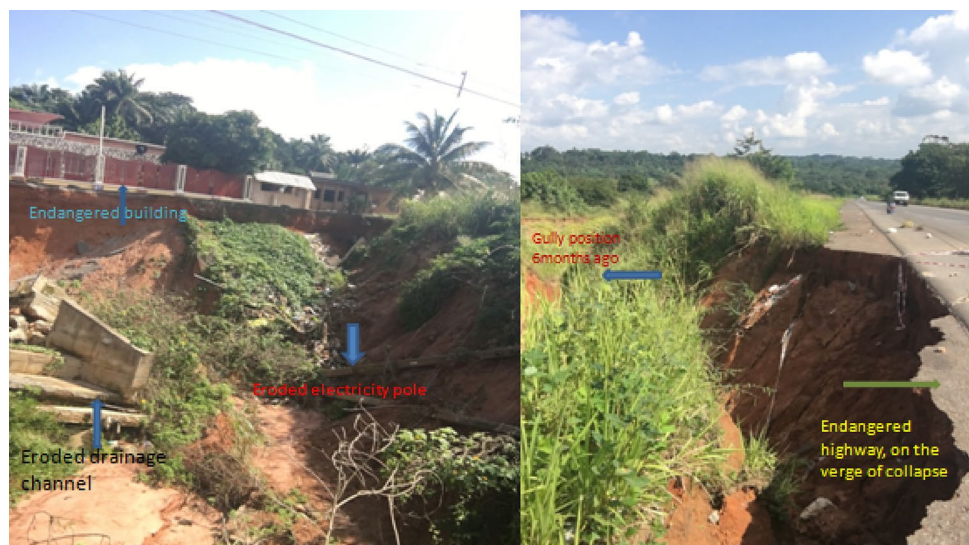
**Fig. 2** Engineering structures destroyed by gully erosion in Udi province

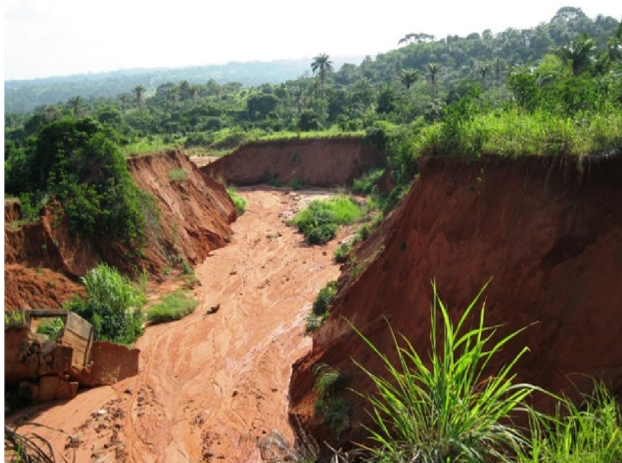
**Fig. 5** A typical V-shape gully in the study area

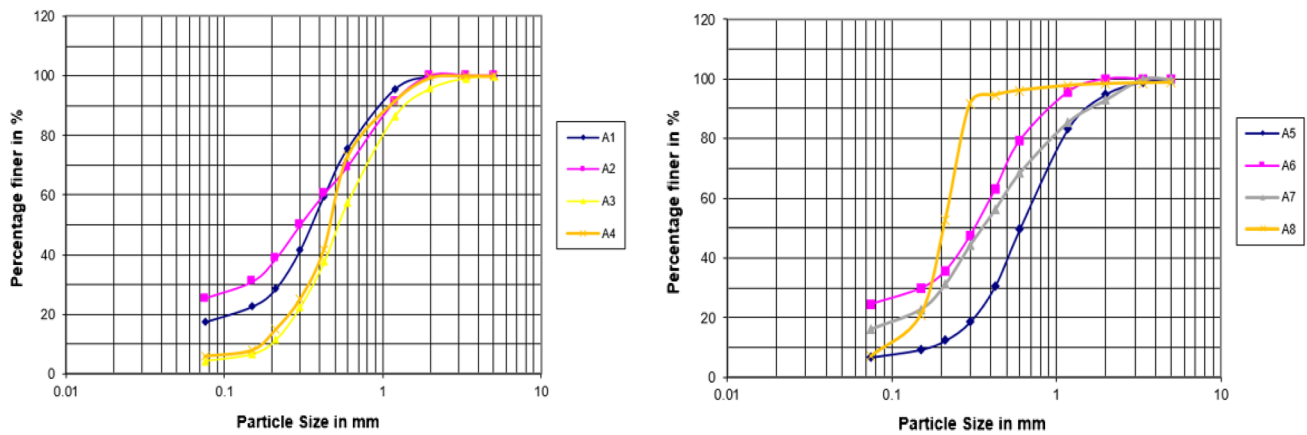
**Fig. 6** Grain size distribution of the soils collected from failed slopes (samples A1–A8)

The results obtained from the grain size analysis are presented in Table 3. Based on the particle size distribution, the percentage contents of gravels, sands, and silts are in the ranges of 0–14%, 74.3–94.8%, and 4.3–24.47%, respectively. The result reveals that there are high percentage of sands and low proportions of silts and gravels, and insignificant amount of clays. This observation corresponds with the observations made in the field and the work of Emeh and Igwe (2017). However, it was observed that the particle size distribution curves (Fig. 6) are of similar s-shapes for all the gully sites, confirming the predominance of sands in the gully slope materials. Traditionally, clays and silts constitute the fines content of a soil. The fines serve as natural binders that enhance the cohesion of a soil and its resistance to erosion (Igwe and Egbueri

2018). In other words, the lower the percentages of the fines, the lower the cohesion, and the higher the erodibility of the soil and vice versa. According to a Unified Soil Classification System (USCS) presented in Arora (2008), the soils were classified into two major groups, silty sand (SM) and poorly graded sands (SP) (Table 3). Based on the results presented, the soils are adjudged to have high erodibility tendency (Igwe and Egbueri 2018), because the high amount of loose sands in the slope materials has strong implications for gully erosion occurrence. It is also suspected that some of the gully materials may be failing due to liquefaction during the rainy season.

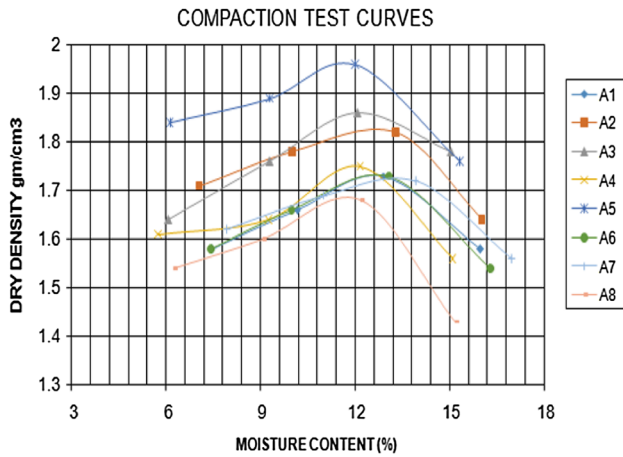
**Fig. 7** Compaction curves for the soil samples

The compaction characteristics of the soils are presented in Table 5 and Fig. 7. According to Egbueri et al. (2017) and Igwe and Egbueri (2018), compaction tests can reveal (1) how loose or compacted a soil material is and (2) the relationship between compaction effort and the optimum water content. In this study, the compaction result showed that the soil optimum moisture content (OMC) ranges from 12.0 to 13.5%, while the maximum dry density (MDD) ranges from 1.65 to 1.96 g/cm<sup>3</sup> (Table 5). The result revealed that the soils have low OMC and poor MDD. These results suggest that the soils are loose materials and hence require very little force to detach and transport the particles (Igwe and Egbueri 2018). Additionally, the loose nature of the soils has more influence on their water holding capacity and hydraulic conductivity (Egbueri et al. 2017; Igwe and Egbueri 2018).

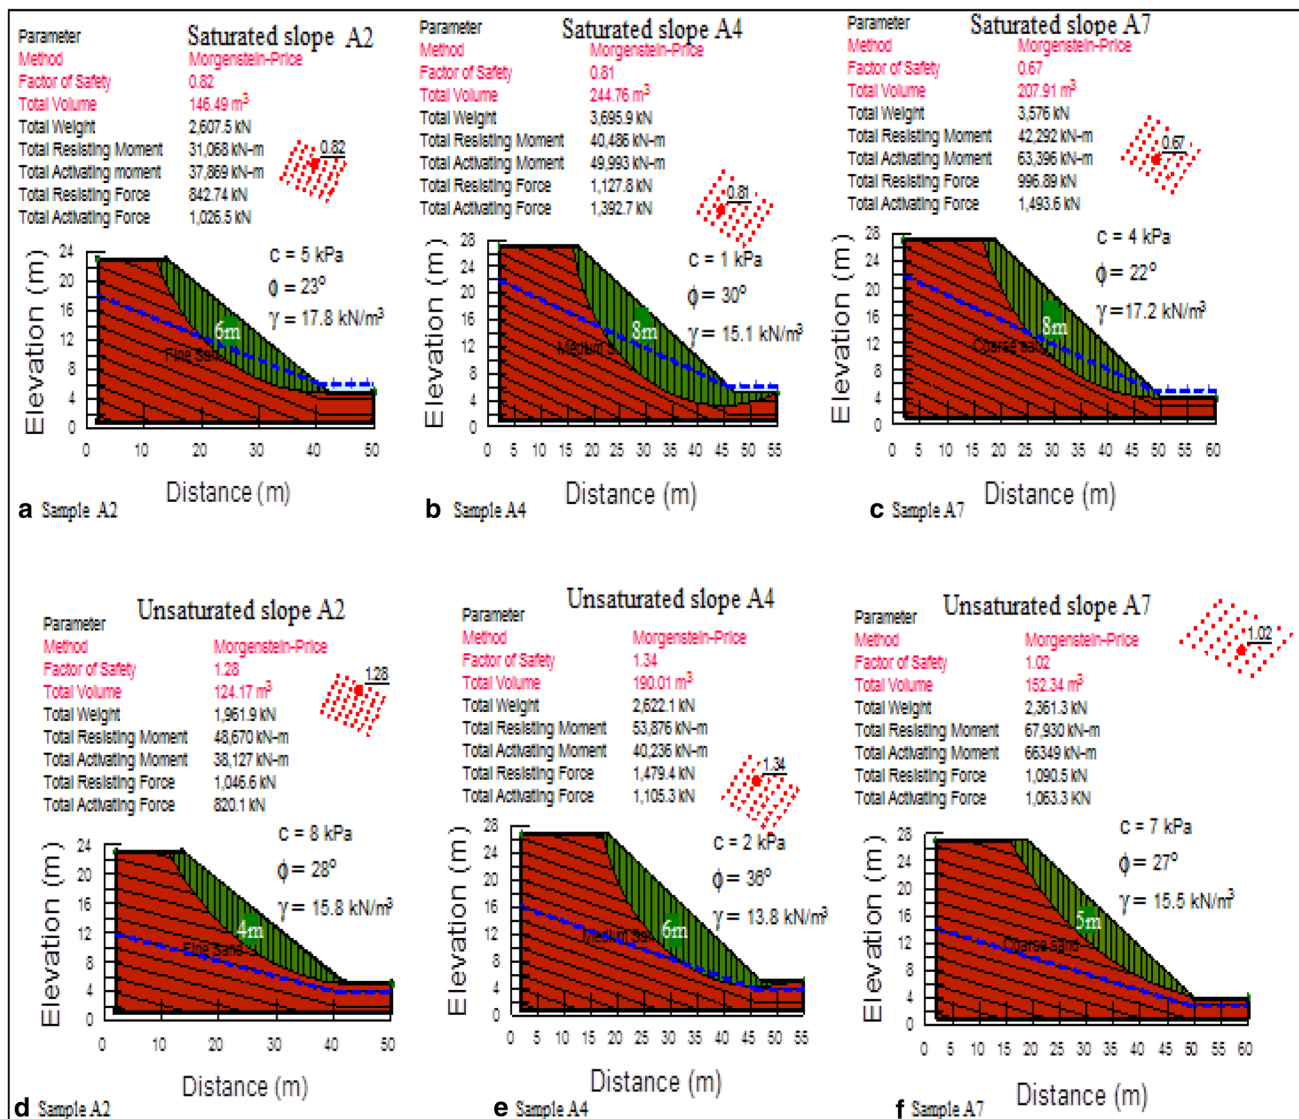
Fig. 8 Stability models for both saturated and unsaturated conditions

The simulated FoS values for both dry and wet conditions indicate several disparities in this research. In the event of a possible gully erosion, model (Fig. 8) predicts that the slope failure would be relatively rotational slip surface passing slightly below the toe of the slope and having an average depth of about 6 m and a sliding mass of about 146.49–176 m<sup>3</sup> as water content increases within the slopes. A slide with this geometry can be considered to be a low-to-medium-magnitude soil movement, because it occurs regularly in saturated state. A drop in rainfall infiltration during the dry season improved the FoS of the gully slope, and as can be observed from Fig. 8, a significant drop of the FoS from 0.82 to 1.28 showed a reduction in the sliding mass from 146.49 to 124.17 m<sup>3</sup>.

To simulate both saturated and unsaturated pore-water pressure failure mechanisms in the slope mass, the material grain size was taken into account. Usually, a coarse-grained soil slope fails in saturated condition because its high permeability causes a rapid development of positive pore-water pressure. In fine-grained soils, however, there is no rapid development of positive pore-water pressure, owing to the relatively low permeability. In Fig. 9, pore-water pressure was simulated for both wet and dry conditions to understand the mode of pore-water buildup in both conditions. The variation in pore-water pressure in all the sites witnessed very rapid pore-water pressure response in the wet condition. Possibly, the infiltration through the soil decreases the matric suction.

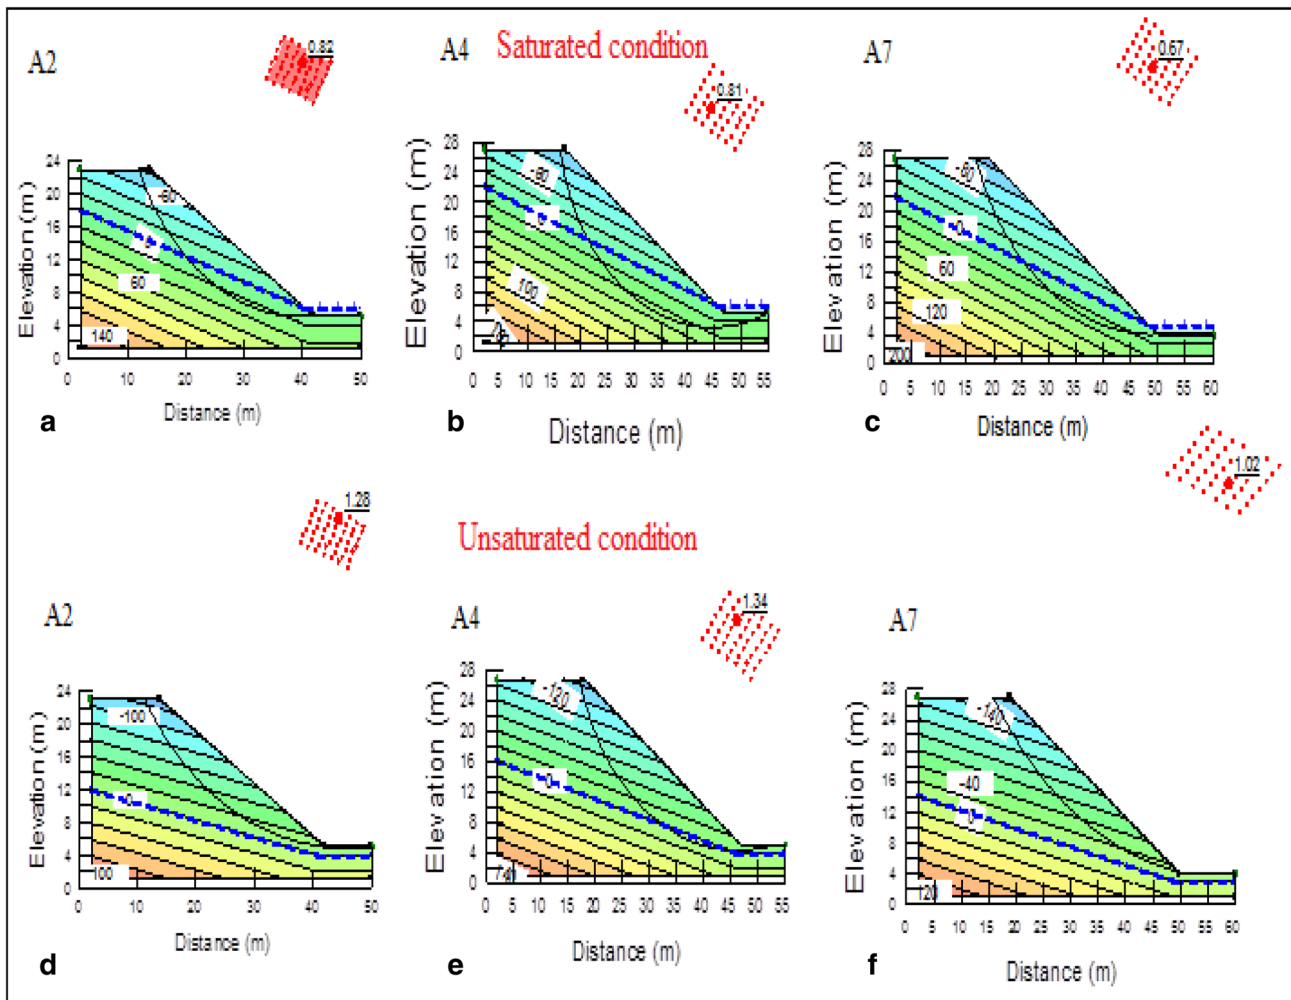
**Fig. 9** Soil pore-water pressure variations for both wet and dry conditions

gully slopes ranged from  $-80$  to  $-60$  kPa, validating the fact that the soils are almost homogenous and tend to have relatively similar pore-water pressure condition (Fig. 9). The rainfall infiltration and residual soils' self-weight increase, while the wetted zones' matric suction decreases or even disappears. In the dry condition, there is little or no rainfall; thus, the pore-water pressure decreased from  $-100$  to  $-140$  kPa. The fundamental cause of negative pore-water pressure appears to be osmotic and adsorptive effects, hydrostatic stresses, and the surface tension of water. Negative pore-water pressure may exist in both saturated and partially saturated soils.
