Enhancing Levee Resilience Through Material Compatibility: A Comprehensive Study on Erosion Dynamics

Liaqat Ali¹ · Norio Tanaka^{1,2}

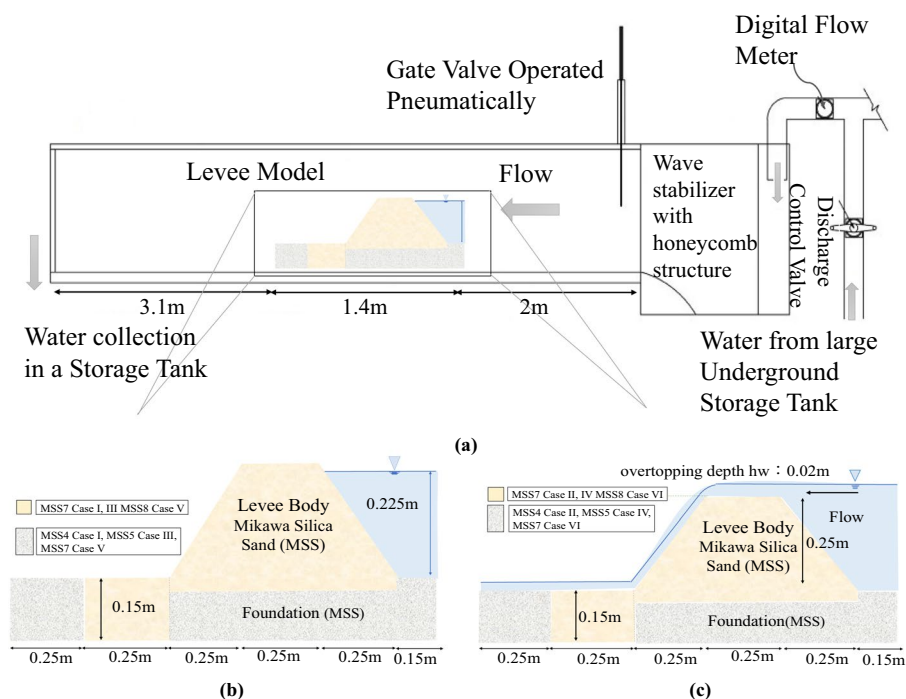
Fig. 1 Illustration of experimental configuration: **a** Side view of the flume with the levee model; **b** Cross-section of the levee model during seepage erosion tests; **c** Cross-section of the levee model during overtopping erosion tests (adapted from Ali and Tanaka 2023)

shown in Fig. 1a. The embankment model within the flume was constructed to a scale that simulates real-world conditions, and the levee had a geometric scale ratio of 1:20, where the dimensions of the model levee corresponded to an average height of 5 m for a real levee in Japan.

During this study, six distinct experimental cases were conducted as shown in Fig. 1b, c, and detailed in Table 1. The experiments were designed to systematically investigate the impact of varying levee and foundation materials on levee erosion resistance. Specifically, the levee material varied between finer Mikawa silica sand No. 7 (MSS7) and No. 8 (MSS8), while the foundation material was varied among coarser Mikawa silica sand No. 4 (MSS4), No. 5 (MSS5), and No. 7 (MSS7). The experimental cases were organized as follows: Case I and Case II: The levee material was MSS7, and the foundation material was MSS4. Case III and Case IV: The levee material was MSS8, and the foundation material was MSS5. Case V and Case VI: The levee material was MSS8, and the foundation material was MSS7. The specific characteristics of these materials are detailed in Table 2. This systematic variation allowed for a comprehensive analysis of how different material combinations influence erosion dynamics under both seepage and overtopping conditions.

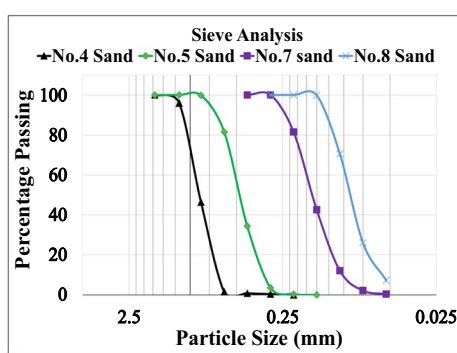
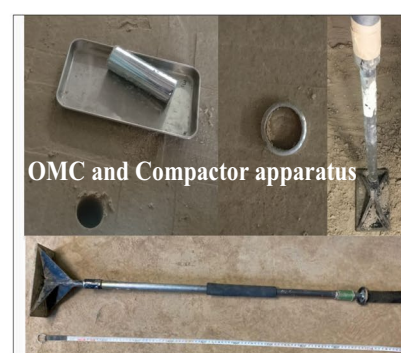
Fig. 2 Levee model soil and preparation: **a** Sieve analysis for Mikawa silica sands used for embankment preparation **b** Soil compaction methods and optimum moisture content sampling

The embankment and foundation were created by compacting Mikawa silica sands (Mikawa Silica Co., Ltd.) with median grain sizes as shown in Fig. 2a. The optimum

moisture content for the different sands is listed in Table 2 as determined by Ali and Tanaka (2023). The embankment and foundation were compacted to 82% to 85% of the maximum dry density using a hammer, with each 5 cm layer receiving 6 blows, achieving the desired compaction. To ensure the

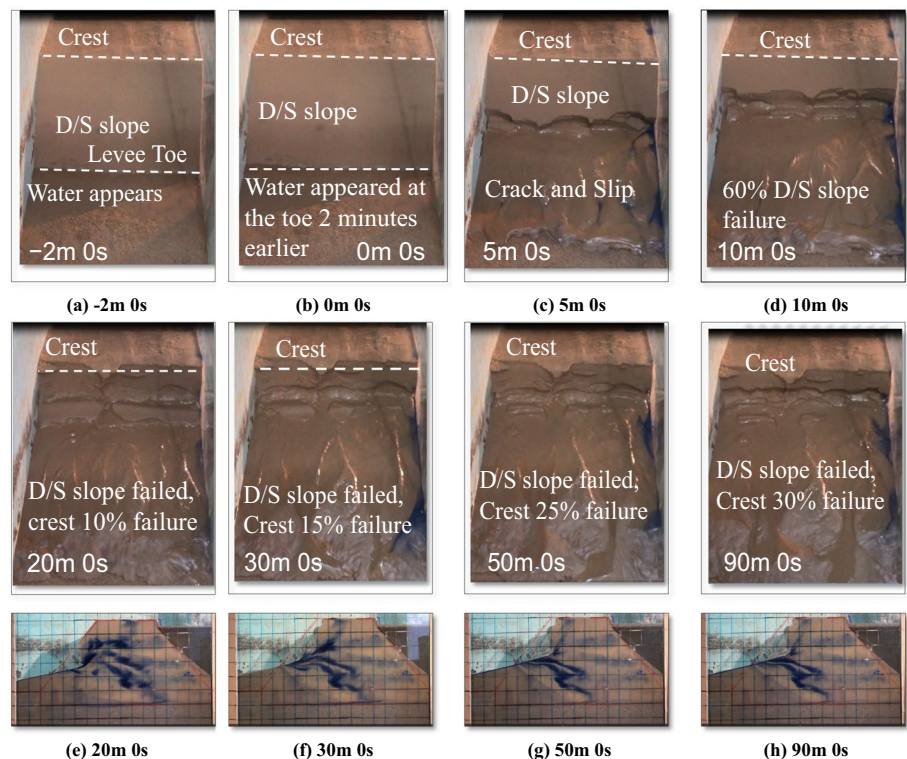
Fig. 3 Seepage erosion process in Case I SE-S74; observations from top and side views at various time intervals (m for minutes, s for seconds)

The beginning of slip failures and the formation of cracks were observed within the first five minutes. Approximately 60% of the downstream slope experienced failure within the first 10 min as shown in Fig. 3b–d. The erosion process exhibited rapid progression during this initial phase.

The erosion process continued at a significant pace, with 100% of the downstream slope failing by the 20 min mark as shown in Fig. 3e. Failures extended progressively towards the crest during this phase.

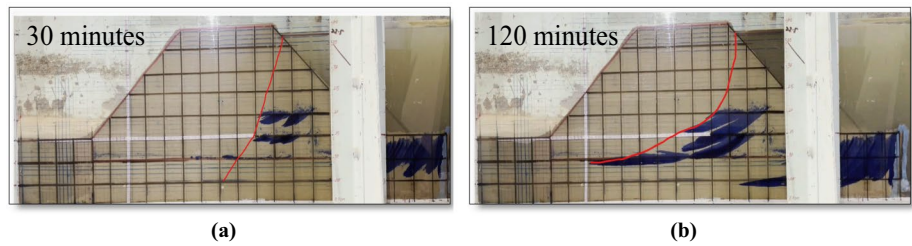
Fig. 5 Seepage erosion process in Case V SE-S87; observations from a side view at 30 and 120 min

In seepage erosion Case V SE-S87, which used MSS8 for the levee body and MSS7 for the foundation, the results were markedly different as shown in Fig. 5a, b.

No erosion or appearance of water at the downstream toe was observed even after 2 h. This case demonstrated exceptional resistance to seepage erosion, indicating excellent material compatibility and significantly lower hydraulic

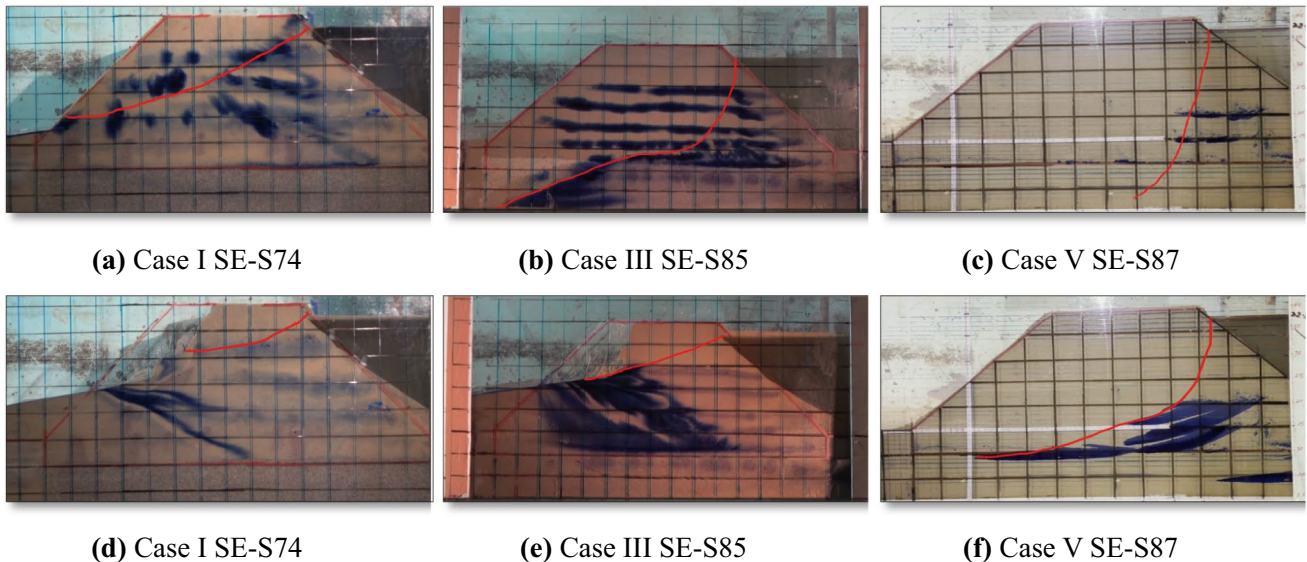
Fig. 6 Phreatic line progression in seepage erosion experiments (a), (b), and (c) when the water level is at 0.225 m upstream (d), (e), and (f) after about one hour

In Case I SE-S74, where the hydraulic conductivity ratio (k_E/k_F) between the levee and foundation materials is approximately 60, the movement of the phreatic line is rapid due to the high hydraulic conductivity of

the foundation material and the significant difference in material properties as shown in Fig. 6a, d. When the upstream water level reaches 0.225 m, the phreatic line quickly rises above the downstream toe, even before the water fully reaches the set level. This rapid ascent is indicative of quick saturation and a substantial risk of failure. Indeed, early erosion is observed with 60% downstream slope failure within the first 10 min, progressing to 100% downstream slope failure and 15% crest erosion within 20 min. This demonstrates the immediate impact of a high hydraulic conductivity foundation on erosion dynamics.

Case III SE-S85 also has a high hydraulic conductivity ratio of 60. The phreatic line here also shows rapid movement due to the high permeability of the foundation material as shown in Fig. 6b, e. At the initial stage, as the water reaches 0.225 m, the saturation line ascends quickly, causing early signs of instability. By the 5 min mark, water appears at the downstream toe, and significant erosion is observed with complete downstream slope failure and 35% crest erosion occurring within the first 60 min. The rapid rise and high phreatic line underscore the vulnerability of the levee to erosion when there is a large disparity in hydraulic conductivity between the levee and foundation materials.

In stark contrast, Case V SE-S87 demonstrates a slower movement of the phreatic line as shown in Fig. 6c, f. With a hydraulic conductivity ratio of 8, which is significantly lower than in SE-S74 and SE-S85, the difference in material properties is minimized. When the water level reaches 0.225 m, the phreatic line rises much more gradually. Even after one hour, the phreatic line remains well below the downstream toe, reflecting a much slower saturation process. This controlled ascent contributes to the stability observed in SE-S87, where no erosion occurs, highlighting

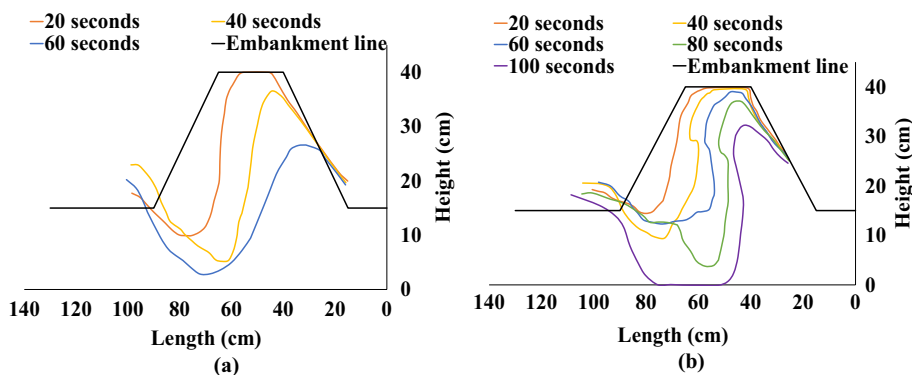
Fig. 7 Surface profiles of Levee at different time intervals **a** For overtopping erosion Case II OE-S74, **b** For Overtopping erosion Case VI OE-S87

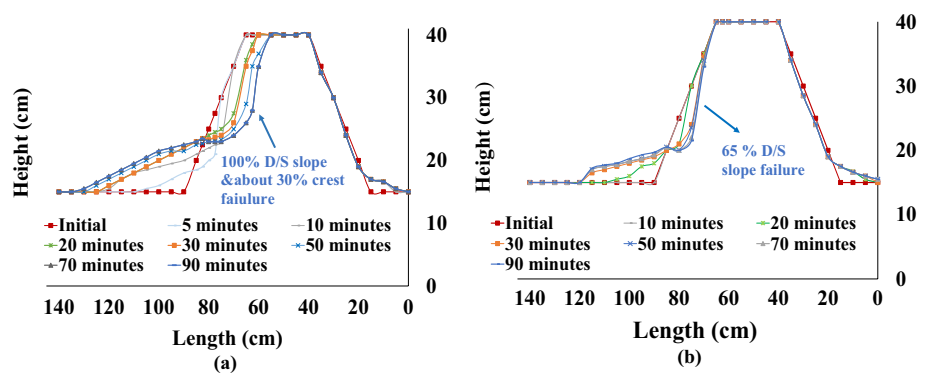
Fig. 8 Surface profiles of Levee at different time intervals **a** For Seepage erosion Case I SE-S74, **b** For Seepage erosion Case IO-E7-F5 (Ali and Tanaka 2023)

material while varying the foundation material. In Seepage erosion Case I SE-S74 (Table 1), the observed erosion dynamics were quite pronounced. The outcome revealed that 100% of the downstream slope experienced failure, and there was notable erosion on the crest, accounting for approximately 30% of its total extent as shown in Figs. 8a and 9a. The erosion process in SE-S74 exhibited a series of distinct stages and eventually stabilized after 90 min.

On the other hand, IO-E7-F5 featuring the same MSS7 levee material but MSS5 foundation material, demonstrated a remarkably different erosion response. Notably, only 65% of the downstream slope failed, there were no instances of crest failure observed in this case extent as shown in Figs. 8b and 9b.

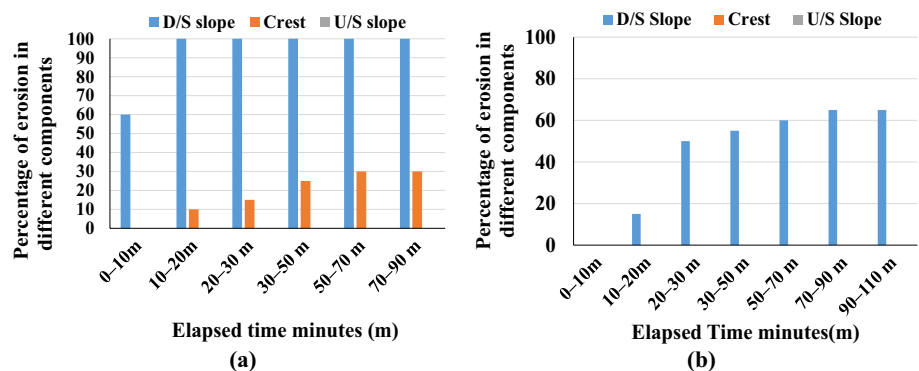
Fig. 9 Percentage of seepage erosion in different components of the levee over time in **a** SE-S74 and **b** IO-E7-F5

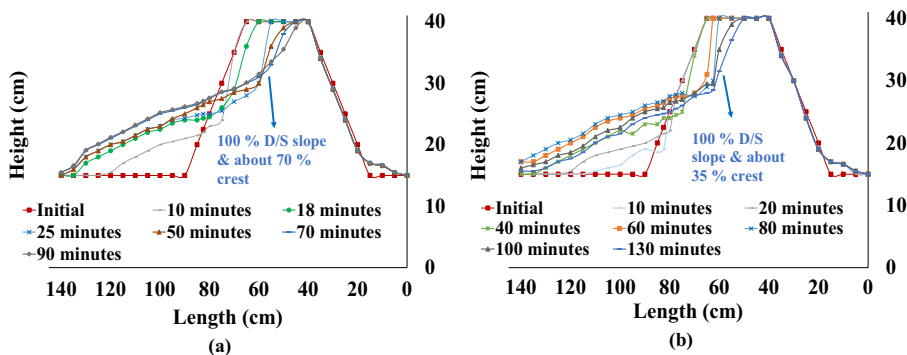
Fig. 10 Surface profiles of Levee at different time intervals
a For Seepage erosion case IO-E8-F4 (Ali and Tanaka 2023),
b For Seepage erosion Case III SE-S85

On the other hand, a rapid and extensive erosion process was observed in Seepage erosion case IO-E8-F4. Remarkably, within the initial 60 min, 100% of the downstream slope failed, and there was substantial crest erosion, accounting for 70% of the total crest extent as indicated in Figs. 10a and 11a. In contrast, SE-S85 displayed a distinct erosion pattern. It reached a stabilization point after 150 min, with 100% downstream slope failure and approximately 35% crest erosion as shown in Figs. 10b and 11b. However, despite sharing the foundation material with IO-E7-F5, SE-S85 did not match the erosion resistance exhibited by IO-E7-F5.

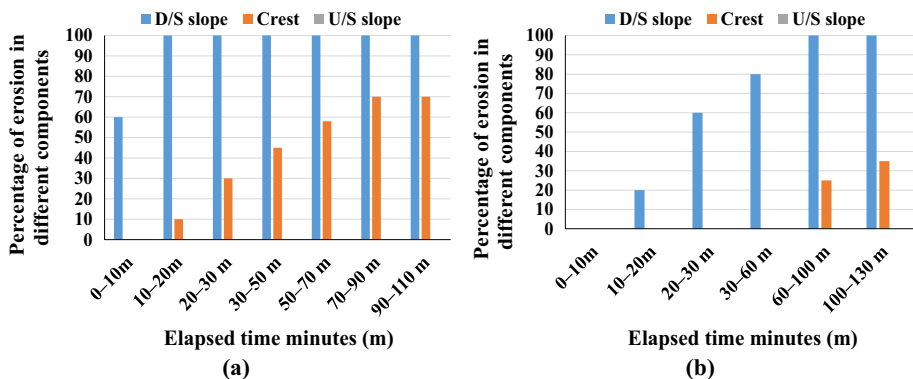
Fig. 11 Percentage of seepage erosion in different components of the levee over time in **a** IO-E8-F4 and **b** SE-S85
