Experimental Study on Strengthening of Corroded RC Beams with High-Performance Steel Fiber Mortar and Normal Reinforcements

Abstract

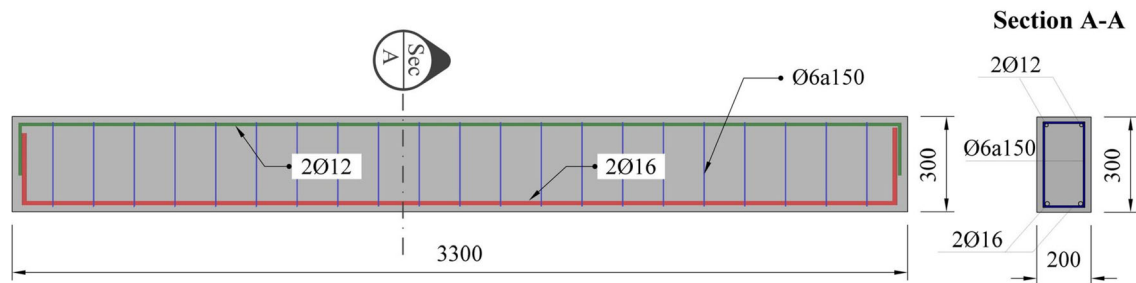
Fig. 1 Dimensions and reinforcement details of RC beams

In this study, six identical simply supported RC beams, as shown in Fig. 1, were fabricated. The beam length was 3.3 m, in which the length between two supports was set to 3.0 m. The height and width of the cross-section were 300 mm and 200 mm, respectively. Two D16 reinforcing bars were arranged in the tensile area. Meanwhile, two D12 rebars were installed in the compression area. Transversal reinforcements (D6) with 150 mm spacing were used. The mechanical properties, shown in Table 1, were obtained from the laboratory tests of used reinforcements. All values in the table were averaged of three specimens for each

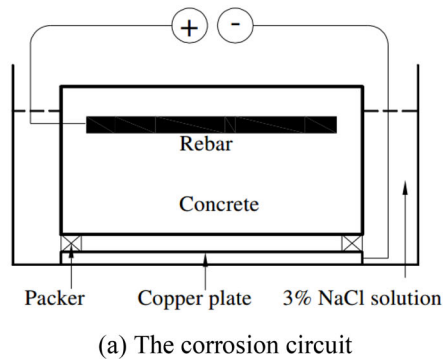
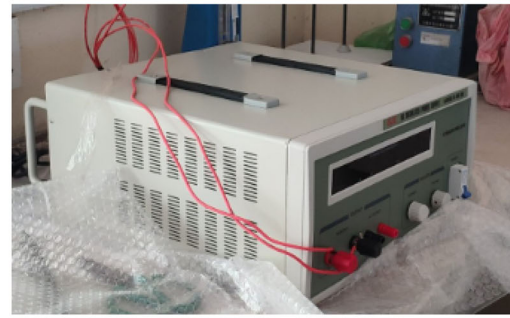
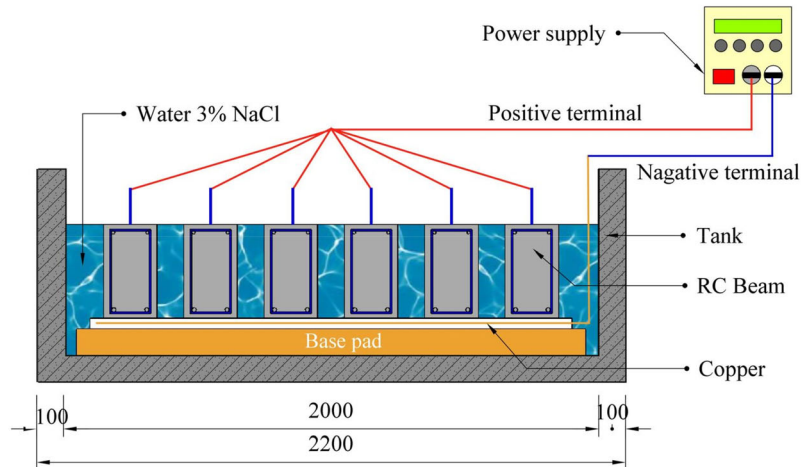
Fig. 3 The accelerated corrosion test

A range of 3–5% NaCl solution and 100–3000 $\mu\text{A}/\text{cm}^2$ electrical current density have been widely used in conducting the accelerated corrosion process [33–36]. In this study, to speed up the corrosion of the reinforcement, the RC beams were immersed in a salt 3% NaCl solution, and the reinforcing bars were connected to a direct current of 900 $\mu\text{A}/\text{cm}^2$. The three pairs of RC beams were corroded in 1 month, 2 months, and 3 months, respectively. According to the design of the corrosion test, reinforcements were connected to the current anode, while the negative electrode of the current was connected to a copper rod. The use of power supply DC QJ6030S (0 ~ 60 V / 0 ~ 30A, 2 Output) for testing is shown in Fig. 3.

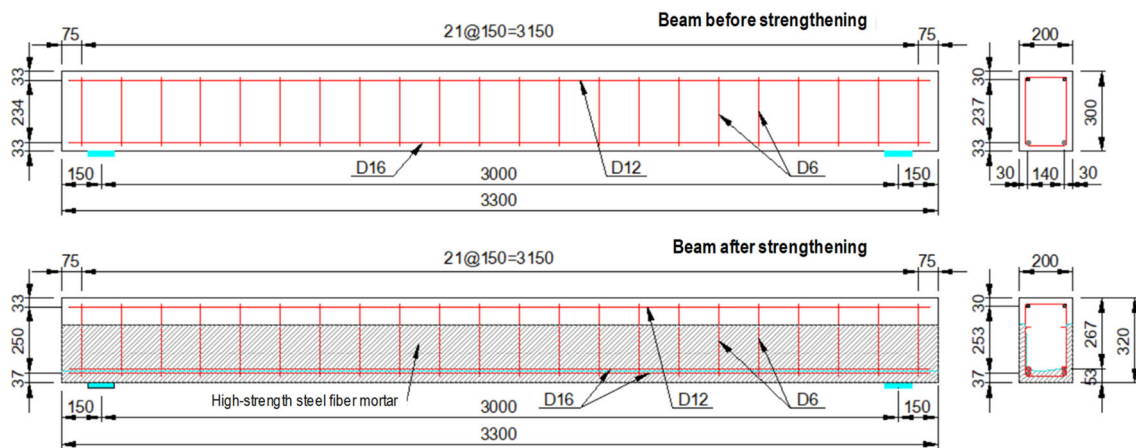
Fig. 5 Configuration of RC beams before and after strengthening

After accelerating corrosion tests, three beams with three corrosion levels (1 month, 2 months, and 3 months) were selected to strengthen with high-performance steel fiber mortar. Figure 5 shows the dimensions of the beam before and after strengthening with high-strength steel fiber mortar and reinforcements. It should be noted that the concrete cover was removed within two thirds of the beam depth

and the bottom, as cross-hatched in Fig. 5. These beams are referred, namely, H1, H2, and H3. The ratio of water to cement was 0.325. In this mortar mix, black silica fume with 15% of the weight of cement, was used, as shown in Fig. 6a. The BASF ACE 8588 superplasticizer was used with 2% of the weight of cement. Steel fibers (in Fig. 6b) with a tensile strength of 2985 MPa, provided by Anhui Elite Industrial Co., Ltd. [38], was utilized for strengthening. The fiber length and diameter are 0.2 mm and 12.8 mm, respectively.

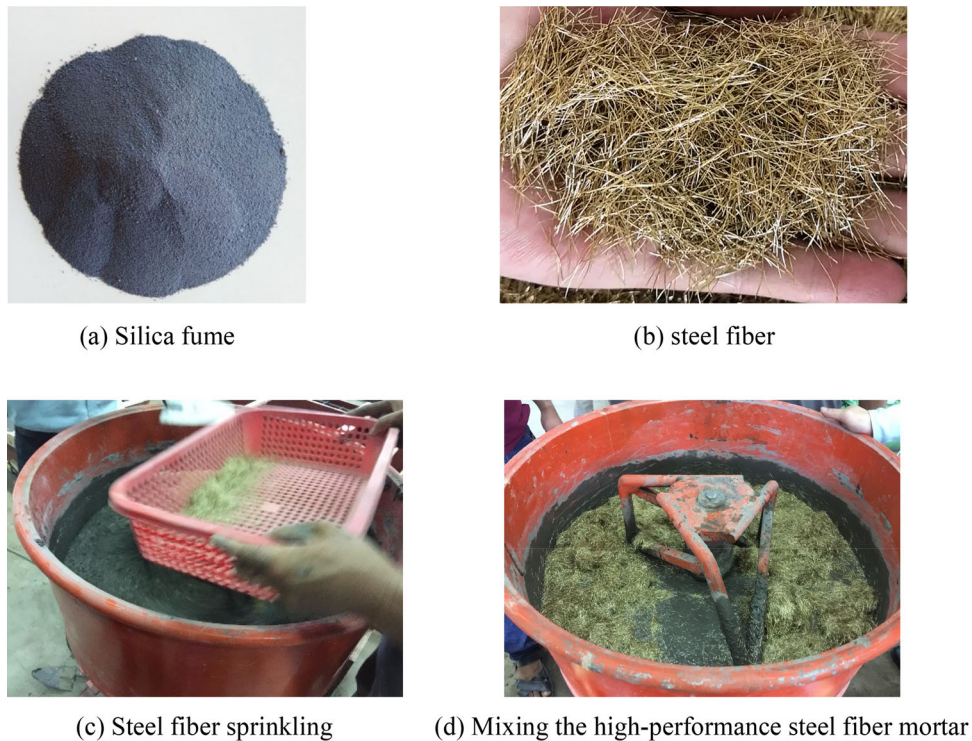
Fig. 6 High-performance steel fiber mortar

To avoid clumping of the reinforcement, the reinforcement was sprinkled into the mortar mixture during the mixing process through a plastic rack, as shown in Fig. 6c,

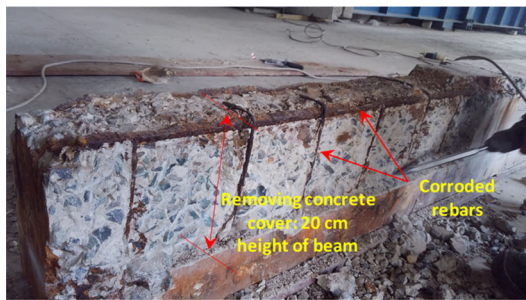
(a) Removing concrete cover

Fig. 7a. All cover concrete layer at two thirds of the beam height (i.e., 20 cm) and the bottom were removed using concrete cutters and drills, as shown in Fig. 7a–b. The reinforcements were cleaned of the corroded part and continue to use. Two longitudinal reinforcements with D16 were newly added to the tensile area, as shown in Fig. 7b. The new bars were connected to the old bars (i.e., corroded ones) using binding wires, as shown in Fig. 7c. Additionally, U-shaped transversal reinforcements (in Fig. 7d) with a diameter of 6 mm and a spacing of 150 mm were attached to the beams. The new transversal rebars were drilled into the concrete and binned with the longitudinal rebars using steel wires. After setting up the formwork (Fig. 7e), self-compacting high-performance steel fiber mortar was poured to strengthen the corroded RC beams as well as provide a protective layer for the reinforcements (Fig. 7f). Therefore, the cross-sectional height of the beam after strengthening was increased up to 320 mm, as shown in Fig. 7g.

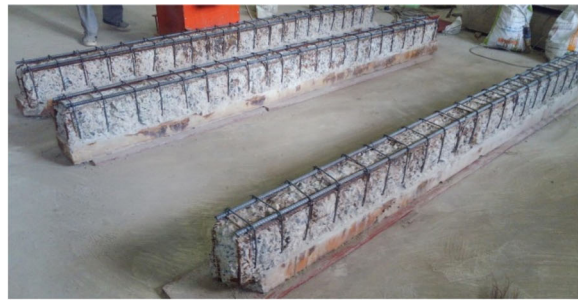
(b) Installing strengthening reinforcing bars

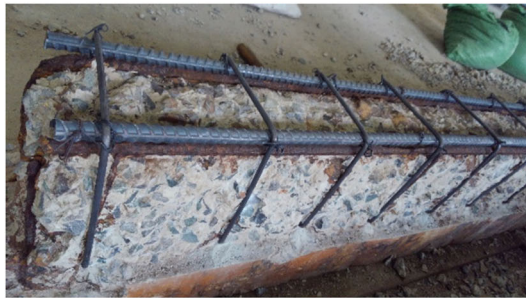
(c) Attachment of new reinforcements

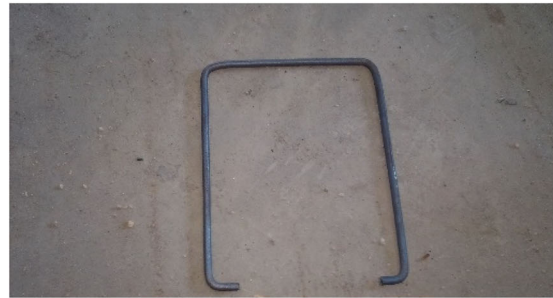
(d) Additional U-shaped rebars

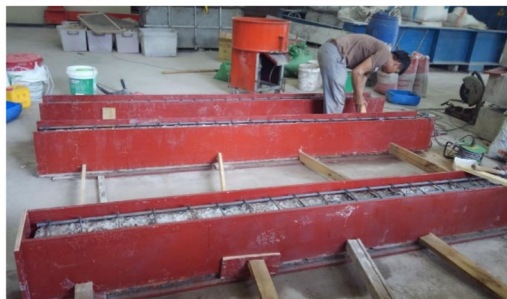
(e) Installing the formworks

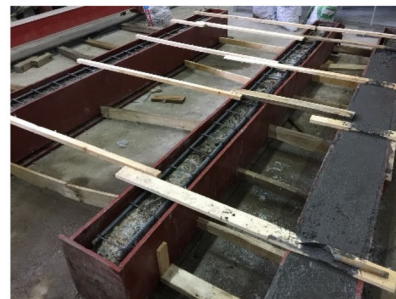
(f) Pouring the high-performance steel fiber mortar

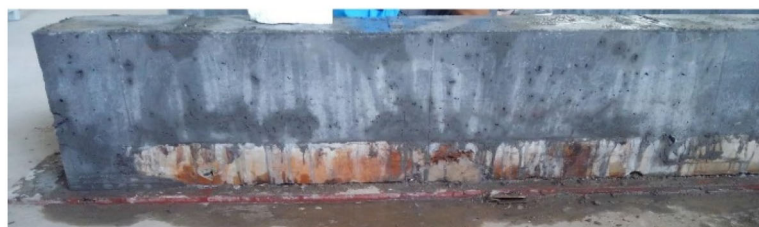
(g) Removing the formworks

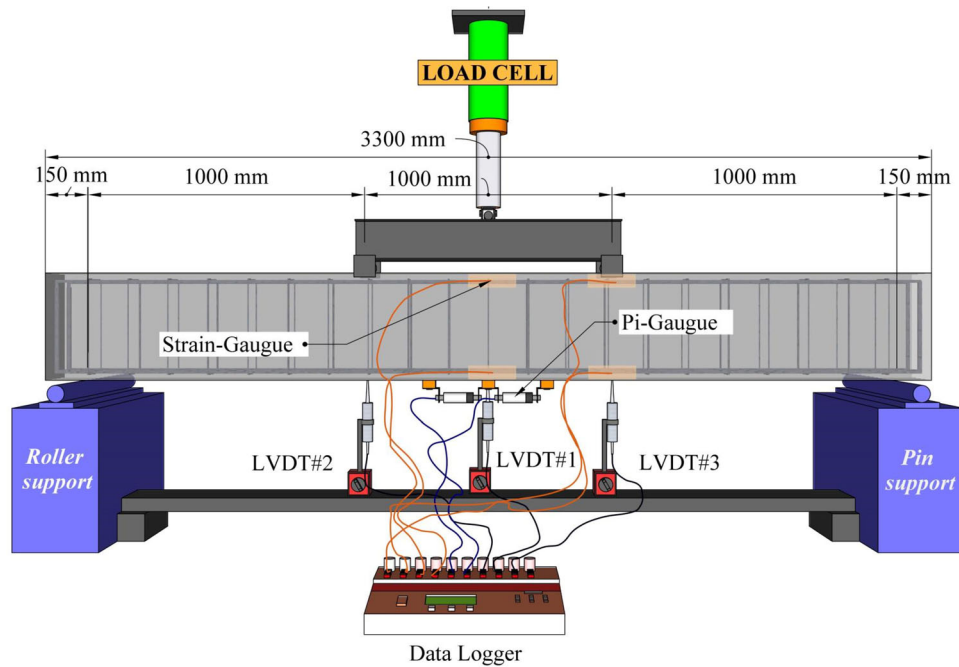
Fig. 8 Schematic diagram of experiments

All three corroded RC beams and three strengthened RC beams with high-performance steel fiber were then taken to bending tests. The test set-up is illustrated in Fig. 8. The RC beams were placed on two bearings and loaded through two points, as shown in Fig. 9. The applied load was gradually increased through the beam deflection control. The loader and strain gauges were connected to the data logger so that the force and deflection can be recorded simultaneously. Additionally, two pi-gauges were used to detect cracks occurring on the beam. One is at the center of the beam and the other is on the left of the beam. During the loading process, the relationship between applied load and deflection as well as crack formations were monitored.

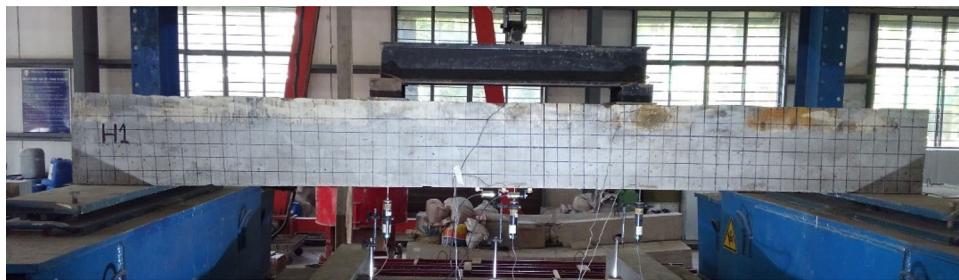
Fig. 9 Bending test setup

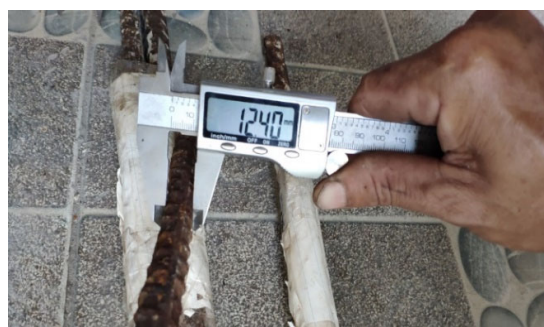
(a) Measuring diameter of rebar after corrosion

The tested beams were crushed to remove the reinforcing bars and the diameter of all rebars was measured, as shown in Fig. 10a. Then, the weight of the remaining rebars was

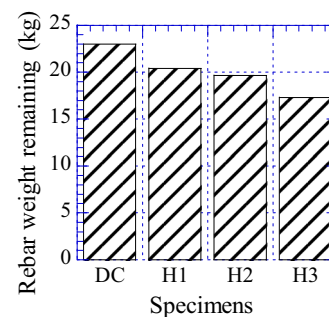
(b) Weight of rebars after corrosion

checked, as shown in Fig. 10b. Noting that, in this figure, the DC is referred to as the non-corroded RC beam, while H1, H2, and H3 are referred to as 1-month, 2-month, and 3-month corroded RC beams. For the DC beam, the original weight of reinforcements was 23 kg, whereas, the weight of beams H1, H2, and H3 was reduced to 20.4 kg, 19.7 kg, and 17.3 kg, respectively. In other words, the weight loss of those corroded beams was 11.3%, 14.3%,

and 24.8%, respectively. The longer embedded time in the salt solution the more corroded in the RC beam. Moreover, the loss of reinforcement due to corrosion was not even along with the reinforcing bars. Accordingly, the cracks were spread wider at where the reinforcement was

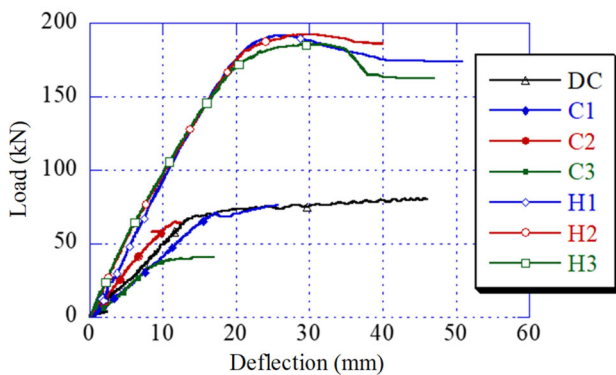
Fig. 11 Load versus displacement at the middle of the tested beams

Figure 11 shows the relationship between load and deflection of different tested RC beams including three various corroded beams (i.e., C1, C2, and C3), three strengthened beams with high-performance steel fiber mortar and normal reinforcements (i.e., H1, H2, and H3), and one non-corroded beam (i.e., DC). It can be observed that the flexural stiffness and ductility of beams strengthened with high-performance steel fiber mortar and normal reinforcements were significantly improved than those of the corroded and non-corroded beams. Moreover, there was a minor difference in strength and stiffness of the

corroded RC beams after strengthening. It is attributed to the reason that the high-performance steel fiber mortar plays a very important role in providing the flexural capacity of the RC beam.

The strength of beams H1, H2, and H3 were 191.87 kN, 192.37 kN, and 185.94 kN, respectively, with a difference of less than 3.3%. The mean strength of those strengthened beams was 190.06 kN, which was 2.35 times higher than that of the non-corroded beam (i.e., 80.91 kN). After strengthening, the strength of the beams was 2.52 times increased than that of the corroded beams (i.e., C1, C2, and C3).

Additionally, the stiffness and ductility of strengthened RC beams were significantly improved compared to those of corroded beams. The stiffness of retrofitting beams was double increased than that of non-retrofitted beams, meanwhile, the ductility was 1.5–2.0 times enhanced after strengthening. Also, a descending branch was visible in the load–deflection curves of the strengthening RC beams. This behavior was not observed for the non-retrofitted beams, which was failure suddenly after reaching a yielding state. This finding highlighted that the high-performance steel fiber mortar can be a feasible solution for the strengthening of corroded or degraded RC structures.

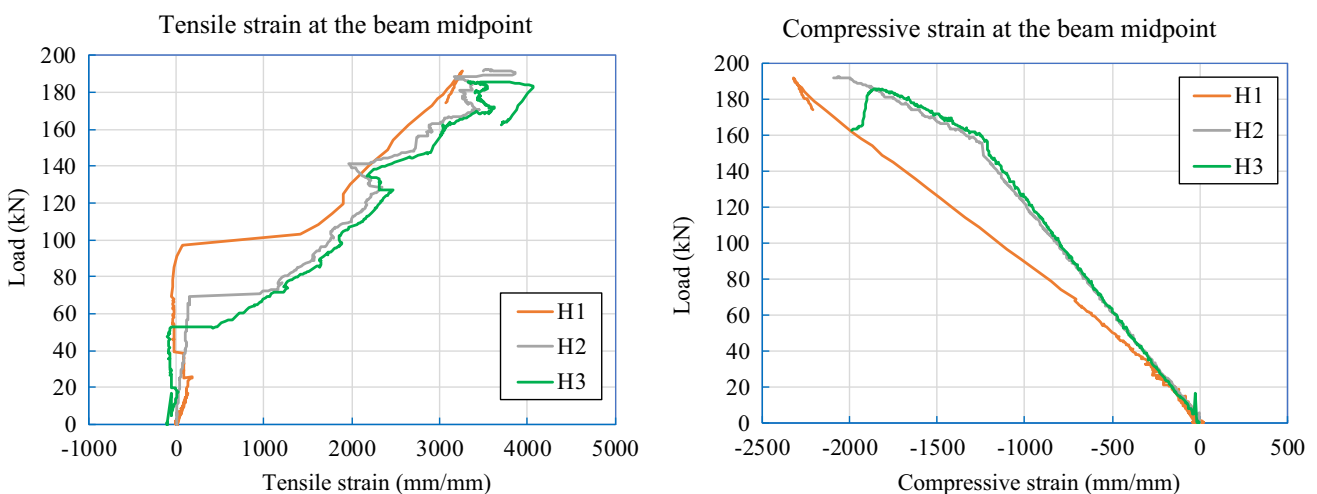
Fig. 12 Load versus strain of concrete at the middle of strengthened beams

Figure 12 shows the relationship between applied load and strain of concrete at the middle of the strengthened beams. It can be found that the tensile concrete strains of strengthened beams H1, H2, and H3 were rapidly developed after the applied loads exceeded 100 kN, 70 kN, and 50 kN, respectively. Additionally, at a load of 185 kN, all the beams reached tensile strains, approximately, 3200, 3500, and 4000 mm/mm, respectively. Meanwhile, the compressive concrete strains of those beams were gradually increased up to ultimate values, 2300, 2100, and 2000 mm/mm, respectively.

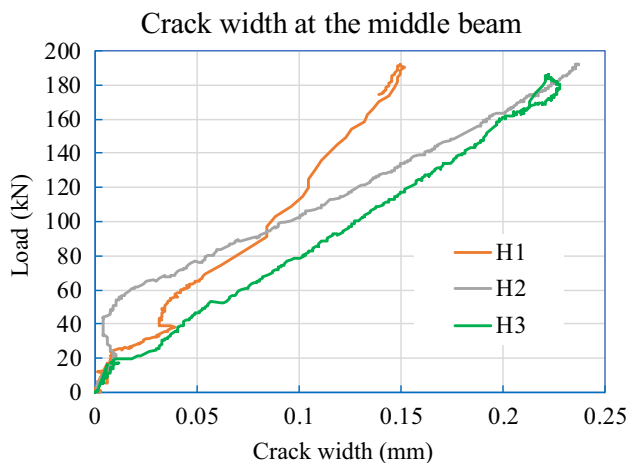
Fig. 14 Development of crack width at the middle of strengthened beams

Figure 14 shows the evolution of crack width at the middle of strengthened beams. The crack widths of H1, H2, and H3 were gradually expanded and attained the ultimate values of 0.15, 0.23, and 0.22 mm, respectively. Moreover, it was shown that the crack width of beams H2 and H3 were larger than that of H1. This is attributed to the reason that beam H2 and H3 were more significantly corroded than that H1 was imposed.

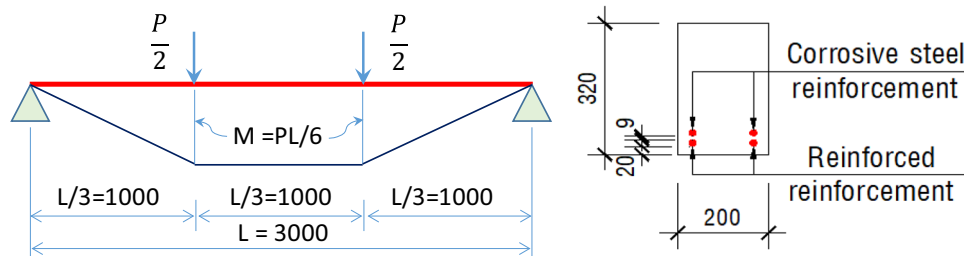
Fig. 15 Calculation of flexural capacity of RC beam

In this section, a comparison of the flexural capacity of RC beam between theory and experimental tests is presented to emphasize the contribution of high-performance steel fiber mortar to flexural strength. The theoretical calculation of the flexural capacity of RC beams is shown in Fig. 15. The results of the calculated theory were complied with the guideline of TCVN 5574-2012, as provided in Table 5. It was found that bending moments (i.e., M_u) of three beams H1, H2, and H3 without strengthening with high-performance mortar were 68.1, 66.8, and 63.4 kN.m, respectively. Specifically, the bending moments of the H2 beam and H3 beam were relatively smaller than that of H1 since the reinforcement loss in H2 and H3 beams was higher than that in H1. Accordingly, the calculated ultimate loading ($P_u^{cal.}$) can be determined using equation $P_u^{cal.} = 6M_u/L$, resulted as 136.2, 133.7, and 126.8 kN, respectively. It should be noted that the theoretical calculation ignored the

tensile strength of concrete and steel fiber mortar. In other words, the $P_u^{cal.}$ values in Table 5 do not consider the effects of the steel fiber mortar.
