# Analysis of Large-Scale In Situ Shear Tests of Sandy Gravel with Cobbles

## Abstract

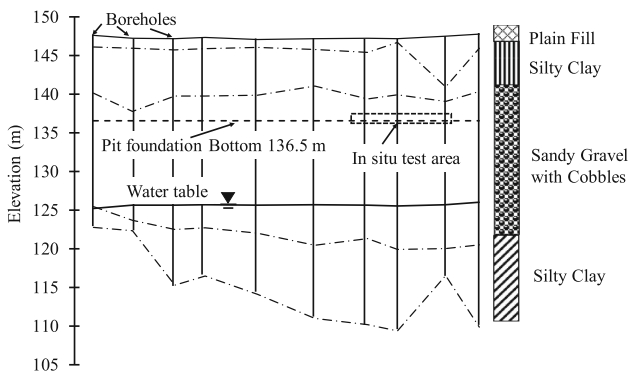
Fig. 2 Ground profile of the site

10 m deep below the ground surface. The base of the excavation was located in this layer. Therefore, the sandy gravel layer had a great impact on excavation performance. The water table at the site was approximately 22 m below the ground surface, which was well below the depth of concern.

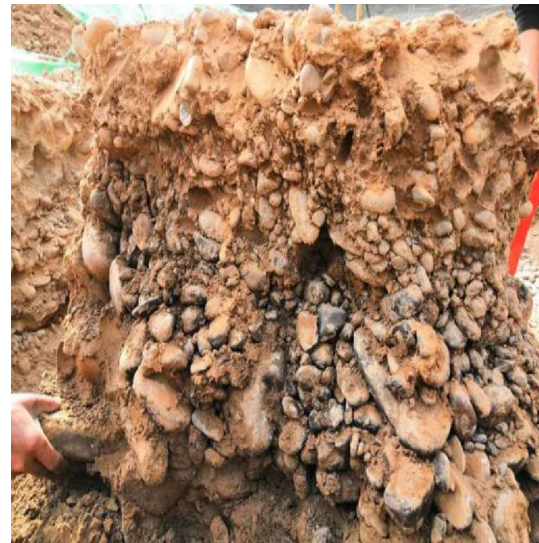
Fig. 3 Exposure of in situ soil columns

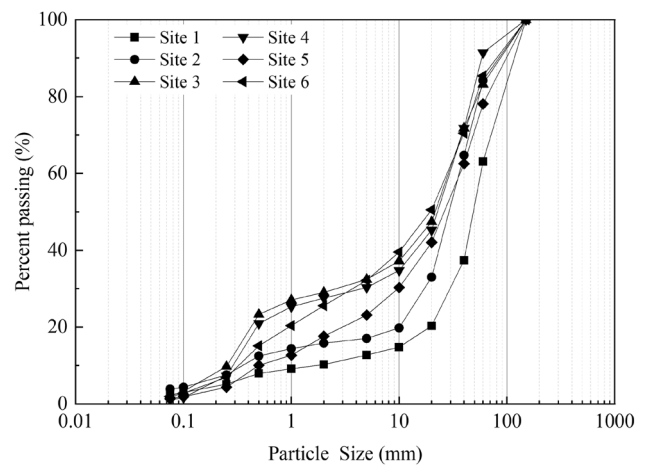
Fig. 4 Particle size distributions of the soil samples

samples. Most samples contained approximately 15 to 40% cobble. The grading parameters are listed in Table 1. The soil can be classified as sandy gravel with cobbles [21]. The moisture content of the soils at the test sites ranged from 3.04 to 5.78%, with an average value of 3.92%. DCP was

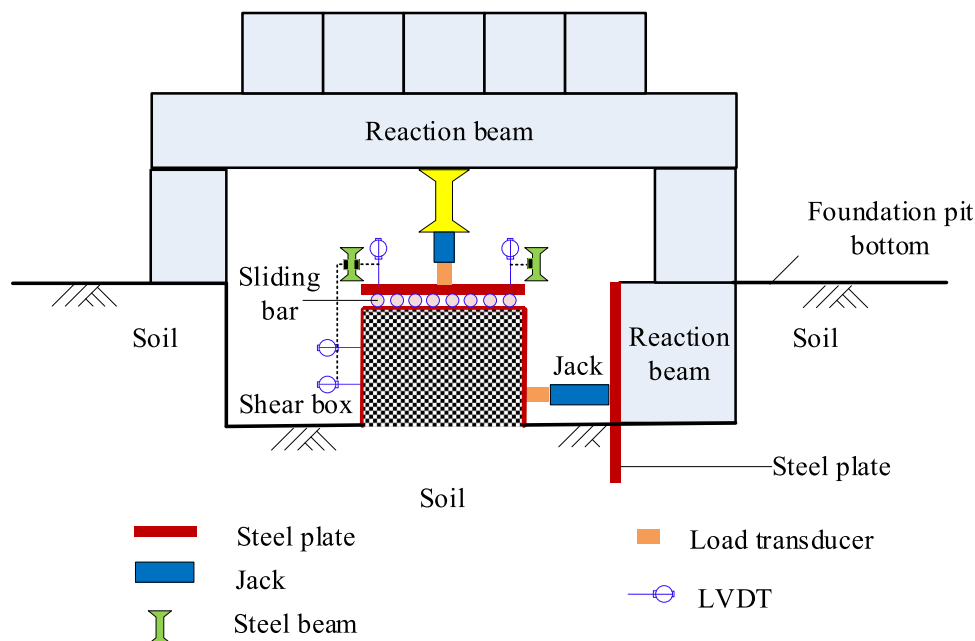
Fig. 5 Diagram of the test setup

In situ direct shear tests were performed per the specifications for field shear tests commonly used in China [22]. A diagram of the setup is shown in Fig. 5. Unlike normal shear box setups, which include a top and a bottom shear box, the setup in situ has only one shear box made of a 0.5 m cubic-shaped hollow steel column to provide confinement to the soil. The lower part of the soil is confined by the foundation soil, as shown in Fig. 5. A vertical load is applied on the top surface of the soil column confined in the steel column via a loading plate, and the column is sheared laterally to measure the resistance of the soil. This setup is similar to that used for in situ tests of rocks [23].

To form one soil sample, a 2.5 m long  $\times$  3 m wide  $\times$  0.8 m deep test pit was excavated at the base of the excavation to form a soil column (1 m long  $\times$  1 m wide  $\times$  0.8 m tall) at the centre of the test pit. The soil column was carefully shaped to fit into the steel column. The top surface of the soil column was flattened, and the voids were filled with fine sand to ensure the even distribution of loading from the load plate. Loading was applied via two square steel plates with a thickness of 3 cm and a width of 49 cm wide; these steel plates were placed on the

A 2 m long  $\times$  0.5 m wide  $\times$  0.8 m high concrete beam was placed on one side of the pit as the reaction beam for horizontal loading. A 3 cm thick steel plate (70 cm  $\times$  50 cm) was fixed on the inner side of the beam as the footing of the lateral loading jack. Steel beams and concrete blocks were used to provide reaction forces for vertical loading. Four linear variable displacement transducers (LVDTs) were installed on the four corners of the loading plate, and four LVDTs were installed on the other side of the shear box to measure vertical and lateral movement, respectively. Figure 6 shows photos of the test system. The vertical and lateral loadings were applied using hydraulic jacks. The tests used six vertical loading levels: 12.5 kN, 25 kN, 50 kN, 75 kN, 100 kN, and 150 kN. The vertical and horizontal loadings were applied as per Chinese Standard recommendations [24].

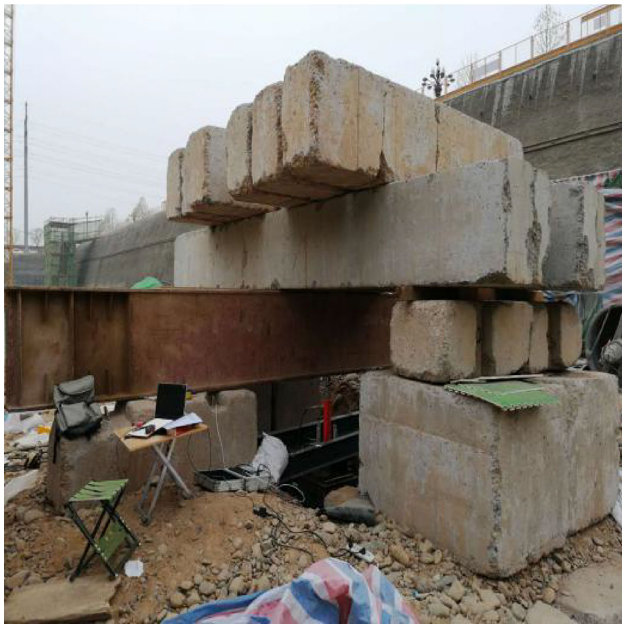
Fig. 6 Test setup for the in situ large-scale direct shear test

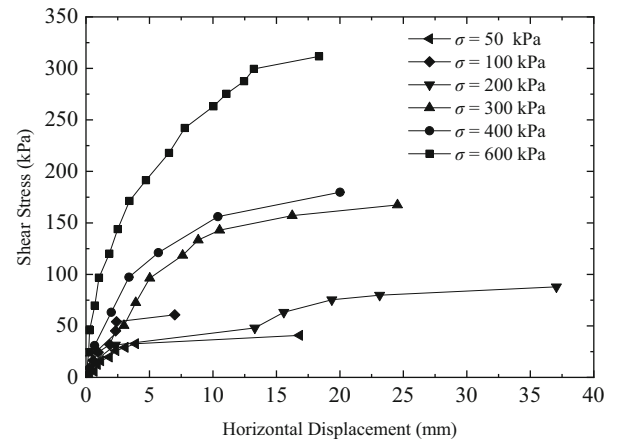
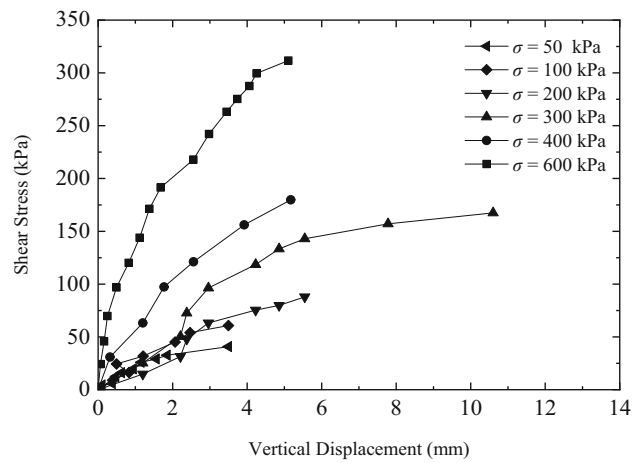
Fig. 7 Shear displacement curve. a Horizontal displacement and b vertical displacement

Figure 7 shows the load–displacement curves of the samples under shear. The positive displacements in Fig. 7b indicate downwards movement. The shear displacement curves of the samples show that the samples behave similarly to those of medium-density sand. The nearly linear relationship between the normal stress and shear stress at failure shown in Fig. 8 indicates that the friction angle ( $\phi$ ) of the soil is approximately 26.7° (assuming that the cohesion is zero), as calculated using Eq. (1):

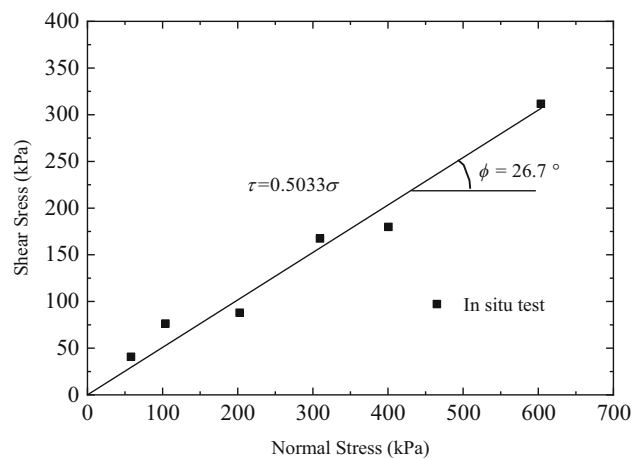
Fig. 8 Normal stress vs. shear stress curve

where  $\phi_1$ ,  $\phi_2$ ,  $\phi_3$ , and  $\phi_4$  are empirical parameters affected by the soil type, relative density, soil gradation, and particle shape, respectively. Based on the characteristics of the soil tested at the site,  $1^\circ$  (gravel + sand),  $6^\circ$  (very dense,  $0^\circ$  (medium), and  $-3^\circ$  (subrounded) were used for  $\phi_1$ ,  $\phi_2$ ,  $\phi_3$ , and  $\phi_4$ , respectively, in the test soil [29]. According to this method, the friction angle of the soil at the site should be  $40^\circ$ ; this value is also much greater than that obtained from Fig. 8.

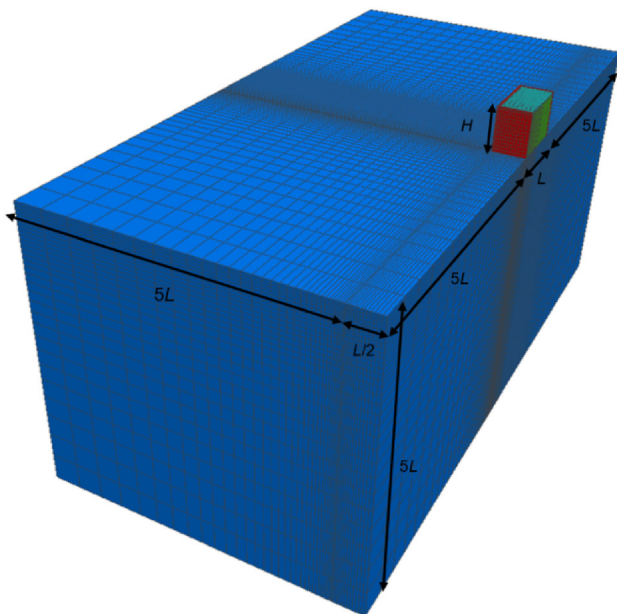
Fig. 9 Finite difference model (half model) of the in situ shear tests

Finite difference analyses were performed using a finite difference method in FLAC3D (FLAC3D, 2018) to study the discrepancy between the friction angles obtained from the empirical methods and the direct shear test results. Considering the symmetrical nature of the shear box, a half model was built for the numerical analysis, as shown in Fig. 9. In the figure,  $L$  is the width of the shear box, which is 0.5 m, and  $H$  is the height of the shear box. The ground is surrounded by horizontal constraints on three sides except for the right face for the symmetry boundary, whilst the shear box experiences vertical constraints at its base. The size of the shear box was 0.5 m  $\times$  0.5 m  $\times$  0.35 m, and the box was modelled as rigid walls. A total of 122,040 elements were generated in the model. A friction angle of 48° was assumed for the soil with a cohesion of 1 kPa to avoid numerical instability. Four in situ direct shear tests were simulated with the finite difference model, except for the case with 200 kPa of normal loading, where the horizontal load–displacement behaviour was clearly abnormal. The

For comparison, a test on a rock sample [36] was also simulated to compare the applicability of in situ rock test methods [23] to rock samples. Considering the symmetry of the model, to enhance computational efficiency, only half of the model was constructed and analysed, with a symmetry boundary set at the centre of the model. The ground was 10  $L$  ( $L$  is the length of the sample) in length and 5  $L$  in width and depth. The ground was surrounded by horizontal constraints on three sides except for the right face for the symmetry boundary, and the ground experienced vertical constraints at its base. A test under a normal load of 433 kPa was modelled. The cohesion and friction angle of the rock obtained from the shear tests were 423 kPa and 52°, respectively [36]. The values were used in the numerical modelling with an assumed Young's modulus of 600 MPa and a Poisson's ratio of 0.25. Mohr–Coulomb failure criteria were used for both the soil and the rock in the analyses.

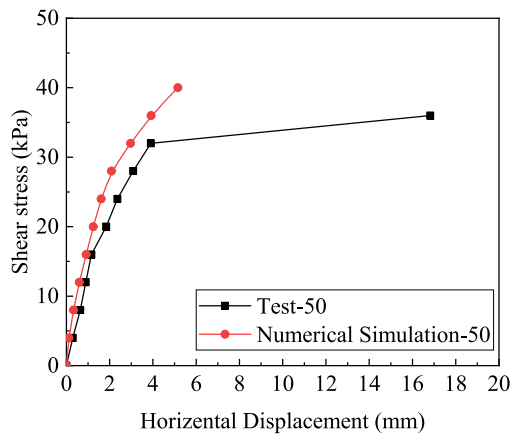
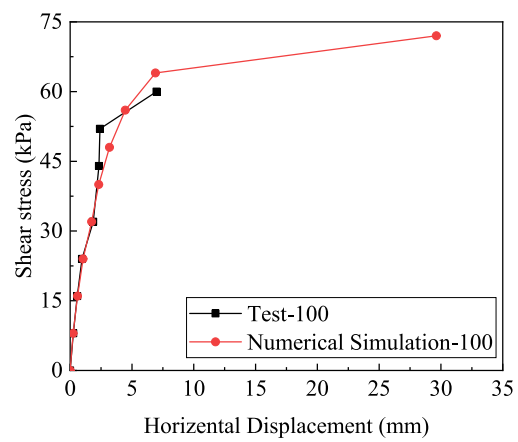
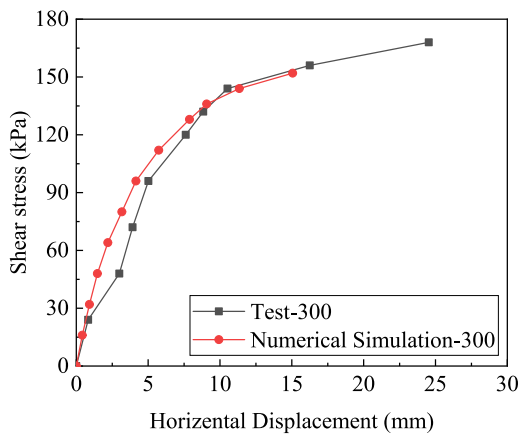
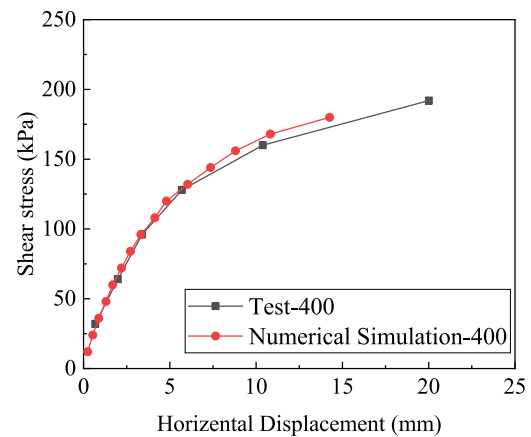
Fig. 10 Shear displacement curve of sandy gravel with cobbles obtained via in situ tests and numerical modelling

Figures 10 and 11 compare the shear displacement curves of the soil and the rock obtained from in situ tests with those from the numerical analyses. With the assumed soil friction angle, which is almost twice that of the value calculated with Eq. (1), the results from the numerical analysis compare quite well with the in situ test results. This indicates that Eq. (1) cannot be used to obtain soil shear strength parameters with the test method used at the site but is suitable for the rock tested [36].

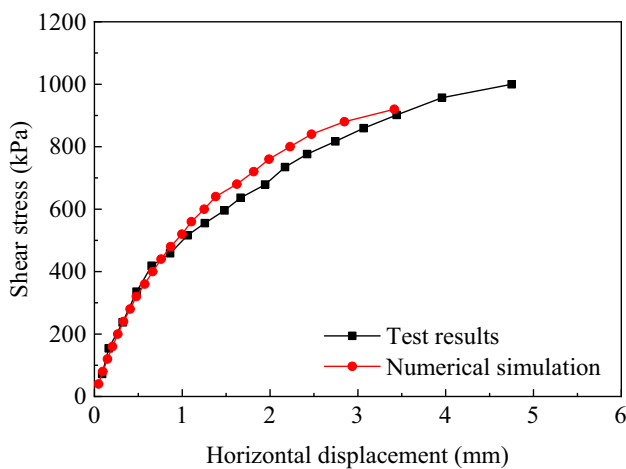
Fig. 11 Shear displacement curve of the rock specimens tested by Xing et al. [36]

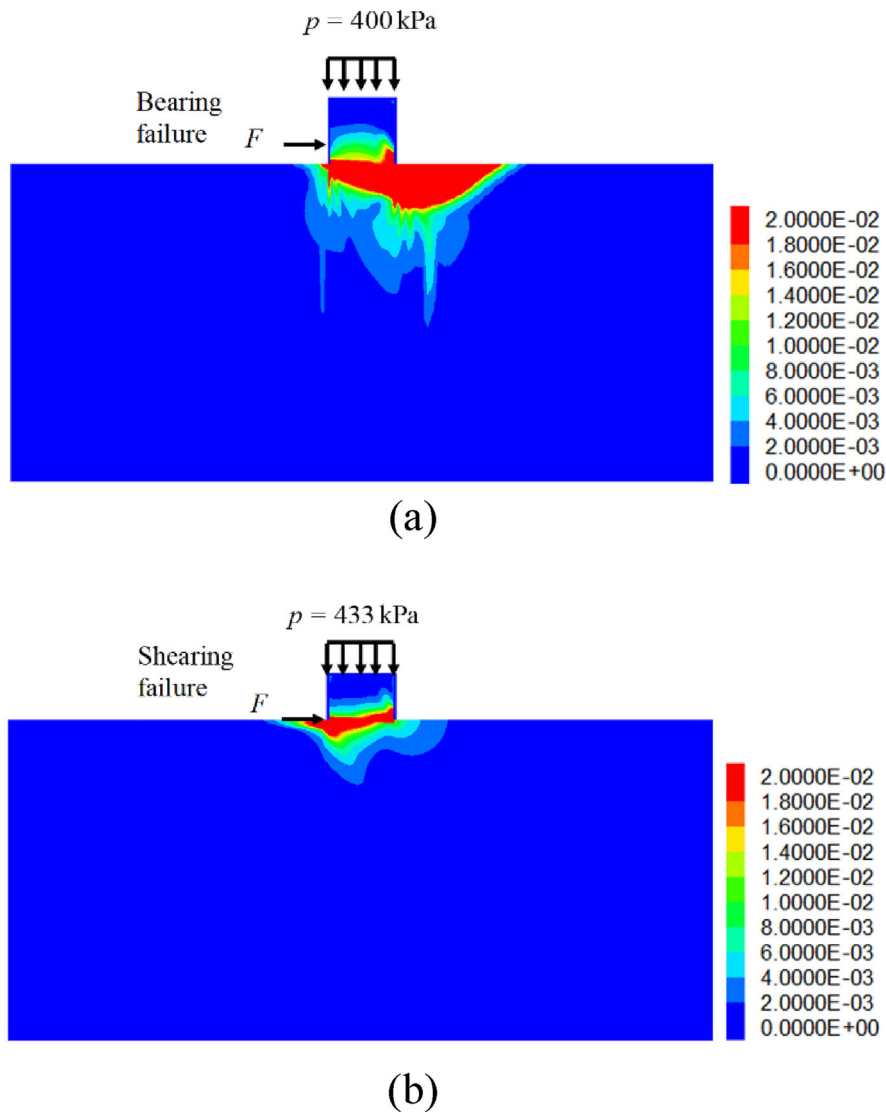
**Fig. 12** Shear strain contours on the plane of symmetry for direct shear tests on (a) sandy gravel with cobbles sample and (b) rock reported in Xing et al.

To further explain the discrepancy between the performance of the test on rock and soil, the failure plane observed in the numerical simulations is presented in Fig. 12. For the rock sample, the shear plane is along the base of the shear box (Fig. 12b). For the soil sample, the shear failure (Fig. 12a) occurs deep in the ground rather than along the base of the shear box. The shear surface in the soil is similar to that of bearing-capacity failures of shallow foundations [37]; this type of failure is different from the shear failure mechanism observed in soil cracking box direct shear tests and rock in situ shear tests [23]. Therefore, the friction angle obtained using Eq. (1) would be lower than expected since the incorrect failure mechanism was used.

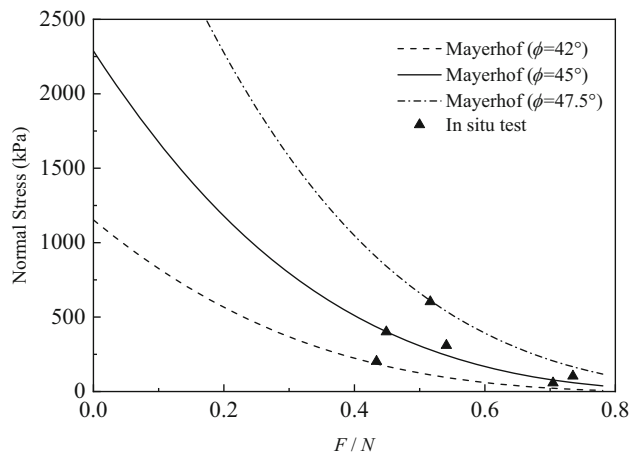
**Fig. 13**  $F/N$  vs. normal stress obtained from Meyerhof bearing-capacity theory

In the back analysis for this in situ test, the cohesion  $c$  and foundation depth were set to zero, the width and length of the plate were both 0.5 m, and the weight of the sandy gravel with cobbles was 22 kN/m<sup>3</sup>. The variation in  $F/N$  with  $N$  for different soil friction angles is plotted in Fig. 13, along with the in situ shear test results. Based on the bearing-capacity theory, the friction angle of the soil was within the range of 42° to 47.5°, which was close to the values obtained from the empirical methods, DCP tests, and the value used in the finite difference analysis discussed earlier. This again confirmed that the test results obtained from the shear tests could not be analysed directly using the direct shear theory described in Eq. 1. Therefore, back analysis is recommended using the bearing-capacity theory of shallow foundations to obtain the shear strength of the soil.
