Structural health monitoring: detection of concrete flaws using ultrasonic pulse velocity

Abstract

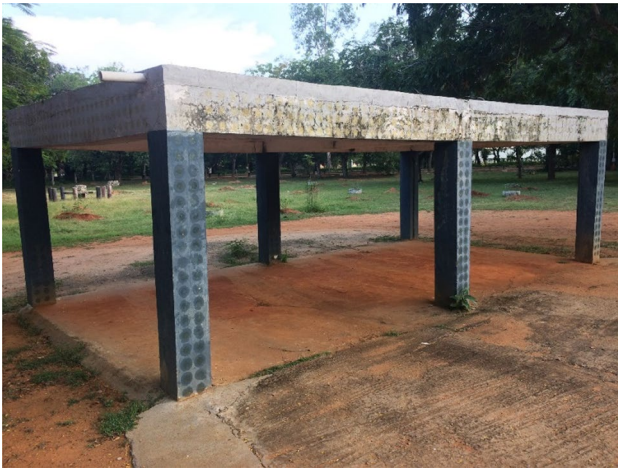
The car parking shed is an RCC framed structure consisting 2-bays along length and 1-bay in other direction. The apparent height of the column is 180 cm on an average, totally 6 columns. The length of the beam is varying from 290 to 323 cm. This car parking shed was constructed by students itself. The depth of beams 30 cm. The thickness of a brick layer on beam as parapet is around 11 cm. The grade of concrete used for construction is around M20. Figure 3 shows a photograph of a car parking shed. The AutoCAD drawings of car parking shed with measurements and designation to beam and columns are shown in Figs. 4 and 5.

- Corrosion of rebar.
- Cracks occurred at some places in the beam.
- Spalling of the concrete slab.
- Dampness and fungal growth are observed at some locations.

Fig. 3 Photograph of car parking shed located at NITT

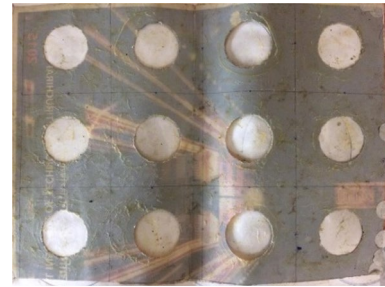
To ensure the proper positioning of the transducers during the UPV data collection, a grid sheet of 10 × 10 cm

Fig. 6 Grid sheet of 10 × 10 cm size for UPV testing

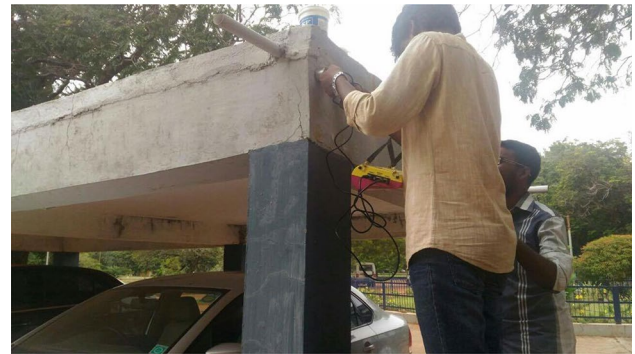
Fig. 7 Photograph taken while testing of the structure

was prepared which is shown in Fig. 6. During the UPV test, the indirect measurement/surface probing methodology was adopted. The aim of this study is to verify the concrete homogeneity of concrete in the car parking shed using UPV, by mapping the data collected. The photograph taken while testing the structure was shown in Fig. 7.

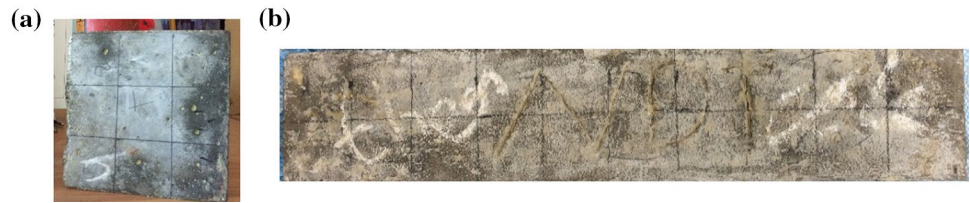
Fig. 11 Core samples of a concrete cube of the 15×15 cm showing the presence of tennis ball inside concrete

In order to check if the diagnosis made using the contour map images was reliable or not, the samples were broken at the points chosen based solely on the contour images. Figures 11 and 12 show the suspicious zones which are coinciding with the concrete specimen defects, providing clear evidence that the defects were accurately located using only NDT data, with no prior knowledge of their position.

On referring Table 2 for the concrete quality, the cube of 15×15 cm is showing the contour map pointedly with blue color which depicts the exact location of the tennis ball knowingly kept inside the concrete cube. The beam contour map has three points of blue color on the beam showing the position of thermocol placed in the concrete beam.
