Experimental evaluation of RC frames retrofitted by steel jacket, X-brace and X-brace having ductile ring as a structural fuse

Ali Kheyroddin^{1,2} · Reza Sepahrad¹ · Mohammad Saljoughian¹ · Mohammad Ali Kafi¹

Received: 28 September 2018 / Accepted: 5 April 2019 / Published online: 22 April 2019
© Springer Nature Switzerland AG 2019

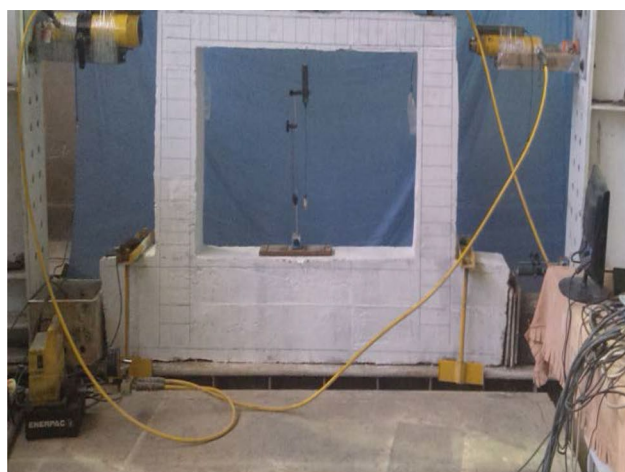
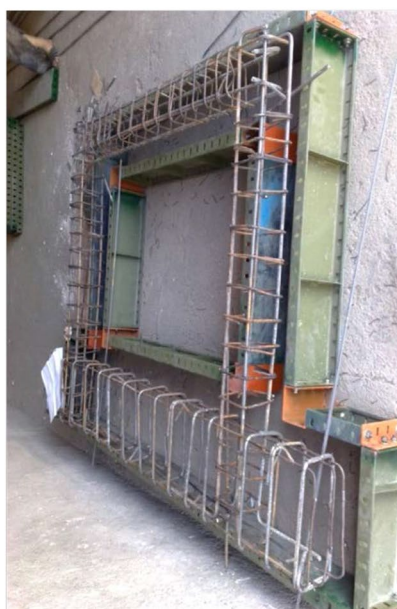
Fig. 1 **a** The reference moment resisting frame and **b** frame reinforcement

The reference sample is the RC frame shown in Fig. 1. The distance between the columns of the experimental rigid frame is 300 cm from each other, and the height of the rigid frame is about 210 cm. Thus, by considering the length required for applying the load by the jack on both sides and also the suitable distance for the cyclic displacement of frames, the length span of the frame was considered 160 cm. Also, the frame height plus the foundations was considered equal to 140 cm. The foundations of all frames were constructed in the form of a strip, and the space between the foundations and the experimental rigid frames were filled by steel plates to avoid from any movement, displacement, and uplift of the foundation during the test. Also, to make the test frame close to the actual

structure and create the fixed condition for the support, the foundation was attached to the rigid floor of the laboratory through some rods. The beams with the height of 15 cm and the width of 20 cm and the columns with a square cross-section with a width of 20 cm were selected. The concrete cover was considered equal to 2.5 cm. For the column reinforcing bars, the minimum value of the code equal to 1 percent is used, and four reinforcing bars with a diameter of 12 mm were considered for the columns. For the beam reinforcing bars, two bars with a diameter of 8 mm at the top and two bars with a diameter of 10 mm at the bottom were used, so that the ratio of the beam bars are equal to 0.0085 which met the minimum (0.0035)

Four samples similar to Fig. 1 were constructed. The concrete specifications and the bar mesh for these samples are similar. There of these frames were retrofitted with different methods shown in the Fig. 2. The naming of the samples is as follows:

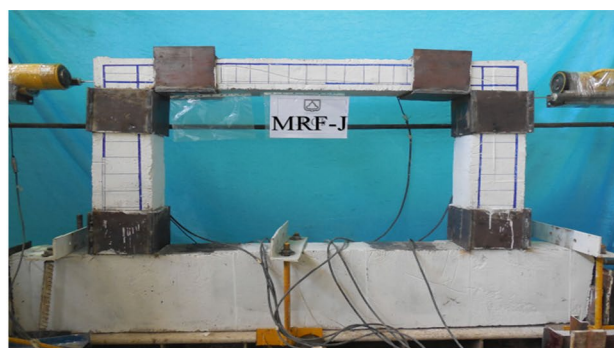
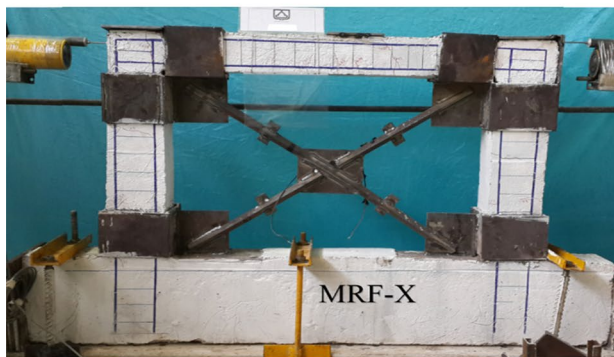
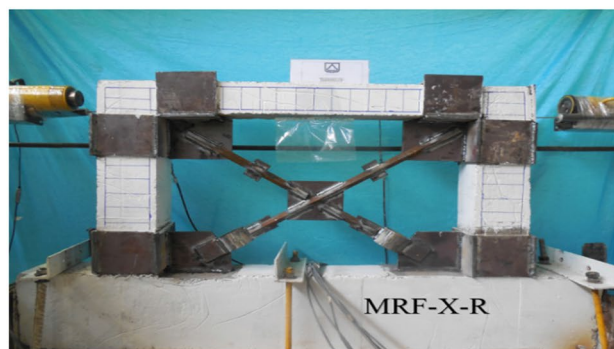
Fig. 2 Specimens 2, 3 and 4

For connection, the steel brace to the RC frame, two methods including direct and indirect can be used. The direct method is used in this test. For welding, the steel brace to the corner connection plate, the steel jackets around the beam and the column are used. Also, for further investigation of the impact of steel jackets, only one frame is equipped with the steel jacket to see its impact on the frame behavior.

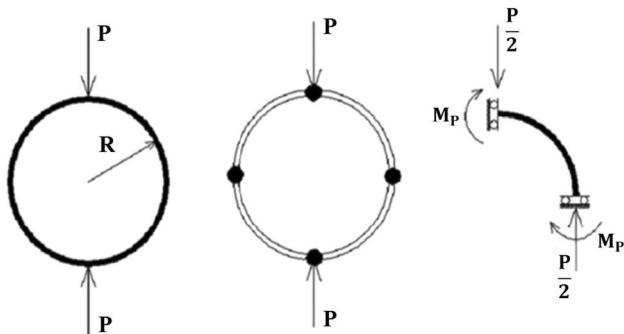
Fig. 3 Steel ring loading and place of plastic hinge formation [1]

Also, for the sample MRF-X-R in which the steel ductile ring has been used, two rings without a gap with a length of 8 cm and a thickness of 8 mm (outer diameter = 114 mm, inner diameter = 98 mm) were welded at the bottom of the brace at the connection point to the corner plate. The first note that should be mentioned is the diameter and the thickness of the ring. Based on this fact that using this ring in the sample is for increasing ductility and avoiding from the brace buckling, the ring should be ruptured along the weld line and not along its line or another line [according to the previous studies noted in the followings (Fig. 3 and Eq. 1)] before the brace is buckled.

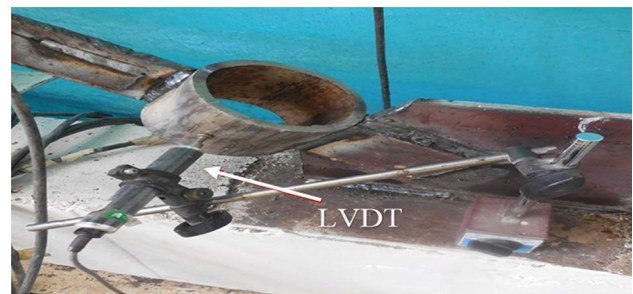
Fig. 4 LVDT on the ring

Also a LVDT was used on the rings that is shown in Fig. 4.

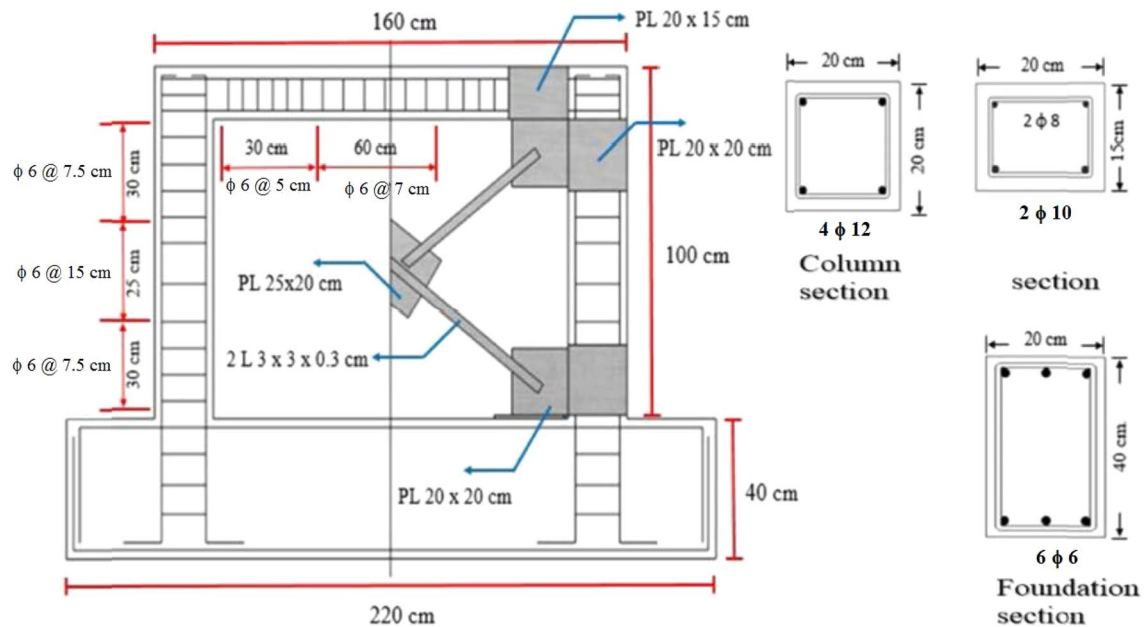
Fig. 5 Details of RC frame, brace and curb

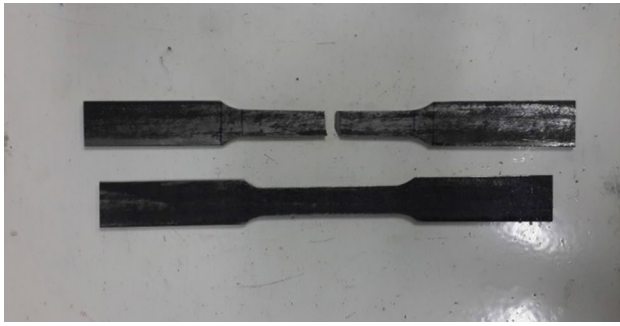
Fig. 6 The steel belt prepared for the tensile test

In order to determine the angle specifications, due to the inappropriate section of the angle for the test device, first apart from one side of the angle was cut to create a belt, then using a pattern available for testing the steel belt it should be turned. The steel belt prepared for the tensile test is shown in Fig. 6 and the results are shown in Table 2.

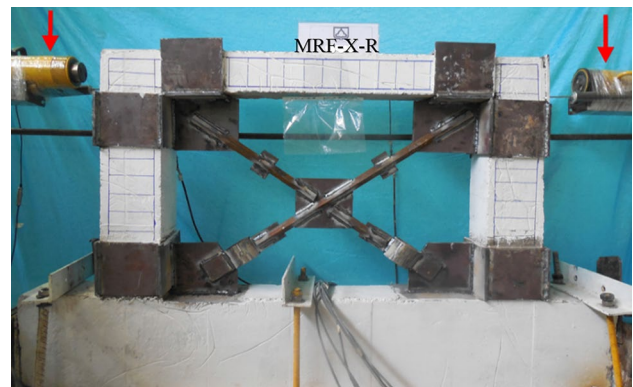
Fig. 7 Two compressive hydraulic jacks

Two compressive hydraulic jacks were used in both sides and at the top of the frames so that when one jack in one side is pushing, the other jack is in the discharge mode and vice versa. Also, ATC-24 [3] is used for the applied displacements in these tests.

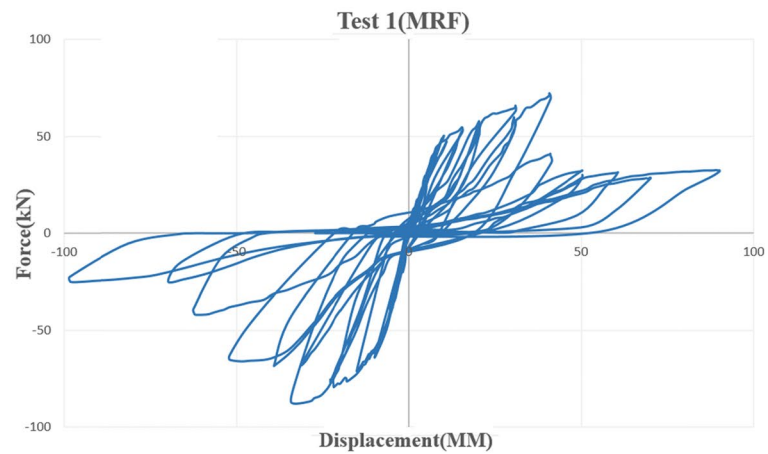
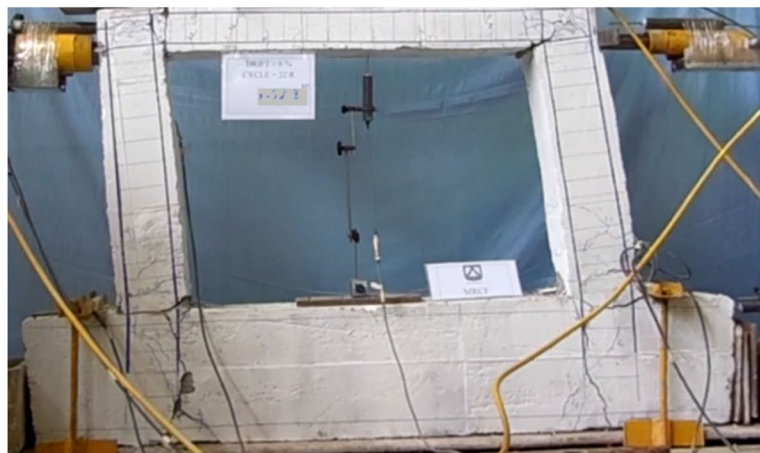
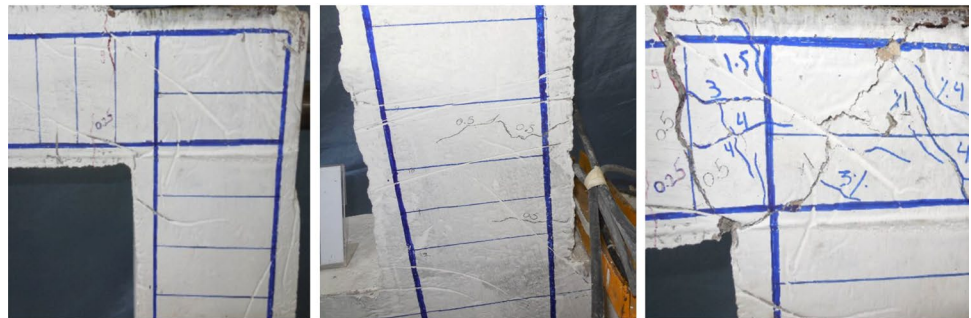
Fig. 8 The obtained results and the failure of the (MRF) specimen **a** the hysteresis diagram **b** condition of the frame at the end of loading **c** 0.25% of drift **d** 0.5% of drift **e** 4% of drift

The hysteresis diagram of force–displacement and the progression of the MRF sample crack in different cycles are shown in Fig. 8. The first crack occurred in the 2.4 mm displacement in the 0.24% drift (the distance of the load

applied to the column base was 1000 mm) at the location of the beam–column connection, and in the 0.5% drift, some cracks were appeared at the column base. Also, in the 1% drift, the first plastic hinge occurred in the bars of the right side column. By increasing the loading, new cracks were appeared and the depth of the previous cracks increased. Then, in the right side loading and the 4% drift,

the sample bore the maximum force equal to 72 kN, and after that, the bearing capacity decreased. Also, in the left side loading and the 3% drift, the sample bore the maximum force equal to 86 kN, and after that, the bearing capacity decreased. After the graph drops down to 85% of the maximum force in the 4% drift, the test did not stop and continued in a cyclic form until the 10% drift. The reason for the continuation of the test was the observation of the frame behavior in very high drifts and the observation of concrete crushing.

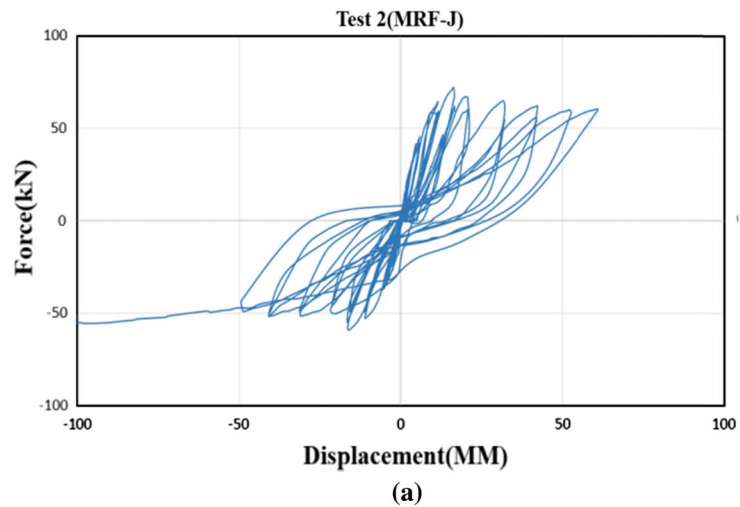
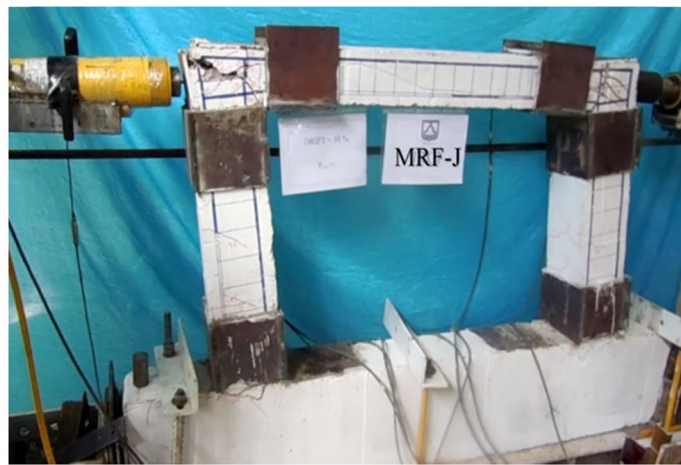
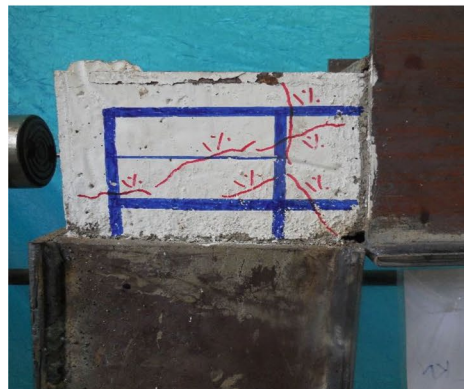
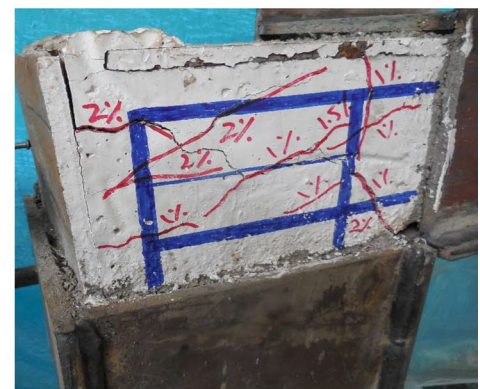
Fig. 9 The obtained results and the failure of the (MRF-J) specimen **a** the hysteresis diagram **b** condition of the frame at the end of loading **c** 1% of drift **d** 2% of drift

The hysteresis diagram of force–displacement and the progression of the MRF-J sample crack in different cycles are shown in Fig. 9. By continuing this process until the 0.5% drift, no cracks were observed. That could be due to this reason that the initial cracks were covered by the steel jackets and were not observable. Based on the strain gauges results, the first plastic hinge was formed in the top bar of the beam at the connection point to the right side column. By finishing the 1% drift, the first cracks were seen in the panel zone. By continuing the loading until the 2% drift, new cracks appeared in the panel zone and the previous ones got wider and the frame recorded the maximum force

borne equal to 72.01 kN and after that the bearing capacity of the frame decreased. In this test, due to the presence of the steel jackets, the shear stress applied to the panel zone increased, and the panel zone was not able to bear the forces, and the plastic hinge occurred in the panel zone instead of the beams, and it also led to decrease the early force of the sample. After the graph drops down to 85% of the maximum force in the 5% drift, the experiment did not stop and continued until the 10% drift in the form of cyclic. The reason for the continuation of the test was the observation of the frame behavior in very high drifts and the observation of concrete crushing.

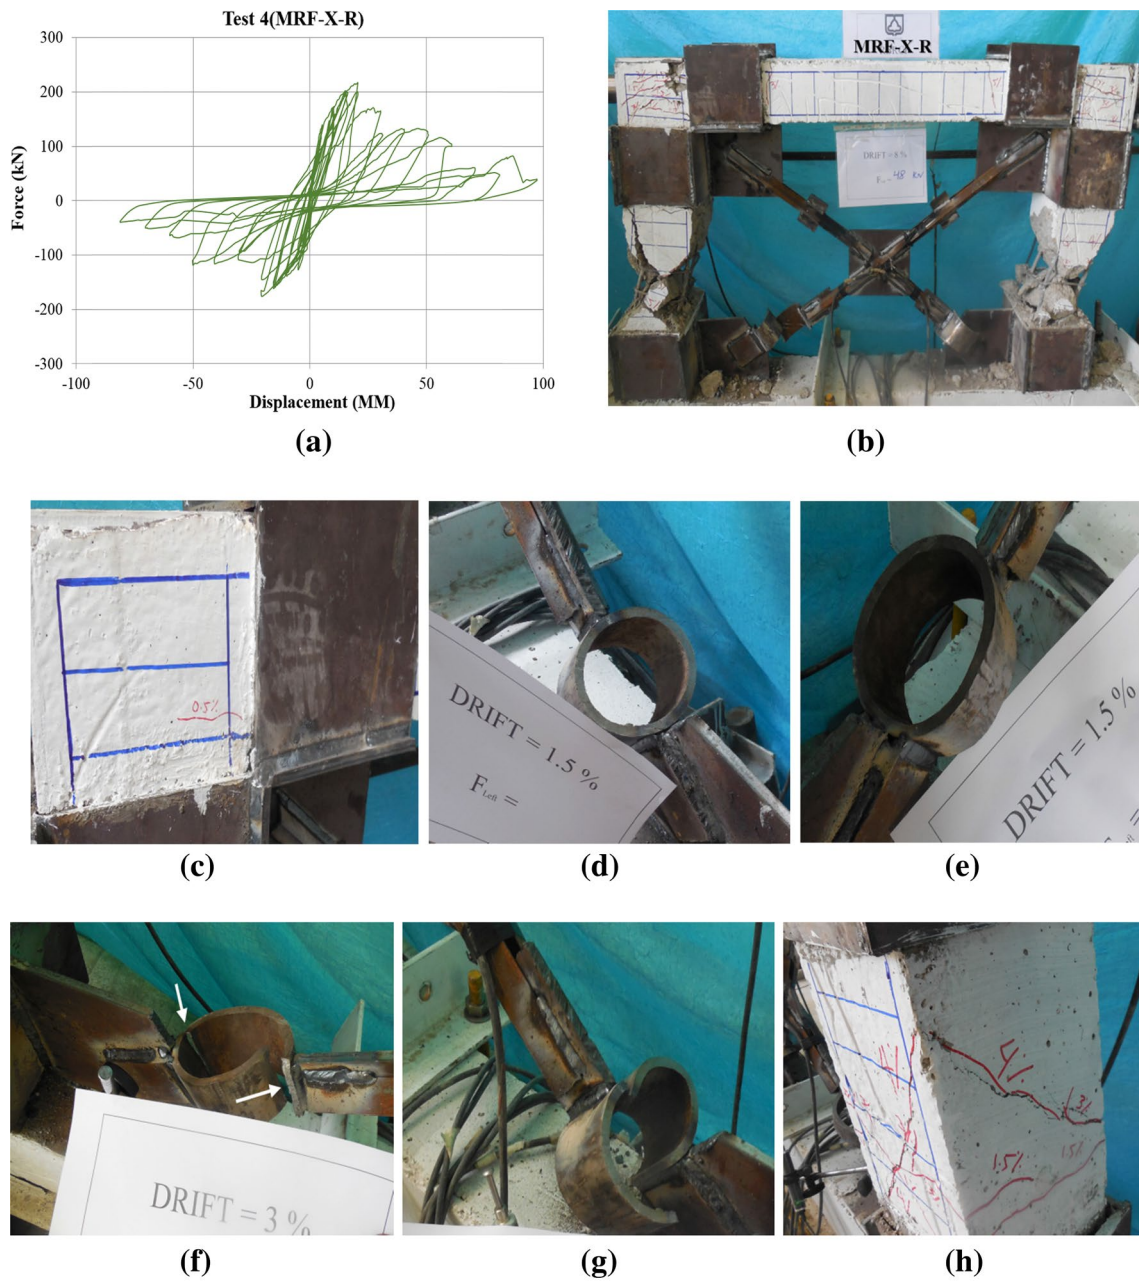
Fig. 11 The obtained results and the failure of the (MRF-X-R) specimen **a** the hysteresis diagram **b** condition of the frame at the end of loading **c** 0.5% of drift **d** the ring was compressed in 1.5% of drift **e**

elongation of the ring in 1.5% of drift **f** rupturing of the rings in 3% of drift **g** engaging two cut rings after rupturing **h** 4% of drift

As seen in the previous sample, due to the use of the convergent X-brace the force borne by the frame significantly increased. Now, the hysteresis diagram of force–displacement and the crack progression of the MRF-X-R sample in different cycles are shown in Fig. 11. In this

sample, two rings without a gap with a length of 8 cm and a thickness of 8 mm (outer diameter = 114 mm, inner diameter = 98 mm) were used at the bottom of the brace at the connection point to the corner plate. In the 0.5% drift and under the load of 89.518 kN and the displacement of 3.285 mm the first crack occurs in the left panel zone. In

the 1% drift, some cracks are created in the panel zone and the right column. Then, in the 1.5% drift and under the force of 183.203 kN and the displacement of 12.46 mm, the ring that is in the pressure is accumulated, and the tensile ring becomes an open oval (the rings are deformed). From this time, LVDT is installed on the rings to see the

collapsing and opening of the rings. Subsequently, in the final cycle and the 1.5% drift and under the force of 200.04 kN and the displacement of 14.925 mm a crack was appeared along the weld line in the ring and the rings are plastic deformed. Then, in the 3% drift the ring under pressure is ruptured under the force of 104.688 kN and the displacement of 12.62 mm and the frame bearing capacity decreases. By continuing this loading, this ring is ruptured from the opposite side of the previous cut and along the

weld line and when the loading direction changes and the other ring is placed under the tension (at the same 3% drift) the ring is ruptured approximately simultaneously from both sides under a load of 108.667 kN and a displacement of 21.725 mm. The interesting note about the rings is that since the left or right loading engages two cut rings, in the loading helps the RC frame. In the 4% drift, a deep crack was appeared near the steel jacket at the base of the left column and the previous cracks get wider. In the

As shown above, in the final sample the brace remains almost intact, and the rings act as a fuse. If we want to explain the last sample, in summary, we should say that first, the rings became the bending plastic hinge. Then, the base of the left column became the shear joint, and after that, the right column base and subsequently the base of the left steel jacket were destroyed by shear.

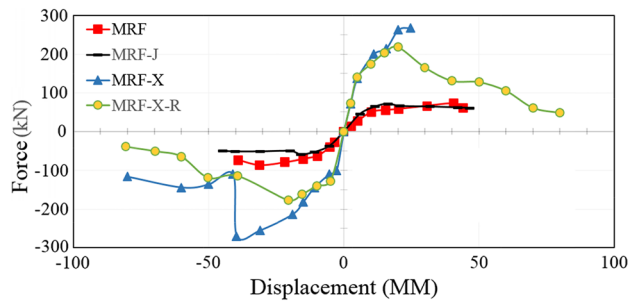
Fig. 12 The push diagram of four samples

The push diagram of four samples is shown in Fig. 12. As shown, the maximum borne for the MRF-X sample was 270 kN which was 3.12 times the reference sample. Also, for the MRF-X-R and MRF-J samples, it was 2.51 and 0.83 times the reference sample, respectively.

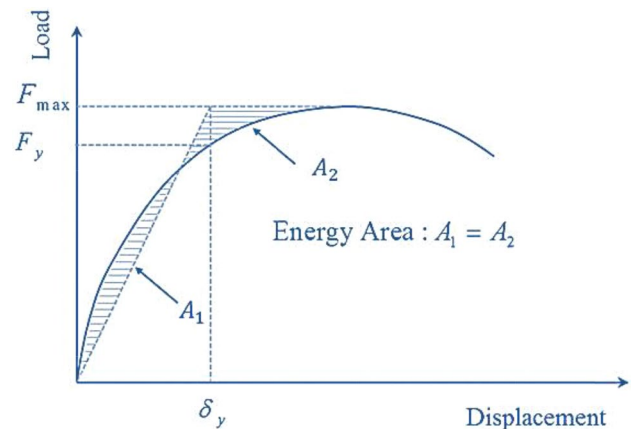
Fig. 13 The idealized bilinear diagram

Ductility is one of the most important parameters for seismic evaluation of a structure. To obtain the ductility, using the push diagram for determining the force and the yield displacement is accompanied by some difficulties. This difficulty is due to this fact that the push diagram does not have a certain yield point. The yield point in the push diagram is not clear, and it is due to several factors including the non-linear behavior of the material and starting the yield in different parts of the structure in different levels due to the indeterminacy of the structure and re-distribution of forces [11]. For this purpose, the idealized bilinear diagram is used. Different definitions provided for drawing the idealized bilinear diagram for obtaining the yield location of structures. In this study, the method provided in Fig. 13 is used. In this method, the bilinear diagram is drawn so that the energy absorption level (the surrounded area) be the same in both diagrams.

In this method, a line parallel to the horizontal axis is drawn from the maximum force of the structure, then the line of the elastic part of the structure is drawn from the beginning of the coordinate axis to intersect the line of the maximum force. The enclosed area between two actual and ideal diagrams (energy absorption level) should be equal to each other to be representative of the actual diagram of the structure (FEMA-451 [6]). The results obtained from the bilinear diagram of the test frames are listed in Table 3.

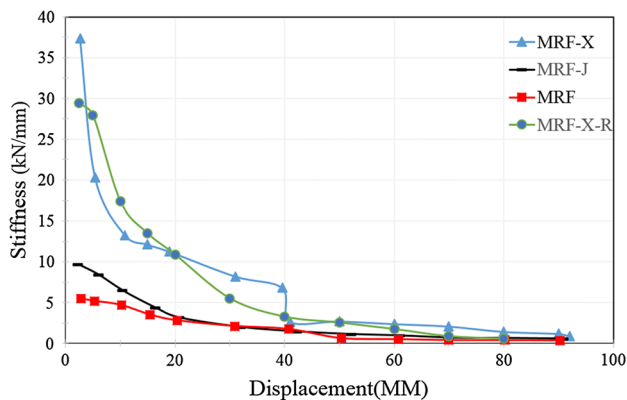
**Fig. 14** Stiffness-displacement diagram

For each sample, the lateral stiffness level is calculated in each drift. The calculation trend of stiffness is by dividing the maximum force of each cycle to its corresponding displacement and is consecutively calculated for each drift. By progress during the experiment, the lateral stiffness of the frame decreases as shown in Fig. 14.

Adding the brace to the RC frame in the MRF-X sample increases the initial stiffness of the frame about 6.7 times, which is a significant value. In the MRF-X diagram, in the relative displacement of 40 mm, a severe drop is seen which is the buckling moment of the brace. At the time of removing the brace from the lateral resistance system, the stiffness of the MRF-X-R sample is a slightly more than the MRF sample and after that continues with a constant value. This excessive stiffness is due to the performance of the corner connection plates as well as the buckled brace member. In the MRF-X-R sample, the initial stiffness value is 5.35 times the reference sample stiffness which according to the more ductility than the MRF-X sample it has an acceptable stiffness. For the MRF-J sample, the frame stiffness is also 1.76 times the reference sample due to the acceptable performance of steel jackets and the stick and grout between them with concrete. Thus, using the steel jackets in this method can be assured about the complete involvement of steel jackets. The lateral stiffness of the MRF-J sample until the relative displacement of 20 mm is more than the

reference frame, and after that, they are equal to each other, and it indicates the frame stiffness increase in initial displacements by the steel jacket.
