Evaluation of sulfate ions in degrading armed concrete structures of a sewage treatment station: case study

Abstract

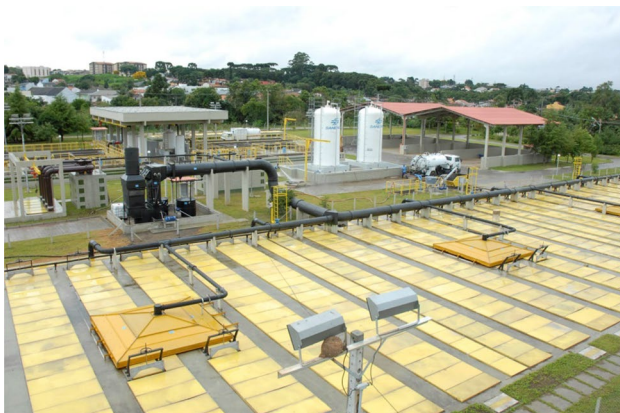
Fig. 1 UASB type reactors (Source: <http://site.sanepar.com.br/> Accessed on: 12/5/16)

The Sewage Treatment Station also has gas scrubbers to control bad odors. For a while, the reactor tanks were capped, as shown in Fig. 1, in an attempt to minimize the bad odors, but since the concrete was rapidly deteriorating, they were uncovered.

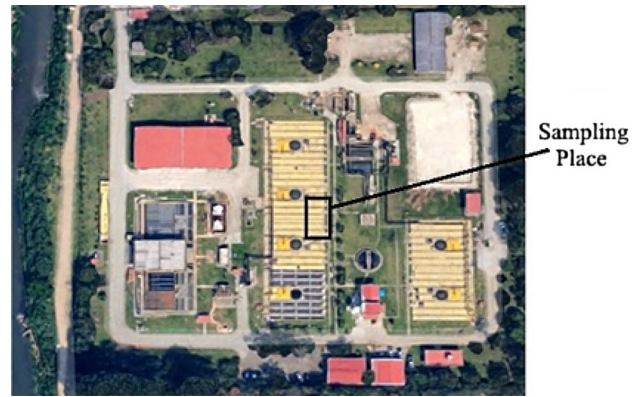
Fig. 2 Layout of Sewage Treatment Station (Source: Google Earth. Accessed on: 12/05/16)

During the visit to this Sewage Treatment Plant, four samples were taken, one from each tank, of the deteriorated part of the concrete of a UASB reactor, which at the time of the visit was deactivated for routine cleaning. Figure 2 shows the layout of the Sewage Treatment Station with indication of the Sampling place, as well as in Fig. 3, the sampling tanks.

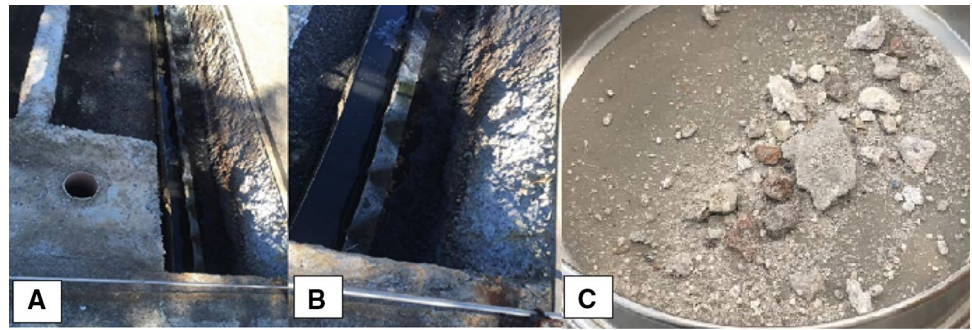
Fig. 4 Collection of samples
(Source: The author (2016))

The structural elements of the tanks that make up the reactor were visibly damaged, as illustrated in Fig. 4, so it was possible to manually withdraw the samples.

Figure 4a shows an overview of the interior of one of the sample collection tanks, while Fig. 4b shows the deterioration of the concrete due to the sulphate attack, and Fig. 4c shows the sample removed from the site, that due to high porosity and low resistance of the concrete, it was possible to make the collection manually.

indicated in Table 2, as well as the deterioration found at the site, shown in Figs. 4b, 5, where surface deterioration and corrosion of the reinforcement are shown.

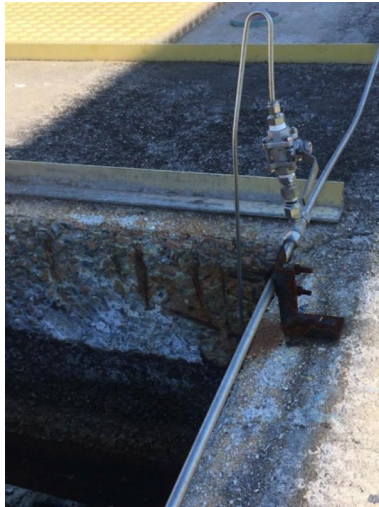
Fig. 5 Reinforcement corrosion (Source: The author (2016))

With a visual analysis it is possible to observe the deterioration of the concrete and the corrosion of the reinforcement, as indicated in Fig. 5.

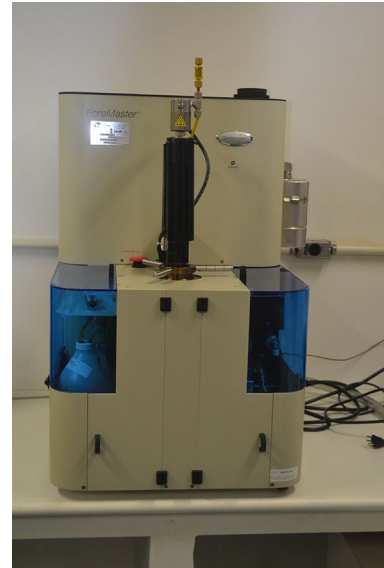
Fig. 6 Quantachrome Poremaster 33 (Source: <http://www.quantachrome.com/> Accessed on: 12/05/16)

The equipment used was the Poremaster 33, from Quantachrome, which can be visualized in Fig. 6, and whose technical data are in Table 1.

The assay was performed on a 0.17 g sample. The procedure consists of placing the sample in a container and applying a low pressure to the liquid, which allows the filling of most of the large pores. As the pressure increases, the small pores are also filled. With the values of the pore volume of the concrete penetrated by the mercury and with the respective pressure applied, a porosimetric curve is obtained.

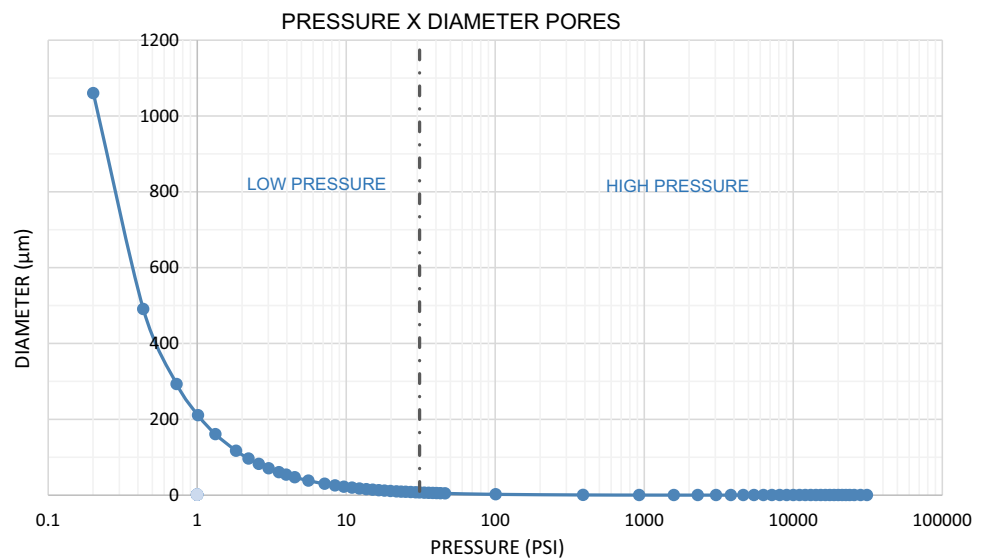
Fig. 7 Pressure applied to mercury versus pore diameter (Source: The author (2016))

During the porosimetry test, for complete filling of the pores with mercury, was necessary to increase considerably the pressure applied in the liquid. The relationship between pressure applied on the mercury and the diameter of the pores can be seen in Fig. 7. The dashed line consists of the division between low and high pressure, and this value corresponds to 31.074 PSI.

Based on Fig. 7, was observed that 43.75% of the pores were filled with mercury at a low pressure, and thus, to fill the other 56.25% needed to apply high pressure, which reached 31,304.36 PSI. With this, it is concluded that most of the pores are very small.

The Analyzes of Figs. 7 and 8, was possible to conclude that the pores with larger diameters are first filled with a low pressure, and for full filling of the pores, a considerable pressure increase was required. Consequently, the higher the volume of mercury intruded in the sample, the smaller the pore diameters.

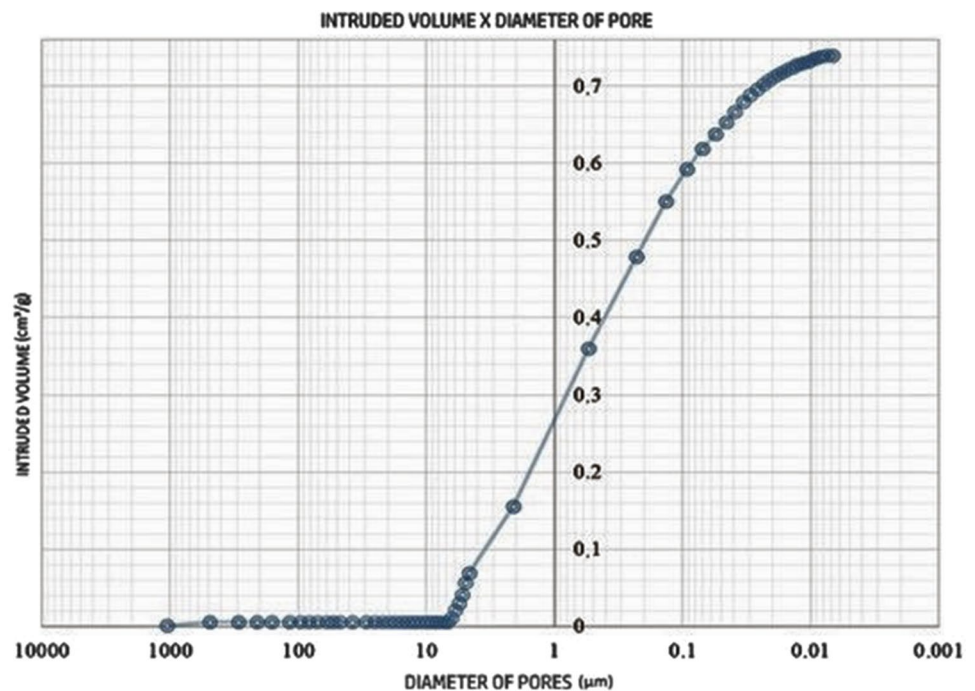
Fig. 8 Intruded volume versus pore diameter (Source: The author (2016))

Another analysis was the relationship between the pore diameters and the intruded volume of mercury, which can be observed in Fig. 8. Thus, the higher the volume of intruded mercury, the smaller the pore diameter.
