Characterization of mortars on the facade of buildings in Gaza-Palestine using experimental techniques

Abstract

Keywords Historic mortars · Pathology · Characterization · Palestine mortars · Historic facade

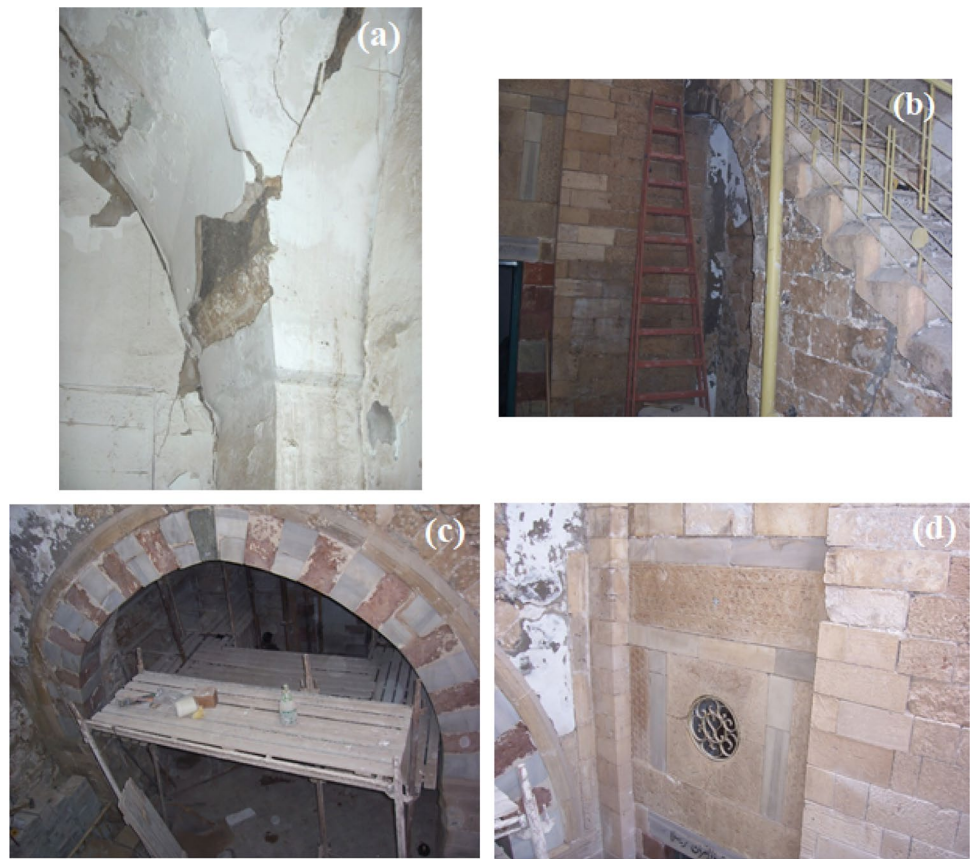
Fig. 2 Photos from Al-Ashi building. **a** Surface wear of the inner lining. **b** Internal staircase to access the second floor. **c** Platform for collecting samples. **d** Detail of the external coating of the building. Source: Archive of Islamic University of Gaza

Al-Ashi (Fig. 2) is a building that once functioned as an old public toilet, called Hammam al-Askar, close to the market, built in approximately 1920 BC, subsequently transferred to a housing building, which was abandoned by the owners for some years.

Geographically, this building is located in the housing district in the city center, less than 1 km from the Mediterranean Sea. Because it functioned as a public toilet during its early years of foundation, this building was subject to an accelerated degradation, since the humidity coming from the toilets area a strong contrast to the dry and arid climate of the region.

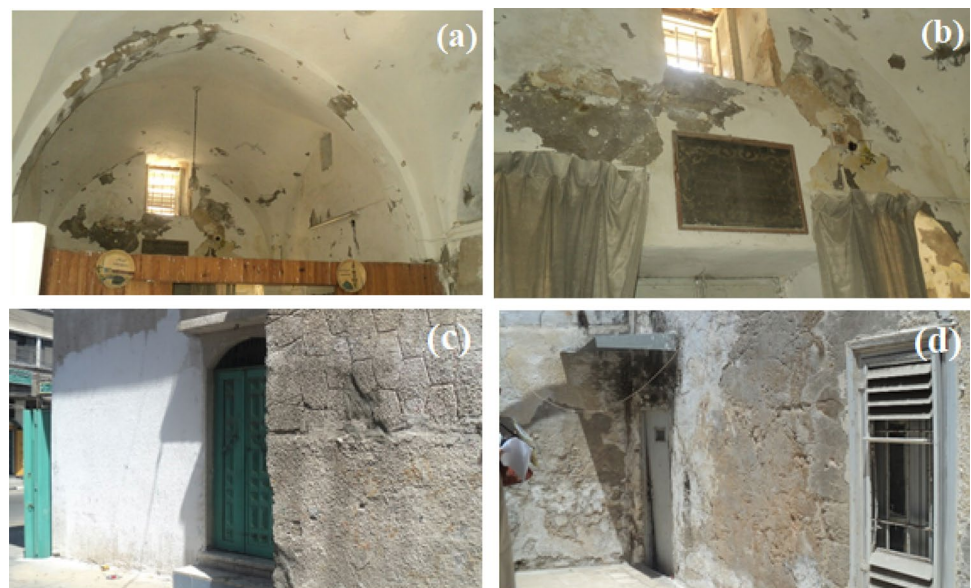
Fig. 3 Photos from Al-Ghussain building. **a** Degradation of the building internal roof. **b** Degradation of the building internal wall. **c, d** External coating of the building and details of degradation. Source: Archive of Islamic University of Gaza

The Al-Ghussain building (Fig. 3) is a historical house located in the Al-Daraj neighborhood, Gaza, on Al-Wahda Street, near of the Sabat Al-Alami, being built in 1865 BC to be a residential building. The building has an area of approximately 245 m², representing the classical architecture, which prioritized the lighter and grayish tones, due to influences from other cultures in the region.

As it is located on one of the main roads in the city of Gaza, the traffic of vehicles is intense in the vicinity, contributing to a high incidence of pollution, causing a degradation in the mortars lining the facades of this building. As it is located approximately 5 km from the oceanic

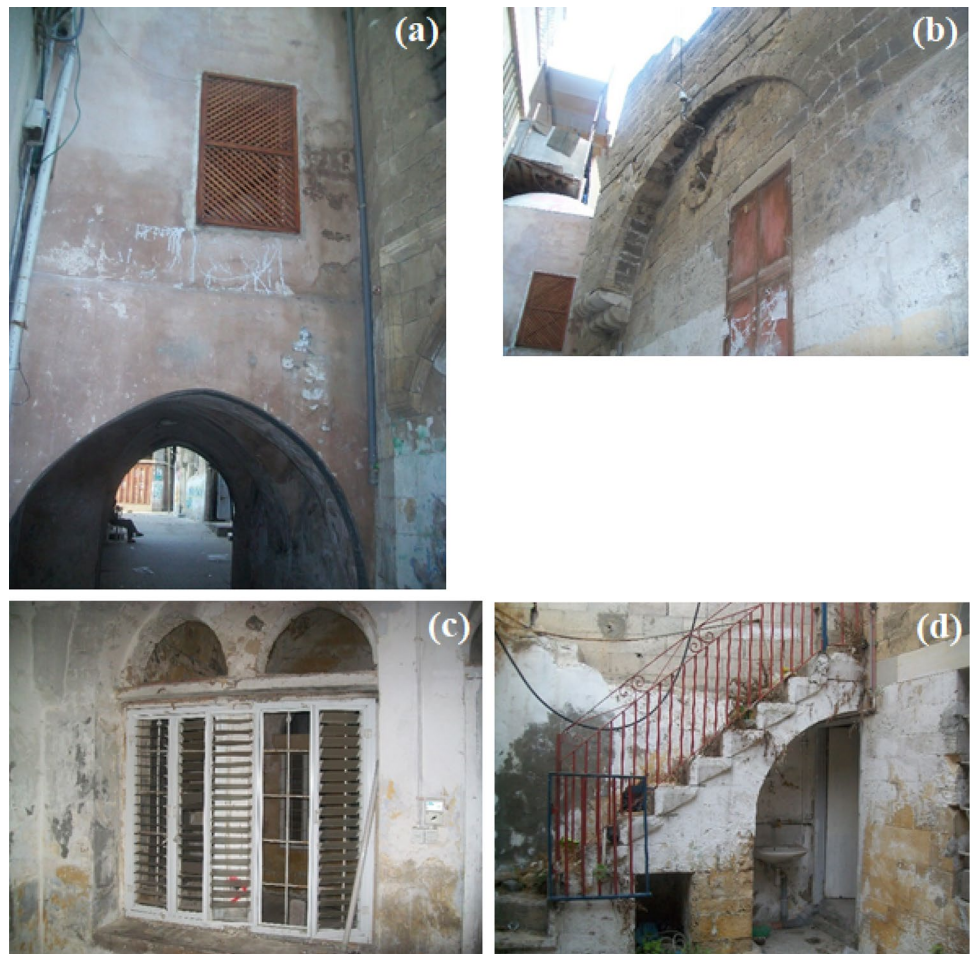
Fig. 4 Photos from Al-Hato building. **a** Arches of the external facade of the building. **b** View of the external facade of the building. **c** Detail of the degradation of the facade and windows. **d** Detail of the degradation of the external facade and access stairs to the second floor. Source: Archive of Islamic University of Gaza

The Al-Hato building (Fig. 4) is considered one of the houses belonging to the Ottoman era, characterized by large spaces and the use of domes. Built in 1331, with the intense use of natural resources, it illustrates the revolution in construction techniques provided by Ottoman architecture. In 2003, the building underwent a renovation in one of its spaces, but without compromising the building's original architecture.

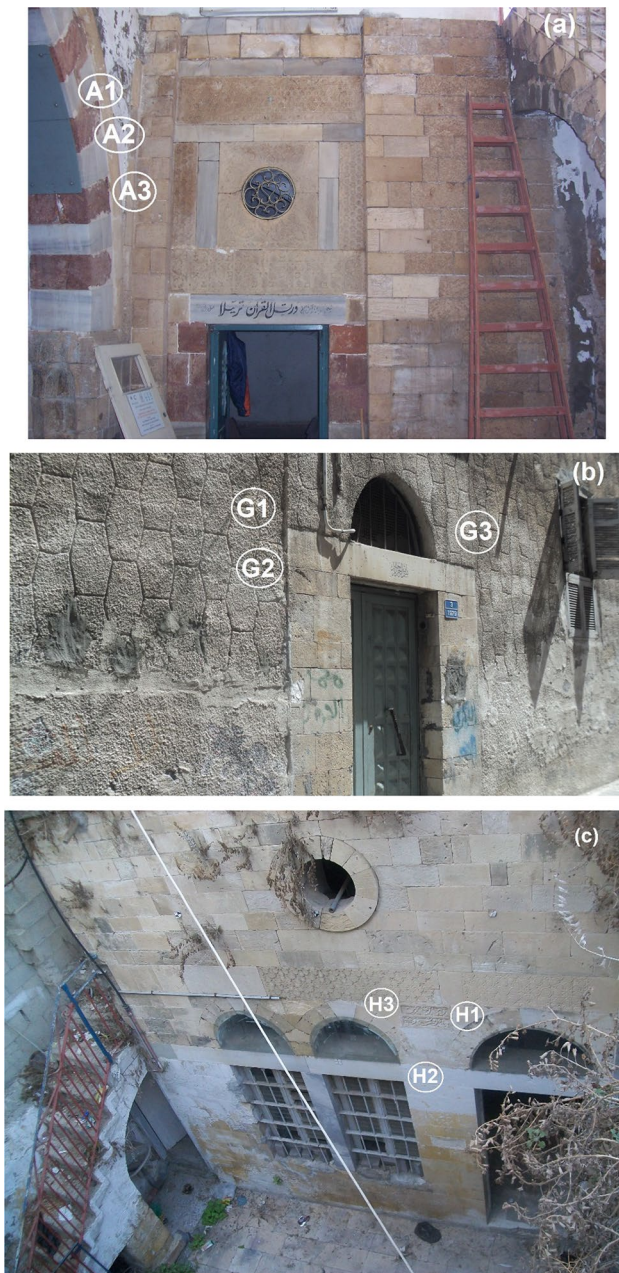
Fig. 5 Sample 1, 2 and 3 collection location: **a** Al-Ashi; **b** Al-Ghusain and **(c)** Al-Hato. Source: Archive of Islamic University of Gaza

In this study three different buildings were chosen, as highlighted in the introduction: Al-Ashi, Al-Ghussain and Al-Hato. Fig. 5a–c shows the points where the mortar samples of each building were collected. The chosen facade was the one most exposed to the external environment, with a higher

index of pathologies, and with the least amount of interventions or reforms, according to information obtained by the building owners. This information is kept in a registry of the Islamic University of Gaza (Faculty of Engineering), which tracks renovations and alterations in these buildings.

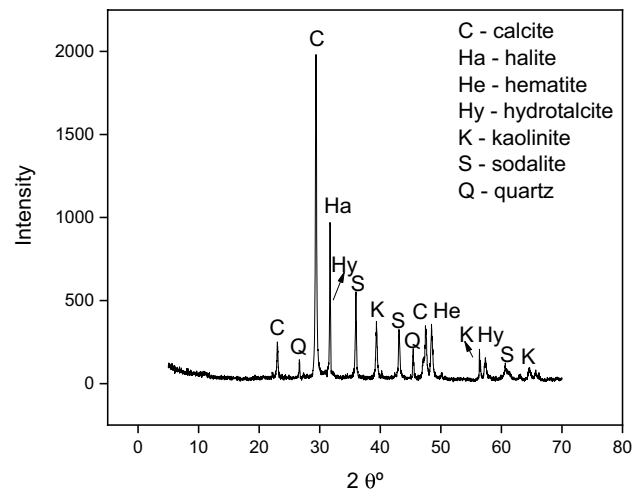
Figure 6 shows the XRD results for Al-Ashi mortar samples. The results presented correspond to sample 1, to avoid excessive information in the figures. The main minerals identified in Fig. 6 are also shown in Table 2. Figure 6 and Table 2 shows the presence of sodalite, a typical mineral of the alkaline activation of binders rich in aluminosilicates that originate geopolymers [22]. It is also possible to identify the presence of kaolinite in the sample. This suggests that the mortars in the region were produced using clay from the region, known to be kaolinite [16, 23], as a binder, responsible for the formation of sodalite minerals after alkaline

**Fig. 6** XRD analysis of Al-Ashi mortar

activation. In Fig. 6 it is also possible to identify the presence of hydrotalcite and calcite minerals. This information indicates that, in addition to kaolinite clay, it was used in the limestone found in the region as binders. This probably led to the formation of hydrotalcite identified in the XRD. This mineral is a hydrated calcium aluminate, it presents in the alkaline activation of calcium rich binders [24, 25], such as limestone, in the presence of aluminate phases, from the use of kaolinitic clay [26]. It is further evidence of the use of the principles of alkaline activation for the production of Al-Ashi mortars. Thus, it is observed that the mortars in the region were probably produced through the use of kaolinitic clay and limestone as a binder. Limestone deposits are abundant in the region, and justify the presence of calcite in this composition [27]. There was the presence of hematite in the clay, responsible for the reddish coloring of the mortars, as it is detected in Fig. 6. In addition, the presence of quartz was detected, probably used in the mortars as fine aggregate or present as impurity in the clay and limestone. It was also possible to detect halite, showing the occurrence of chlorine in the material. The chlorine most likely comes from sea water, a possible material used as an activating solution for the alkaline activation reaction that originated the mortars in the region. The use of salt as an alkaline activated in historic mortars has been proven by other authors [20, 28].

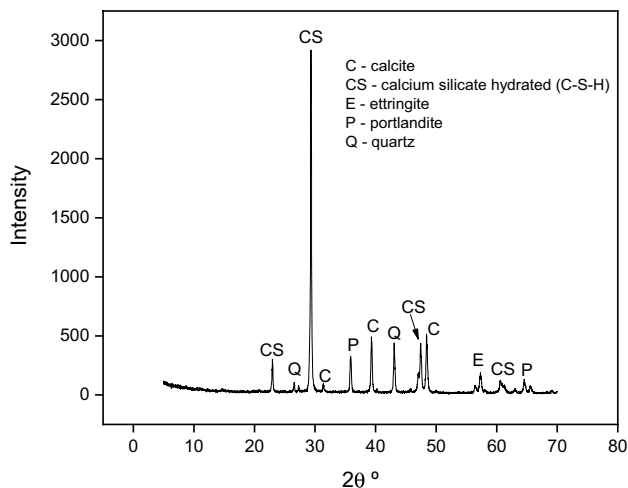
Figure 9 and Table 4, which presents the XRD results for Al-Ghussain's sample 1, confirms the information observed in Table 3. The formation of C–S–H (calcium silicate hydrate), secondary ettringite and portlandite (calcium hydroxides) minerals, typical of natural hydraulic binders hydration, is verified [34, 35]. In addition to these minerals, the presence of quartz is observed, probably due to the use of sand as aggregate, and calcite probably from limestone. No peaks related to the dolomite mineral are detected, due to the low amount of MgO observed in the composition, which suggests that the limestone used is predominantly based in calcite. The presence of this last

Fig. 9 XRD analysis of Al-Ghussain mortar

It is observed in Fig. 9 and Table 4 that the ettringite present in mortars is secondary, not primary. It is known that the primary ettringite is formed soon after the hydration of the natural hydraulic binders, and that it disappears

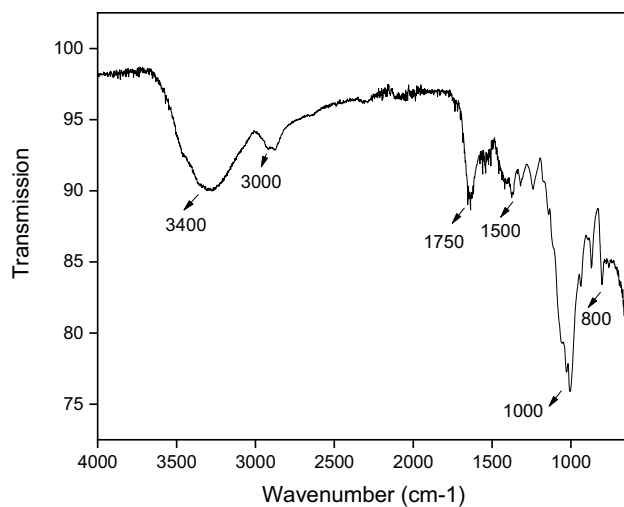
Fig. 13 FTIR analysis of Al-Hito mortar

Figure 13 shows the FTIR analysis for sample 1 of Al-Hato mortars. The same events described in the analysis of Fig. 8 are observed, which reported the FTIR of the sample from Al-Ghussain. This is an indication that the basic raw material used to produce the natural hydraulic mortar in the region is similar, probably from the same limestone deposits. Although the events observed in 3400 cm^{-1} (constitution water), 3000 and 1500 cm^{-1} (portlandite), 1750 and 1000 cm^{-1} (CSH) [49, 50], the events observed by Al-Ghussain mortars are equivalent, it is valid to point out that there is an event in 800 cm^{-1} exclusive to Al-Hito mortars. This event can be attributed to the decomposition of C–C bonds, indicating the presence of organic matter [54, 55], linked to the use of natural fibers in the region's mortars. This proves the results discussed by the XRD analysis.
