Influence of different bacterial strains on cracks self-healing in cement-based matrices with and without incorporated air

Abstract

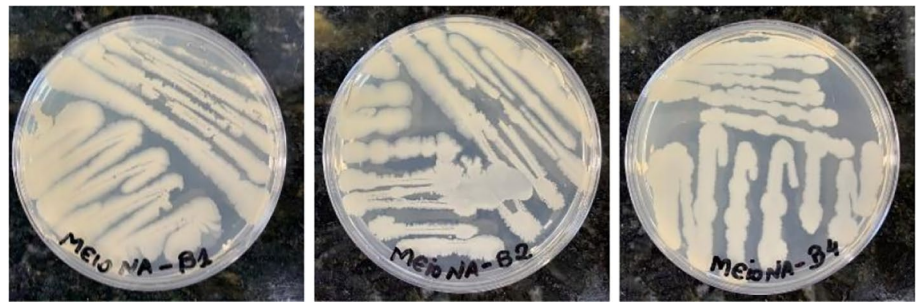
Fig. 1 Bacteria visible in the depletion streaks on Petri dishes

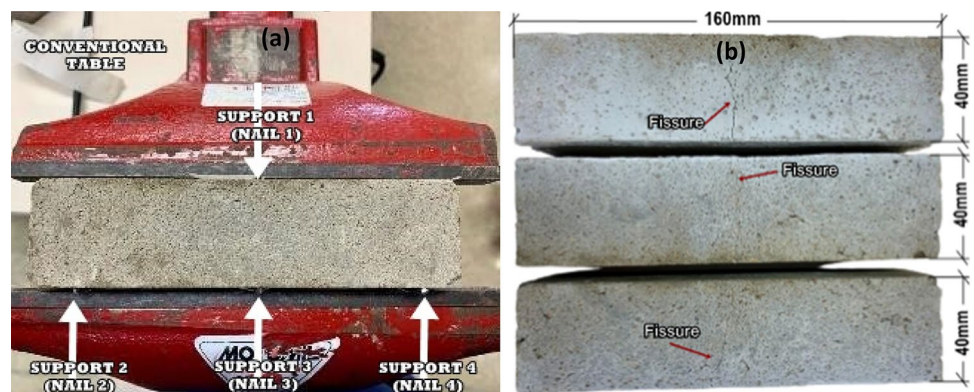
Fig. 2 Opening of cracks in prismatic specimens by means of manual loading in a 4-point bench vice a protocol used b resulting cracks

A manual cracking protocol was defined for crack opening with a bench vice and 4 supports (Fig. 2a) since the mortars presented low tensile strength with a fragile rupture. In this process, it was not possible to establish the cracking load nor to control the crack opening size, which presented thicknesses ranging from (Fig. 2b) 0.38 to 2.84 mm (Table 5).

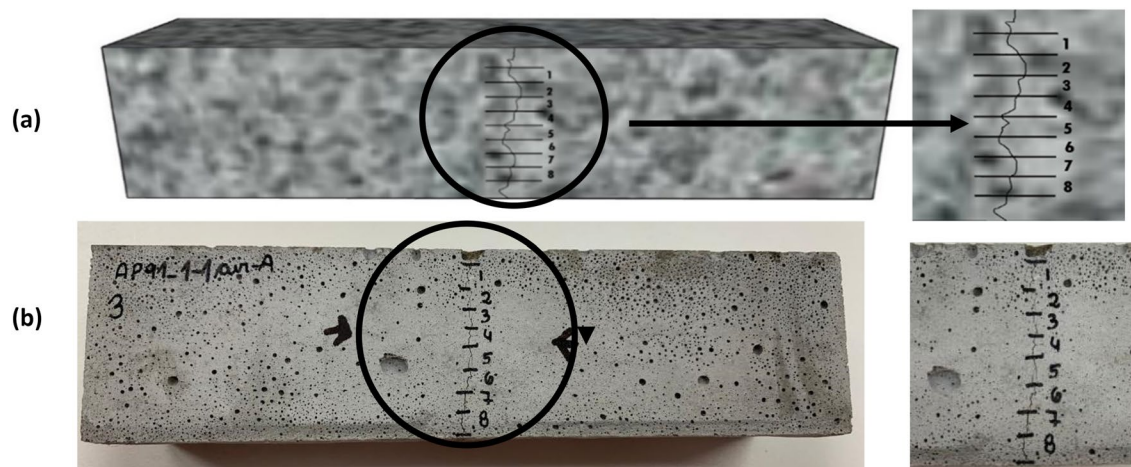
Fig. 3 Division of the cracks into 8 spaces for visualization with an optical microscope **a** schematic and **b** real photos

48 specimens (24 with and 24 without reinforcement—in triplicate per variable) were visually analyzed using an optical stereomicroscope Zeiss Discovery. V12, with Zeiss PlanApo S 1.0×FWD 60 mm lens, connected to a Zeiss Axiocam 105 camera with up to 100× magnification, and with AxioVision SE64 software to evaluate the self-healing of mortar specimens by the closing of cracks over time. The unreinforced specimens were photographed at ages 1 (reading 0), 14, 21, 28, 42, and 56 days, and the reinforced specimens at ages 7 (reading 0), 14, 21, 28, 42, 56, and 70. For visualization and reading in the Stereomicroscope, all specimens’ cracks were marked and divided into 8 approximately equidistant zones (Fig. 3), adapting the reading procedure from the literature [19] and generating 2496 images.

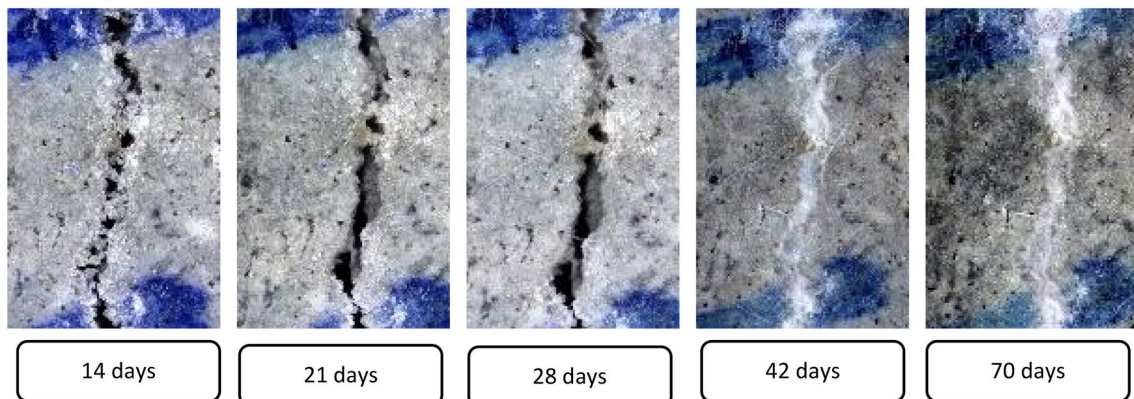
Fig. 4 Precipitated product detachment at the crack edge on BSair specimens

It was verified for BCair specimens fewer healing products in the crack region at 21 and 28 days than at 14 days. The same occurred in BSair specimens' crack area, as shown in Fig. 4, where at 14 days, precipitated product crystals on the crack edge occurred, not visible at the subsequent reading ages (21 and 28 days). For advanced analysis ages (42 and 70 days), total crack closure was observed.

According to [17], a detachment occurs due to the dropping or rupture of the product generated on the crack wall, resulting from handling the specimen or the leaching process. After non-destructive control tests, the specimens re-submersion may generate water pressure on the healing products, causing its detachment and consequent dropping in the region. The study by Roig-Flores et al. [27] suggested that no intermediate measurements should be performed to avoid the accidental removal of newly formed precipitates (7, 14, and 21 days), as they may affect the self-healing performance. If intermediate readings are carried out, a follow-up of the specimens' leaching process by measuring pH and conductivity to check their influence on the process is essential.

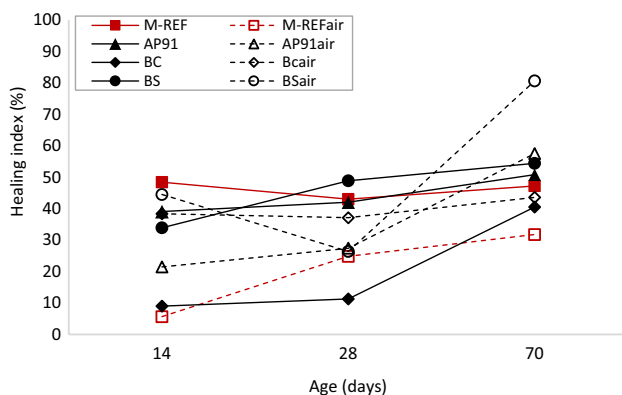
Fig. 5 Healing index over time in cracked and reinforced specimens

By analyzing the healing index (healing rate multiplied by the average crack thickness), it was observed (Fig. 5) that all combinations improved over time, with more favorable results for AIR-incorporated matrices, except in those without bacteria (reference).

The reference specimen presented the highest healing index at 14 days (7 days after the crack opening), indicating that autonomous self-healing occurred primarily at early ages due to hydration product formation in the matrix. For 28 and 70 days, higher healing indexes for specimens with bacteria addition were observed, indicating that the microorganisms may be acting and favoring the cracks' autonomous self-healing in the last ages.

The lower healing index at 28 days for some specimens was associated with the precipitated product's detachment. In the first healing ages, the compounds formed did not adhere well to the crack walls and could be easily removed by the leaching process or action resulting from handling the submerged specimens.

The best results were obtained for the BSair, AP91air, and BS specimens, which presented healing indexes of 80.63%, 57.54%, and 54.42%, respectively. It must be highlighted that these mortars have the *Bacillus subtilis* species bacteria. This strain has already been used in other studies [13, 14, 17, 28], presenting satisfactory self-healing results.

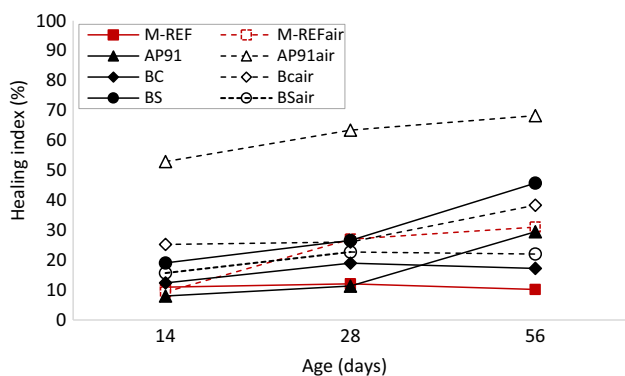
Fig. 6 Crack healing index over time for unreinforced specimens

A high healing index was observed for AP91air specimens. All specimens containing bacteria presented Rh results higher than the M-REF specimens, demonstrating the efficacy of using biological agents in self-healing cracks in cementitious materials, corroborating with studies of [9, 13, 17, 18, 28]. Furthermore, a higher healing index was noticed for air-incorporated specimens, in agreement with studies of [29, 30], except for the BSair variation.

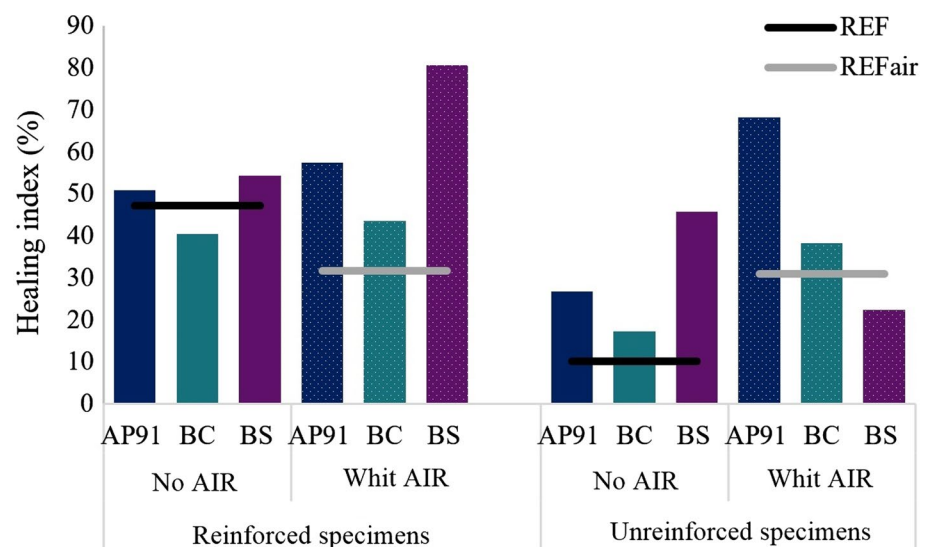
Fig. 7 Comparison of the final healing index of reinforced (70 days) and unreinforced (56 days) specimens

A more effective self-healing process was noted for reinforced specimens when comparing the final healing index between reinforced (70 days) and unreinforced (56 days) specimens (Fig. 7). For the unreinforced specimens, the crack closing occurred only punctually in some mixtures, including the reference specimens, without air incorporation. It may be associated with the cohesive nature intrinsic to cracks in cementitious materials, which may be intensified by reinforcement [25].

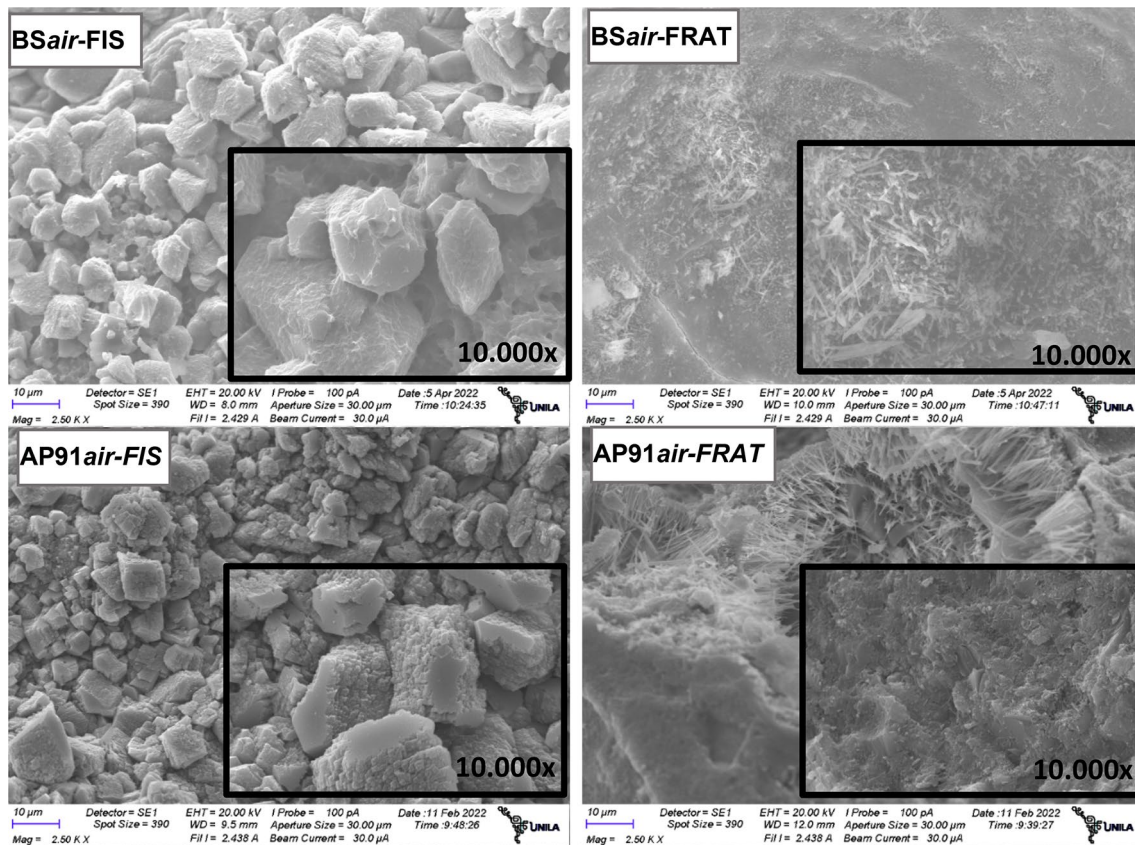
Fig. 8 SEM microstructural images of reinforced specimens with a higher healing index at 2500 \times and 10,000 \times magnification in the crack region (FIS) and fractured face (FRAT)

The analysis results at 77 days in the reinforced specimens group are seen in Fig. 8 (specimens with FIS and FRAT faces) and 10 (specimens with FIS face).

All specimens showed crystal formation except for M-REF. The cracked faces of the BSair and AP91air specimens were composed of a cluster of precipitated crystals, while the cracked face of the reference specimen presented a smooth surface. As the substantial presence of crystals was observed only in the cracked faces (FIS), while the fractured faces (FRAT) showed a characteristic cementitious matrix, it was concluded that the crystals formation is related to bacterial activity and that even with the biological agents present in the cementitious matrix, due to the incorporation in the mixing water, the precipitation occurred in the crack region where water and oxygen are found.

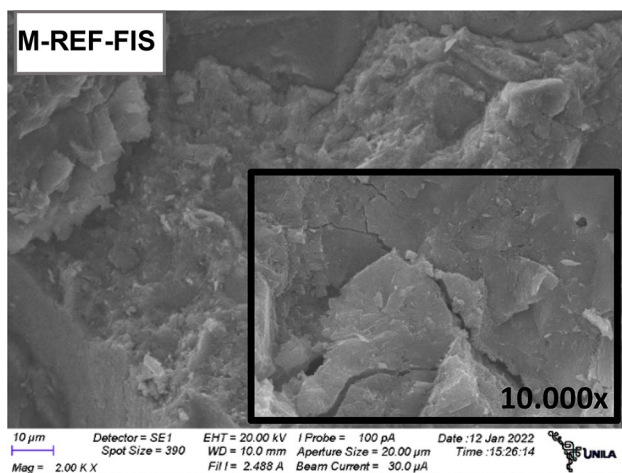
Fig. 9 SEM microstructural images of the cracked region (FIS) of the reference specimens at 2500 \times and 10,000 \times magnification

The energy dispersive spectroscopy (EDS) analysis was performed to verify the composition of crystals precipitated in the cracks. The presence of Calcium, Oxygen, and Carbon atoms was verified, demonstrating CaCO_3 crystals formation. From the reference specimen analysis, peaks of the same compounds (C, Ca, and O) were observed, corroborating what was found in the visual analysis in Stereomicroscope—in which mortars without biological agents presented autogenous self-healing, precipitating calcium carbonate in lower amounts than specimens with biological agents (Fig. 9).

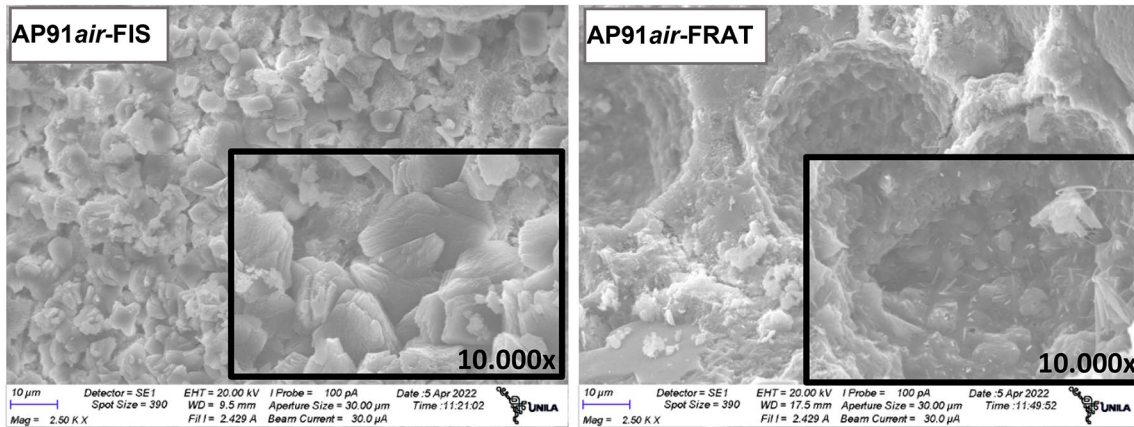
Fig. 10 SEM microstructural image of the unreinforced specimens with the highest healing index in the region of the crack (FIS) and fractured face (FRAT) at 2500× and 10,000× magnification

SEM microstructural analysis was also performed on the specimens without reinforcement that presented the best healing index, AP91air, both on the cracked and fractured faces. The images are presented in Fig. 10, which showed

a thick layer of precipitated crystals, where due to the C, Ca, and O peaks presence in the EDS, it is CaCO_3 possibly precipitated in larger quantities by the biological agents that, given the presence of AIR, had more space to metabolize and precipitate the product. From the reinforced specimens' images, a difference in the matrix between the cracked and the fractured faces was noticed, indicating that the bacteria developed substantially in the cracked region due to the greater space and greater water and oxygen presence.

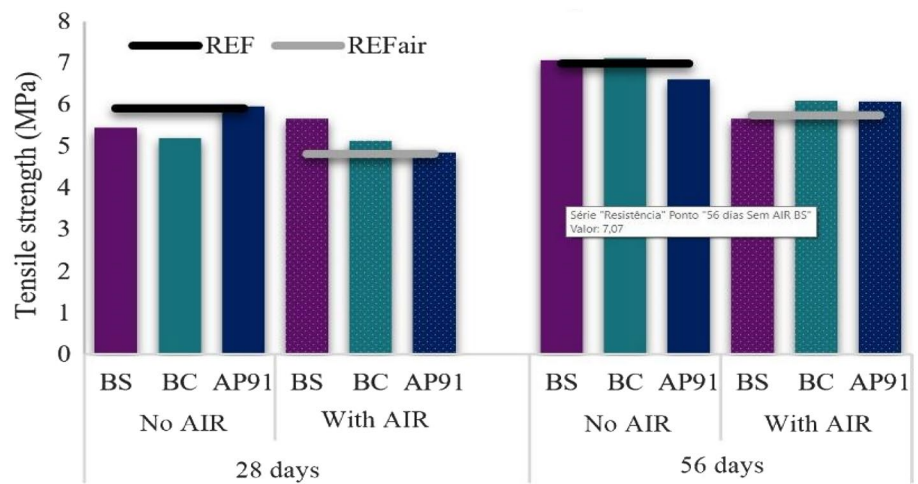
Fig. 11 Flexural tensile strength of intact specimens with AP91, BC, and BS bacteria at 28 and 56 days

Figure 11 shows the flexural tensile strength results, where air incorporation impaired the flexural tensile performance of mortars, especially at 56 days, both in the reference specimens and the ones containing bacteria. Similar results were found by [30], who obtained an approximate 48% reduction in flexural strength in AIR-incorporated specimens compared to the reference specimens. In this study, the reduction at 56 days in the reference specimens was about 18%, while for the specimens with bacteria, the highest reduction was obtained in the BSair specimens (20%) and the lowest one in the AP9air specimens (8%).

It was also noted that the AP91air and BCair specimens presented tensile strength values higher than the reference AIR-incorporated specimens, but not those without AIR. At 56 days, the specimens without AIR did not reach results higher than the reference one; however, the BS and BC specimens obtained similar results.

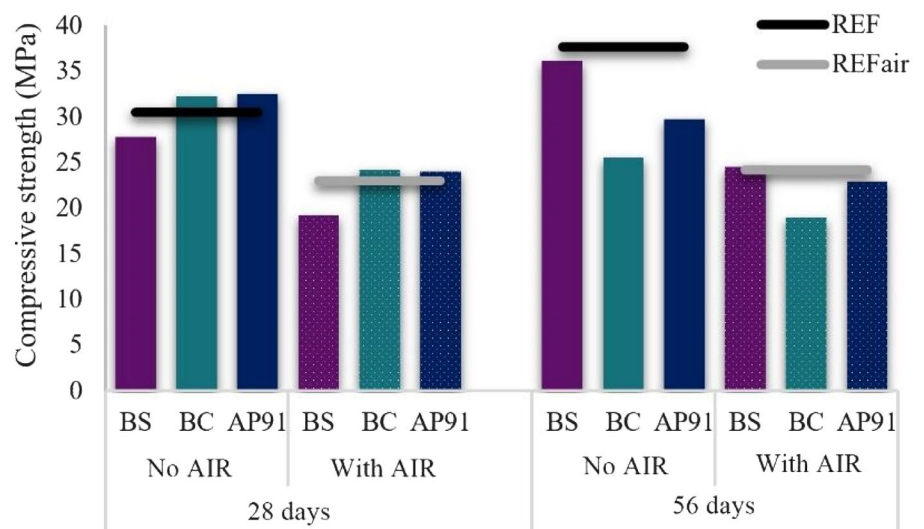
Fig. 12 Compressive strength of intact specimens with AP91, BC, and BS bacteria at 28 and 56 days

Figure 12 shows the specimens' compressive strength values, where all specimens, except for the variations M-REF, M-REFair, BS, and BSair, decreased strength at 56 days compared to those at 28 days [17]. Reported a similar result,

A decrease in the compressive strength of the AIR-incorporated specimens was observed, similar to the tensile strength results [30]. Reported a 56% reduction in the specimens' compressive strength at 28 days. The authors cited that this decrease was caused by the additional air voids in the matrix originating with AIR. In this study, BCair and AP91air bacteria specimens reduced the compressive strength by 21.64% and 5.5%, respectively, while BSair showed a slight increase of 1.17%, all with respect to M-REFair.
