# Hydraulic failures of earthen dams and embankments

Priyanka Talukdar<sup>1</sup> · Arindam Dey<sup>1</sup>

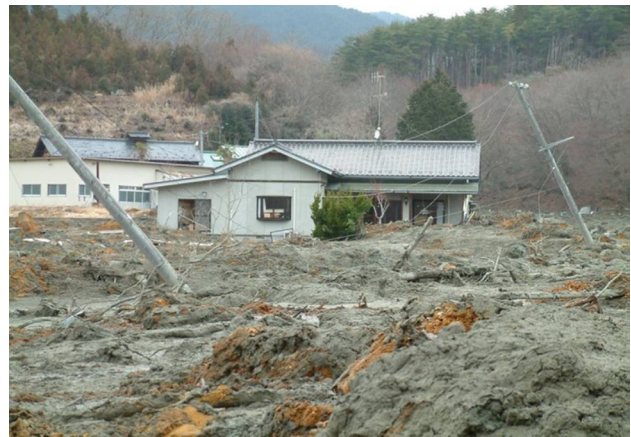
**Fig. 12** Affected house inundated by liquefied tailings over the down reach of the Kayakari Stream [114]

analysis of 3500 tailings dam worldwide. Breaching caused by the 2011 Japan earthquake of the Kayakari tailings dam resulted in liquefaction of the tailings, destroying many houses at the down reach of the Kayakari stream, as shown in Fig. 12 [114, 115]. Dam foundation instability leading to breaching in the Mount Polley mine tailings, releasing 4.5 million cubic meters of tailings posed serious pollution to the environment in the year 2014 [116]. The scenario of the Mount Polley mine tailing dam after failure was shown in Fig. 13 [117].
