Influence of deteriorated stirrups on the shear performance of RC beams incorporating fly ash and enhanced with carbon fiber-reinforced polymer strengthening

Abstract

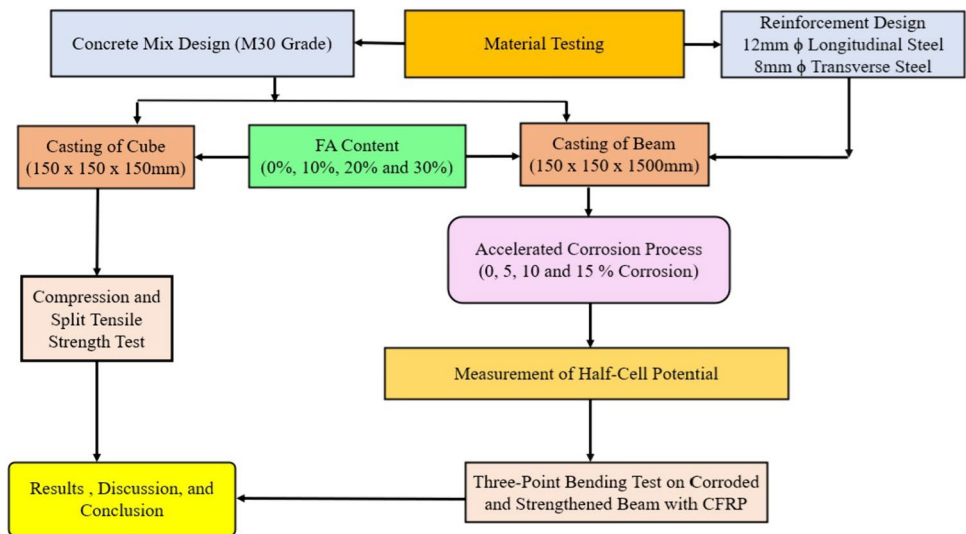
Fig. 1 Flow Chart for Experimental methodology

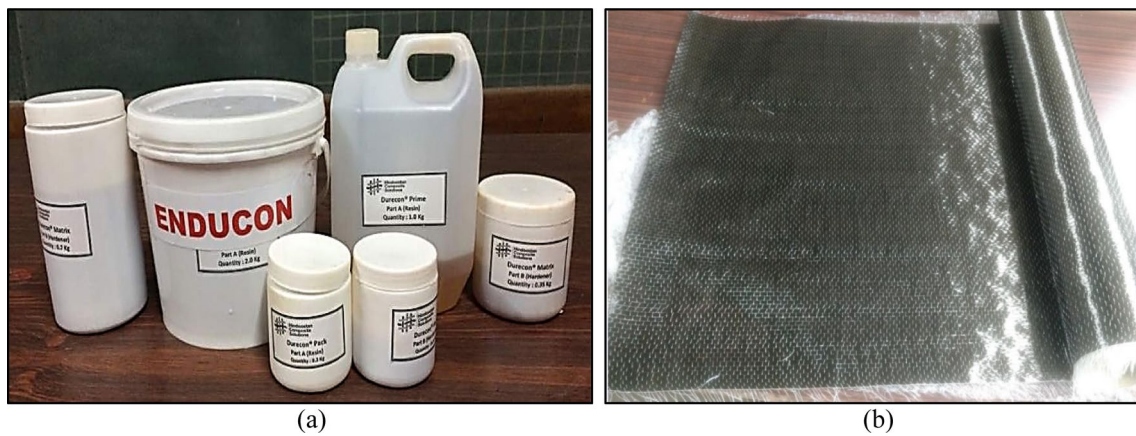
Fig. 2 Strengthening materials, (a) Resin and hardener, (b) CFRP Sheet

viscosity in liquid form, allowing them to impregnate the carbon fiber fabric effectively. The phase composition of the resin includes the various molecular structures of epoxy molecules, which determine properties such as viscosity, flexibility, and adhesion. An epoxy resin and a hardener mixed, undergo a chemical reaction that results in a strong and durable polymer matrix. A hardener initiates the cross-linking reaction that transforms the liquid resin into a solid polymer network. Common hardeners include polyamines and polyamides. The phase composition of the hardener involves the various functional groups and molecular structures that participate in the chemical reaction with the epoxy resin. This reaction forms covalent bonds, leading to the formation of a three-dimensional network structure, which provides the cured epoxy with its mechanical strength and durability. Adhesives bond the concrete surface and multiple layers of CFRP laminate, creating a path for the shear load. Protective coatings safeguard cured CFRP reinforcement from environmental damage. Figure 2 shows strengthening materials including resin, hardener, and CFRP Sheet.

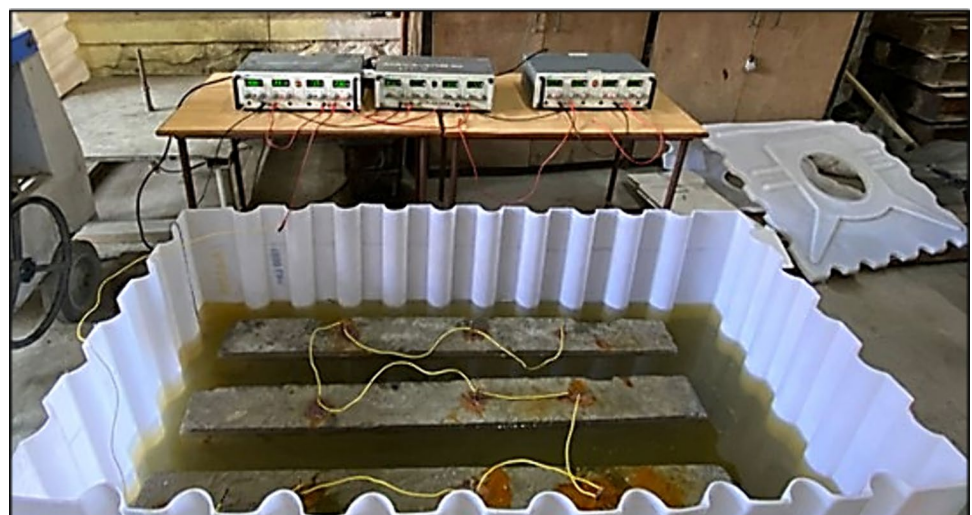
Fig. 5 ACP setup

To expedite the corrosion process in the test specimens, an ACP was employed [21, 22, 52–60]. Figure 5 shows the schematics of the ACP. After curing, the test beams were immersed in a tank containing a 5% NaCl solution, by weight of the water. Throughout the testing, the depth of the water was kept constant at the beginning of each setup. In this setup, a stainless-steel plate served as the cathode

(negative terminal) of the circuit, while a copper wire connected all the stirrups, acting as the anode (positive terminal). With a 26 V DC power flowed from the anode to the cathode and led to the oxidation of stirrups, involving loss of electrons and resulting in corrosion [61]. Maintaining a constant current density of $270 \mu\text{A}/\text{m}^2$, specimens CB1–CB3 and SB1–SB3 underwent corrosion for durations of 4, 8, and 10 days, respectively to achieve 5, 10, and 15% of stirrup corrosion [61]. The main steel and stirrups were insulated by applying epoxy grout at the junction to prevent corrosion of the main steel and to control the corrosion rate of the stirrups. Faraday's law, given by Eq. 1, correlates mass loss with a magnitude of electrical current (DC), and exposure duration was used to calculate the theoretical mass loss of stirrups due to corrosion. [42].

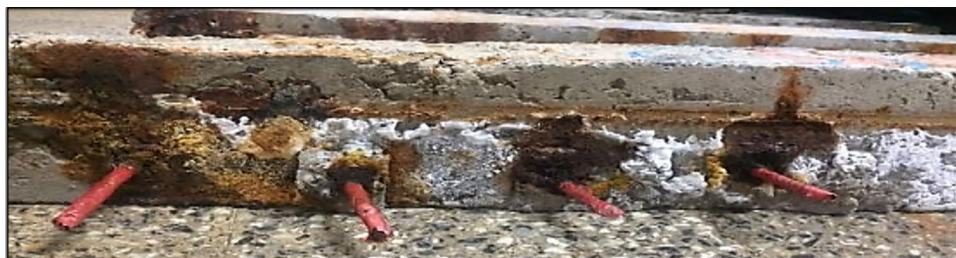
Fig. 6 Corroded beam specimen

corrosion reaction for iron, and $F = 96,500$ C/equivalent is Faraday’s constant. This allows for accelerated completion of steel bar corrosion in a short duration of time. Figure 6 shows a typical corroded beam specimen after ACP.

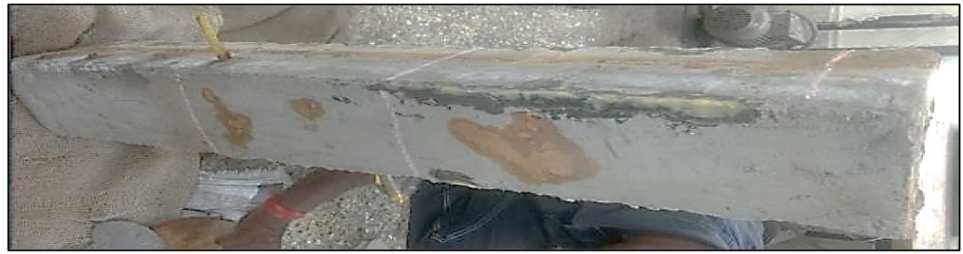
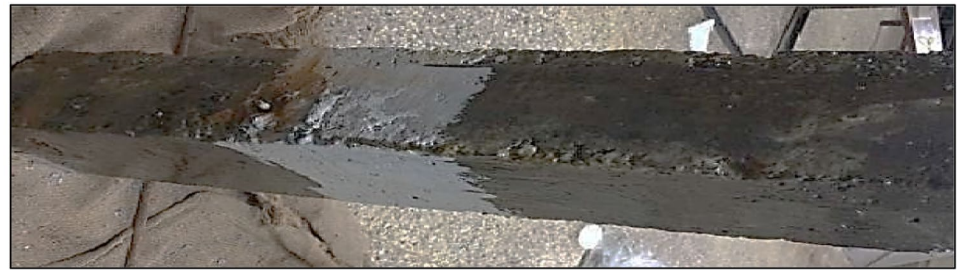
Fig. 8 a Putty Filling, b Prime coating, c Saturated coating d Fiber laminate

applied over the saturated resin area at room temperature, and a protective coating was added to the CFRP sheet to shield the bonded FRP reinforcement from environmental damage. The beams reinforced with CFRP sheets were cured for 5 days at room temperature before testing. Figure 8 shows a retrofitting procedure which was used for this research. In this research, all four sides of the beams are wrapped and this scheme is more efficient than two-side and three-side wrapped schemes.

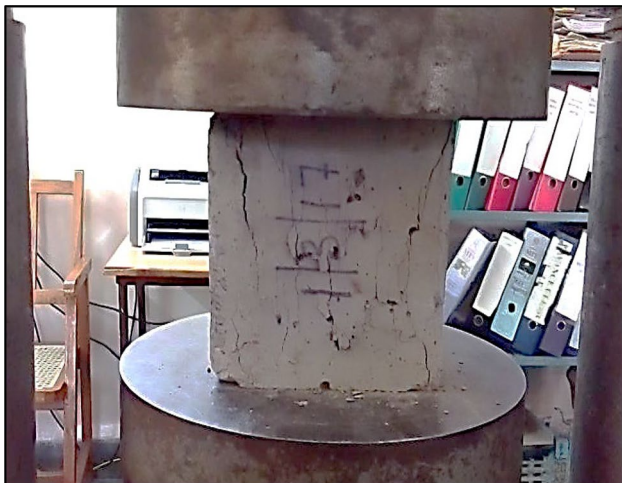
Fig. 9 CS test

The compression testing machine (CTM) is employed to assess the CS of concrete using standard cube-size molds following a 28-day curing period. Testing was conducted on three cubes following the IS: 516:1959 guidelines [70], and the individual strength of each cube as well as the average CS were recorded. Additionally, cylinders were tested using a 2,000 kN capacity CTM. Three cylinders were subjected to testing following IS: 5816–1959 guidelines [71], and the individual and average split tensile strength (STS) were noted. Figures 9 and 10 show the experimental setup for CS and STS of concrete.

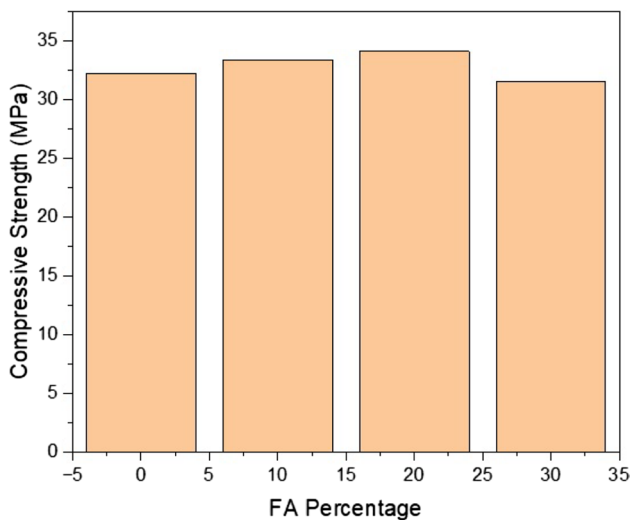
Fig. 11 Effect of FA percentage on CS

It was noted that the CS increased by 3.59% and 5.57% when incorporating 10% and 20% FA, respectively. However, CS decreased by 2.17% when 30% FA was used, compared to 0% FA, after a 28-day curing period. The CS exhibited marginal improvement up to a 20% cement replacement with FA, and further replacement beyond 20% resulted in a slight decrease in strength at 28 days. However, up to 30% FA demonstrated the desired strength for M30-grade concrete. This trend was also observed in STS. Figures 11 and 12 present the CS and STS of concrete with varying FA percentages after a 28-day curing period.

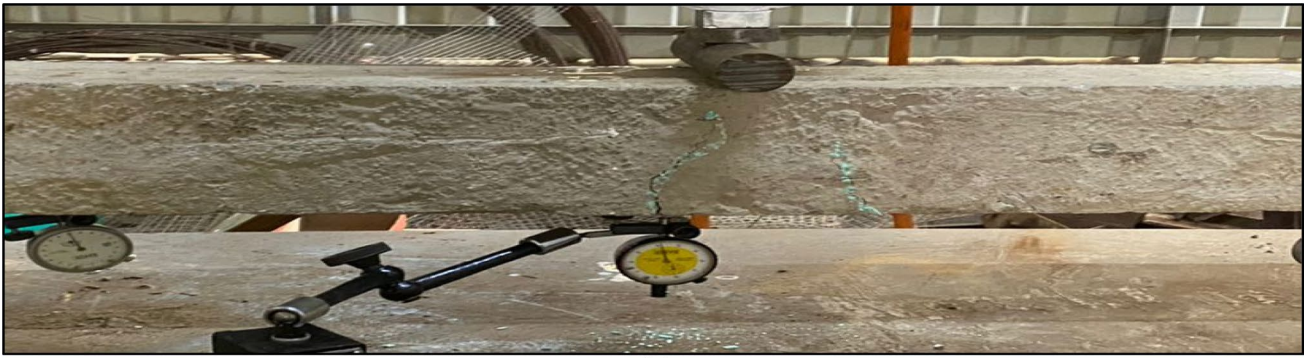
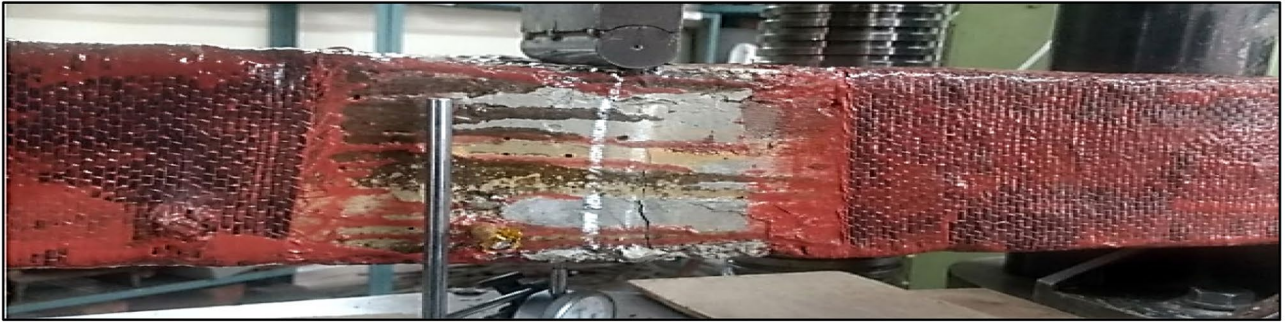
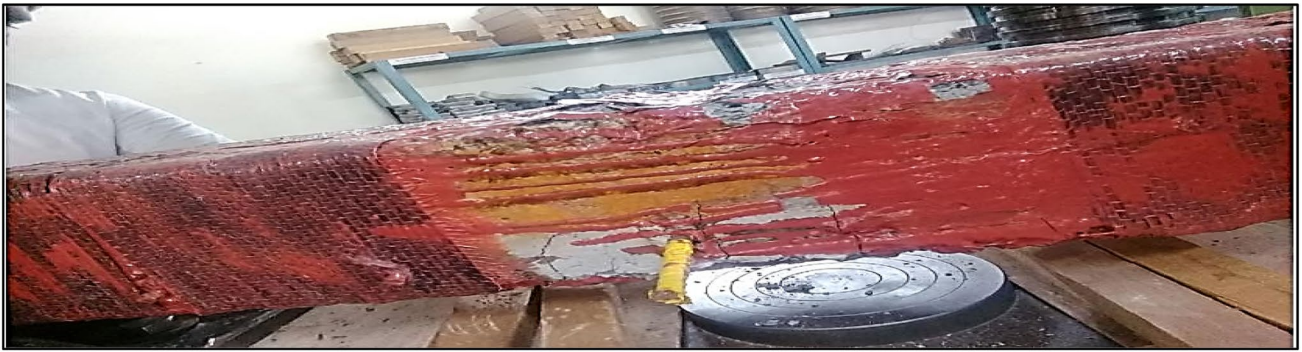
Fig. 16 Beam failure mode-a Beam-SB0, b Beam-SB1, c Beam-SB2, d Beam-SB3

Diagonal cracks confirm shear pressure failure and there was sudden widening of cracks during damage. Corroded beams experienced shear compression failure, and most of the cracks intersected with diagonal cracks perpendicular to the length of the beam. The development of these diagonal cracks in the shear bending zone depends on the tensile strength of concrete under multiaxial stress. The development of load cracks remained consistent and which is unaffected by variations in corrosion expansion cracks under different stirrup corrosion conditions. Under a small load, vertical cracks emerged directly beneath the applied load in the bending tension zone. As the load increased, additional vertical cracks appeared in the shear flexural zone. All test beams exhibited shear compression failure. As diagonal cracks formed, deformation and stirrup strain in each beam quickly increased. This likely

propagation. The specimens failed due to CFRP debonding before achieving its ultimate strength and the concrete was crushed. Figure 16 illustrates the failure mode for both corroded and strengthened beams.

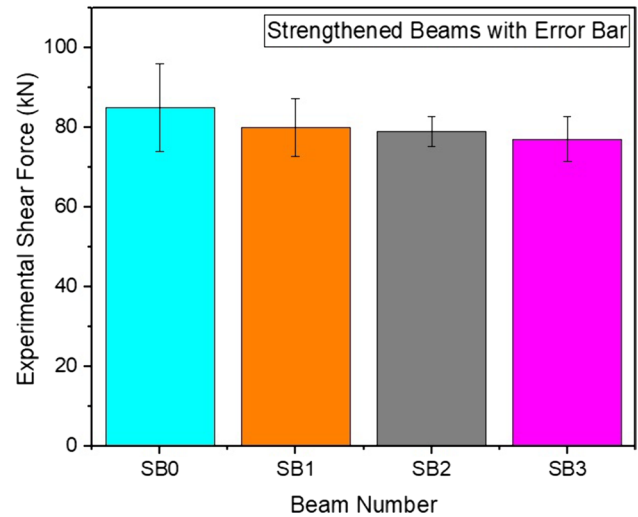
Fig. 17 Experimental shear force with error bars
