# Flexural behavior of corroded one-way slabs strengthened with CFRP in two different techniques

## Abstract

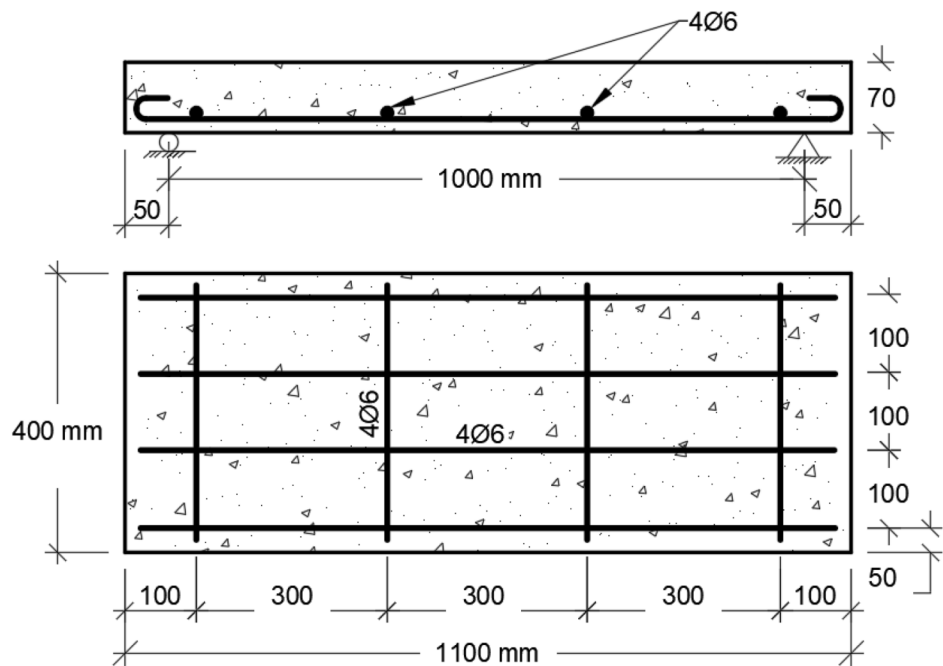
Figure (1) depicts a cross-section of the test specimen, displaying structural features. The test specimens were reinforced concrete slabs that were 1100 mm long by 400 mm wide, with a depth of 70 mm and an effective depth of 60 mm. Tensile reinforcing rebars were constructed from deformed steel with a diameter of 6 mm. The specimen’s construction was meant to cause flexural failure.

**Fig. 1** Tested specimen details

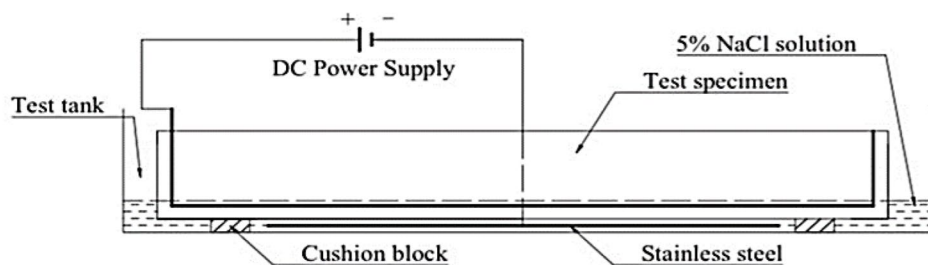
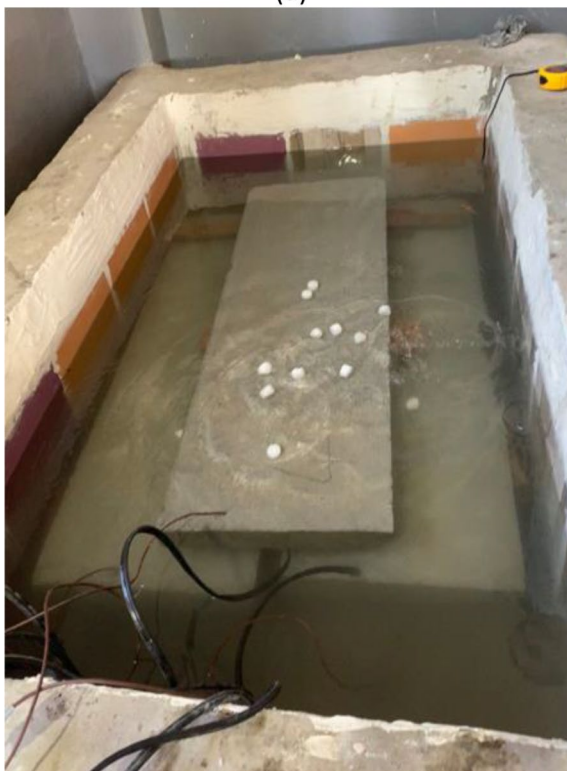
Figure (2) shows the arrangement used for the accelerated corrosion process. A direct current (DC) power supply from Shanghai Wenkai Power Supply Equipment Ltd. in Shanghai, China, with a current density of  $1 \text{ mA/cm}^2$  was used for stability. Faraday's law states that the duration and quantity of current running through reinforcing rebars determines their corrosion levels. Corrosion impairment lasted from 20 h (S1-3) to 576 h (S3-3), resulting in modest to severe damage. Figure (3) depicts slab specimens following the corrosion of the reinforcing rebar.

**Fig. 2** Accelerated Corrosion Setup; a) schematic of setup, and b) close up view

To simulate corrosion damage in test specimens, a direct current (DC) power supply from Shanghai Wenkai Power Supply Equipment Ltd. in Shanghai, China was used. After curing the test specimens, they were placed in a sealed tank with a 5% NaCl solution. The liquid level was above the slab surface. The anode consisted of longitudinal reinforcing

rebars connected to the positive terminal of an external power supply, while the cathode was a stainless-steel rod connected to the negative terminal.

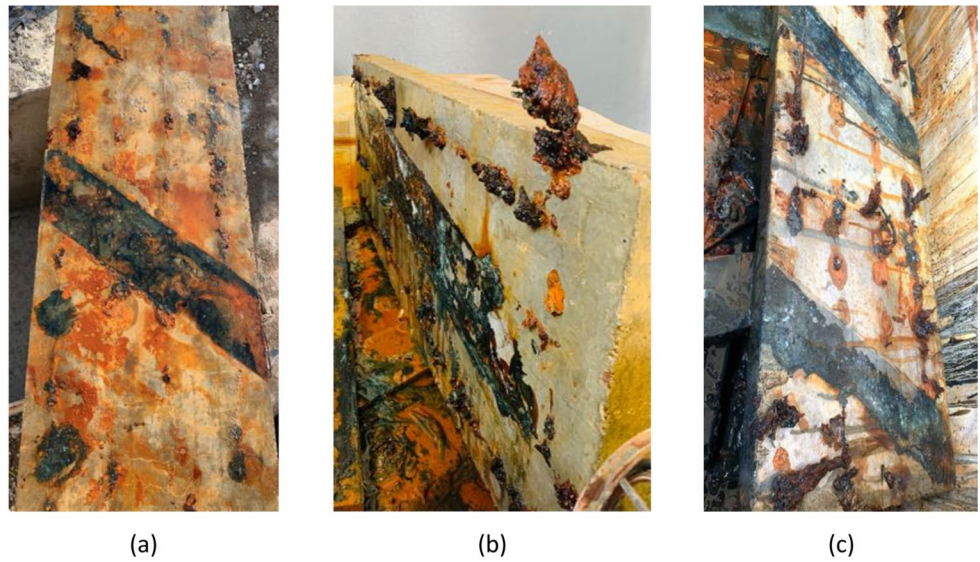
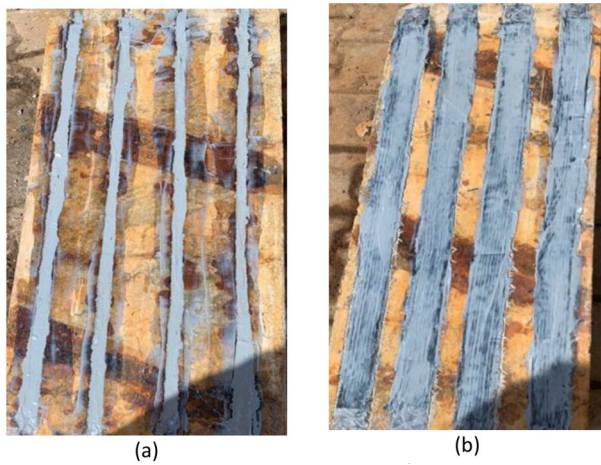
**Fig. 3** The Investigated RC Slabs Bottom After Corrosion; **a)** Weak Corrosion, **b)** Moderate Corrosion, and **c)** Severe Corrosion

Following the fast degradation of the longitudinal steel reinforcement, corrosion-related fractures were mapped and reported. The observed fracture patterns were consistent across all corroded specimens. Because corrosion happened at random, the cracks along the longitudinal steel bars were not evenly distributed. After the slab specimens failed to load, three steel coupons were extracted from the corroded longitudinal reinforcing rebars. After removing the rust using diluted hydrochloric acid, the length and weight of the reinforcing rebars were measured. After comparing their weight loss per unit length to that of uncorroded coupons, the observed corrosion degree was determined. Table (4) shows the tension reinforcing rebars before and after corrosion at each corrosion level.

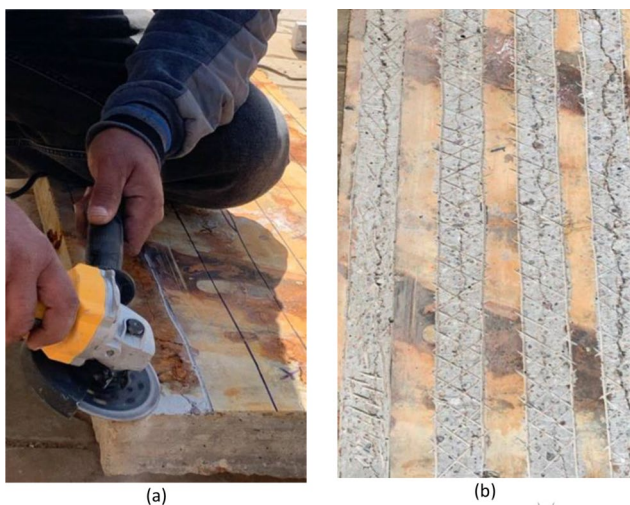
Figure (4) depicts the configuration of the CFRP reinforcement. One layer of four CFRP sheets of 50 mm width was bonded to the tension face of the slab with a length of 1100 mm, and four CFRP robs for NSM with a diameter of 6 mm and a length of 1100 mm.

**Fig. 4** Strengthening Methods; **a)** NSM, and **b)** CFRP strips

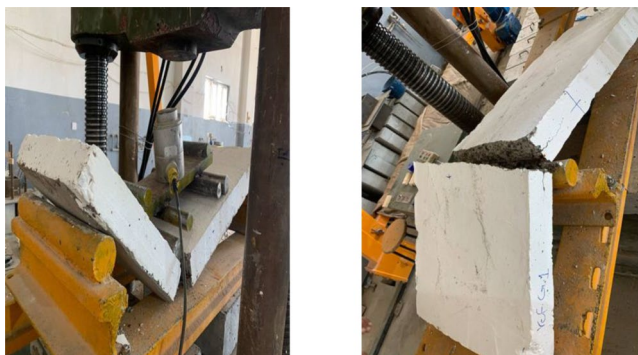
The specimens required to be cured for seven days after strengthening. We used three electrical dial gauges to measure the strain in the concrete at the slab's midspan. The test setup's configuration is shown in Fig. (6 and 7). After that, two-point loading tests were performed on each slab until it

**Fig. 6** Test Setup

failed. The loading points were spaced 333.33 mm apart. Up to failure, the loading was measured via a hydraulic jack and two 20-ton pressure transducers. Installing linear variable displacement transducers (LVDTs) with a 100 mm range capacity (Donghua Testing Ltd., Taizhou, China) allowed for the monitoring of the displacement of the slab at the midspan.

Fig. 7 Slab Test

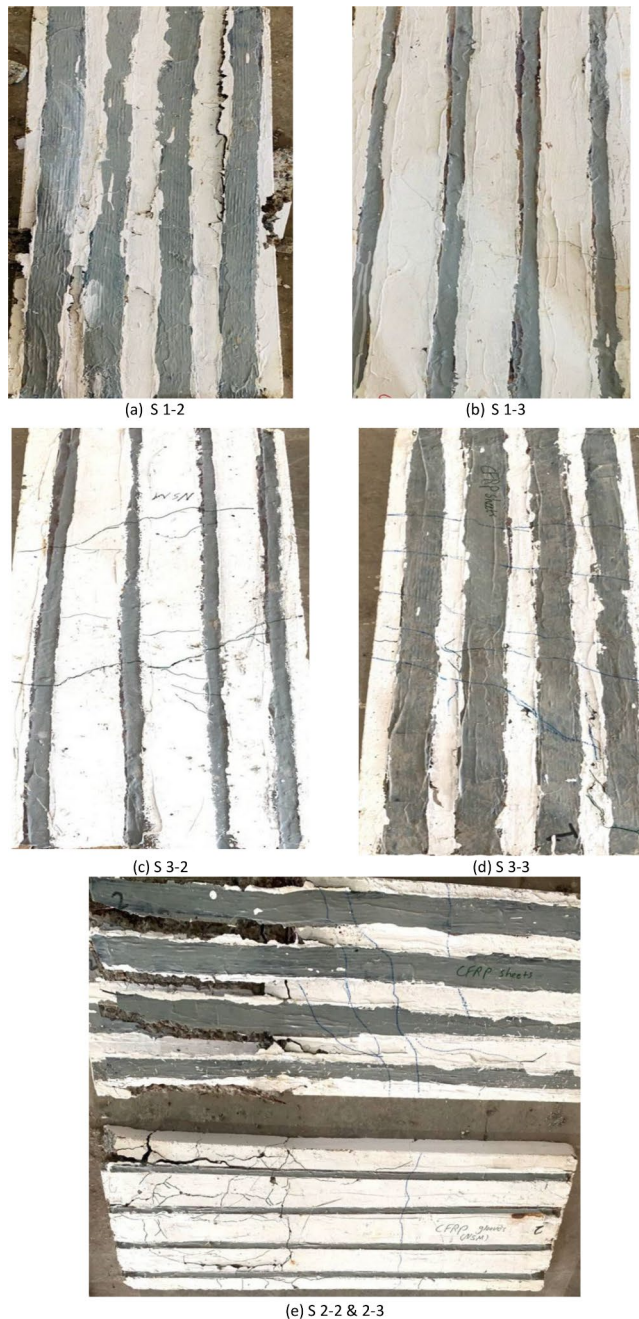
Figure (8) displays the crack profiles of slab specimens under ultimate loading. Each and every specimen has a flexible failure mode. The failure modes of every slab specimen

**Fig. 8** Failure Crack Modes for Tested slabs; a) and b) group 1, c) and (d) group 3, and e) group 2

were significantly impacted by the amounts of corrosion on the reinforcing rebars.

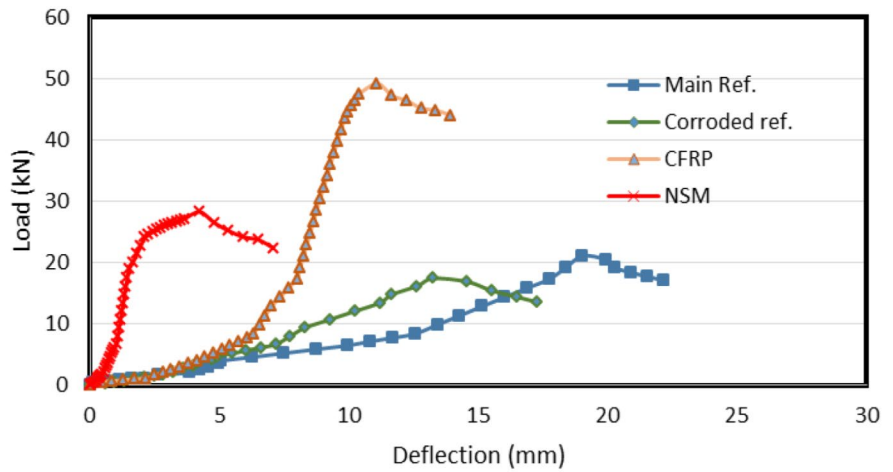
The load–midspan deflection curves for each slab are shown in Fig. (9). The inflection points generally divide the load–midspan deflection curves of S0 into three sections. During the early phase, the slab is in its elastic condition before the first fractures appear. The curve begins the second stage and its slope somewhat lowers after the first inflection point. The curve reaches the third stage following the second inflection point. Up to the maximal load, the slab specimens’ deflection increases quickly, and the curve modifies and becomes soft. The corrosion of the reinforcing rebars caused the corroded slab specimens to be less rigid than the control slab (S0).

**Fig. 9** Load–Deflection Curves for Group 1 (11% Corrosion Level)

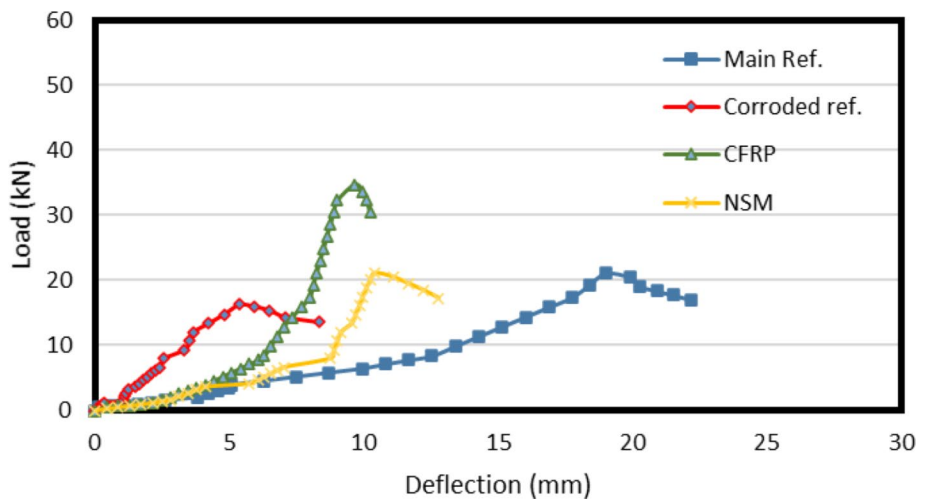
Shown in Fig. (10), when the corrosion level increased, the binding behavior between the concrete and the reinforcing rebar degraded and the slab’s mechanism progressively changed from “slab action” to “arch action.” The load–midspan deflection curves of all the corroded slabs tended to be smoother as the corrosion level increased, and the yield platform of the reinforcing bars became less visible, making the inflection point less noticeable. Furthermore, as the corrosion level above 20%, the slab specimen’s final deflection dramatically reduced.

**Fig. 10** Load-Deflection Curves for Group 2 (26% corrosion Level)

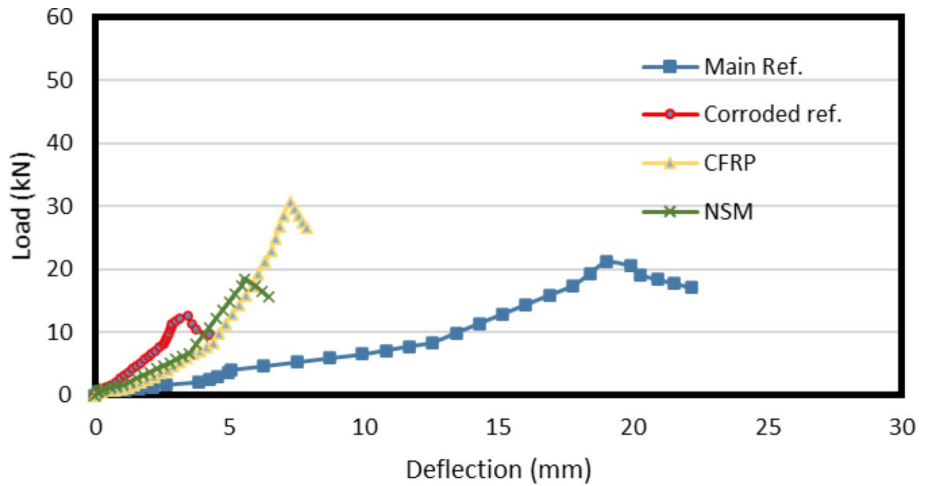
**Fig. 11** Load-Deflection Curves for Group 3 (42% Corrosion Level)

Upon corrosion of the longitudinal reinforcement, the carrying capacity of the concrete slabs, and the deflection decreasing for each corrosion percentage from the aforementioned, the load-deflection curves in Figs. (10) and (11) are evident. The benefits of adding CFRP reinforcement to the concrete slabs were evident: each slab’s bearing capacity rose to a greater extent than that of other slabs, indicating a weaker corrosion. This is because the corrosion process doesn’t have a significant impact on the iron. Additionally, the fiber-reinforced slabs’ bearing capacity dropped as the rate of corrosion rose. However, it continues to be stronger than the slab was prior to strengthening, demonstrating the robustness and high tensile resistance of the fibers utilized as well as the epoxy used.
