The Mardi Gras Shipwreck Project: Overview of Methods and Tools

Abstract The Mardi Gras Shipwreck Project was not intended to be a full recovery and documentation of an historical shipwreck 1220 m (4,000 ft.) below the surface, rather, it was a mitigation of impacts in order to comply with federal law. The principal goal was to reduce the surface visibility of the site while documenting the archaeological provenience of the artifacts and determining, as much as possible, the age, cultural affiliation, function, and historical significance of the site. This goal dictated the method of data recovery and the tools selected to meet the objective. In an extreme environment, where such a project had never been attempted before, methods and tools had to be adapted to meet the challenge. Some of the methods were successful and others were not. Ultimately, the project succeeded in its mission, and both successes and failures have informed subsequent archaeological recovery work in very deep water.

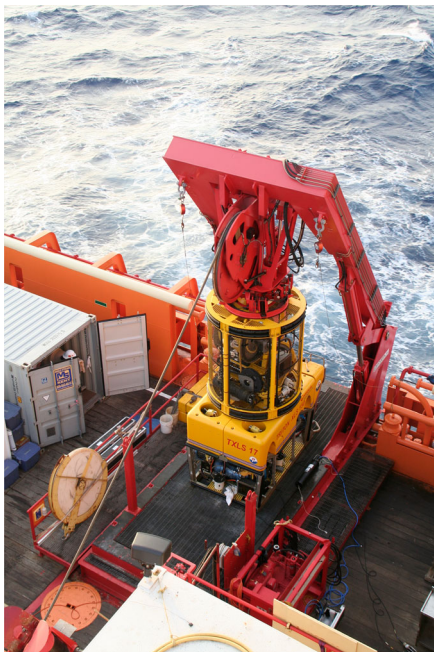
Fig. 1 The Perry Triton XLS-17 ROV employed in the Mardi Gras Shipwreck recovery. (Photo by Alexis Catsambis, 2007.)

Texas A&M University's selection of a suitable ROV was largely dictated by cost and availability in the post-Katrina Gulf of Mexico. Ultimately, Veolia Environmental, a French firm that was relatively new to the Gulf of Mexico ROV market, was contracted to provide a Perry Triton XLS-17 ROV, support vessel, and crew (Ford et al. 2008). The XLS-17 was a large 150 hp work-class ROV controlled by pilots from the surface via a fiber-optic cable (Fig. 1). The ROV was equipped with two manipulator arms, one robust "five-function" arm for heavy lifting, and one more dexterous "seven-function" arm capable of more refined and intricate movement. In addition, the ROV mounted sector-scanning sonar, video and still cameras, lights, a hydraulic system for powering various tools carried by the manipulators, and a water pump that could be used to either blow away sediment or excavate with a dredge. Despite its large size, the XLS-17, is, like most ROVs, positively buoyant, so thrusters mounted on top of the vehicle push it downward, which allows it to hover close to the bottom without disturbing soft bottom sediments.

It also has a slightly buoyant cable that prevents it from being dragged through the site and is deployed from a tether management system, or "top hat," that both serves as a down weight for the cable to the surface and isolates the ROV itself from the up-and-down movement of the ship. The XLS-17 performed well for excavation and recovery of artifacts entirely due to the skill of Veolia Environmental's pilots.

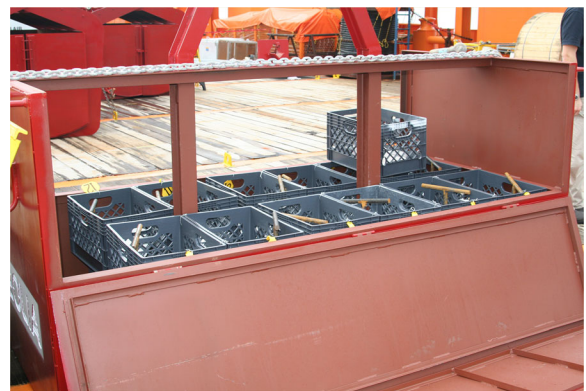
Fig. 2 The artifact recovery box, showing individually numbered crates into which single artifacts were placed. The hinged lid would be closed for the ascent to the surface. (Photo by Amy Borgens, 2007.)

they were numbered sequentially according to the section from which they were removed and placed in a numbered bin for recovery to the surface (Fig. 2). Although time consuming, this process resulted in confidence in the accurate positioning of artifacts within the site and in the overall mapping of the site itself. In the future an opportunity may arise to re-map the remains using equipment that was unavailable in 2007, such as a camera-equipped autonomous underwater vehicle (AUV).

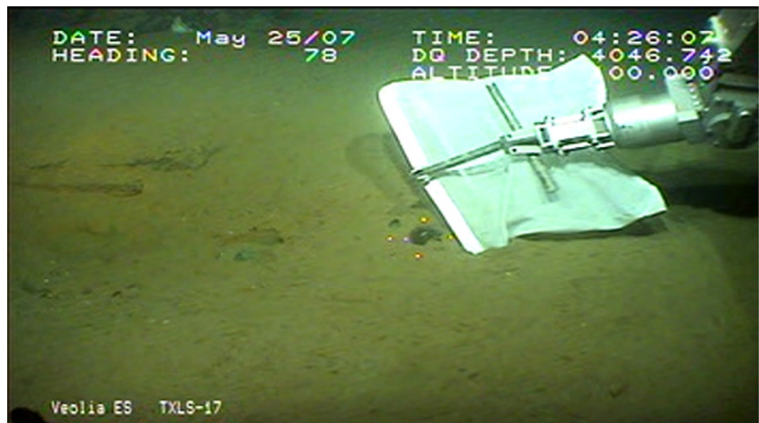
Fig. 4 A pool skimmer modified into a collection device with the addition of a “T-handle.” (Photo courtesy Texas A&M University, 2007.)

Unfortunately, a ready-made tool kit for ROV excavation does not exist, and the fabrication of the right tool onsite from available materials is often necessary. Some effective devices can be constructed from tools readily available in the local hardware store with the addition of a T-handle that can be gripped by the manipulator claw and a strong magnet to secure it to the ROV frame. Paintbrushes, an ice scoop, a dustpan, and a small shovel proved useful as excavation tools. The archaeology team thought to try some pool leaf skimmers as well, which proved useful after some onsite modification (Fig. 4). Even a fry basket “liberated” from the galley was modified into a collection tool (Fig. 5). These

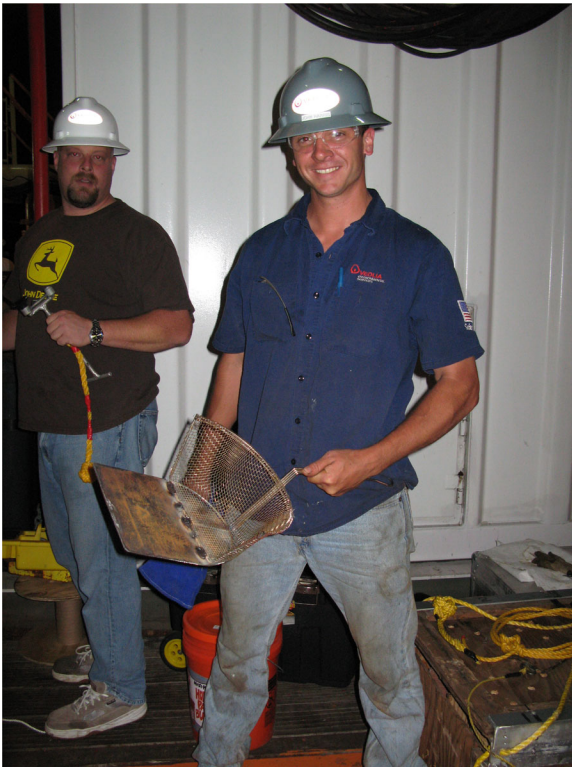
Fig. 5 One of the ROV pilots displaying an artifact retrieval tool modified from a fry basket. (Photo by Laura Landry, 2007.)

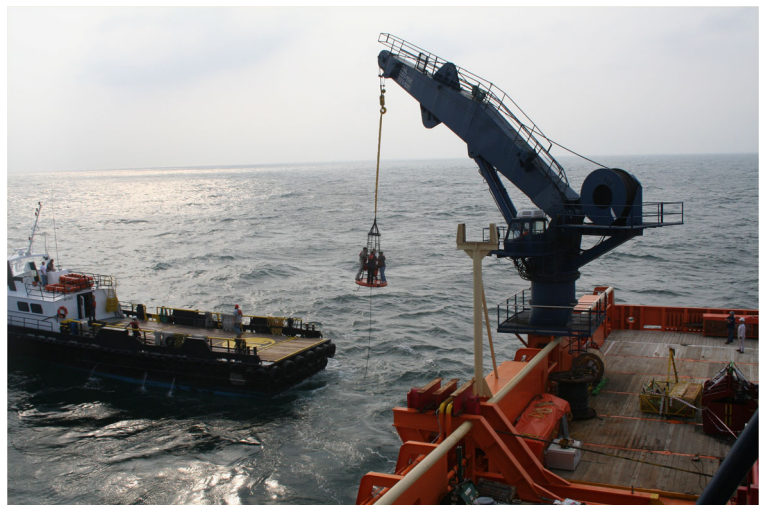
Fig. 6 The onboard crane of the ROV support ship *Toisa Vigilant* in use transferring personnel from a crew boat. The crane also was used to raise artifacts from the seafloor. (Photo by Amy Borgens, 2007.)

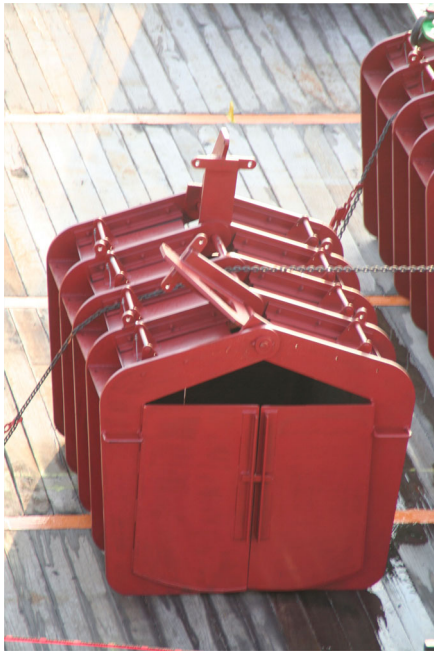
Fig. 7 The large-artifact retrieval tool (LART). (Photo by Alexis Catsambis, 2007.)

One of the greatest challenges faced by the archaeological team was the recovery of several large artifacts or features that could not be lifted by the ROV alone. These included a cannon; a ship’s stove; a large concretion in the stern; and a wooden crate filled with muskets, pistols, swords, and other edged weapons. The cannon was relatively easy to bring to the surface using the large crane (Fig. 6) mounted on the aft quarter of the 80.5 m (264 ft.) ROV support-ship *Toisa Vigilant* using canvas straps and a spreader bar. The stove, the concretion, and the wooden crate were far more difficult challenges, and their recovery was accompanied by considerable discussion and angst. Working with Veolia’s engineers, Texas A&M’s archaeological staff developed devices that they somewhat euphemistically termed large-artifact retrieval tools (LARTs) (Fig. 7), but which were, for all intents and purposes, hydraulically actuated clam-shell buckets. The LARTs were intended to be slowly

lowered by the ship's crane over the artifact or feature and then closed using the ROV's hydraulic "hot stab." After testing the device offsite, a LART was first applied to the large concretion in the stern area of the wreck. The LART succeeded in enveloping the concretion and removing it from the site en masse.

Unfortunately, the weight of the LART caused it to bite more deeply into the substrate than anticipated. Despite first excavating around the concretion to recover any small finds and to try to ascertain whether hull structure lay beneath the concretion, the excavation had not proceeded deeply enough to fully establish the absence of structural remains. In fact, the LART bit into and removed frames and bisected part of the boom that lay buried to one side of the concretion. The concretion remained encapsulated in the steel LART until it was removed at the Texas A&M Conservation Research Laboratory, where it was carefully excavated. The stern concretion has proven to be a key element in the interpretation of the site, but the inability to control the vertical depth of the cut dissuaded the staff from using this method elsewhere on the site. The archaeological staff was acutely aware of the unorthodox appearance of the device, but ultimately deemed its use both justified and essential to accomplish the Section 106-driven goals of the project in much the same way a backhoe might be used on land.
