# Unearthing South Australia's Oldest Known Shipwreck: The Bark *South Australian* (1837)

James W. Hunter III · Kieran Hosty · Rick Bullers · Irimi Malliaros · Adam Paterson · Chris Wilson · Tim Zapor · Katarina Jerbic · Wendy van Duivenvoorde

**Abstract** In early 2018, a collaborative team composed of maritime archaeologists, museum specialists, and volunteers from the South Australian Department for Environment and Water, South Australian Maritime Museum, Silentworld Foundation, Australian National Maritime Museum, MaP Fund, and Flinders University surveyed for and located the shipwreck site of the bark *South Australian*. Lost at Rosetta Harbor (at the western end of modern-day Encounter Bay) in December 1837, *South Australian* is South Australia's oldest documented shipwreck. Its significance also derives from its use as one of the earliest immigration ships to ferry European settlers to the colony of South Australia, as well as careers

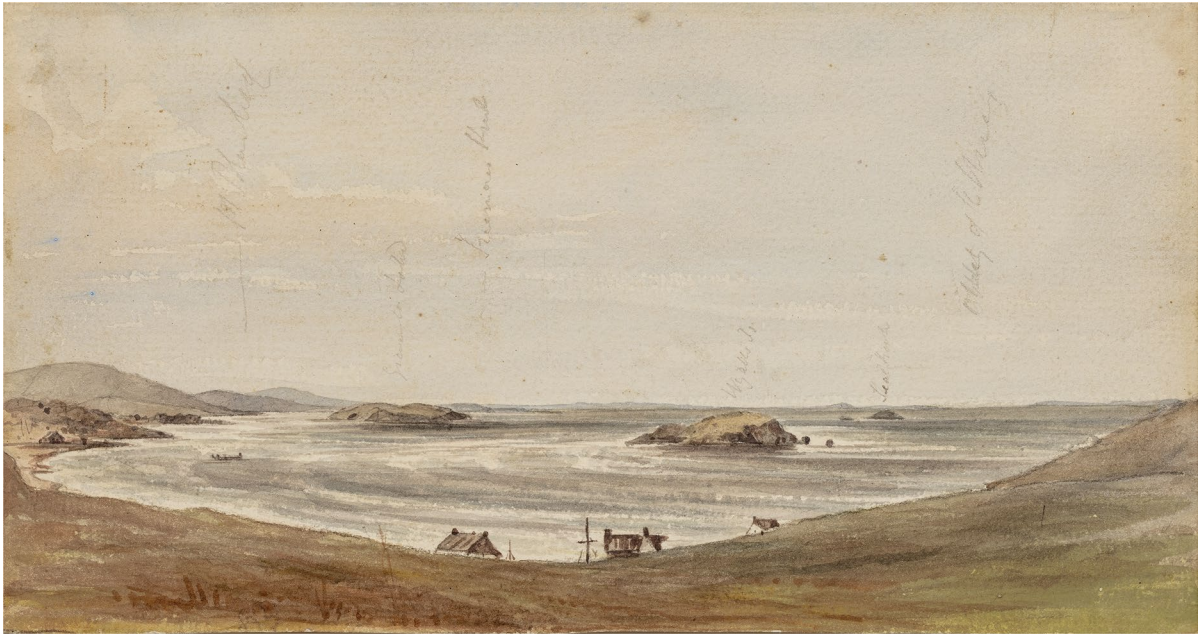
**Fig. 4** Watercolor of Rosetta Harbor by E. C. Frome, 1841, showing *South Australian*'s wrecked hull in nearshore waters at center left of the image. (Image courtesy of the Art Gallery of South Australia.)

of the vessel was still visible above the water's surface for a few years, as evidenced by its appearance in a watercolor painted by artist E. C. Frome when he visited Rosetta Harbor in 1841 (Fig. 4). Although no supporting evidence is known to exist in historical sources, there is little doubt the wreck was targeted for opportunistic salvage and scavenging by the crews of nearby whaling stations, as well as local Aboriginal people and the earliest inhabitants of Yilki, the area's first permanent European settlement.

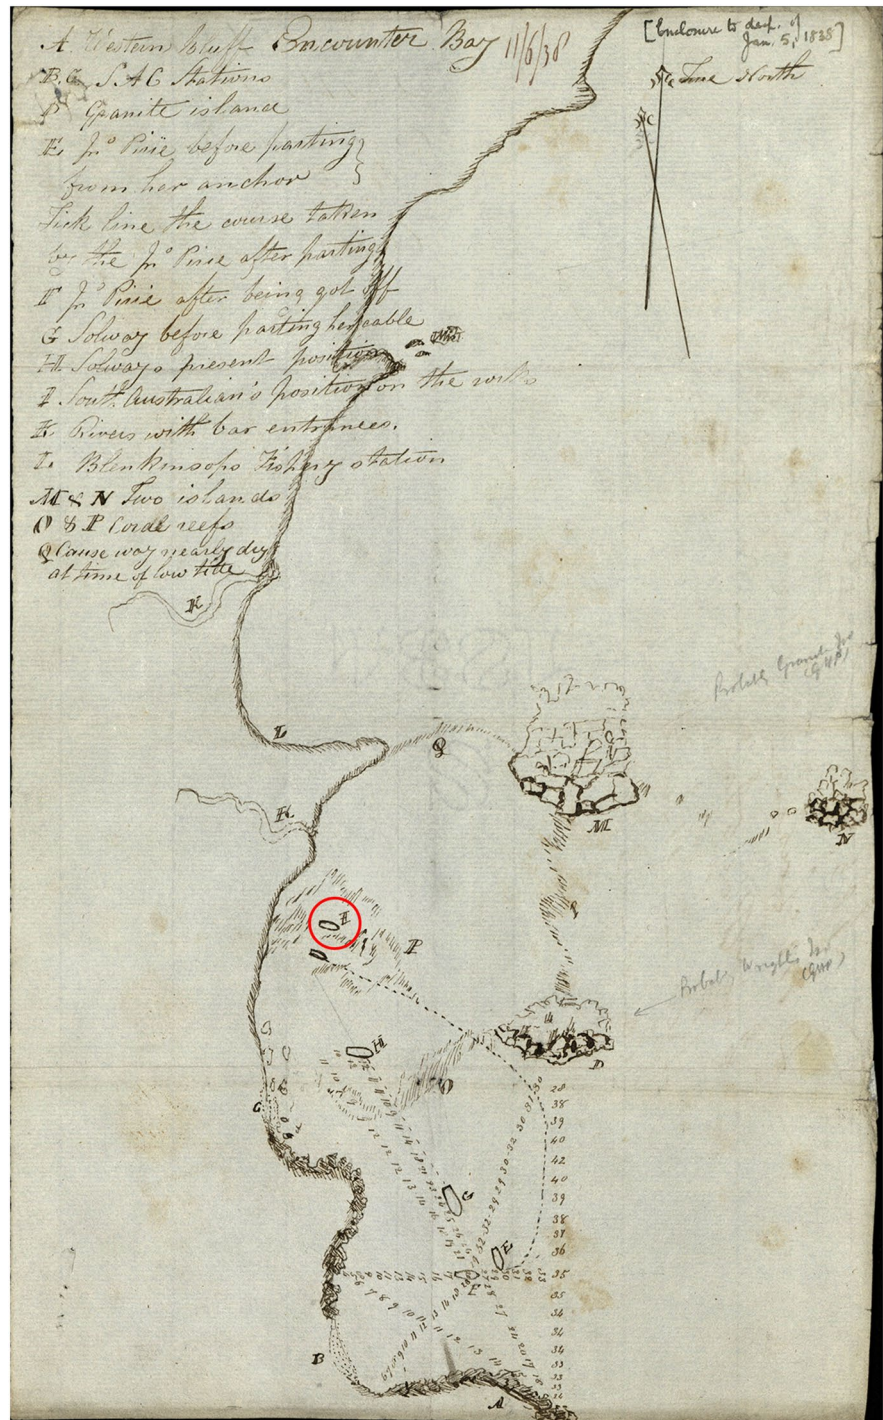
**Fig. 5** Henry Mildred’s 1838 sketch map of Rosetta Harbor, showing *South Australian*’s loss location (circled). The associated caption reads: “I. *South Australian*’s position on the rocks.” (Map courtesy of the State Library of South Australia.)

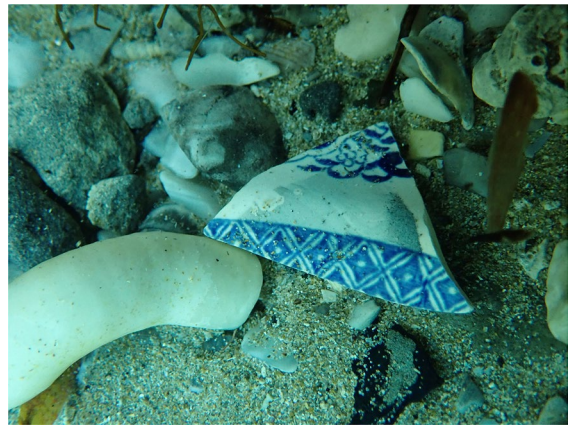
**Fig. 9** Sherd of hand-painted blue-and-white pearlware in situ. (Photo by Irimi Malliaros; courtesy of SAILS.)

Four fragments of decorated ceramic were observed on *South Australian*, three of which were left in situ, and the other recovered in June 2019 for analysis. All four were located at the interface between the wreck site's midships and stern sections. One in situ fragment was an example of hand-painted blue-and-white pearlware that may have originated from a teacup or small lid (e.g., for a sugar bowl or teapot). Both surfaces were covered in a clear, shiny glaze, and the exterior featured a brilliant underglaze cobalt blue hand-painted decoration that comprised part of a floral motif at one end, and a trellis band with a repetitive dot-diaper pattern at the other (Fig. 9).

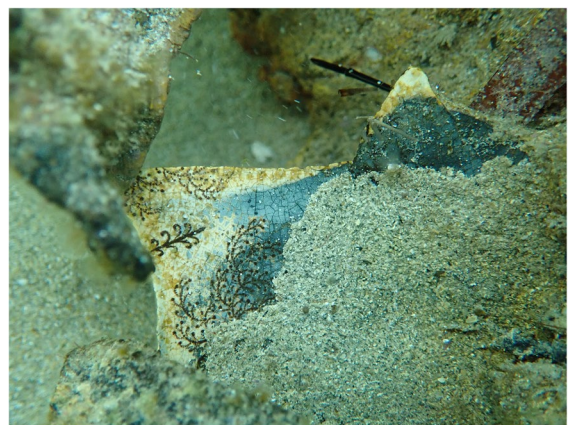
**Fig. 10** Seaweed- or Fibre-pattern transfer-printed ceramic sherd in situ. Note the encapsulating iron concretion. (Photo by Irimi Malliaros; courtesy of SAILS.)

The two other fragments left in situ appear to be examples of either "Seaweed" or "Fibre" pattern transfer-printed ceramics that originated from a bowl, cup, or similar form of tableware (Fig. 10). Both are mostly embedded in iron concretion, but what remains visible features pale blue underglaze decoration atop a white refined earthenware body. The blue underglaze appears hazy or blurred and may represent a form of flow-blue transferware design. One sherd features a delicate, dark brown dotted or "stippled" dendritic design atop the blue underglaze, while the other retains part of a plain vessel rim. Both are covered in a clear lead glaze that exhibits extensive cracking.

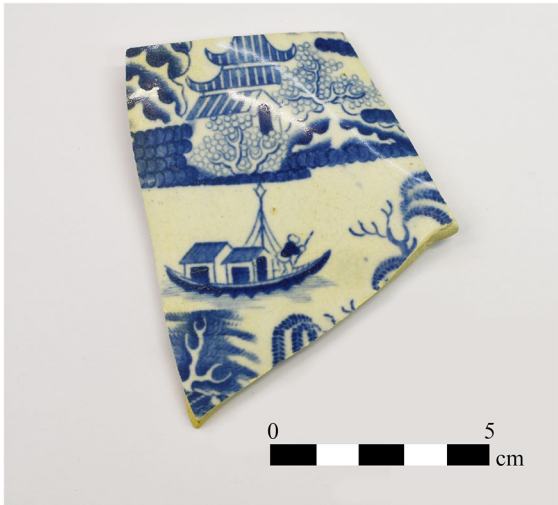
**Fig. 11** Sherd of transfer-printed Blue Willow pattern ceramic recovered from *South Australian* in June 2019. (Photo by Katarina Jerbic; courtesy of SAILS.)

The recovered ceramic fragment is somewhat larger and appears to have originated from the body of a wide, straight-sided vessel, such as a washbasin or chamber pot. Like the smaller sherd, it is covered in transparent shiny glaze on both its interior and exterior surfaces; however, its exterior is decorated with a transfer-printed "Blue Willow" pattern riverine landscape (Fig. 11). The sherd's interior surface is undecorated, and its bright white paste strongly suggests it is a form of whiteware.

Transfer-printed Blue Willow pattern ceramics were first introduced around 1790 and are characterized by a riverine landscape that depicts a bridge and large pagoda in the foreground, several small pagodas or houses on

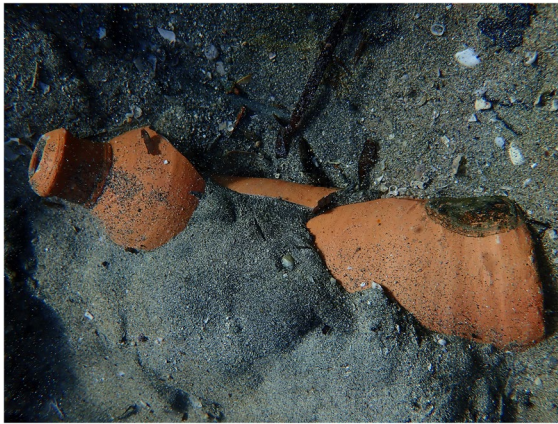
**Fig. 12** Broken stoneware mineral-water jug in situ in *South Australian*'s bow section. (Photo by Irini Malliaros; courtesy of SAILS.)

Remnants of a salt-glazed stoneware jug were located during the June 2019 survey, immediately adjacent to the waterway within *South Australian*’s port bow section (Fig. 8). Although broken, the jug appears mostly intact, but was embedded within iron concretion and consequently left in situ (Fig. 12). Its color, ceramic composition, and overall form closely resemble stoneware jugs manufactured for German mineral-water producers, such as Selters and Tolles, during the early 19th century. Due to its perceived therapeutic properties, German mineral water was immensely popular throughout Europe, and was shipped to myriad European colonies during the 18th and 19th centuries (Krivor et al. 2010:137). Neither a handle nor seal—features common on German mineral-water jugs—were observed on the example found on *South Australian* but may be obscured by concretion.

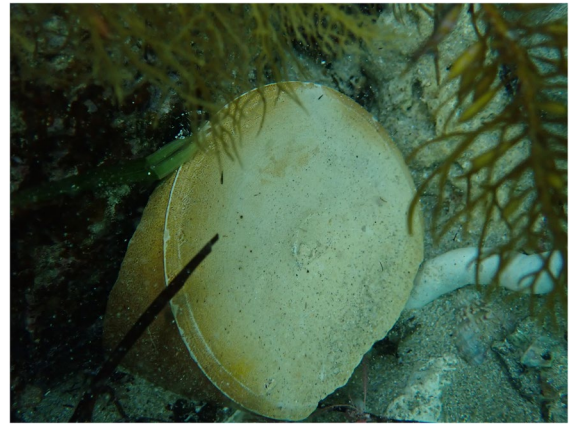
**Fig. 13** Basal fragment of Derbyshire stoneware jug in situ. (Photo by Irini Malliaros; courtesy of SAILS.)

A complete basal fragment of another salt-glazed stoneware vessel was located within the midships/stern interface but not recovered (Fig. 13). Its gray/buff paste and honey-brown colored external glaze most closely approximate Derbyshire stoneware produced during the first quarter of the 19th century (Oswald and Hughes 1974; Hildyard 1985:82). The sherd features a dark colored internal glaze that suggests it was produced after 1825, when olive green lead glazes were added internally to Derbyshire stoneware jars and bottles, but before 1835, when they were replaced by clear Bristol glazes (Askey 1998).

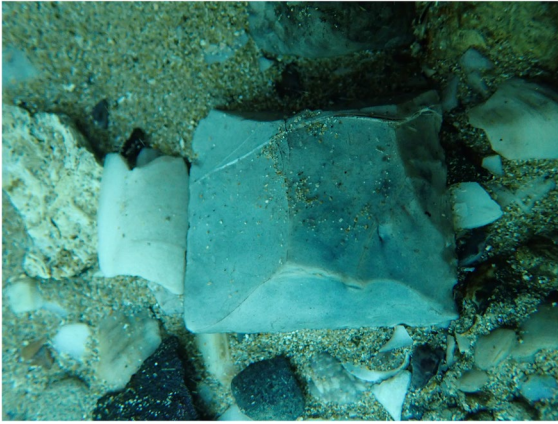
**Fig. 15** Possible flint strike-a-light or fire starter in situ. (Photo by Irini Malliaros; courtesy of SAILS.)

The second flint observed on *South Australian* differs from the first, most notably in size. It appears to be much larger than usual, measuring approximately 4–5 cm long on each of its four sides (Fig. 15). The bevels of both the heel and leading edge appear to have a similar angle, suggesting it is a possible "double-edge" gunflint, while the bevels on the two sides are more acute and demicones are apparent on the side edges of the platform (de Lotbiniere 1984). While not conclusive, the apparent size of this flint precludes its use in standard small arms or artillery, and more closely matches gunflints for wall pieces, as per Skertchly (1879). However, the greater likelihood is that it was used as a strike-a-light/fire starter (J. Ferguson and Torben B. Ballin 2018, pers. comm.; Torben B. Ballin 2021, pers. comm.).
