# A comparative study of hardness/scratch/wear properties of TiCN and TiAlN coatings on DIN 1.2842 steel by CA-PVD method

In the present study, TiCN and TiAlN were deposited on DIN 1.2842 (AISI O2) steel, and their mechanical properties was compared by investigating coating thickness, adhesion strength, microhardness, and elastic modulus. To carry out characterizations, micro-wear test, Rockwell C adhesion, microhardness test, and scratch test were applied on TiCN- and TiAlN-coated DIN 1.2842 (AISI O2) steel. Deposition of the TiCN and TiAlN coatings was carried out on the hardened steel substrates (55–57 HRC) at 450–500°C by cathodic arc physical vapor deposition (CA-PVD) method. As a result of the applied tests, adequate adhesion strength was obtained for both hard coatings. Through thickness microcrack, buckling failure mode and buckle spallation failure mode are observed at critical loads as Lc1, Lc2, and Lc3, respectively. TiAlN coating has better indentation hardness properties and elastic modulus. Wear resistance of TiAlN coating is better than that of TiCN coating due to similarity with substrate and tougher metallic character.

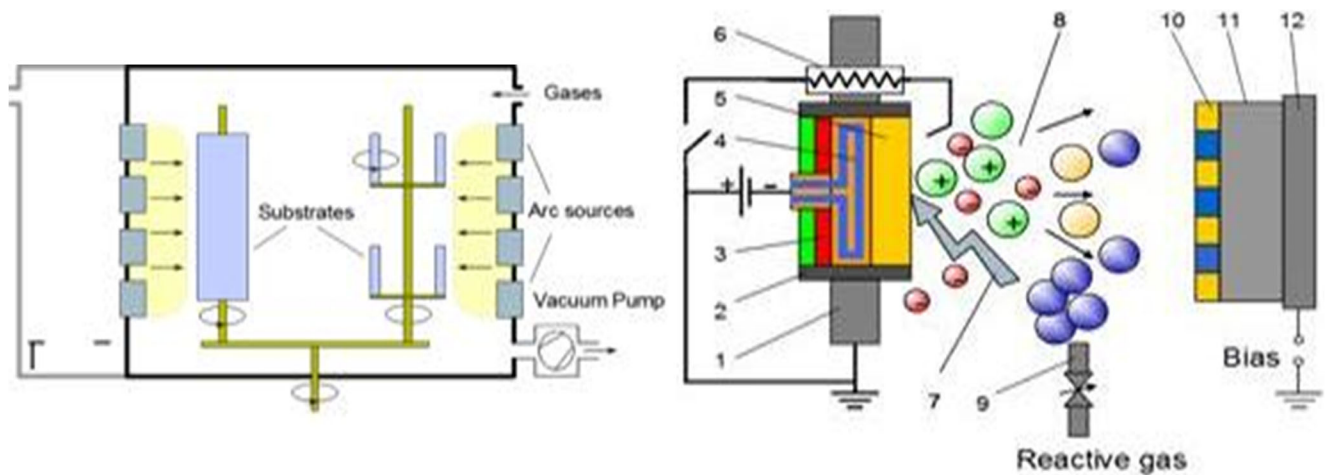
**Fig. 1** The schematic representation of the coating process (1, part of the coater wall; 2, insulator; 3, magnet system; 4, cooled copper plate; 5, target; 6, ignitor; 7, arc; 8, ionized metal vapor; 9, reactive gas inlet; 10, coating; 11, tool; 12, tool holder)

Cathodic arc coating method is used to deposit TiCN and TiAlN PVD coatings on all of the steels. Coating process was performed at a temperature in the range of 450–500°C. Figure 1 shows the schematic representation of coating process.

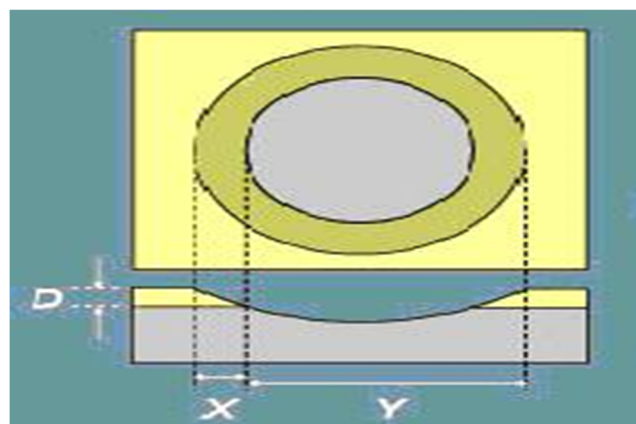
**Fig. 2** Schematic representation of the CSM Calotest

EDX analysis of TiCN- and TiAlN PVD-coated steel rods was first carried out. Then, microhardness tests were performed. After microhardness test, to calculate the coating thickness abrasion, tests were performed on all samples using a 0.5 µm size diamond abrasive solution in CSM Calotest Abrasion Test Machine. After the abrasion test, an elliptical attrition appeared on the surfaces because of the specimen round shape. The inner and the outer radiuses of the ellipses were measured using an optical microscope and image analysis software (Fig. 2).

Coating thickness was calculated by using measured radius values in Eq. (1). This test also helped us to detect if the coating was a single layer and if there were any impurities (droplet density, Schiff Fehler, SF) within the coatings. Coating thickness,  $D$ , is calculated by using following equation:

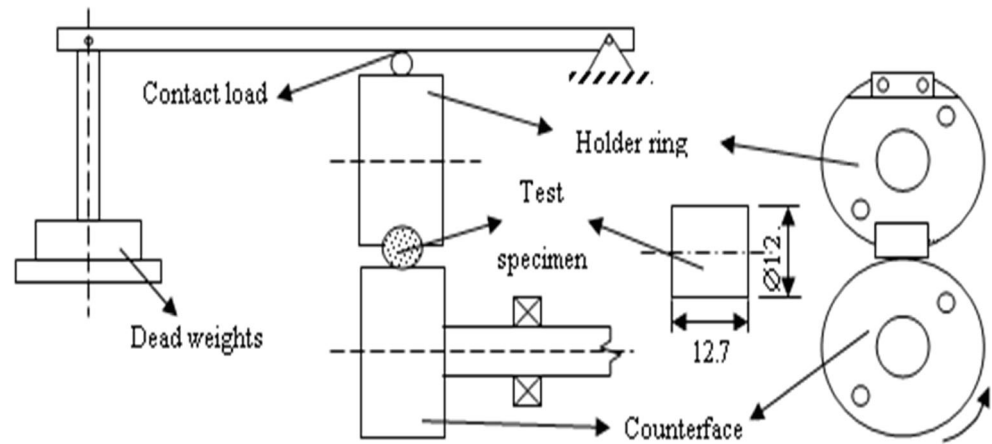
**Fig. 3** The schematic diagram of wear test apparatus

To evaluate the wear characteristics of the coatings, a pin-on-roller type of apparatus (PLINT multipurpose friction machine) was used as shown in Fig. 3. Load was controlled by adjusting manually, and revolution speed of roller was controlled and recorded to a computer automatically. The samples were loaded against the abrasive roller, which was made out of nitrided cast iron, with the help of a cantilever mechanism. The wear pin was cleaned in acetone before and after the wear tests, and then the dried pin was weighed on a microbalance with 0.1 mg sensitivity. Each test was performed with a new roller. In all wear test, the revolution speed (500 rpm) and load (67 N) are kept constant, but sliding distance is varied as 300, 600, 900, 1200, 1500, and 1800 m, and wear amount was determined for all specific cases.

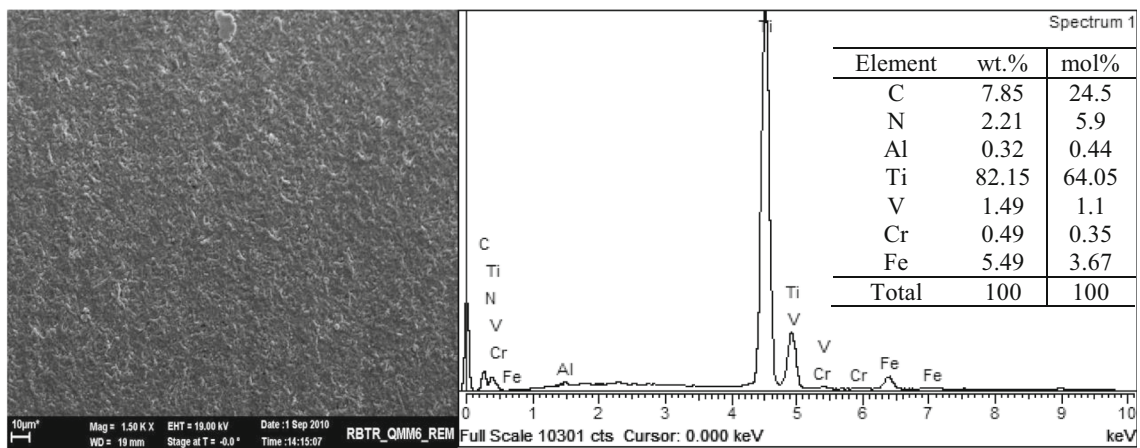
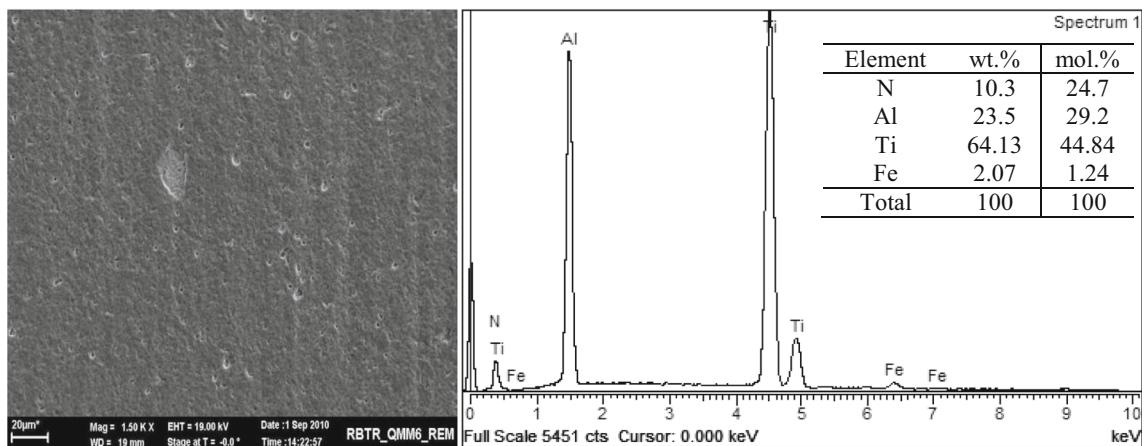
**Fig. 4**  $\times 1500$  picture and EDX analysis of coatings: **a** TiCN and **b** TiAlN

Chemical composition and microstructure of the coated surfaces were also characterized by using SEM-EDX. Figure 4 shows  $\times 1500$  magnification picture and EDX analysis of the TiCN- and TiAlN ceramic-coated DIN 1.2842 (AISI O2) steel surfaces. EDX results show that, for TiCN coating, the steel peaks come from main metal due to high voltage acceleration as 19 kV, which may penetrate the electrons through 3 microns, so Fe-Cr-V elements come from main metal. When the molar ratios of elements were calculated by EDX wt%, the average TiCN formation can be evaluated as  $Ti_{0.675}(C_{0.258}N_{0.062})$ . This composition is more in metallic character after subtraction of main

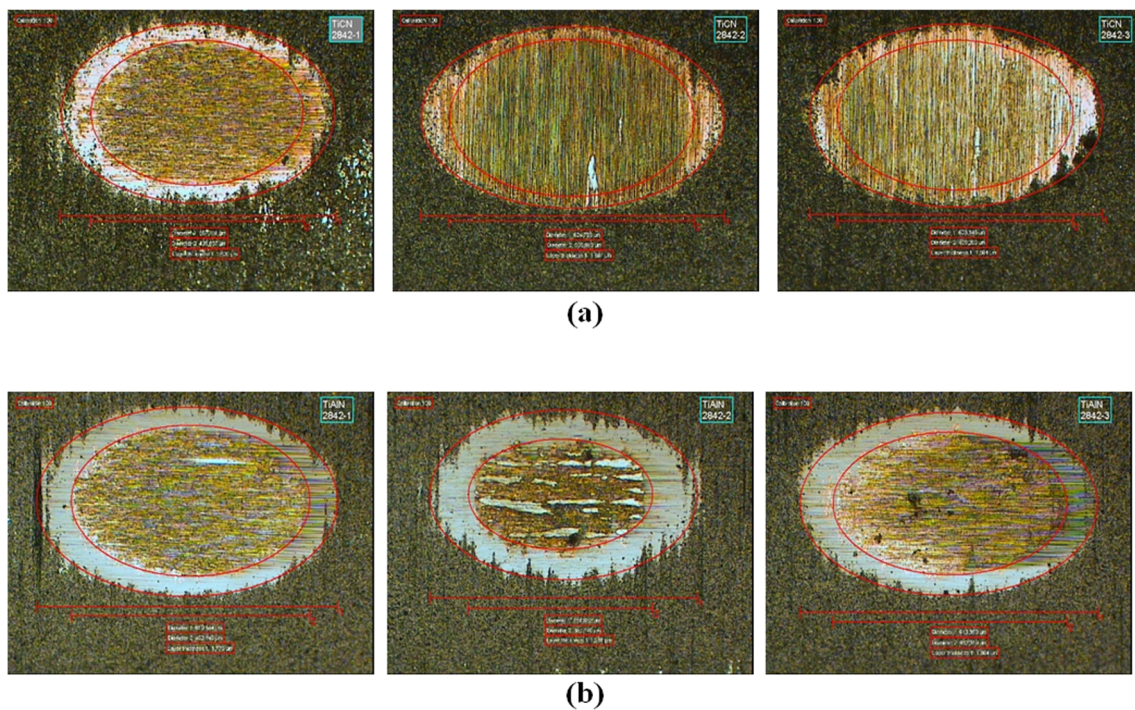
**Fig. 5** Coating surfaces of abrasion wear: **a** TiCN and **b** TiAlN

TiCN and TiAlN coating thicknesses were measured on three samples using a CSM Calotest Abrasion Instrument. Figure 6 shows the tracks of Calotest abrasion. Track of abrasion test gives information about coating quality such as surface cleanness, impurities, and adhesion strength. As it is seen in Fig. 8b (middle picture), removal of coating (white color and black or gray color) was obviously seen in the inner side of elliptical attrition.

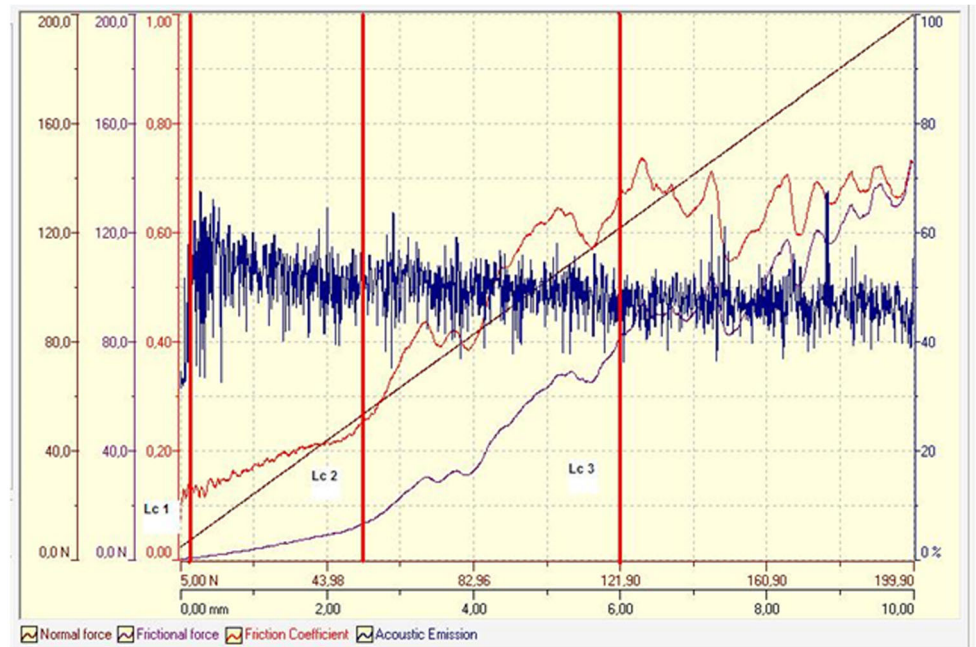
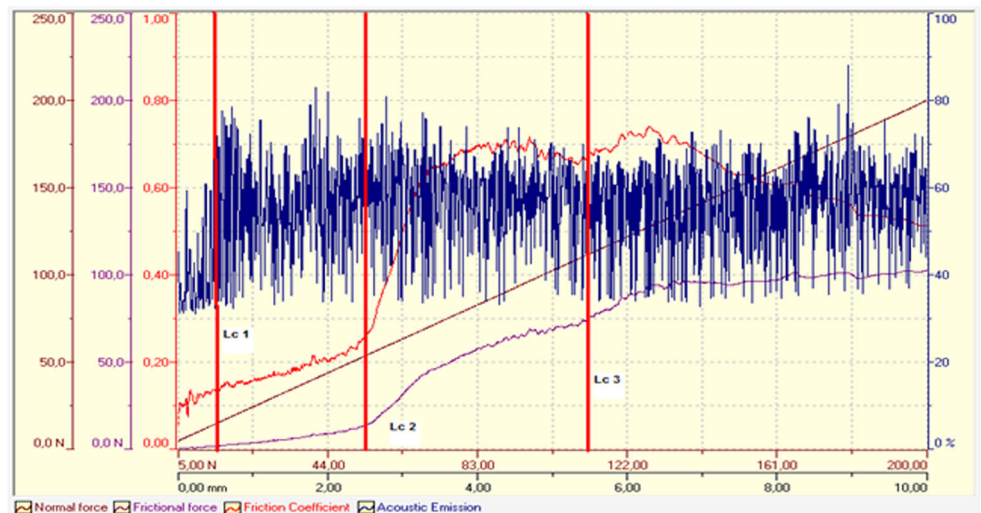
**Fig. 6** Scratch test results of DIN 1.2842 steel: **a** TiCN and **b** TiAlN

$L_{c1}$  critical load is determined using the acoustic signals in scratch test data. However, the ability of getting acoustic signals is depended on the coating thickness. Valli et al. [1] used scratch test to characterize TiN coating on M2 HSS and ASP30 sintered HSS. According to their study, it was required to have at least  $1.5 \mu\text{m}$  TiN coating thickness in order to obtain acoustic signals. The coating thickness of TiCN ( $1.635 \mu\text{m}$ ) and TiAlN ( $1.854 \mu\text{m}$ ) was measured sufficiently higher than  $1.5 \mu\text{m}$  in this study; therefore, the acoustic signals could be acquired and interpreted. Figure 7 depicts the scratch test results for TiCN and TiAlN coatings on the surfaces of DIN 1.2842 steel, and Table 4 gives scratch tests results and their average values.

When the experiment results are investigated, the critical loads ( $L_{c1}$ ,  $L_{c2}$ ,  $L_{c3}$ ) are defined by analyzing three significant parameters, which are acoustic signal, friction force, and friction coefficient.  $L_{c1}$  is determined critical load point, where the acoustic signal rises immediately.  $L_{c2}$  is critical load point where the friction force and friction coefficients increase at the same time with a higher slope. The location, where the acoustic signal and the friction coefficient started to create straight lines, is the determined location of  $L_{c3}$  critical load.

The average values of TiCN and TiAlN coating properties were compared. While the critical load ( $L_{c1}$ ) where the first microcrack occurred for TiCN coating is  $7.92 \text{ N}$  at  $0.15 \text{ mm}$  distance, for TiAlN coating  $L_{c1}$

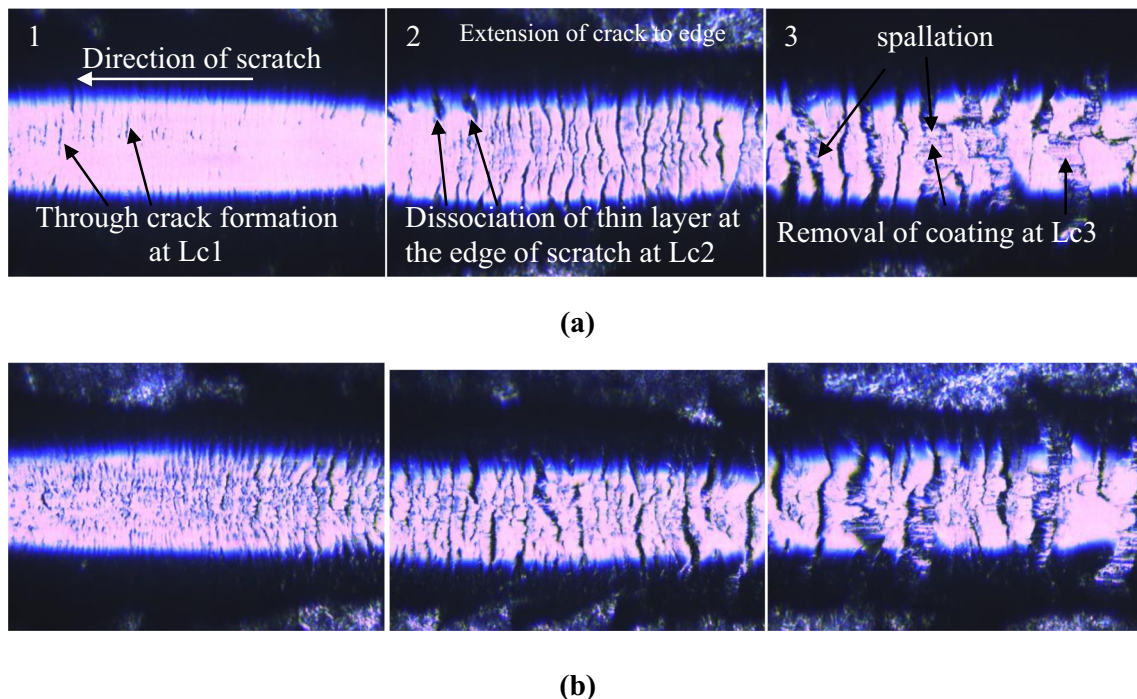
**Fig. 7** The optical microscopy top view of the scratch lines and critical loads obtained from scratch test for DIN 1.2842 steel: **a** TiCN and **b** TiAlN

The groove created in the scratch test was examined using an optical microscope with  $\times 200$  magnification in order to determine the failure mode. Figure 8 shows the formation of through thickness microcrack ( $L_{C1}$ ), load bearing capacity ( $L_{C2}$ ), and complete removal of the coating ( $L_{C3}$ ) for TiCN and TiAlN coatings of DIN 1.2842 steel. In both coatings, the through thickness cracks occur at the critical load of  $L_{C1}$  (Fig. 8a1 and b1).

Through thickness cracks in the TiCN coating are fine and less amount as compared to cracks in the TiAlN coating. At critical load of  $L_{C2}$ , buckling failure mode was observed in both coatings. Buckling failures typically appear as curved cracks extending to the edges of or beyond the scratch track (Fig. 8a2 and b2). In this failure mode, failure occurs in response to the compressive stresses generated ahead of the moving indenter. Localized regions containing interfacial defects allow the coating to buckle in response to the stresses. Individual buckles spread laterally by propagation of interfacial crack. At the critical load of  $L_{C2}$ , slopes of coefficient of friction and frictional force increase sharply (Fig. 7a and b). At the critical load of  $L_{C3}$ , buckle spallation failure mode was observed. Removal of coating occurs when through thickness cracks form in regions of high tensile stress within the coating.

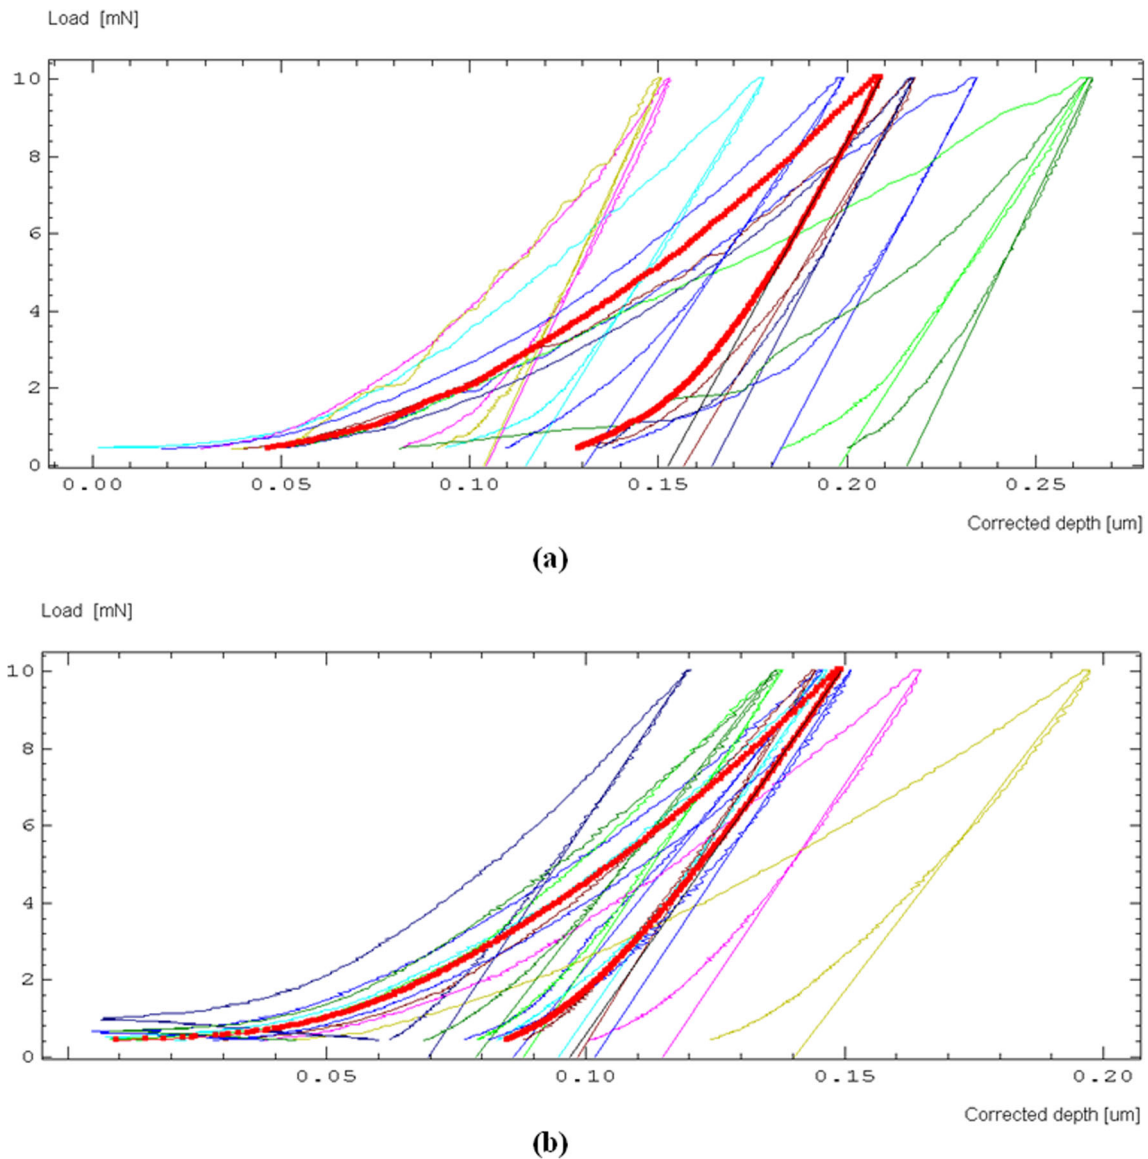
**Fig. 8** Load-depth diagram obtained after dynamic microhardness test for **a** TiCN and **b** TiAlN coatings. The graphs include 9 tests and the average curve (red curve)

Dynamic microhardness tests were performed on each sample for 10 times, and the worst test was eliminated; therefore, 9 indentations were used for calculations in order to get reliable results. Figure 9 shows the load vs. depth diagram for 9 tests of TiCN and TiAlN coatings and the software calculated mean curve (red color) for both type of coatings.

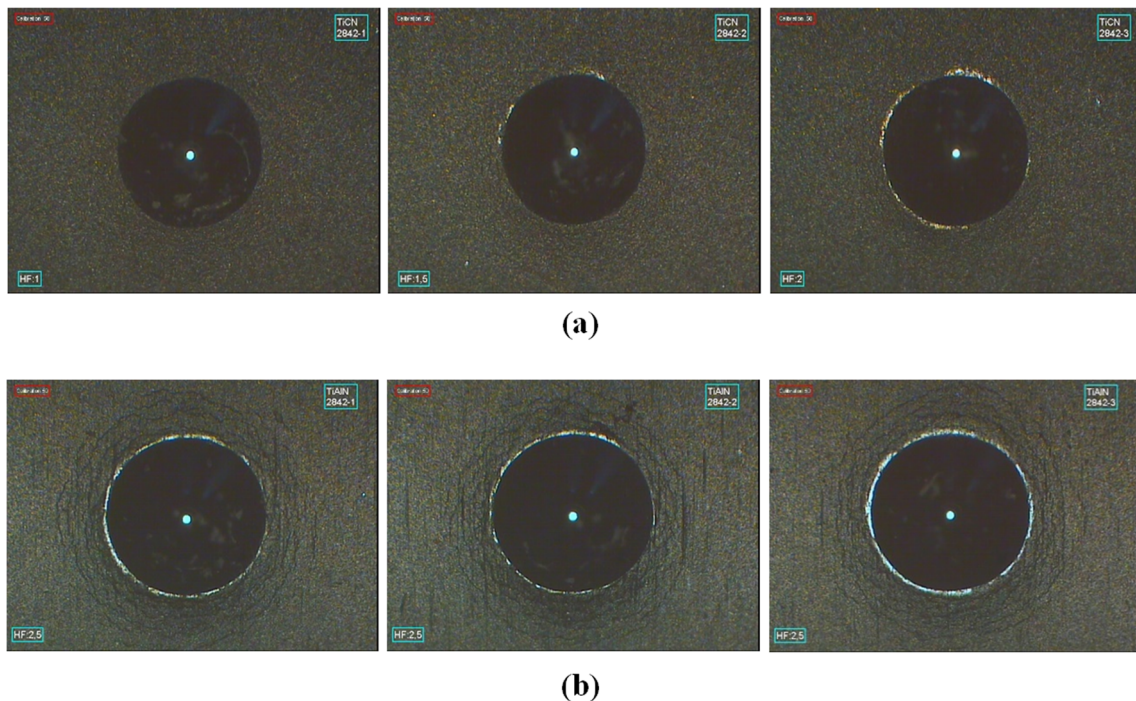
**Fig. 9** Rockwell C adhesion test for 1.2842: **a)** TiCN (HF=1, HF=1.5, HF = 2) and **b)** TiAlN (HF = 2.5, HF=2.5, HF=2.5)

This is the most commonly used test in industry for determining the quality of a coating. Figure 9 shows the Rockwell C adhesion test marks on the surface of steels, respectively. If HF value is above 4, then it means that the coating does not have enough adhesion strength on the surface. This adhesion strength can be concluded as the negative (compression) stress that leads to a better bonding when illustrated in images.

As seen in Fig. 9, HF values for TiCN and TiAlN coatings determined below 4 using the reference images for comparison by the software that was described in standards, respectively. It means that the coatings have high enough adhesion strength to make itself adequate to use. When two coatings are compared, adhesion strength of TiCN coating can be said better than that of TiAlN coating since HF values of TiCN coating are smaller than that of TiAlN coating. TiCN is a more similar coating to substrate than TiAlN by means of elemental composition on DIN 1.2842. The elements of interest in TiCN can be evaluated closer to carbon ratio of DIN 1.2842 by surficial. The carbon content of TiCN was estimated to be around 0.2–0.3 which can be similar on the surface of DIN 1.2842 that may lead to the same C content to form better bonds as well as N, since N is not present on substrate, but has an advantage of bonding to form nitride by Fe as of C.

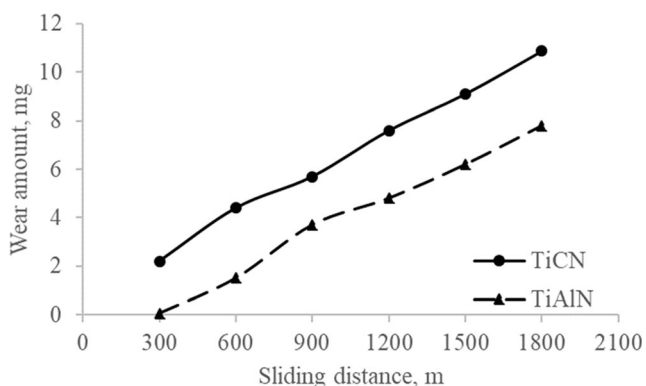
**Fig. 10** Wear test result of coatings

Figure 10 shows the wear test results of TiCN and TiAlN coatings. As the sliding distance increases, wear amount

increases for both coatings. Also, TiAlN coating has less wear amount than TiCN for each sliding distance. Therefore, wear resistance of TiAlN coating is better than that of TiCN coating. Bressan et al. worked on the TiCN and TiAlN coatings on the surface of M2 HSS, and similar result was obtained [22]. It was concluded that in general, the tribological performance of TiAlN is superior to TiCN.
