Non-destructive thickness measurement of thermal barrier coatings using terahertz radiation

Abstract

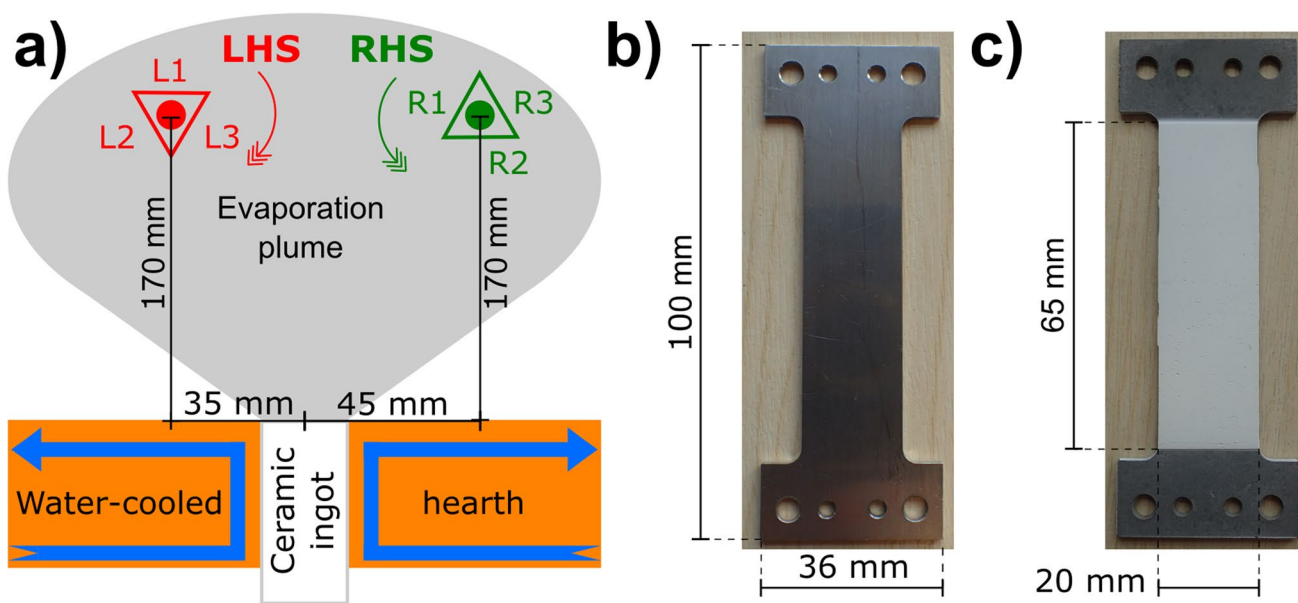
Fig. 1 a Schematic plan view of the EB-PVD deposition chamber where up to three samples can be mounted on each holder (left-hand side — LHS for samples L1, L2, L3, and right-hand side — RHS for samples R1, R2, R3). The dog-bones are mounted to the sample

holder with their long dimension perpendicular to the plane of the schematic. Image of dog-bone substrates **b** before and **c** after TBC deposition (bondcoat and 7YSZ)

Sample substrates were nickel alloy Nimonic® 75, machined to a dog-bone shape, 100 mm long and 36 mm wide. In previous experiments, similar dog-bones were pulled to investigate strain-induced birefringence in the TBC with GHz illumination [13, 14]: in the experiments reported in this paper, the dog-bones were not tensioned but were used to take advantage of existing mounts for the specimens during coating and the THz measurements. A β -NiAl bonding layer, 25–40 μm thick, was deposited onto grit-blasted substrates using Cranfield University's chemical vapour deposition facilities. For aging purposes that will be covered in a future publication, an intentional defect was introduced on the bondcoat of samples R1 and L1. The defect was created by masking-off the central region (around $x=0$ mm, $y=0$ mm, and of 5–10 mm in diameter) during the bondcoat deposition process to provide a region with low aluminium content. Finally, the aluminised samples were grit-blasted again and a ~300- μm -thick, 7 wt.% yttria-stabilised zirconia (7YSZ) layer was deposited using electron beam physical vapour deposition (EB-PVD) in Cranfield's custom-modified Electrotech CL680 vacuum coater (8 kW gun). The coater's loading chamber, described in Fig. 1a, can accommodate six substrates distributed around two triangular sample holders that are continuously rotated during deposition as per the figure. The long dimensions of the samples are laid perpendicular to the perspective of Fig. 1a and have a top–bottom orientation: top is closer to the viewer's perspective. Coating deposition took place at 1030 °C, in a 90% O₂/10% Ar atmosphere at $6 \cdot 10^{-3}$ mbar. The sample holders are designed to mask the end of the dog-bones and restrict the coating deposition to a narrower area of ~65 mm \times 20 mm, as shown in Fig. 1b and c.

to the ingot (Fig. 1). There seem to be small thickness variations within the L samples, as well as within the R samples, with L3 and R2 being the thickest of the groups. This is likely a consequence of the holders not being

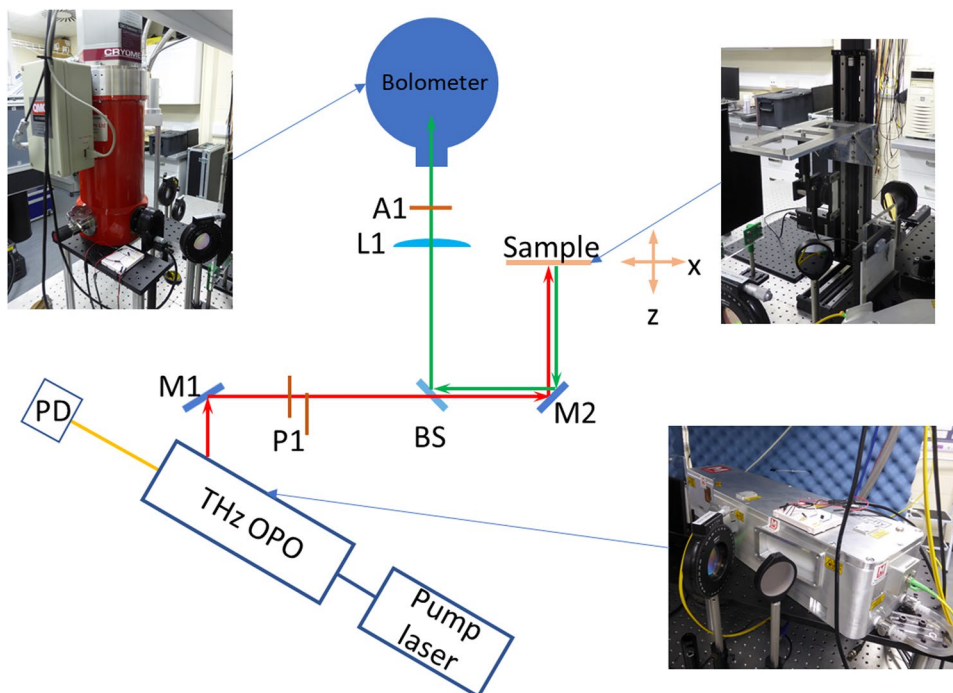
Fig. 2 Schematic of experimental setup. M1, flat mirror; P1, linear polariser; BS, Si beam splitter; M2, parabolic mirror; L1, PTFE lens; A1, linear analyser; PD, photodiode

Figure 2 presents a schematic of the THz experimental setup. The THz idler beam output, produced by the M2 Firefly OPO, under pump illumination supplied by the 1064 nm M2-ICE laser, is passed through a linear polariser (P1) to ensure that

the illumination entering the system is vertically polarised. Due to the observed ~10% pulse-to-pulse THz intensity variation, the near-IR signal beam from the OPO was monitored by an InGaAs photodiode (PD) to allow compensation for this variation to be made. Each measurement point presented in this paper is the average of 50 pulses to further

improve the overall SNR of the data. The parabolic mirror M2 ($f=152.4$ mm) focuses the incident THz beam (shown in red) on to the sample and the reflected beam (shown in green) is then transmitted back along the incident beam path and reflected by the Si beam splitter (BS) into the detection arm of the instrument. The PTFE lens L1 ($f=100$ mm) is then used to focus the reflected THz beam onto the THz detector. In this paper, a cryostatically cooled superconducting bolometer (QMC Instruments Ltd QNbTES/X) was used but the Firefly system is of sufficient brightness that a lower-specification detector, such as a pyrometer, could equally well be used. The sample is translated in X, Y and Z directions by means of a set of motorised translation stages (Zaber Technologies Inc. X-LRQxxxBL-E01; x-,y- 450 mm; z- 75 mm) allowing a scan of the whole sample to be made at a maximum resolution corresponding to the measured focal spot diameter of 1 mm on the TBC specimen. Currently, the overall measurement speed of the system is relatively slow due to the low repetition rate of the THz laser (50 Hz), the need to mechanically translate the samples with each translation point taking approximately 1.5 s and each of the four frequencies approximately 1 s, and the large amount of measuring points (1,200 per sample), leading to a total measurement time per sample of around 5 h.

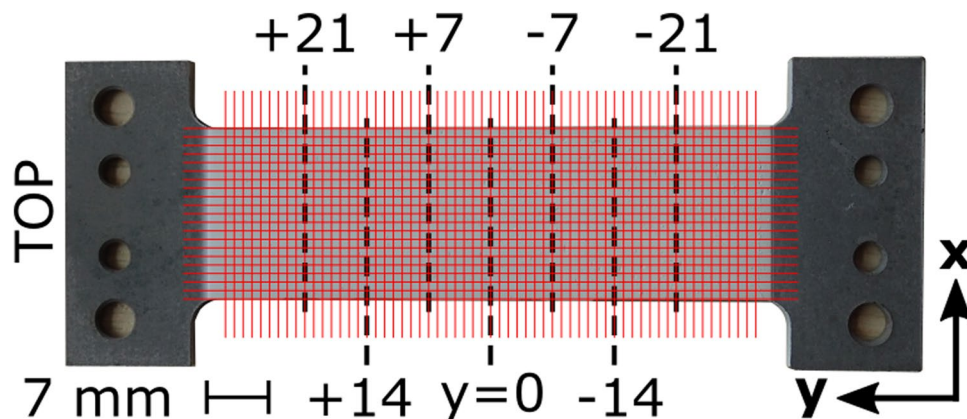
Fig. 3 Dog-bone sample image with superimposed thickness measurement points. Thick black discontinuous lines correspond to transversal cross-sections cut for optical microscopy (every 7 mm from $y=0$) with their nomenclature. The intersection of thin red lines marks THz measurement points (every 1 mm). Regarding orientation, longitudinal direction corresponds to y axis and transversal to x axis

The coating thickness was verified by direct optical microscopic inspection. One sample was cut along seven transversal sections, starting from the centre of the coated area and then at intervals of +7, +14, +21 and -7, -14, -21 mm either side of the centre ($y=0$ mm) as shown in Fig. 3 (black lines). Samples were maintained in the same orientation throughout the experiments, with the orientation up-down being consistent for all samples and determined by the specimen orientation in the sample holder during deposition. A resin was applied to the TBC coating prior to mounting and polishing of the cross-sections to avoid damage to the TBC column tips. Samples were inspected using a digital microscope (optical) Keyence VHX6000. Thickness measurements were taken using Keyence's software every mm, on points that coincided with THz measurements (Fig. 3, red lines). The TBC images presented in this article were taken using the back-scattered detector of a TESCAN Vega 3 scanning electron microscope (SEM) at 20 kV, working distance of 10 mm and spot size of 68 nm; cross-sections were previously coated with 10 nm of gold to enhance image resolution.

Sample R2 was selected as a reference sample to validate the THz technique for thickness measurement. R2 was physically sectioned at 7-mm intervals transversally as per Fig. 3 and inspected by optical and electronic microscopy. Representative examples of the cross-sections are shown in Fig. 4, where back-scattered SEM imaging reveals atomic number contrast of the distinct coating layers of the TBC. All images show the columnar microstructure of the TBC growing on the thin Al_2O_3 oxide (thin black line, $< 2 \mu\text{m}$ thickness), which in turn is on top of a $\sim 25\text{-}\mu\text{m}$ $\beta\text{-NiAl}$ layer that appears slightly darker than the underlying Nimonic75® substrate. The thickness of the TBC is relatively homogeneous and there are no major defects present, except for the occasional minor defects known as “carrot growths”, 50–300 μm wide, which are discussed in detail in a later section. The “carrot growths” are produced during regular evaporation in EB-PVD and their presence is tolerated if small-sized and in small quantities. The columns nucleate very finely at the bondcoat interface but grow much wider towards the coating surface. Column inclination changes perceptibly across the longitudinal direction of the sample. Columns in sections $y = +21$ and $+14$ mm (i.e. near the “top” of the sample) are almost perfectly parallel to the xz -plane of the cross-section and the full columns are shown in their entirety (Fig. 4a and b). Near the “bottom” of the sample, the columns have some perceptible tilt with respect to the plane of the cross-section at $y = 0$ mm (Fig. 4c), and this is much more accentuated at

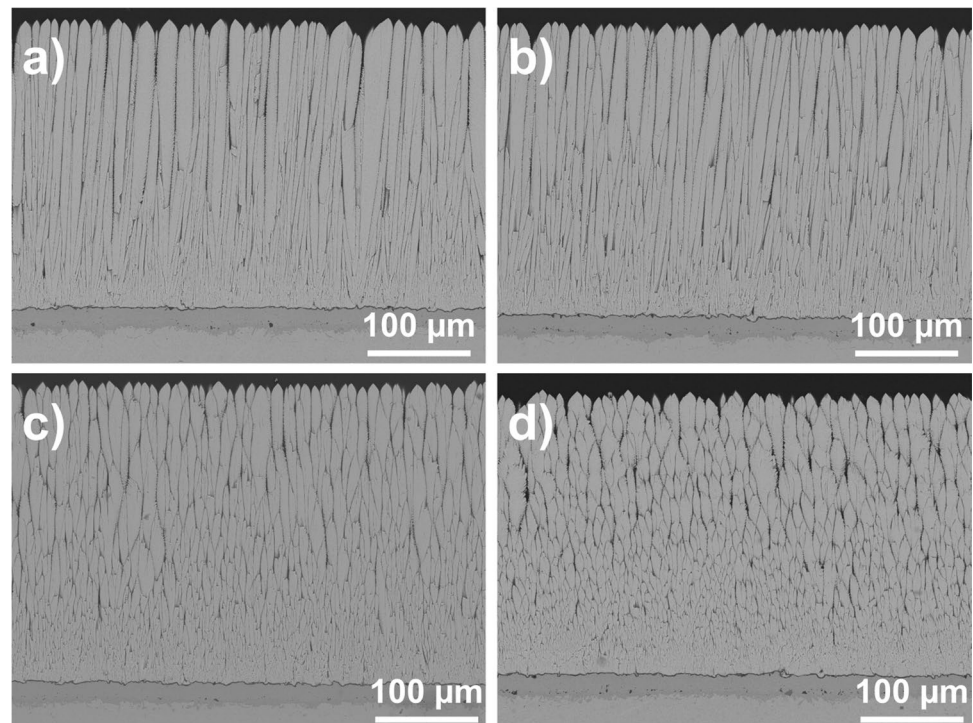
Fig. 4 TBC images from sample R2 at y -sections of **a** +21 mm, **b** +14 mm, **c** 0 mm and **d** –21 mm

$y = -21$ mm where the column intersections with the polished cross-section now appear as small ellipses (Fig. 4d). This variation in the growth direction of the columns is due to the expansion of the evaporation plume and is discussed further in a later section.

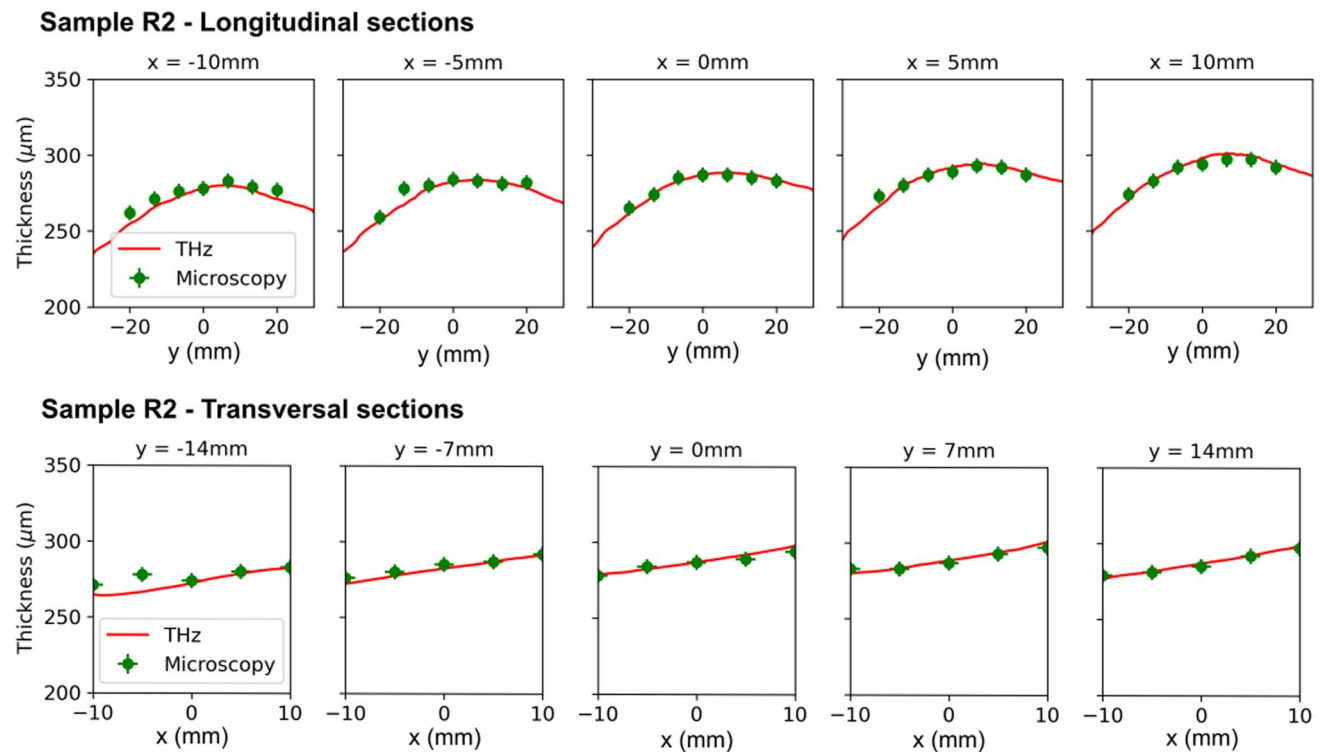
Fig. 5 Comparison of thickness measurements by microscopical inspection of cross-sections (green dots) with THz imaging calculations (red curves) for longitudinal sections at different x positions,

and transversal sections at different y positions on sample R2. Microscopic measurements are only plotted every 5 mm on the transversal sections to enhance clarity

At each transversal section, optical microscopic measurements were taken every 1 mm, the same spatial resolution as THz imaging. The microscopic measurements mostly agree with the thickness curves calculated from THz radiation as shown in Fig. 5. The experimental error considers both the limitations of the measuring device, positioning and the peak-to-valley distance of the columns at the surface. Less than 5% of THz measurement points fall outside the error bars of the microscopic measurements; these are mostly related to “carrot growth” defects and are explained in a subsequent section. Moreover, the graphs reveal different trends for the longitudinal and transversal directions on the samples. Longitudinally, the thickness fits a spherical shape with an absolute maximum at around section $y = +5$ mm. Transversally, the

thickness increases from left to right. Both trends are related to the “point-source evaporator” characteristic nature of the EB-PVD deposition as reviewed in the discussion.

Another minor defect is the change in column inclination across the length of the sample, as observed in Sect. 3.1. The inclination is related to the relative position of the sample with respect to the ingot being evaporated. This does not seem to affect the value of n , deduced through the good agreement of the THz thickness maps and the cross-sections (Fig. 5).

In principle, THz imaging could be deployed as a non-destructive technique for quality control during the manufacturing process of TBCs on industrial scale. Our results show that the method is reliable within a sample (Fig. 5) and within a coating batch (Figs. 6 and 7). This is because any changes in the refractive index caused by column inclination and other minor defects such as “carrot growth” defects are too small to affect the thickness measurement by THz radiation. Moreover, the THz method averages the thickness of the area irradiated, which is less sensitive to the presence of “carrot growths” (Fig. 8) and even column tip variation than direct inspection of the cross-section. Potentially, this method could be applied to batches of samples produced using the same coating technique and deposition conditions, perhaps with the use of one sample per batch to correct for variations in the refractive index value. However, this method cannot be applied as a universal solution, using a single n value, for coatings produced by different deposition methods and with different parameters, because the refractive index is too sensitive to larger variations in coating microstructure. For example, the difference between EB-PVD columns and plasma-sprayed splats is significant: at similar THz frequencies, the refractive index obtained here (3.977) is similar to other EB-PVD 7YSZ coatings measured in the literature (3.73 [9]), but is smaller than for plasma-sprayed 7YSZ coatings, which are in the range of 4.0–5.2 [7, 10, 12, 15]. Even for coatings deposited using the same deposition technique, other factors, such as porosity, stress or density, affect the value of n . Watanabe et al. [15] studied the effect of porosity on plasma-sprayed 7YSZ coatings

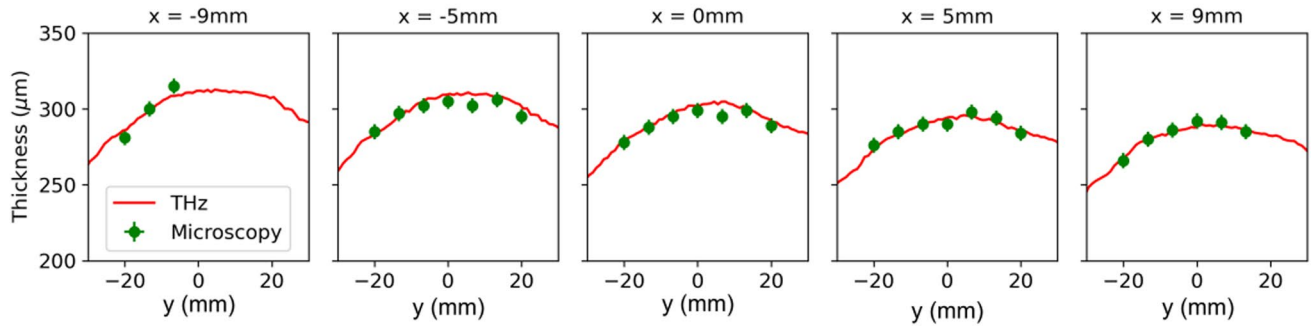
Sample L2 - Longitudinal sections

Fig. 6 Comparison of thickness measurements by microscopical inspection of cross-sections (green dots) with THz imaging calculations (red curves) for longitudinal sections at different x positions, and transversal sections at different y positions on sample L2. Only half of the microscopical measurements are plotted on the transversal

sections to enhance clarity. Some longitudinal sections near the edges of the sample ($x = -9$ and $+9$ mm) miss points of microscopical inspection due to chipping on the sample edges after the heat treatment cycles

Sample L2 was also sectioned to validate THz thickness measurements, calibrated using the refractive index from sample R2. In this case, sectioning happened after the sample had been thermally cycled between room temperature and 1100 °C for 20 × 1-h cycles with a short period of forced air cooling, to study the impact of aging to be reported in a further publication. The microstructure of the coating has been little altered for the short thermal cycling and both THz and direct inspection thickness measurements seem unaffected by this cyclic heat treatment. The results from both measurement techniques are in agreement (Fig. 6), which demonstrates that THz imaging using a single refractive index can be used to estimate TBC thickness on the same coating batch. The main source of disagreement (error) between microscopy and THz measurements is due to “carrot growth” defects, as detailed in the subsequent section “3.3. Effect of defects”.

columns and reducing their growth as seen in Fig. 8d. This shadowing effect also produces some discrepancies where direct observation produces lower values than THz counterparts, such as the low outlier in $(x, y) = (0, -7)$ in Fig. 6. In general, discrepancies between direct observation and THz radiation correspond to local effects of “carrot growths”.

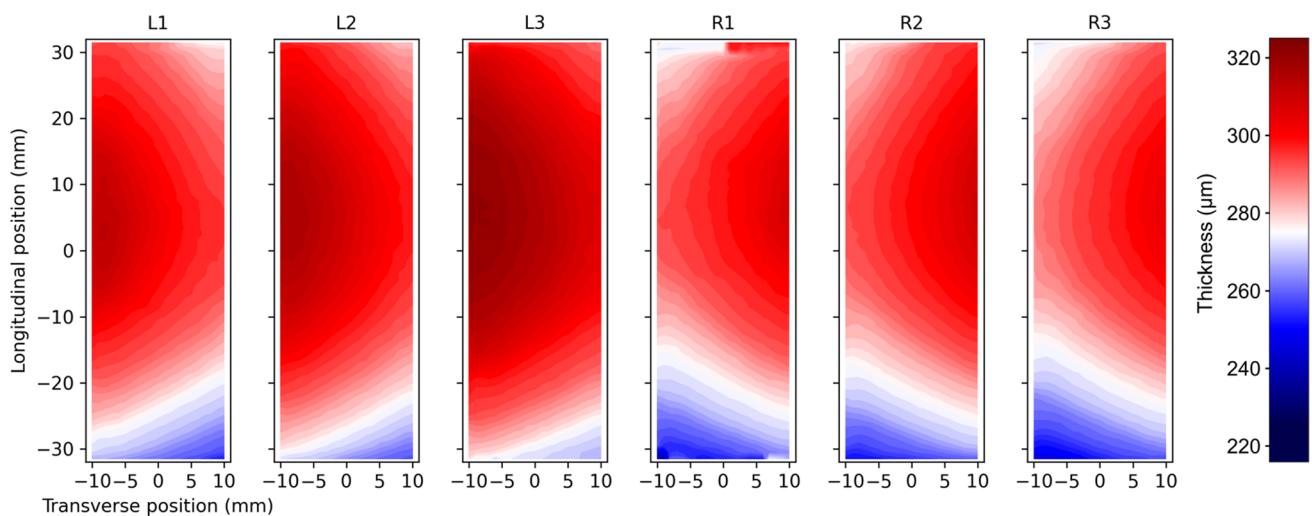
Fig. 7 Thickness maps for all samples constructed from THz reflectivity measurements. Each sample (R1, R2, R3 and L1, L2, L3) is labelled above the corresponding thickness map

Applying the previously obtained refractive index of 3.977, the reflectivity maps can be converted into thickness maps as shown in Fig. 7. These maps reveal a strong handedness of the samples, with all R samples having the local maximum on the right-hand side, whereas all L samples having the local maximum on the left-hand side. This is explained by the direction of rotation of the samples, described in Fig. 1, and their orientation on the holder, perpendicular to the Fig. 1 schematic and considering the sample “top” as closer to the point of view of the reader. The leading edge (i.e. the foremost edge on the direction of rotation) of L samples is the left-hand side, whereas for R samples is the right-hand side. Therefore, the local-maximum side is the leading-edge, as expected. Longitudinally, this local maximum occurs at approximately $y = +5$ mm as noted previously, which corresponds to the small vertical offset of the ceramic ingot with respect to the rotating sample holders. The minimum thickness is located on the bottom corner opposite to the maximum (trailing-edge of the rotation), and the thickness variation across each sample is ~ 40 μm. Samples coated on the left-hand side holder have a greater thickness across their whole surface, which is expected due to the asymmetric position of the two substrate holders in the chamber with the left being closer

perfectly horizontal, so one of the faces of the triangle is closer to the ingot. In summary, the thickness distribution on the samples corresponds well with the distance

to the ingot and the direction of rotation, as predicted by a “point source” evaporation model.

Finally, the bondcoat of four samples (R1 and L1) had an intentional defect around the central area, as described in the methodology. It is noted that the thickness maps of those samples (Fig. 7) are not influenced by the presence of these macro-defects. The THz radiation, at the current frequencies used, is reflected by the metallic nature of the bondcoat and therefore does not see these bondcoat defects. Therefore, the defect induced in the bondcoat (which results in aluminium deficiency) does not change its metallic nature and hence does not affect its reflectivity. The only effect that THz radiation could detect is changes in the thermally grown oxide (TGO). However, the TGO thickness of all samples examined is too small ($< 2 \mu\text{m}$) after this short time of aging to show any effect on the thickness maps.

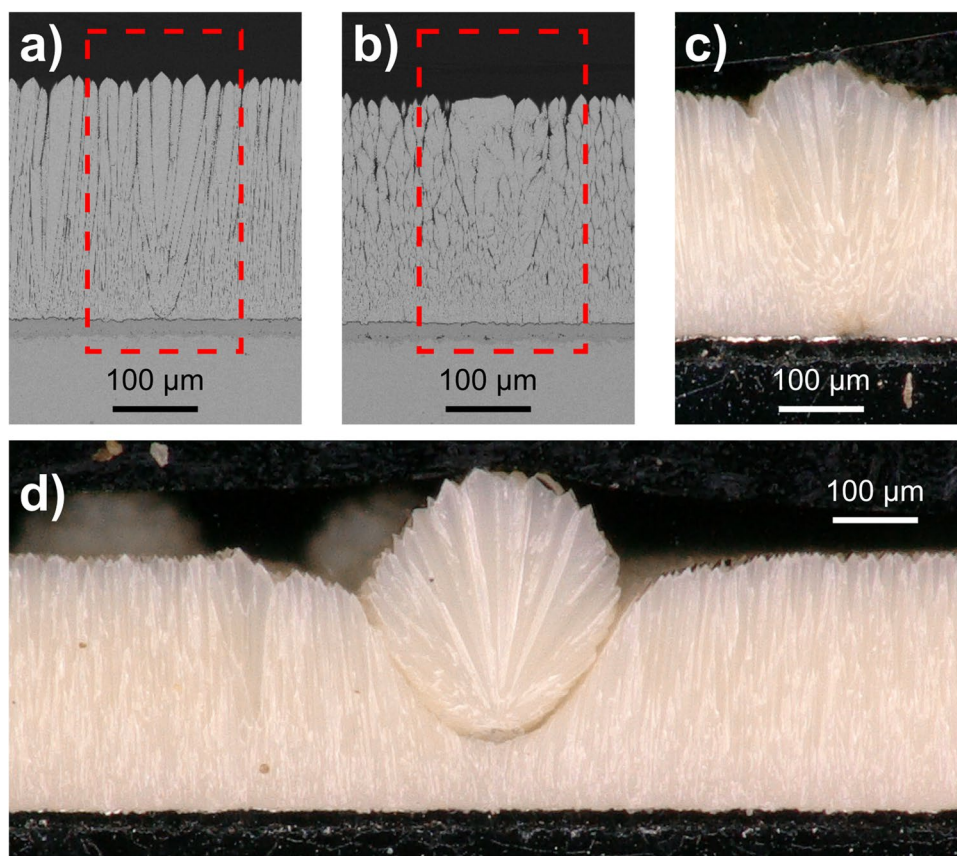
Fig. 8 a and b Cross-sectional back-scattered SEM image from sample R2 highlighting “carrot growth” defects. c and d Dark field digital microscope images of “carrot growths” in sample L2

There are no major defects present within the ceramic layer of the studied TBCs. Some minor defects produced by the nature of EB-PVD deposition are present, but do not seem to affect THz mapping. One example of such defects is the clusters of thicker columns known as “carrot growth” defects, as illustrated in Fig. 8. These are associated with local re-nucleation on a foreign particle that are produced in small numbers as part of nominal EB-PVD evaporation. The “carrot growths” are usually 50–300 μm in diameter and comprise multiple columns; hence, they are smaller than the ~ 0.5 by 1.0 mm diameter irradiated by the THz laser. Consequently, THz measurements give the average of the thickness across the irradiated area and do not resolve “carrot growths”. By contrast, direct examination of the cross-sections produces point measurements at a given position that are affected by the local presence of “carrot growths”. As observed in Fig. 8d, some “carrot growths” can be up to 100 μm taller than the average of neighbouring columns. Moreover, the presence of a tall “carrot growth” creates a shadow around it, partially masking neighbouring
