Short Communication

Stability appraisal of road cut slopes along a strategic transportation route in the Himalayas, Uttarakhand, India

SN Applied Sciences (2019) 1:409 | <https://doi.org/10.1007/s42452-019-0433-4>

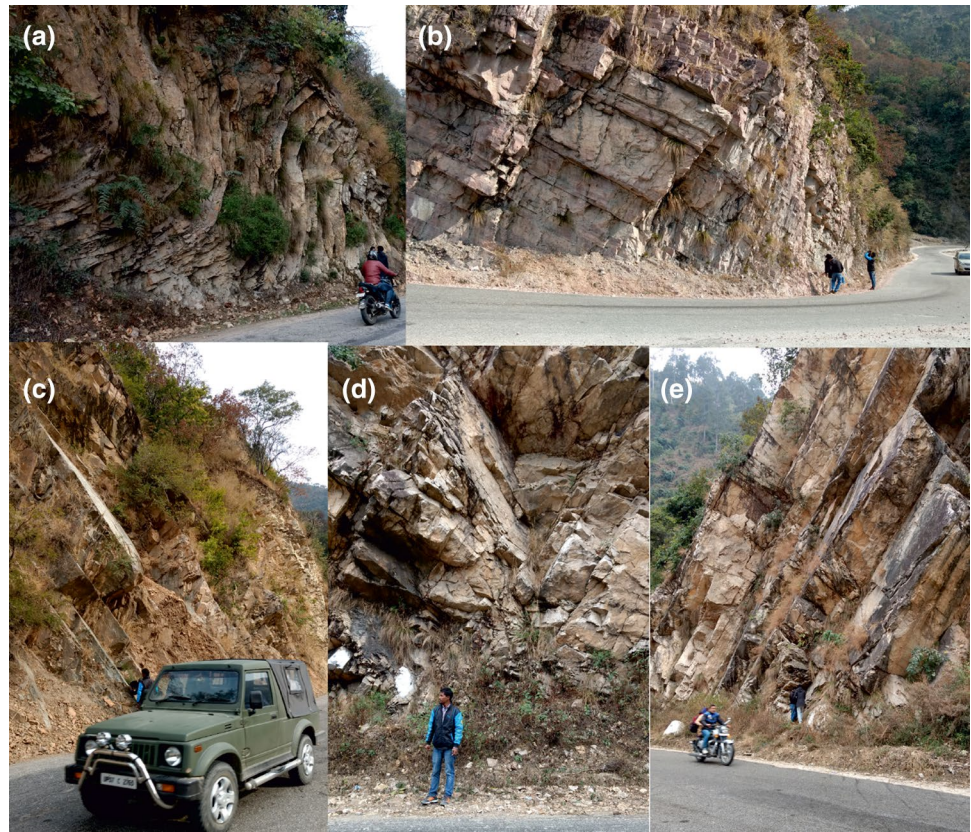
Fig. 2 Unstable conditions favouring structurally controlled failures at road cut slopes along NH-58 from Kaliyasaur to Rudraprayag. **a** Extensively folded discontinuities showing a high stress regime and toppling failure conditions (slope 2); **b** large persistent discontinuities showing daylight conditions favouring planar failure (slope 3); **c** rock mass with large and persistent discontinuities prone to the planar and wedge mode of failure (slope 4); **d** blocky and highly fractured rock mass forming wedge failure (slope 5); **e** persistent discontinuities forming a favourable condition for the planar mode of failure (slope 7)

Seven potential slopes were identified during a field survey along NH-58 from Kaliyasaur to Rudraprayag in Uttarakhand, India. Field data pertinent to slope stability were carefully collected by considering the geological and geotechnical complexities of the precarious Himalayan terrain. The rock mass encountered in the patch was very fragile with multiple sets of persistent discontinuities. Most of the investigated slopes comprise three sets of discontinuities along with some randomly oriented sets forming blocks of different sizes. The prevailing site conditions depicting various structurally controlled failures are illustrated in Fig. 2.

of structurally controlled failures. Orientation of the slope face and prevailing discontinuities was analysed using a Schmidt-type stereonet and the most pronounced mode of failure along with the causative joint set at discrete locations is illustrated in Table 4. Various structurally controlled failures were determined by critical examination and establishing angular relationships between the slope face and prevailing joints. For instance, slope S2 is prone to the toppling mode of failure because of steeply dipping joints. The slope face is inclined by 85° in the N040° direction and critical joint (J1) forming toppling failure is steeply inclined (78°) in the N230° direction. The steep angle and the angle between the dip direction (195°) favour toppling failure. The planar mode of failure is the most prominent in the studied region. Planar failure is likely to occur at slope S3 because of the daylight conditions caused by joint set J1. The dip direction of the slope face and critical joint J1 is nearly parallel to the inclination direction of the slope face and the dip amount of the jointed surface is 40°, i.e.

sufficiently less than the slope inclination and greater than the friction angle of the joint. These conditions together cause a planar mode of failure at slope S3. Unlike toppling and planar failure, wedge failure is formed by a critical combination or intersection of two sets of joints. The probability of the wedge mode of failure is controlled by the orientation of the line formed by the intersection. As witnessed in slope S5, the great circles of joint set J2 and J3 intersected in such a way that the point formed by their intersection fell in the critical zone between the great circle of slope and friction. This indicates that the line formed by their intersection plunges in the direction of the slope face with less plunge, thereby forming the critical conditions of wedge failure.

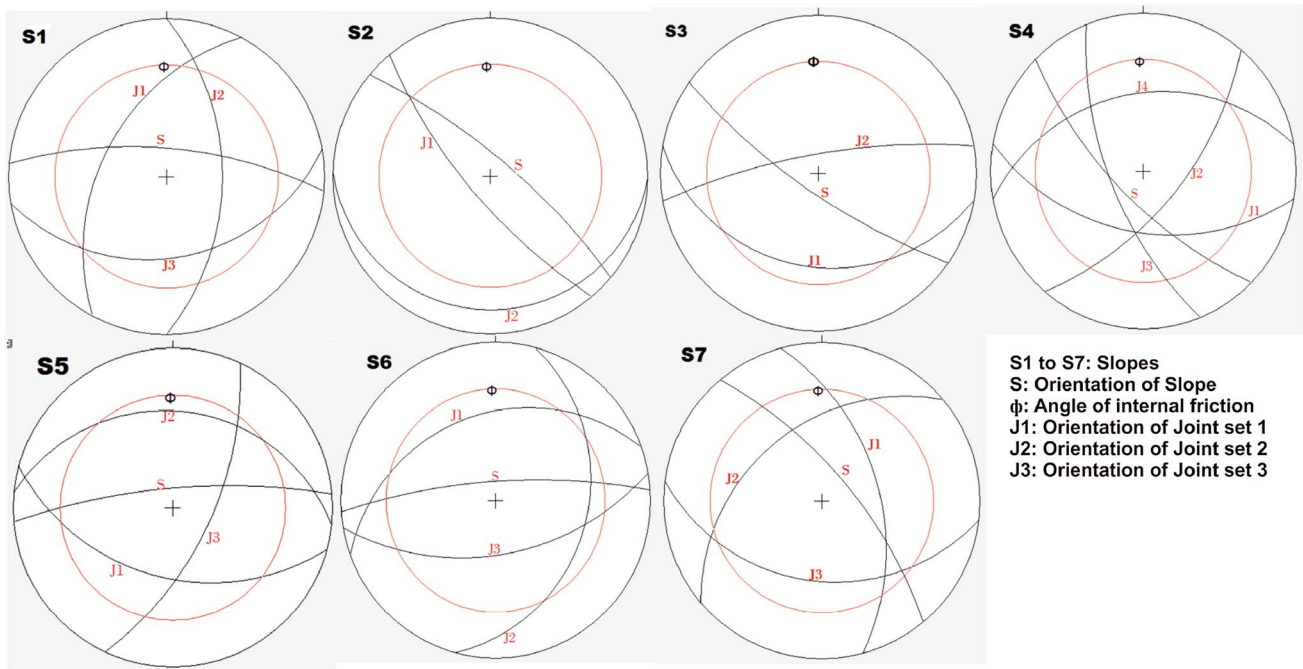
Fig. 3 Kinematic analysis of road cut slopes along NH-58 from Kaliyasaur to Rudraprayag

The orientation of slope facets and major discontinuity sets at each location were recorded and great circles plotted on a stereonet (Fig. 3) to analyse the angular relationship between the slope face and prevailing sets of discontinuities. Such geometric evaluation of the relative orientation enables identifying the varying potential

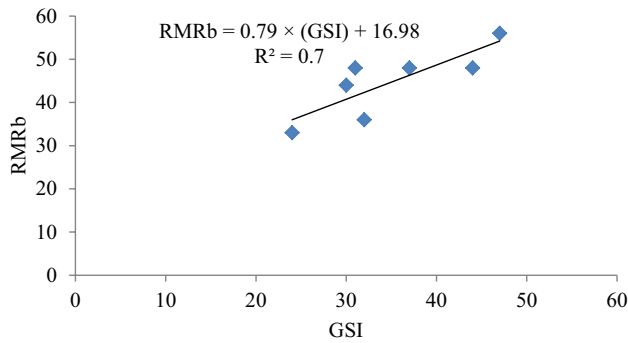
Fig. 5 Correlation between RMR_{basic} and GSI

failure may occur at location S2. Moreover, quantified GSI values are also similar to the basic quality of rock mass obtained by the RMR method. The linear correlation between RMR_{basic} and GSI values can be used for further indirect estimation elsewhere. The present work provided a comprehensive understanding of the prevailing stability grades of road cut slopes along NH-58 from Kaliyasaur to Rudraprayag. For swift and hassle-free socio-economic escalation of the region, such studies should be performed in other vulnerable sections of the Himalayas.
