Wear behavior of wire electric discharge machined surface of 316L stainless steel

Abstract

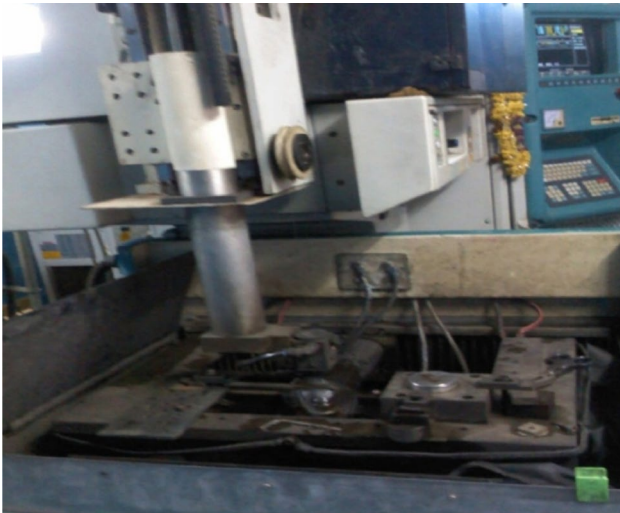
Fig. 1 Japax LDM50 wire EDM

Japax LDM50 wire EDM shown in Fig. 1 [14] is used in the present investigation for machining the specimens. Based on the previous studies, the wire EDM parameters that are considered for experimentation are T_{ON}, IP, SV and WT [19, 20]. Brass wire is electrode and distilled water is the dielectric liquid. Specimens of size 10 mm diameter and 35 mm length are machined according to Taguchi L8 orthogonal

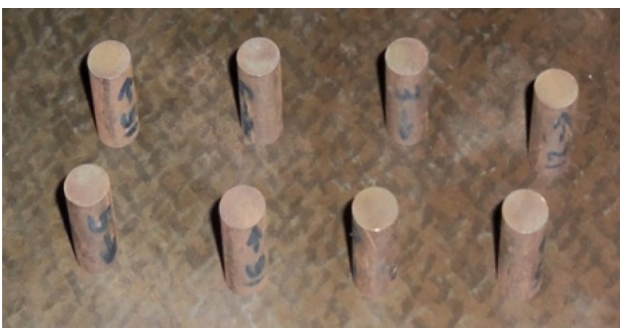
Fig. 2 Machined specimens

array with four parameters and two levels and are shown in Fig. 2. Table 2 shows the corresponding machining conditions. All the eight conditions of machining are designated as MC1 to MC8 and are presented in Table 3.

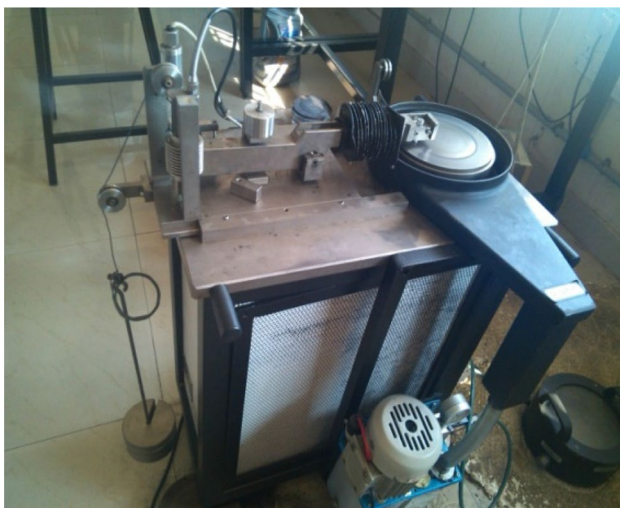
Fig. 3 Pin on disc apparatus

Figure 3 shows pin on disc apparatus used for conducting wear tests for wire EDMed specimens at different machining conditions. Specimens of size 10 mm diameter and

35 mm length were machined at different machining conditions. D2 steel is used as the disc material. A load of 5 kg was applied for a sliding distance of 1000, 1500 and 2000 m respectively. All the specimens are subjected to wear test at the same load and sliding distance and at a speed of 750 rpm. For the worn out surface of the cylindrical specimens, the SEM images are captured and the wear surface were analyzed.

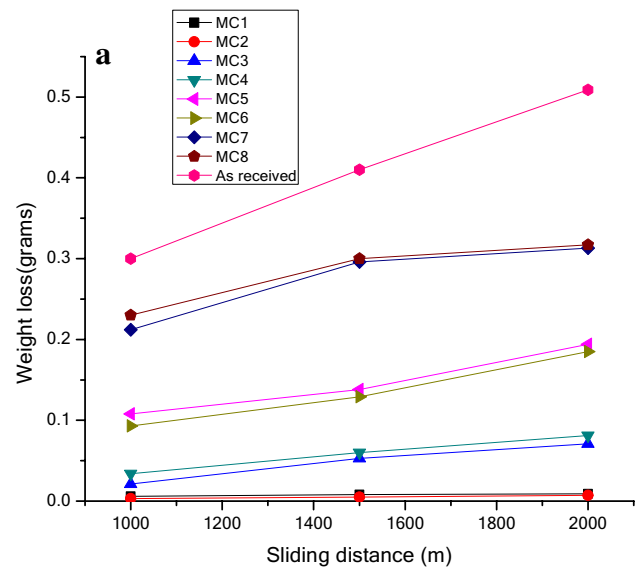
Fig. 5 Variation of weight loss w.r.t. **a** sliding distances **b** machining conditions

Figure 5a demonstrates the weight loss variation with sliding distance at different machining conditions and Fig. 5b represents the variation of weight loss with different machining conditions at different sliding distances. It was noted that the weight loss increases with the increase in the sliding distance for all the cases. It is also identified that the weight loss at machining condition MC1 and MC2 are close to each other. The same similarities of closeness of weight loss are observed between the machining conditions MC3 and MC4, MC5 and MC6 and also between MC7 and MC8. The maximum weight loss was reported for as received material. The corresponding wear test results are

presented and tabulated in Table 3. At similar values of product of T_{ON} and IP (proportional to discharge energy), the weight loss is almost the same and the other parameters, servo voltage and wire tension are showing least impact, hence only four cases were considered one from each set taking low cutting speed as criteria. All combinations of discharge energy levels are covered in the selected machining conditions MC2, MC4, MC5 and MC7 which are considered as case-A, case-B, case-C and case-D respectively in the subsequent paragraphs.

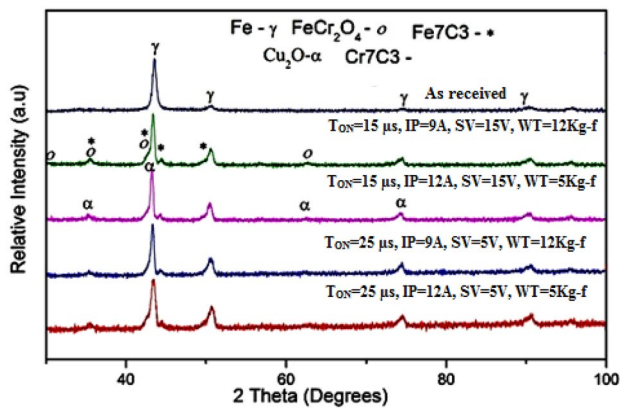
Fig. 4 XRD pattern of the specimens

Patterns of XRD obtained for the specimens machined at different conditions are presented in Fig. 4 [14]. The presence of copper is seen on the machined surface which indicates the transfer of wire electrode material. High temperatures resulted during machining led to the formation of various oxides can be observed. At high temperatures, the formation of chromium carbides and chromium oxides are observed. This shows the depletion of chromium from the parent material. This shows the occurrence of metallurgical modifications.

The microhardness values of the specimens are shown in Table 3. The Vickers microhardness value for the as received material is observed to be 280 VH and found to be high for all specimens machined with wire EDM. It is noticed that at lower discharge energy level, hardness was found to be high and then declined with increase of discharge energy. A high value of 354 VH was observed for case-A and a least value of 282 VH was reported for case-D and the hardness for case-B and case-C were found to be 339 and 311 VH respectively. The high hardness for case-A resulted because of hard thin layer comprising of Cu, $FeCr_2O_4$, Cu_2O , Fe_7C_3 and Cr_7C_3 from the wire electrode, which is evident from XRD shown in Fig. 4. For case-D, low hardness was reported because of chromium depletion.

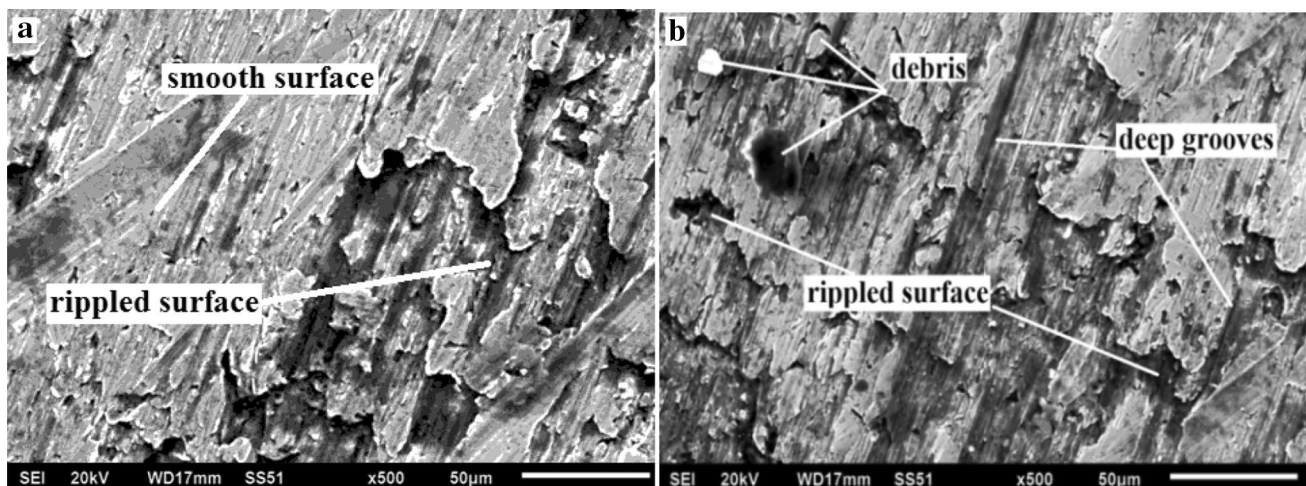
Fig. 6 SEM image of as received 316L SS material **a** at 1000 m **b** 2000 m

Figure 6a, b shows the SEM micrograph of worn morphology of the as received 316L SS material at a sliding distance of 1000 m and 2000 m respectively. From Fig. 6a it could be observed that the surface consists of smooth and

rough patches. This rough patch consists of rippled surface which shows predominant wear. This feature is more significant as the sliding distance increases. As the sliding distance increase the smooth patch vanishes and the size of the rough patch increases and this rough patch consists of deep grooves, debris and rippled surface showing abrasive wear. This feature is demonstrated in Fig. 6b. The wear behavior of wire EDM specimens for four above mentioned machining conditions are presented below.

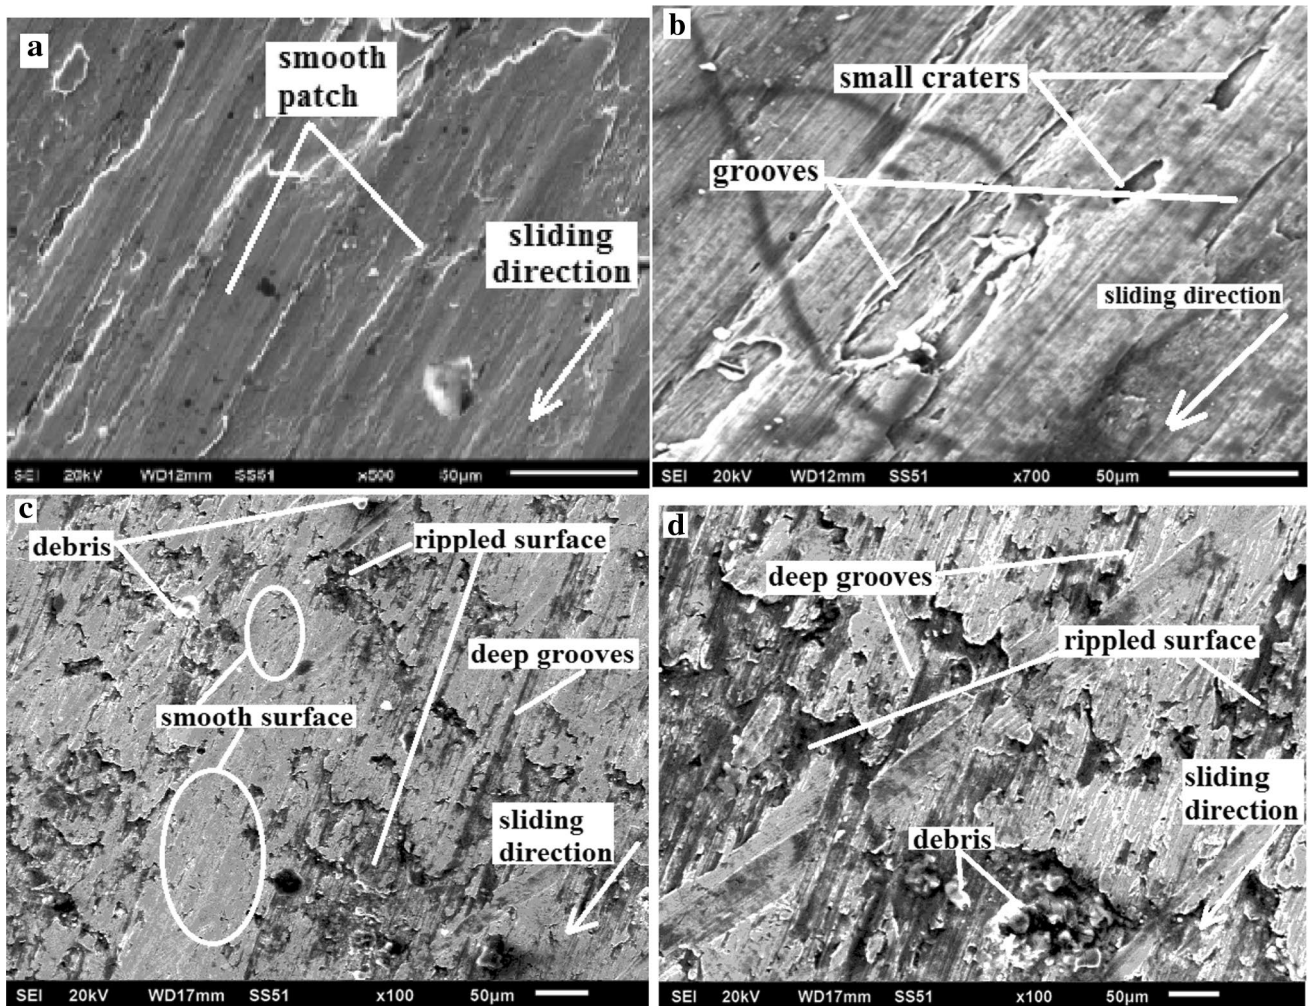
Fig. 7 Worn morphology of wire EDMed specimens at **a** case-A **b** case-B **c** case-C **d** case-D

Figure 7a–d indicates the worn surface of wire EDMed surface for the four cases at 2000 m of sliding distance. Figure 7a represents the morphology of worn surface for case-A. From the figure it was noticed that the surface is covered with smooth area without evidence of loss of material which represents high resistance to wear. The high wear resistance at this machining condition was probably due to the following reason.

The worn morphology for case-B is represented in Fig. 7b. The surface consists of thin grooves in the sliding direction along with small craters. Also the hardness at this condition is observed to be 311 HV which is less when compared to case-A. Hence, at this machining condition weight loss is marginal.

The SEM image showing worn morphology for case-C is presented in Fig. 7c. For this case, increase in rough surface was observed with grooves, debris and rippled surface. The wear was observed to be high in comparison with case-B. At this machining condition, there is still increase

Figure 7d demonstrates the SEM image for case-D. The surface consists of deep grooves running in the direction of sliding with large rough patches with the presence of debris showing predominant wear at this condition. The hardness at this condition is observed to be 282 HV, which is low among other machining conditions. This low hardness resulted in high amount of weight loss of the material. As the availability of discharge energy increases, more amounts of material melts causing deposition of FeCr_2O_4 , Cu_2O , Fe_7C_3 and Cr_7C_3 as thick white layer and is shown in Fig. 9 [14]. During the process of oxidation the depletion of high amounts of chromium from the material occurs resulting in low hardness. The increasing amount of discharge energy leads to increase in the oxidation of wire EDMed surface which leads to the decrease in the hardness of the surface [21–24]. Also, during cooling of the high amount of molten material may not properly solidify thus forming craters and rough porous surface. SEM micrograph on the surface at this machining condition shows this feature and presented in Fig. 10. Due to the presence of more oxidized and porous layer on the machined surface, the specimen subjected

Due to availability of low discharge energy at this machining condition, a thin protective hard white layer consisting of oxides and carbides is formed on the surface along with copper compounds which is due to deposition from the wire electrode resulting in harder surface which eventually decreases the wear of the surface. Figure 8 [14] shows the thin protective hard white layer formed during the machining process. This white layer consists of $FeCr_2O_4$, Cu_2O , Fe_7C_3 and Cr_7C_3 and is evident from the XRD. Also the hardness at this machining condition is 321 VH which was the highest value reported among all the specimens machined at different conditions. As the hardness is directly proportional to wear resistance, the

in the discharge energy generating high temperatures and the molten material solidifies quickly and small portion is flushed away by the dielectric fluid creating rough surface with pores and oxides formation. Also depletion of chromium from the parent metal is observed causing high amount of wear. Also the hardness value of 311 HV was observed showing reduction in hardness. Hence wear resistance is observed to be lower than case-B.

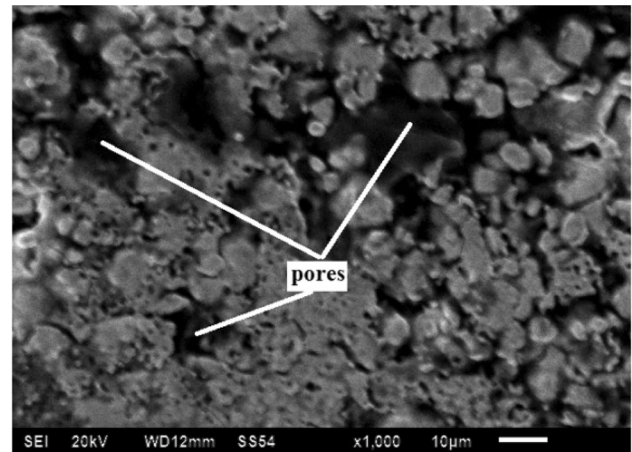
Fig. 10 SEM image of white layer on the machined surface for case-D

to wear test wore at a faster rate showing rough oxidized areas with scratches along the sliding direction.
