Analysis of Insulation Diagnosis for Generator-Motor Stator Winding in Pumped Storage Power Plant

Abstract

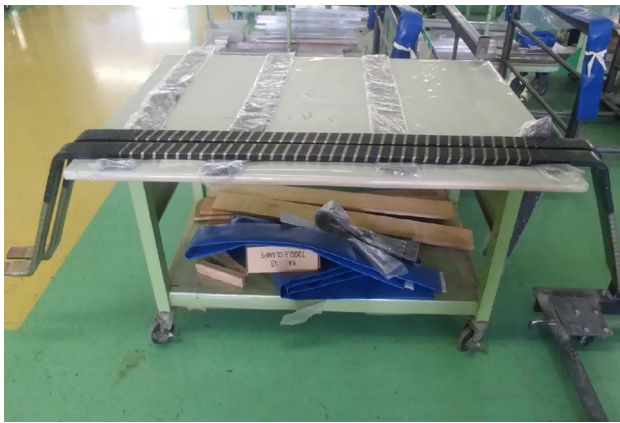
Fig. 2 Manufactured bars with sparsely wound outer corona-preventive tape (Type-C bars)

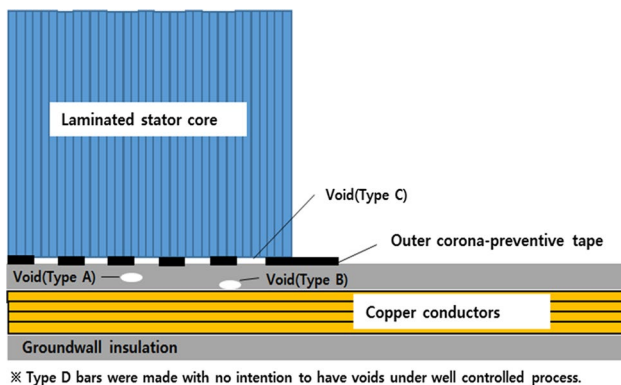
Fig. 3 Fabrication of defected bars

Second, another set of bars were manufactured with an additional layer of Teflon tape in the layers of the groundwall insulation. The Teflon tape was intentionally introduced to produce large artificial voids within groundwall insulations owing to different contraction properties during the heating process. To effectively introduce internal voids for this type of bars (Type-A bars), an additional rapid cooling process after heating at 150 °C for 4 h was applied, unlike other type of bars. Third, two other bars were designed to have voids between the conductors and the groundwall insulations by eliminating inner corona-preventive tapes (Type-B bars). Finally, outer corona-preventive tapes were sparsely wound spaced at 8-mm intervals along the straight portion of the other two bars (Type-C bars) to shape artificial gaps between the groundwall insulation and the iron core, as shown in Fig. 2. The concept of fabricating defected bars as explained above is shown in Fig. 3.

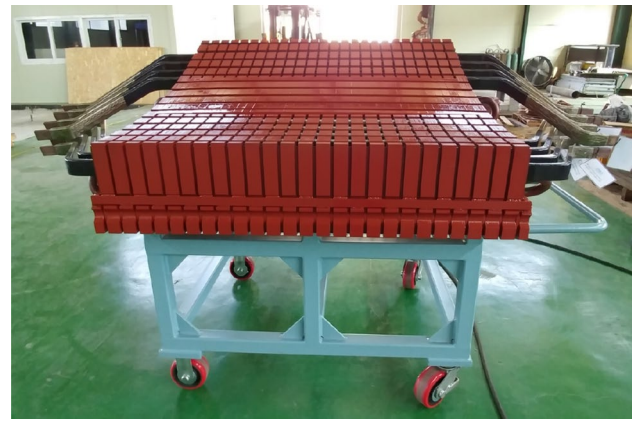
Fig. 4 Stator core with inserted bars on a carrier

As a whole, four cases of generator-motor stator bars were placed in the slots of the specially designed stator core that can accommodate a maximum of 10 bars at a time with lamination of 1.6-mm-thick steel on a movable carrier, as shown in Fig. 4, to simulate internal discharge (Type-A, 2

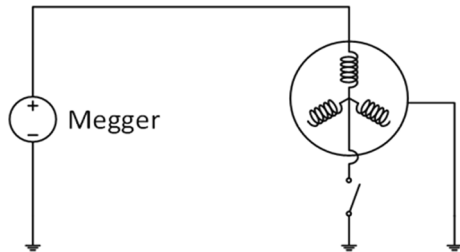
Fig. 6 Circuit diagram for IR and PI test

The IR and PI values are measured before the AC high-voltage test depending on the circuit diagram of Fig. 6 to ensure that the stator insulation is dry and clean enough to apply high-voltage AC. From the IR and PI test results summarized in Table 2, the test values are seen to meet the standard criteria of IEEE Std. 43 when those were converted from 26 to 40 °C. (IR ≥ 100 MΩ, PI ≥ 2) [9]. Therefore, it was concluded that the dielectric strength against high-voltage AC was sufficient for all eight stator bars.

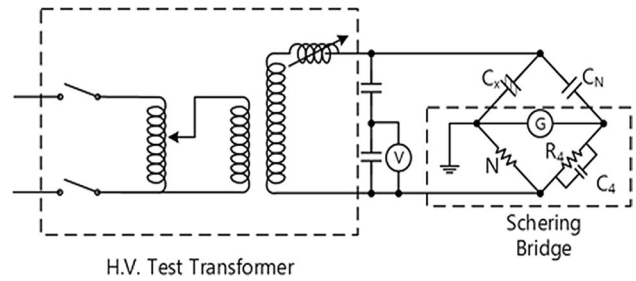
Fig. 7 Circuit diagram for DF estimation

The circuit diagram of estimation of the dissipation factor (DF) is showed in Fig. 7. The value of DF was measured while increasing the AC voltage from 1 to 13 kV with a step size of 1 kV as shown in Fig. 8, and $\Delta \tan \delta$ was also obtained by subtracting DF at 2 kV from DF at 13 kV (phase voltage $\times 1.25$) as an index for overall insulation deterioration. From Table 3, the value of $\Delta \tan \delta$ was shown to be large in the order of Types A, C, B, and D for both specimens of each type. The largest defect made was observed in the Type-A bar with $\Delta \tan \delta$ values of 3.16 and 3.05 for A1 and A2, respectively. The sharp rise in DF around 5 kV for Type-A bars implies that that an

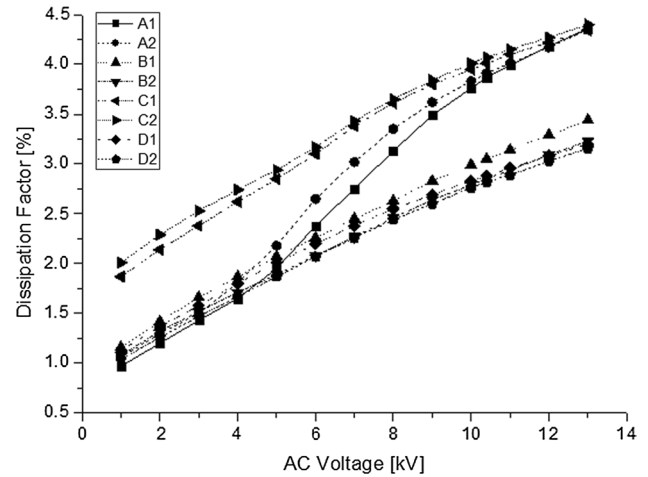
Fig. 8 Characteristics of DF vs. AC voltage

avalanches of electrical breakdown started at this point. This fact corresponds to discharge inception voltage (DIV) of Type-A bars in Table 5, as shown later. Therefore, DF can be used to check whether there is any PD activity present or not. Apparently, Type-D bars showed the best insulation quality with the lowest values of 1.83 and 1.90 for D1 and D2, respectively.

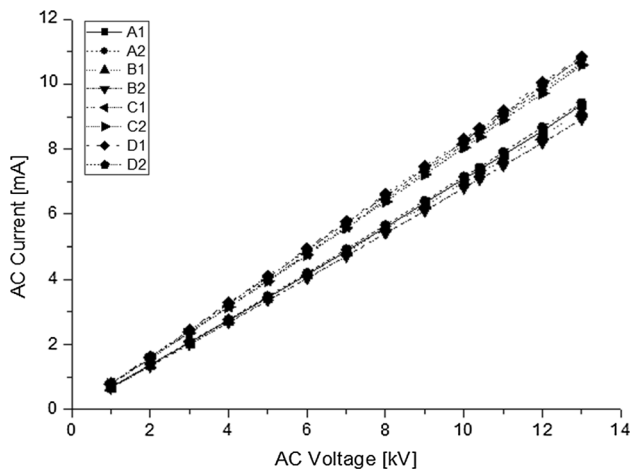
Fig. 10 Characteristics of AC current vs AC voltage

The circuit diagram for AC current estimation is shown in Fig. 9. The AC current and ΔI were recorded while increasing the AC voltage from 1 to 13 kV with a step size of 1 kV as shown in Fig. 10. ΔI is obtained from the following equations:

From the test results listed in Table 4, Type-A bars had the highest value of ΔI for both cases of bars, indicating the largest voids. Type-D bars were in the most-healthy condition recording 2.41 and 2.91 for D1 and D2, respectively, which were the lowest for each specimen. When listing the value of ΔI from the highest to the lowest, the sequence was the same as that of $\Delta \tan \delta$. This indicates that both $\Delta \tan \delta$ and ΔI perform as indices with regard to overall insulation deterioration.

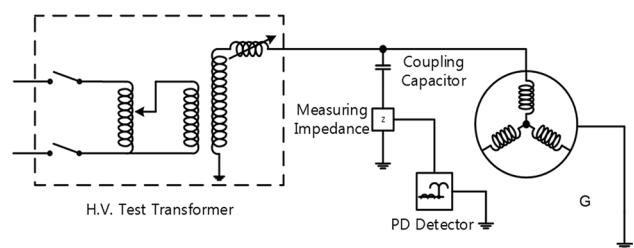
Fig. 11 Circuit diagram for offline PD estimation

The circuit diagram of estimation of offline PD is shown in Fig. 11. Unlike $\Delta \tan \delta$ and ΔI which indicate the overall condition of insulations, PD test gives the information

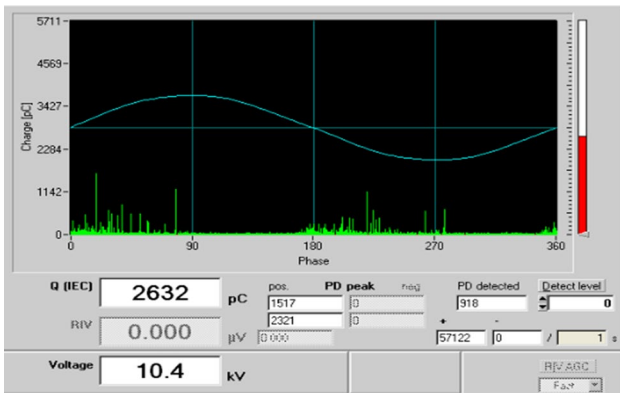
Fig. 12-2 PD magnitude and pattern of Type-B (B1) (2632 pC at 10.4 kV)

12–4, as expected. In Fig. 12–3, the slot discharge pattern was observed clearly for Type-C. For Type-B, as shown in Fig. 12–2, it seems that the maximum PD magnitude occurred in positive voltage cycle which indicate conductor delamination PD pattern. However, it's difficult to recognize it because the artificial voids between the conductor and groundwall insulation were fabricated into a small size to

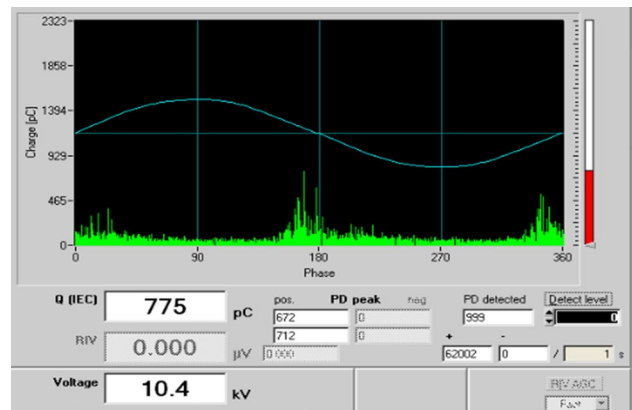
Fig. 12-4 PD magnitude and pattern of Type-D (D1) (775 pC at 10.4 kV)

To investigate the PD pattern, the second specimen (A2, B2, C2, and D2) of each type was omitted because it had the same pattern as the first specimen (A1, B1, C1, and D1) for each case. Some features of PD patterns and their interpretation from different sources of discharges were investigated in reference [10, 11]. In reference [10], the PD pattern on four cases for two generators that had dielectric breakdown was studied. And three types of PD patterns and their mechanism were analyzed for high-voltage motors in reference [11]. When referring to these studies, it could be deduced that Type-A and Type-D bars demonstrated typical internal discharge in the groundwall insulation from Figs. 12–1 and

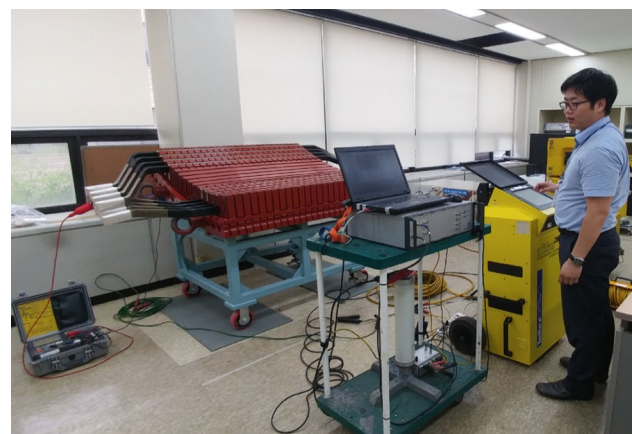
Fig. 13 Conducting offline insulation diagnosis (DF, AC current and PD) on bars with artificial defects

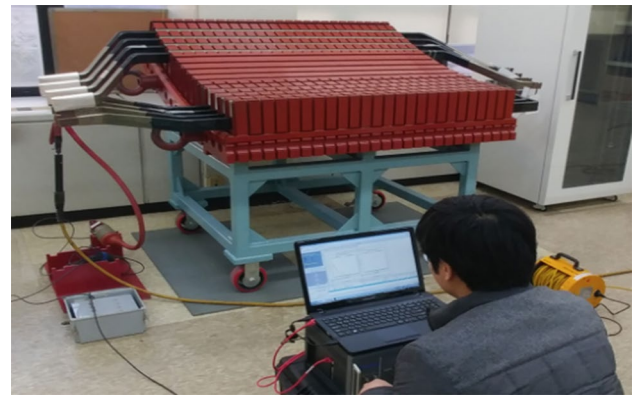
Fig. 15 Performing online PD test

distinguish it from internal discharge PD pattern. Furthermore, Roebel bars with epoxy-mica insulation tend to be rarely affected by delamination at the conductor-insulation interface [7]. Therefore, additional work was performed using an online PD detector (TGA-B, IRIS) with a 80-pF coupling sensor, as shown in Figs. 14 and 15, to further study the PD pattern for Type-B.

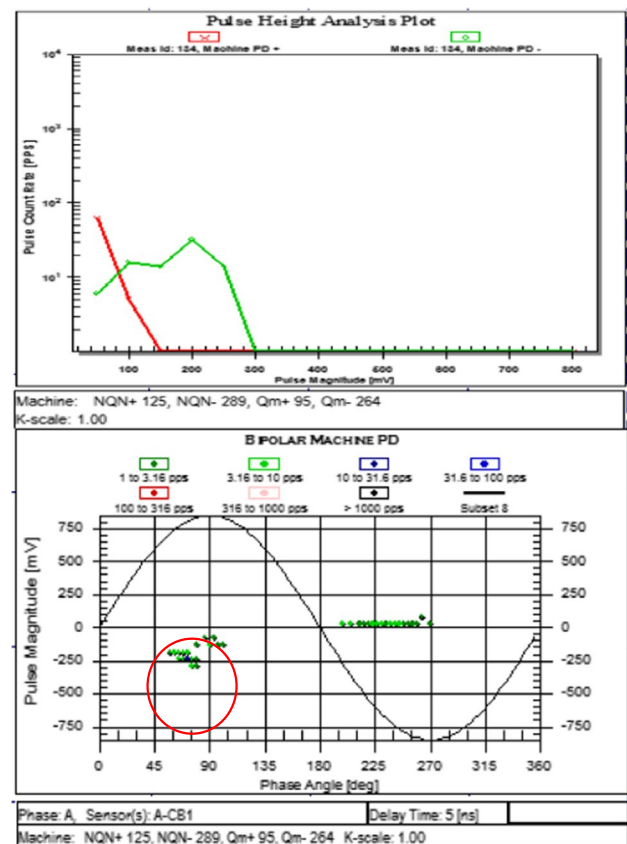
Fig. 16 PD pattern for Type-B1 at 13.0 kV (NQN +:125, NQN -:289, Qm +:95, Qm -:264, Qm-/Qm +:2.78)

Recommendations were provided for testing of sample coils to obtain a better quality form-wound stator winding in reference [12]. When referring to sample coil test method in [12], the schematic for the estimation of online PD to detect void in stator bar insulation is described in Fig. 14. For this test, an online PD detector (TGA-B, IRIS) and Coupling Capacitor of 80-pF were set up as shown in Figs. 15, 16 and 17 show the result of the PD distribution for Type-B1 when applying an AC voltage higher than the phase voltage, namely at 13.0 kV and 15.0 kV. From the test results, it was obvious that the maximum partial discharge occurred in 45°–90° phase and had the discharge pattern of conductor

delamination based on the ratio of Q_m- to Q_m+ : 2.78, 2.00 at 13.0, 15.0 kV, respectively. In reference [13], two cases of online PD measurements for gas turbine generators were analyzed. And online PD measurement data in hydrogen-cooled generators were investigated in reference [14]. When considering the PD pattern from those studies, it was concluded that Type-B bars have the PD pattern of delamination at the conductor–insulation interface.

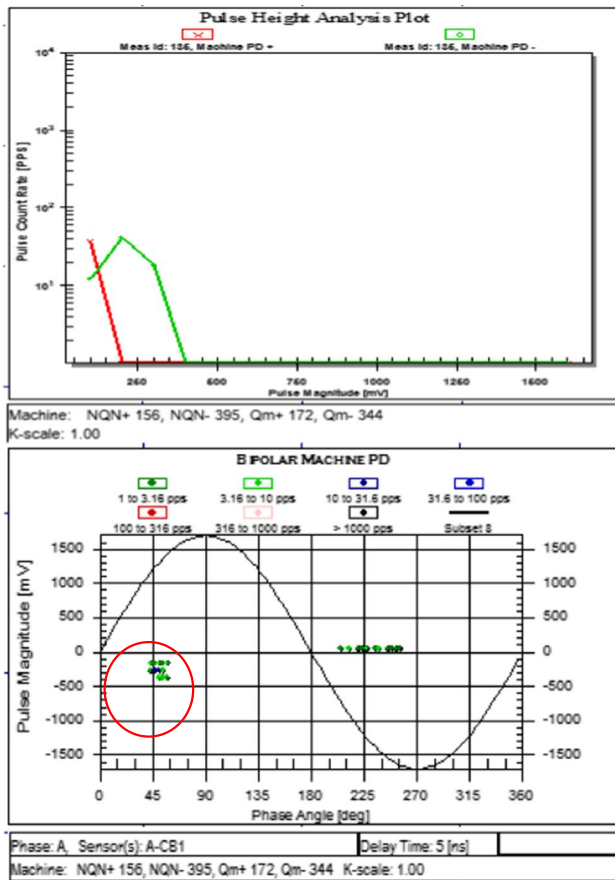
Fig. 17 PD pattern for Type-B1 at 15.0 kV (NQ_N+ :156, NQ_N- :395, Q_m+ :172, Q_m- :344, Q_m-/Q_m+ :2.00)

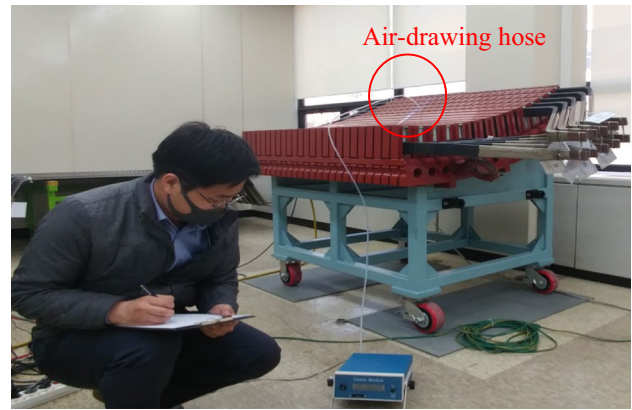
Fig. 18 Ozone estimation of Type-C bars

The schematic diagram for ozone measurement is identical to Fig. 9 except for the installation of the ozone monitor while applying 60 Hz AC voltage up to 15.0 kV on Type-C bars. An ozone monitor (Model 202, 2B technologies) was used to record the data every 10 s with the air-drawing hose placed in the middle of the core through the air duct, as shown in Fig. 18, under an ambient temperature of 26 °C and humidity of 48%.

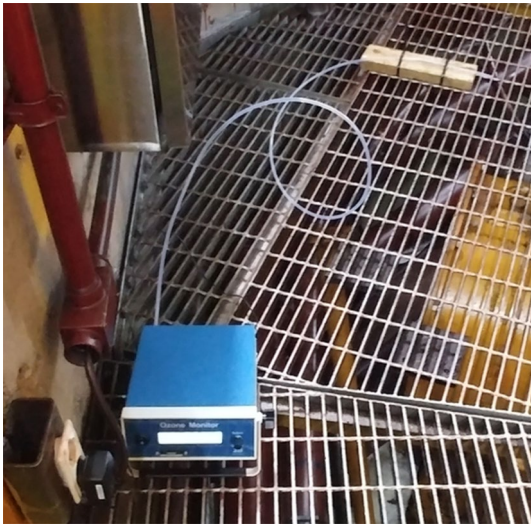
Fig. 19 Ozone monitoring in the generator-motor room

the exception that the air-drawing hose was placed inside a generator-motor room to draw ventilating air. Figure 19 shows the ozone concentration measurement inside one of the generator-motor rooms.

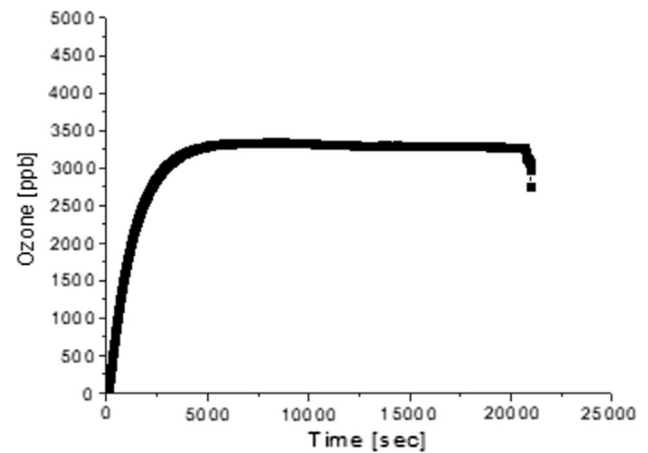
Fig. 20 Ozone measurements in 'A' PSPP

It was found that one of the PSPPs ('A' PSPP) had a significantly higher ozone concentration while that of the others was within the normal indoor range of 10–20 ppb. From the ozone concentration monitoring, it was found that, at rated 18 kV applied under an ambient temperature of 16 °C and humidity of 22%, the 'A' PSPP was saturated to an average of 3400 ppb after 1.5 h after it had started, as shown in Fig. 20.

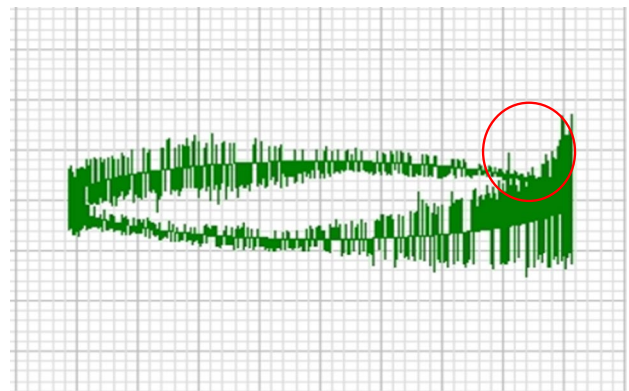
Fig. 21–1 PD measurement before insulation refurbishment (36,260 pC at 10.4 kV, Phase A)

Before ozone measurement, this machine had been diagnosed to have a pattern of slot discharge, as shown in Fig. 21–1. Damage to the semi-conductive layer on the stator winding and winding wear was suspected. Therefore, during the overhaul 2 months before the ozone measurement, insulation refurbishment of stator windings was conducted including replacement of unstable slot wedges, application of insulating paint and varnish on the worn semi-conductive tape on bars near core slots, and replacement of end-winding binding. Figure 21–2 shows PD test results after insulation refurbishment. Significant reductions were apparent on the magnitude from 36,260 to 10,676 pC as well as on the pattern of slot discharge in the 180°–225° phase after insulation refurbishment.

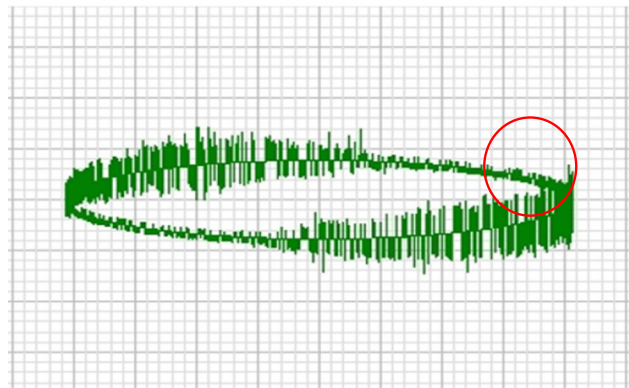
Fig. 21–2 PD measurement after insulation refurbishment (10,676 pC at 10.4 kV, Phase A)

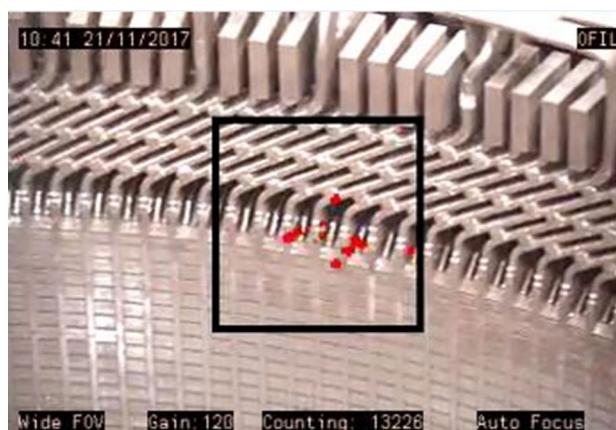
Fig. 22 UV observation (13,226 counting at 10.4 kV, Phase A, Gain: 120)

Additionally, the occurrence of corona was observed at the stator end-winding using a UV camera (Luminar, OFIL). The result showed that the 13,226 pulses were recorded from the PD when applying a phase voltage of 10.4 kV, as shown in Fig. 22. Therefore, it was concluded that the slot discharge due to loose bars was reduced, but discharges at the end winding still existed after insulation refurbishment.
