# Investigation into wear mechanisms of the bearing raceway used in bucket wheel excavators

This article presents the macro- and microstructural analysis of bearing raceways. Raceways of bearings, taken from two machines which had worked 100,000 and 30,000 h, were examined. This provided crucial information on the exploitation history of both bearings, which is especially important for the future design process. After these initial macroscopic observations, it was determined which areas of the bearing had been most severely worn. This was indicated by the areas in which the chassis stiffness was highest. Further microscopic analysis of the individual bearing sections was useful for the identification of the dominating, destructive mechanisms in these areas.

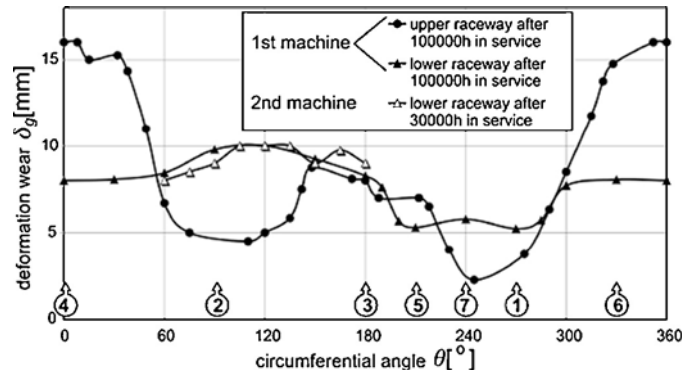
The dislocation wear of the raceway surface into the ring, in the disassembled bearings, has been measured as  $\approx g$ . The measurement was taken using an ultrasonic thickness gauge and verified at select points using a dial indicator. Deformation wear, as shown in Fig. 4, was measured in such a way that for the lower raceway it ranged from 5.2 to 10 mm and for the upper raceway from 2 to 16 mm. Based on many years of experience

**Fig. 4 – Deformations wear of the raceways of the stacker's bearing – a similar level of wear of the lower raceway in both machines, despite different service times. Arrows indicate sites of the raceway surface casts.**

and conducting numerical simulations, Smolnicki [1] revealed that the distribution of deformation wear is highly correlated with disposition of stiffness over the circumference of the bearing. He also observed that the deformation wear was greatest in regions of highest stiffness within the load-bearing construction. Based on the results, it can be stated that deformation wear after 100 and 30 thousand of service hours is similar, which means the incidence of intensive rolling of raceway in the first stage of usage, after which time the phenomenon stops. After the initial deformation wears, further wear is very slow. In the first wear stage, the bearing has to adapt to load construction. It corresponds well with the experimental research on 42CrMo4 (40HM) and C45 (45) steels made by I. Prebil [5] and numerical simulations made by M. Stanco [6].

Referring to Figs. 3 and 4, large deformation wear of the raceway (which reaches, on average, 7% of the diameter of a

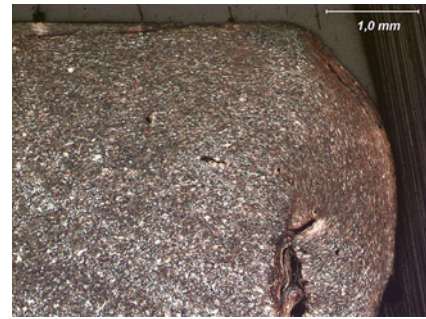
The above chemical composition is typical for thermally altered steel of the kind '50H', as stated in the PN/H-84030/04:1989 standard. As the microscope examination has shown, Fig. 6, this steel has a fine, pearlite structure with ferrite grains and single small separated carbides. This structural state indicates that the steel used for the raceway was 50H in its normalized state (the so called soft state).

**Fig. 6 – A microscopic image of the structural alterations and damages. Elongated visible (light) parts are ferrite separations. Magn. 25x, etched 3%  $\text{HNO}_3$ , light microscopy.**

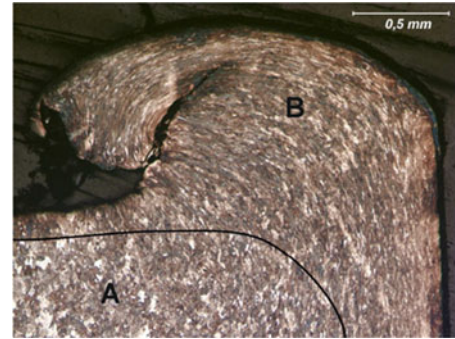
One can observe there is the area of the material free of plastic deformation (area A) and area where besides the clearly visible press texture there are areas of lack material cohesion of the raceway as a result of its exploitation. This area is full of plastically deformed; elongated; segmented; and separated by voids, fragments of raceway material.

**Fig. 10 – Microscopic image of structure alterations and damages in the left side material flow out area, shown in Fig. 9b.** (A) Area of unchanged structure – pearlite with ferrite grains. (B) Structural area with different plastic deformations and plenty of structural incoherence. Elongated visible (light) parts are ferrite separations. Magn. 25 $\times$ , etched 3%  $\text{HNO}_3$ , light microscopy.
