ARTICLE

Exceptional river gorge formation from unexceptional floods

L. Anton¹, A.E. Mather², M. Stokes², A. Muñoz-Martin³ & G. De Vicente³

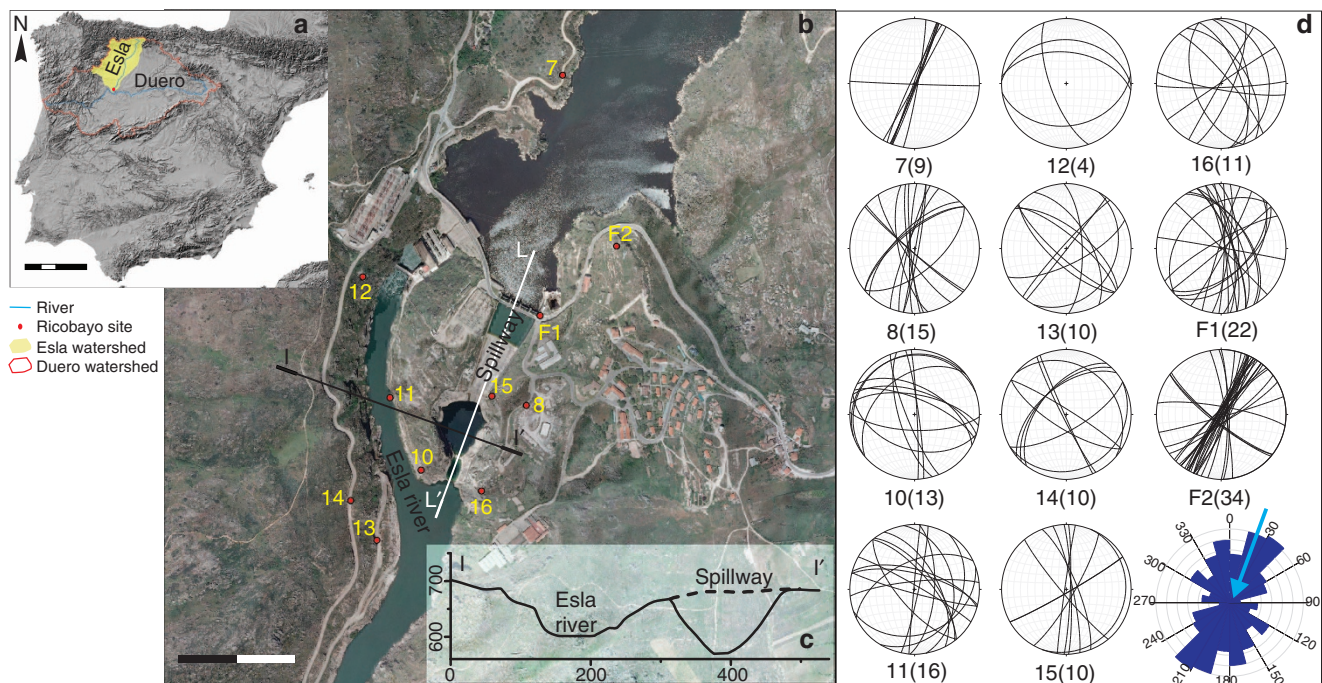
Figure 1 | Field area and fracture pattern. (a) The Río Esla and Duero watersheds and the study area location. Scale bar, 200-km long; (b) the Ricobayo dam, its spillway and sites of measurements and sampling (orthophotograph, IGN, 2011). Location of longitudinal profile shown in Fig. 3i is indicated by L-L'; I-I' indicates the section shown in c; scale bar, 250-m long (bottom left corner); (c) cross-section showing pre-scour (dashed line) and present topography. (d) Stereoplots of fracture orientations (numbers = location, in brackets the number of fractures plotted). Rose diagram of the whole-fracture population (class interval 15°, maximum percentage 14.6, percentage interval 2%). Arrow shows flow direction of spillway.

Dam construction and flood event history. The Ricobayo dam was constructed along the Río Esla in NW Iberia in the 1930s. It is located 4-km upstream of the confluence with the Río Duero (Fig. 1a), allowing formation of a reservoir (area = 57×10^6 m², volume = $1,150 \times 10^6$ m³). The Río Esla (287 km in length) has a catchment area of $\sim 16,000$ km² and a mean (annual) discharge of $5,266 \times 10^6$ m³ per year²⁵. Before dam construction the Río Esla was characterized by seasonal floods with peak discharges ranging from 500 to $>2,500$ m³ s⁻¹ (ref. 26), peaking in winter and spring (Fig. 2a). Throughout the Ricobayo area the Río Duero and its tributaries have deep gorges (~ 100 – 450 m) incised into granite and more rarely into metamorphic bedrock²⁷. The Ricobayo dam is located in a 100-m deep granite gorge section of the Río Esla. Here bedrock is unweathered but intensely

jointed/fractured. The top edge of the granite spillway coincides with a regional low-relief surface ~ 100 m above the modern Río Esla channel (Fig. 1c).

Bedrock discontinuities. Systematic measurements of fractures (joints and faults, see Methods) revealed a pattern in the Ricobayo area dominated by NNE–SSW striking fractures (Fig. 1d). This included a primary NNE left-lateral strike-slip fault system concordant with previous field-based regional structural geological analyses^{34,35}. This primary pattern exerts a significant control on drainage network orientation, as observed in the lower Río Esla reach (Supplementary Fig. 1). Secondary fracture sets oriented NNW–SSE and ESE–WNW are encountered and are significant at outcrop scale (Figs 1d and 4). Most fractures were vertical or near-vertical, although minor subhorizontal unloading joints were also present. Fracture spacing was locally in a 0.3–3 m range (Supplementary Table 1) and fracture length is typically more than several tens of metres, with a vertical persistence along the whole outcrop (Fig. 4). Exposures of discontinuity surfaces revealed a dominance of fresh, tight and unweathered planes. Fracture plots suggest that the primary fracture sets influence river incision and the progression of erosion in the spillway. Vertical and sub-vertical NNW to NNE trending structures determine the bedrock river and spillway gorge orientation (for example, site 15 in Figs 1 and 4a). ESE trending fractures are orthogonal to flow direction in the spillway with sets dipping both against and towards the flow (Figs 1d and 4).

Fracture population analysis. Field survey was undertaken to identify the bedrock fracture pattern. Orientation (trend and dip) of 151 fracture (fault and joint) planes were measured at 11 sites in the Ricobayo area (Fig. 1d). This task was preceded by field reconnaissance to select representative outcrops that encapsulated all of the fracture types and patterns. Stereoplots, histograms, rose diagrams and density plots were used to analyse the data. The fracture pattern is dominated by NNE–SSW striking structures, while secondary fracture sets oriented NNW–SSE and ESE–WNW take weight at outcrop scale (Fig. 1d). Together with the statistical analysis, the dominant trends were identified from aerial and field imagery and then compared with published regional fault patterns³⁴ (Supplementary Fig. 1). Due to the relevance of dip and dip direction of the orthogonal to flow fracture sets in the erosional process^{36,57} and based on field experience (Fig. 4a–d), ESE trending sets were analysed separately. Planes striking within $\text{N}85^\circ \text{ E}$ and $\text{N}140^\circ \text{ E}$ were extracted from the whole population and represented by a stereoplot and density diagram (Fig. 4h).

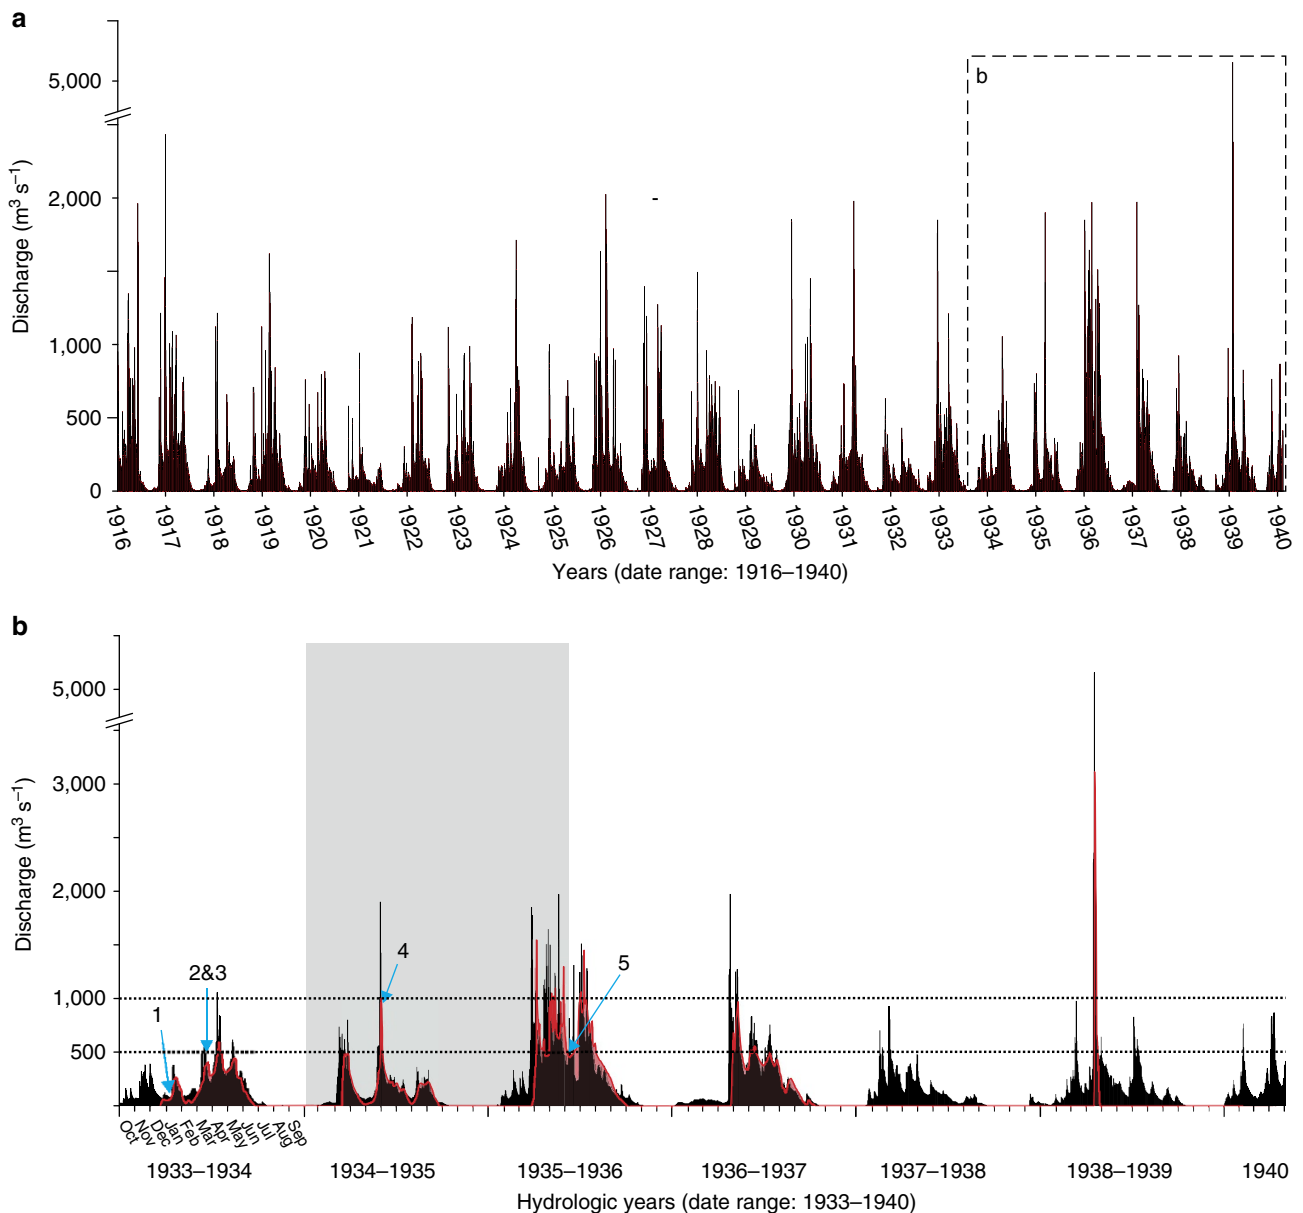
Figure 2 | Floods entering the reservoir and spillway overtopping discharges. (a) Histogram of the Río Esla water discharge series at Breto Gauging station^{30,58} (1916–1940), which is located upstream of the current dam position close to the current upstream limit of the modern reservoir. (b) Detailed water discharge series (1933–1940 hydrologic years, October–September) showing winter rainfall dominance and scour events. Numbers indicate when main scour events 1–5 occurred. Grey area illustrates the period when spillway lip reinforcements were present. Peak flood discharge in the Río Esla is represented in black and flood discharges exiting the spillway are shown in red.

The dam and unlined spillway were simultaneously constructed from 1929 to 1933. The reservoir filled with water by the end of 1933 after which a series of spillway overtopping floods occurred²⁸ characterized by spillway discharges of between ~ 100 and $\sim 1,500$ $\text{m}^3 \text{s}^{-1}$ (Fig. 2b).

These spillway overtopping floods occurred from the middle of December to late June of the 1933–1936 hydrologic years and late January 1936 to the middle of July 1937 (Fig. 2b). This led to installation of flood gates at the spillway entrance that increased the reservoir water storage, and evacuation conduits were constructed²⁹. After these modifications, only a single but large flood event (a flood of $>5,000$ $\text{m}^3 \text{s}^{-1}$) in January 1939 utilized

the spillway. The overtopping spillway discharges from this flood (up to $3,000$ $\text{m}^3 \text{s}^{-1}$) exited over a period of 10 days (Fig. 2b)^{26,28}. From January 1934 to March 1936, the flows overtopping the spillway induced scouring that occurred predominantly in five large scour events (Fig. 3). The process was reported by eye witnesses and documented^{28–30}. Scour event 1 occurred on 10th January 1934 associated with a spillway discharge of ~ 80 $\text{m}^3 \text{s}^{-1}$. As a consequence, a 65-m long, 55-m deep gorge was formed (Fig. 3b,i). Scour event 2 occurred on 22nd March 1934 associated with a spillway discharge of ~ 400 $\text{m}^3 \text{s}^{-1}$, producing 75 m of headward erosion and 30–40 m of incision. Further scour (event 3) occurred the next day associated with a ~ 400 $\text{m}^3 \text{s}^{-1}$ spillway discharge, producing a further 100 m of retreat (Fig. 3c). The floods continued during April and May and the next winter, but only in 1935 (4th March) during a spillway discharge event of

Before and during dam construction, much larger floods (up to $2,500 \text{ m}^3 \text{ s}^{-1}$) occurred in the Río Esla (Fig. 2)^{26,46} but they were not associated with any significant erosion within the spillway gorge. The elevated stream power caused by the artificially created waterfall in the 'spillway channel' outlet is suggested as the driving mechanism for rapid knickpoint retreat and gorge formation.

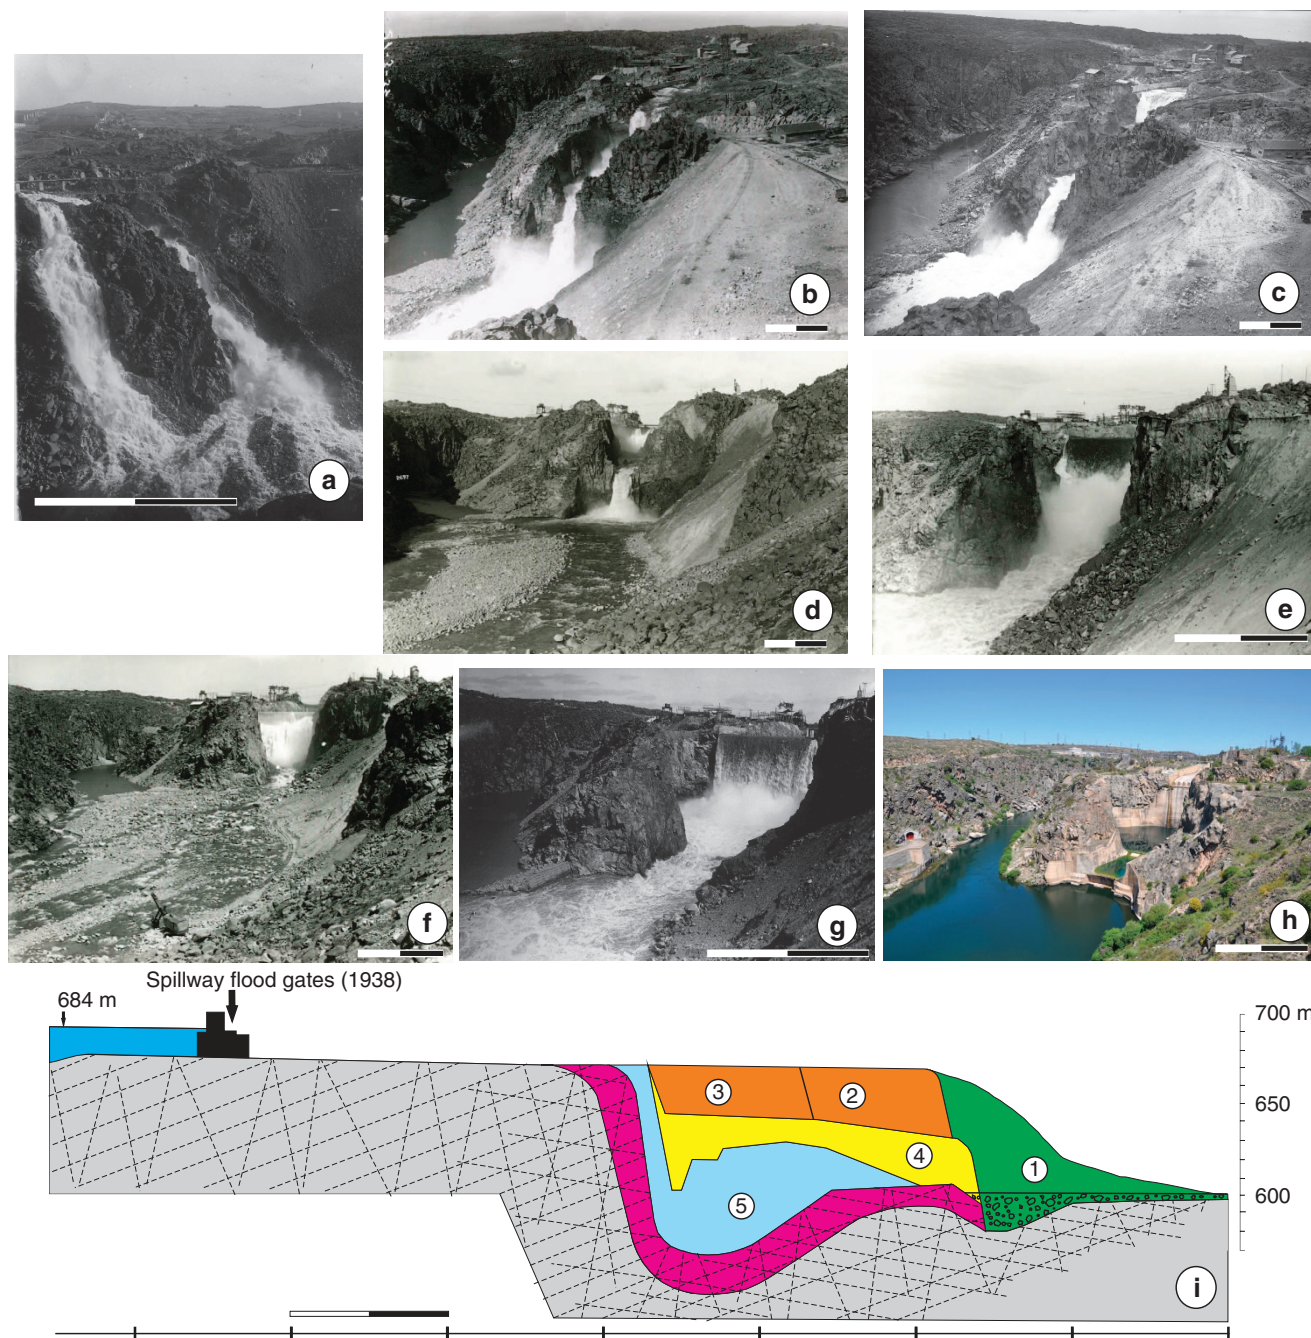
Figure 3 | Historical imagery looking upstream into the Ricobayo spillway and spillway longitudinal section. Photograph dates: (a) 27/12/1933 before scour event 1; scale bar, ~50-m long; (b) 21/3/1934 after scour event 1; (c) 26/3/1934 2 days after scour event 3; (d) 24/1/1935 scour event 4; (e) 5/3/1935 after scour event 4; (f) 6/7/1935 after scour event 4; (g) 7/4/1936 after scour event 5; (h) 2012. Scale bar, ~100-m long (photographs b–h). (i) Historical long profile sketch of the spillway depict the material removed in each stage (modified from Iberdrola³⁰). Scale bar, ~100-m long. Location is indicated by L–L' on Fig. 1b. Flow from left to right. Successive erosion stages (represented by different colours) include the main scour events (1–5) and minor inter-event scouring. Pink area indicates the bedrock reinforced during the concrete revetment work post gorge formation (1940s onwards, h). Spillway flood gates represented were installed in 1938. (Imagery credit Iberdrola).

$\sim 1,000 \text{ m}^3 \text{ s}^{-1}$ was a new large scour (event 4) produced (Fig. 3d–f), with an incision of 22 m below the previous erosion level. The last large scour (event 5) occurred in March 1936 (some $500 \text{ m}^3 \text{ s}^{-1}$; Figs 2b and 3g). Although the erosion occurred predominantly as a result of 5 scour events, minor, intervening erosion from smaller events cannot be ruled out, although eye witness information (survey and photographic data, for example, Figs 3, 5 and 6) suggest these modifications were minor. However, after events 4 and 5, there were several subsequent floods that

caused further widening, and block movement at the base of the plunge pool (stage 5 in Fig. 3i). Thus, we refer to the main scours as ‘events’, and in Fig. 3i refer to ‘stages’ that incorporate both the major event and any minor inter-event modification.

Before the erosion events dam workers established a low gradient (<1°) unlined rock spillway channel. The channel, 400-m long, was inset ~20 m into the bedrock on a topographic high (~70 m above the riverbed; Figs 3i and 5a). The downstream boundary of the spillway was formed by a high angle (~30°) knickpoint lip perpendicular to flow that had been artificially created in the spillway mouth (Figs 3 and 5a,g).

Knickpoint upstream propagation was extremely rapid (> 230 m per y) during the first stages of the gorge formation (main scours 1–3; Fig. 3), but decreased rapidly thereafter (Fig. 6f), superseded by incision and gorge widening (Figs 5–7). The knickpoint lip reinforcement attempts made in summer 1934 could have some influence on this pronounced slowdown in knickpoint retreat, acting in the manner of a resistant cap rock³⁷. Observations and flow data (Figs 2b, 3 and 4), however, suggest otherwise. Between scour event 3 (spring 1934) and the introduction of the artificial reinforcement (summer 1934) there were several spillway overtopping discharges that were similar or higher in magnitude to the events that created the initial gorge (Fig. 2b) but these spillway floods did not cause knickpoint retreat. This would imply that the pronounced decrease in headward retreat rates had already occurred before the introduction of the artificial reinforcement (Fig. 7). Furthermore, the knickpoint reinforcements were only a temporary feature as they were ripped out by flooding in March 1936. While waterfall lip shape, length and height are thought to be influential in affecting waterfall retreat rates³⁸, other studies have highlighted bedrock structure and fracture geometry as playing a fundamental role in block stability^{36,39}, knickpoint morphology and retreat rate^{6,11,20,40}. In this example, the slowdown in retreat rate appears to mirror the timing of when the knickpoint interacts spatially with the area dominated

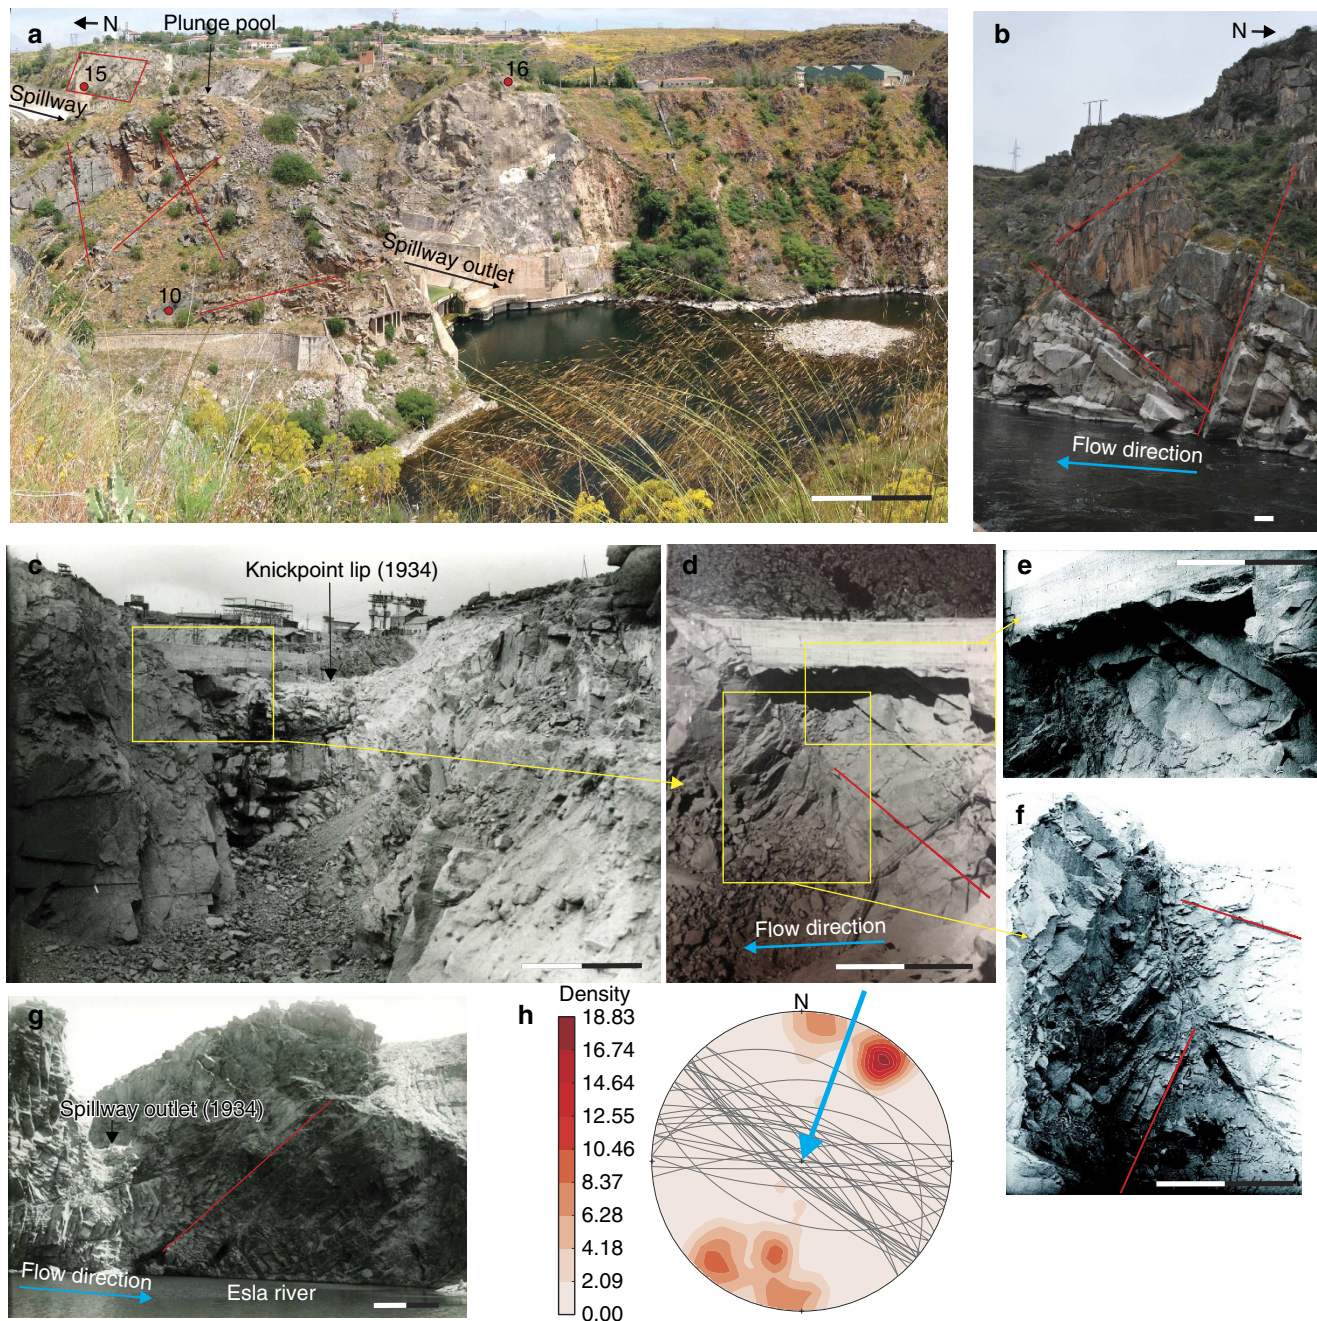
Figure 4 | Field photographs illustrating fracture geometry at the spillway site and Río Eslla. (a) Present spillway outlet and fracture pattern. Red dots indicate measurement sites (Fig. 1), red lines indicate fracture planes. Red box at site 15 represents a \sim N-S fault plane outcrop, parallel to the spillway gorge orientation. Scale bar, \sim 50-m long. (b) Western side of the Río Eslla in front of site 11 (Fig. 1b). Fracture set dipping against and toward the flow. Scale bar, \sim 1-m long. (c) Spillway lip and gorge formed during 1933-1934 hydrologic year (scours 1-3; Fig. 3); scale bar, \sim 50-m long, (credit Iberdrola). Yellow box indicates location of photograph (d). (d) Fracture pattern at the knickpoint lip by summer 1934 when retreat had significantly slowed (credit Iberdrola). Scale bar, \sim 25-m long; Yellow boxes indicate location of photographs (e,f). (e) Detail of fracture orientation (dipping against the flow) at the knickpoint lip. Scale bar, \sim 25-m long. (f) Detail of fracture orientation (dipping predominantly toward the flow) downstream of the knickpoint lip. Scale bar, \sim 25-m long; (g) Fracture sets dipping predominantly against the flow at the \sim 30-m height knickpoint formed at the spillway outlet (confluence with the Río Eslla) by March 1934. This knickpoint disappeared during the fourth main scour (Fig. 3d,e) in March 1935. Scale bar, 25 m. (h) Orthogonal to flow fracture planes dipping towards and against the flow. Stereoplot and density plot of ESE trending fractures, measured at the Ricobayo sites (see Methods).

patterns are found in the regional geological context. However, discontinuity patterns through fracture density and orientation interactions play an important role in the gorge development^{12,20,36}. The existence of several fracture sets with different orientations resulted in the formation of bedrock blocks that were susceptible to removal by plucking and probable block topple

(Fig. 4). Similar (m-scale) blocks can be found elsewhere in the natural reaches of the Río Eslla suggesting this is not just localized to the spillway area. The NNW to NNE structures regionally determines channel orientation patterns. Furthermore, although they are quantitatively less represented, the orthogonal to flow fracture sets within these channels play a key role in the gorge

progression. This structural pattern (Fig. 4) enhances headward erosion when the fractures dipped towards flow and favoured incision when fractures dipped predominantly against flow^{20,36}.

by anti-flow oriented fracture sets, implying that that structural differences along the gorge, with local predominance of fracture sets dipping against the flow, became significant in suppressing the retreat progression³⁰ (Fig. 4d–g).

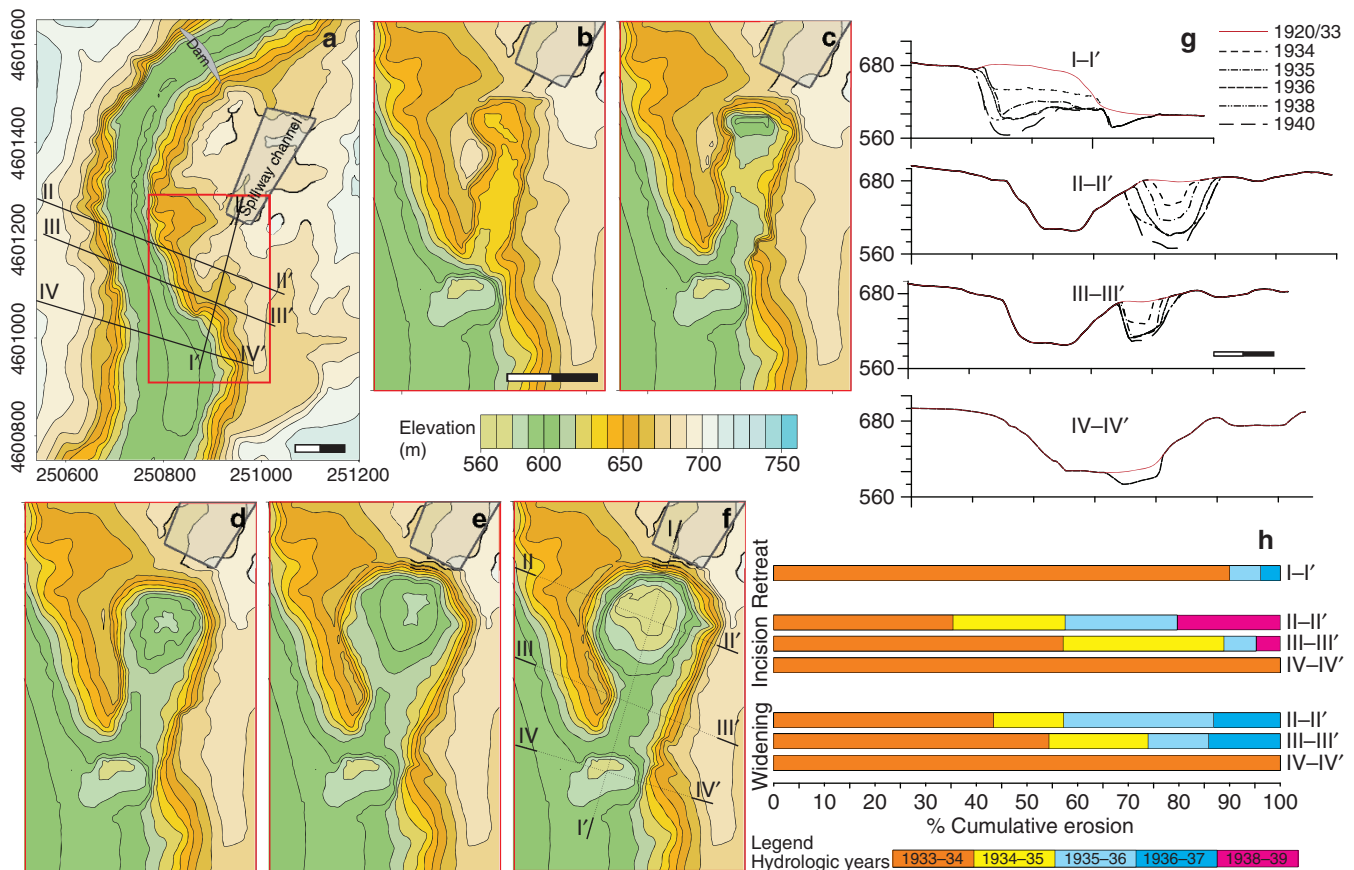
Figure 5 | Contour maps of the spillway topography showing the erosion sequence. Contour lines = 10-m intervals. Map dates: (a) 1920; box = area represented in b-f; Dam and present location of the spillway channel represented. (b) 1934 (after scour events 1–3); (c) 1935 (after scour event 4); (d) 1936 (after scour event 5); (e) 1938; (f) 1940; (g) sections of spillway site in successive years (see a for location). Scale bar, 100-m long. (h) Plot of cumulative percentage of retreat, incision and widening along different gorge sections. Upper reach (II–II’), middle reach (III–III’) and lower reach (IV–IV’).

during the erosion events (1934–1940) was performed through analysis of historic topographic maps^{28,29} (Methods). Digital elevation model (DEM) generation illustrates the former topography of the spillway site and how the bedrock erosion proceeded (Fig. 5). Comparison of successive DEMs enabled spatial and temporal erosion patterns to be quantified for successive stages and allows the calculation of erosion rates (incision, widening, retreat and eroded volume; Fig. 6).

depth increased in the plunge pool with successive outflow discharges and progressive scour formation, the water jet energy focused on the developing plunge pool water body^{41,42}. Over this time bedrock scours occurred predominately at the base of the plunge pool and incision in the middle reach was minimal (Figs 5g,h and 6). Subsequently, as the channel was deepened and enlarged, the rim of the headwall and the gorge sides became unstable and the canyon began widening. Thus, while headwall retreat moved as a wave of erosion upstream creating the canyon, the slowdown in retreat rate promoted a persistent vertical headwall, allowing incision and widening to progress (Fig. 7) and eventually forming the present amphitheatre-headed valley with a 40 m water depth plunge pool (Figs 5 and 6).
