Effectiveness of various types of coating materials applied in reinforced concrete exposed to freeze–thaw cycles and chlorides

This study assesses the durability of coated and uncoated concrete surfaces protected with four different coating materials: water-soluble (BW), solvent-based (BR), mineral (MI), and epoxy (EP). The durability assessment includes evaluating the absorption rate of water, pull-off adhesion strength, and coating material thickness. Concrete samples were subjected to immersion in regular water and a 7% urea solution, followed by cyclic freezing and thawing. Furthermore, the diffusion of chloride ions in concrete was evaluated using the impressed voltage method, with the samples exposed to the aging process immersed in a 3.5% NaCl solution. The results indicate that EP and BW coatings were significantly affected by the presence of urea and freeze–thaw cycles, resulting in a 43% and 47% reduction in pull-off adhesion strength, respectively. Notably, the MI-coated concrete samples exposed to urea solution and the freeze–thaw cycles exhibited a significant reduction in the absorption rate due to the accumulation of crystals on the coating surface, resulting in red

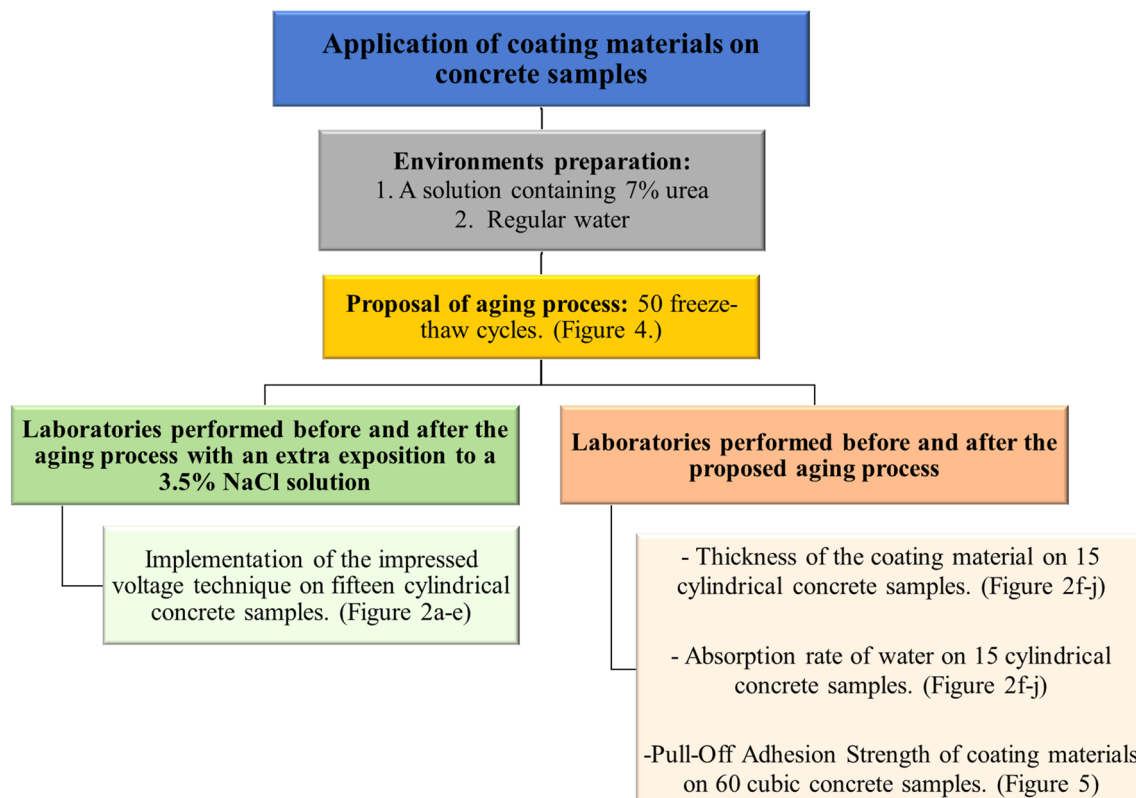
Figure 1. Research methodology.

Experimental procedure. This research study aims to evaluate the effectiveness of different coating materials applied to concrete surfaces exposed to various contaminants. The study will combine quantitative evidence of changes in adhesion strength, absorption, and coating thickness. The findings will contribute to the growing research area on concrete protection in contaminated environments. Figure 1 shows the research methodology used during this study.

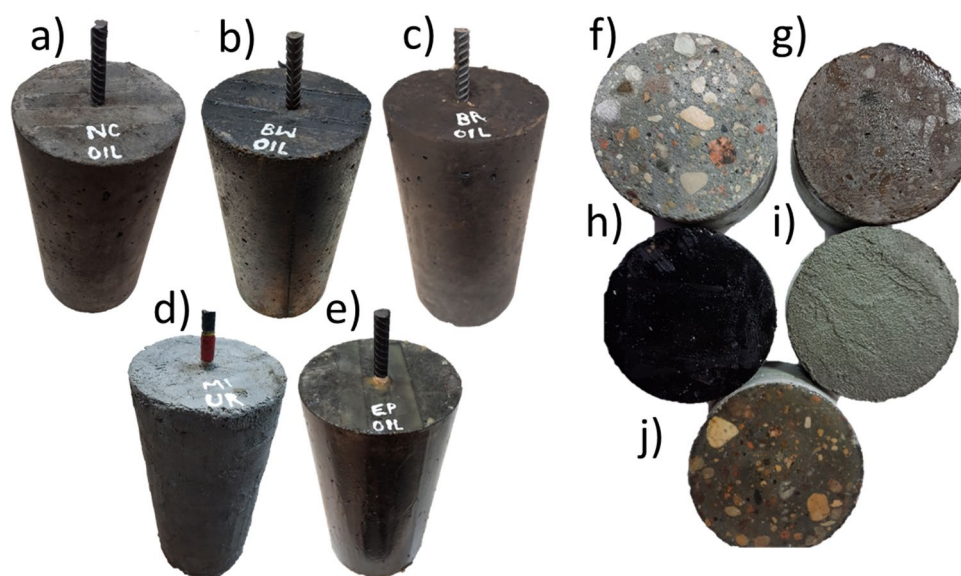
Figure 2. Reinforced concrete samples for the impressed voltage technique: (a) EP, (b) MI, (c) BW, (d) NC, (e) BR. Concrete samples for water absorption rate: (f) NC, (g) BR, (h) BW, (i) MI, (j) EP.

In this study three types of concrete samples were utilized. Pull-off adhesion strength tests were performed on cube-shaped specimens measuring 100×100 mm. Cylinders with reinforced concrete measuring 150×300 mm were used for the impressed voltage technique. Additionally, cylinders measuring 100×50 mm were employed to assess water absorption rates. Detailed illustrations of these concrete specimens can be found in Figs. 2 and 5.

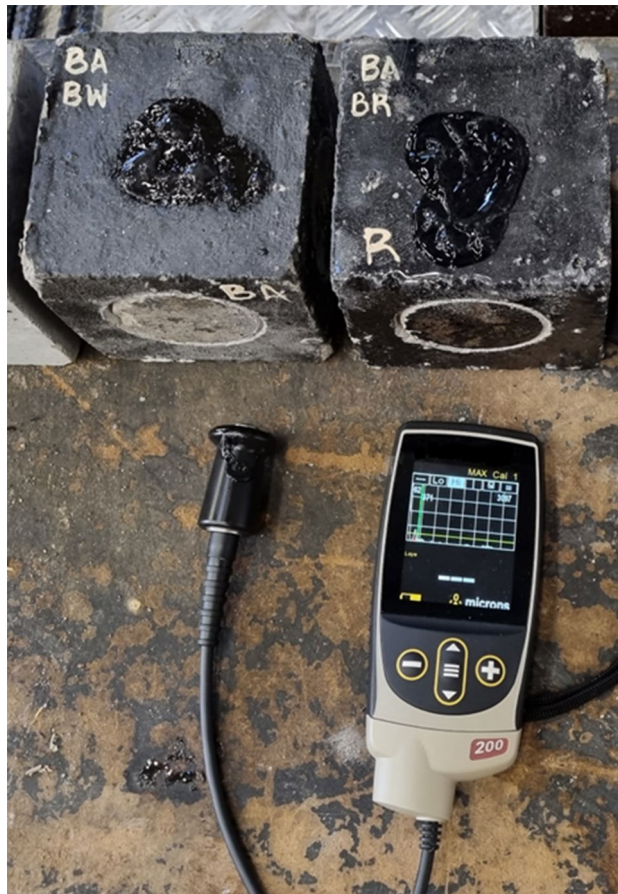
Figure 3. Measurement of coating material thickness.

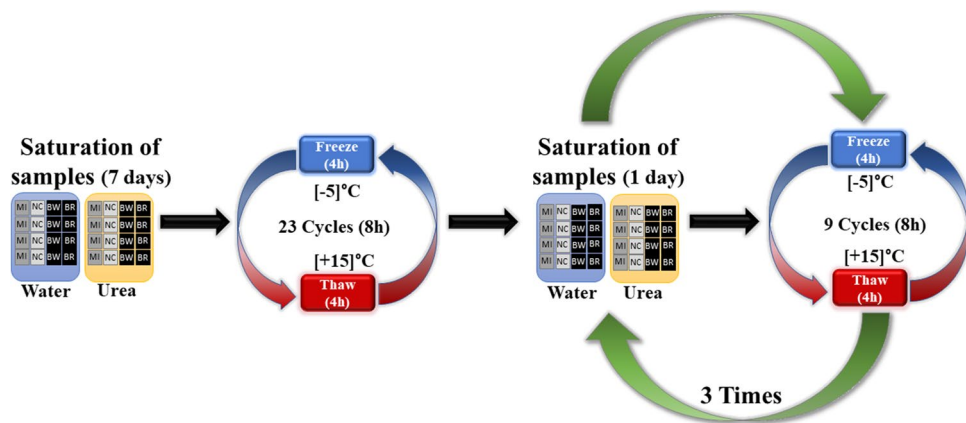
Figure 4. Aging process description. Freeze–thaw cycles and saturation of concrete samples.

Aging process. An accelerated aging test was conducted using a Tropol K-012 frost resistance test chamber, which is commonly employed for assessing the frost resistance of building materials. The specimens were subjected to cyclical freezing in air and thawing in water, while an electronic programmer monitored the cycles.

To simulate freeze–thaw conditions in the laboratory, the test was performed at temperatures ranging between $[-5]$ and $[+15]$ °C. Two solutions were employed to simulate contaminated environments: regular water and urea solution with a concentration of 7%. The aging process, as depicted in Fig. 4, was applied to the samples. Furthermore, each specimen was coated with one of the four materials assessed in this research: BW, BR, MI, and EP. Additionally, a control sample without protection (NC) was included for comparison with the protected samples. After 50 freeze–thaw cycles and a 10-day saturation period, the absorption rate, pull-off adhesion strength, and chloride permeability of each sample were measured.

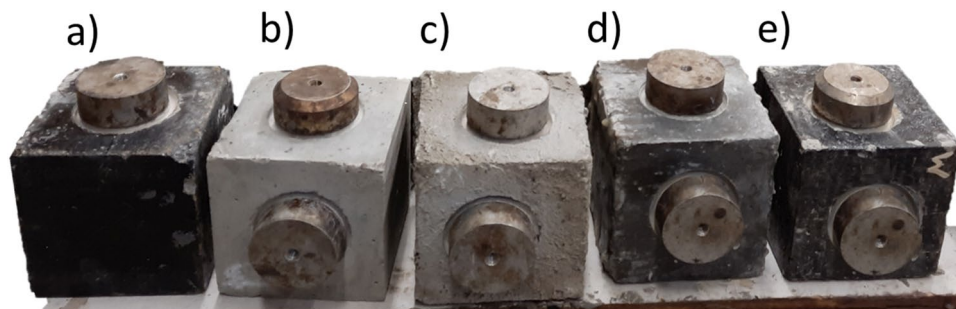
Figure 5. Concrete samples for the pull-off adhesion strength assessment (a) BR, (b) without coating, (c) MI, (d) EP, (e) BW.

Adhesion strength test. The pull-off adhesion strength of coating applied to concrete surfaces was assessed in accordance with the ASTM D 7234-21 standard⁴. Cubic samples, as illustrated in Fig. 5, were used for the test.

To measure the adhesion strength, a DTH 500 DC testing machine with a maximum tensile strength of 5 kN was employed. Metallic dolls with a diameter of 50 mm and a height of 20 mm were utilized. To ensure accurate measurement, a circular notch was drilled to define the specific surface area to be measured. Subsequently, the metallic dolls were securely attached to the concrete surface using an epoxy material. Prior to the aging process, six pull-off tests were conducted for each coating material and environment type. The same procedure was repeated after the aging process.

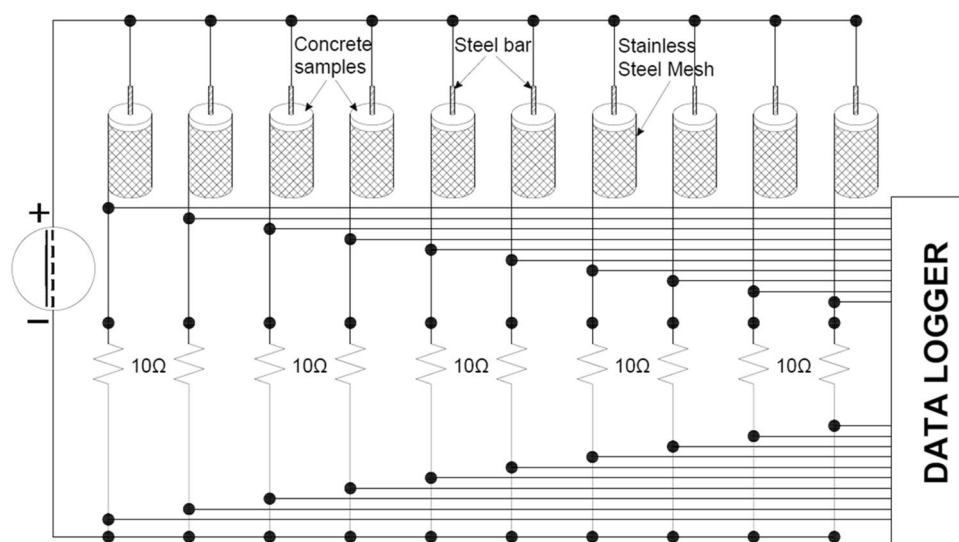
Figure 6. Electrical schematic design for the impressed voltage technique test.

Impressed voltage technique. To assess resistance to chloride ion permeability, the impressed voltage technique specified in the NT BUILD 356 standard²⁸ was employed. A constant direct current of 5 V was applied between a steel bar embedded in the concrete sample and the concrete surface. Furthermore, reinforced concrete specimens were partially immersed in a 3.0% NaCl solution during the test duration.

This test was conducted both before initiating the aging process and after seven days of completing the aging process in both coated and uncoated reinforced concrete samples. The test concluded upon the appearance of cracks or corrosion on the surface of the steel bar. The circuit assembly utilized an external DC power supply, YIHUA 3005D [0–30 V] 5 A, and a measurement data acquisition system capable of connecting ten samples simultaneously. The schematic design is illustrated in Fig. 6.

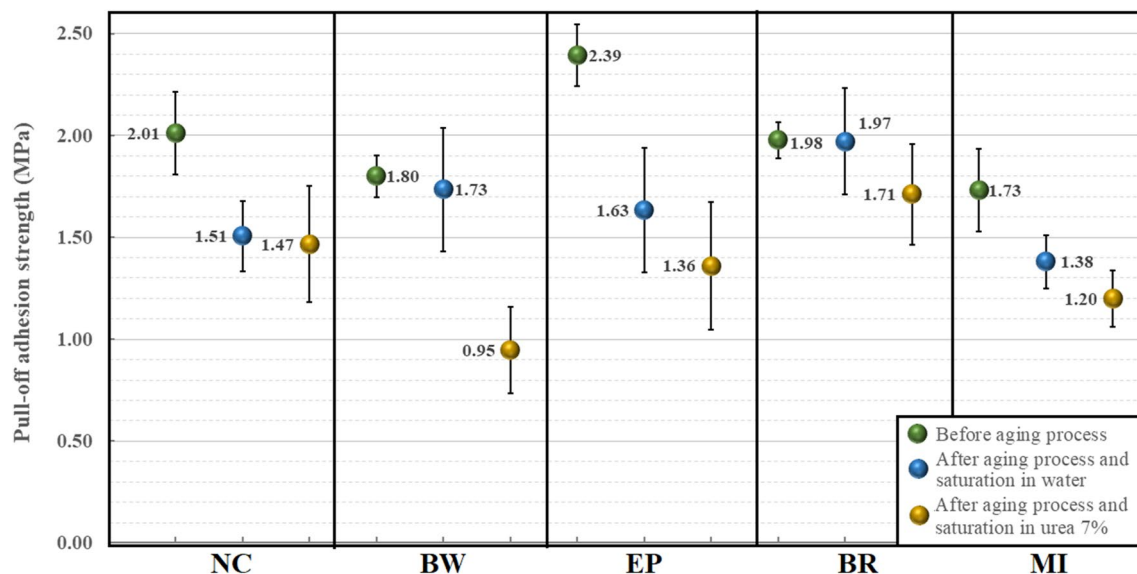
Figure 7. Average pull-off adhesion strength.

The results indicate that exposure to urea led to a decrease in the adhesion strength for all coatings after the aging process. Among the coatings, EP and BW were the materials more affected, exhibiting reductions of 43.09% and 47.22%, respectively, compared to the pre-aging process results. The obtained adhesion strength values for the EP coating, ranging between 1.36 and 2.39 MPa, align with those reported by A. Almusallam et al.¹⁵, who reported values within the range of 1.5 and 3.2 MPa. Similarly, the adhesion strength values for the MI coating align with the findings of Flores-Colen et al.²⁹, who obtained values higher than 1.2 MPa for mineral and cement-based coatings. On the other hand, the BR coating exhibited the least reduction in adhesion strength after the aging process, with reductions of 0.51% for samples saturated in water and 13.63% for samples saturated in urea. This behavior can be attributed to the low water absorption of the material resulting from the presence of hydrocarbon constituents³⁰.

The reduction in adhesion strength observed in BW coatings can be attributed to the formation of ice crystals during the freeze–thaw cycle. The repeated ingress of water followed by freezing can result in an increased moisture content within the material, rendering it more susceptible to damage. The expansion and growth of these ice crystals have the potential to disrupt the integrity of the bituminous material, ultimately leading to cracking and degradation³³.

In contrast, solvent-based coatings (BR) are generally less affected by freeze–thaw cycles compared to other types of materials. This is primarily due to their low water content, which significantly reduces the formation of ice crystals. Solvent-based coatings exhibit better flexibility and toughness compared to water-based materials, allowing them to withstand the stresses and strains associated with freezing and thawing cycles. Their increased resilience and resistance to cracking or delamination contribute to their ability to withstand freeze–thaw conditions³⁴.

Finally, even though mineral coatings usually are more susceptible to damage from freeze–thaw cycles compared to other types of coatings due to its high porosity and the different coefficients of thermal expansion of its materials, in our case the presence of modified polymers in the mixture improved the performance and resistance of MI coating, by incorporating polymers, such as acrylics, latexes, or styrene-butadiene rubber (SBR), into the mix, the resulting composite exhibits improved resistance to cracking³⁵. The polymers can accommodate minor movements and stresses within the material, reducing the likelihood of crack formation and propagation, especially during freeze–thaw cycles or structural movement³⁶. Additionally, it improves the adhesion to substrates and the bond strength and the most important the polymers create a denser and more water-resistant matrix, preventing water from entering the material and reducing the potential for freeze–thaw damage^{37,38}.

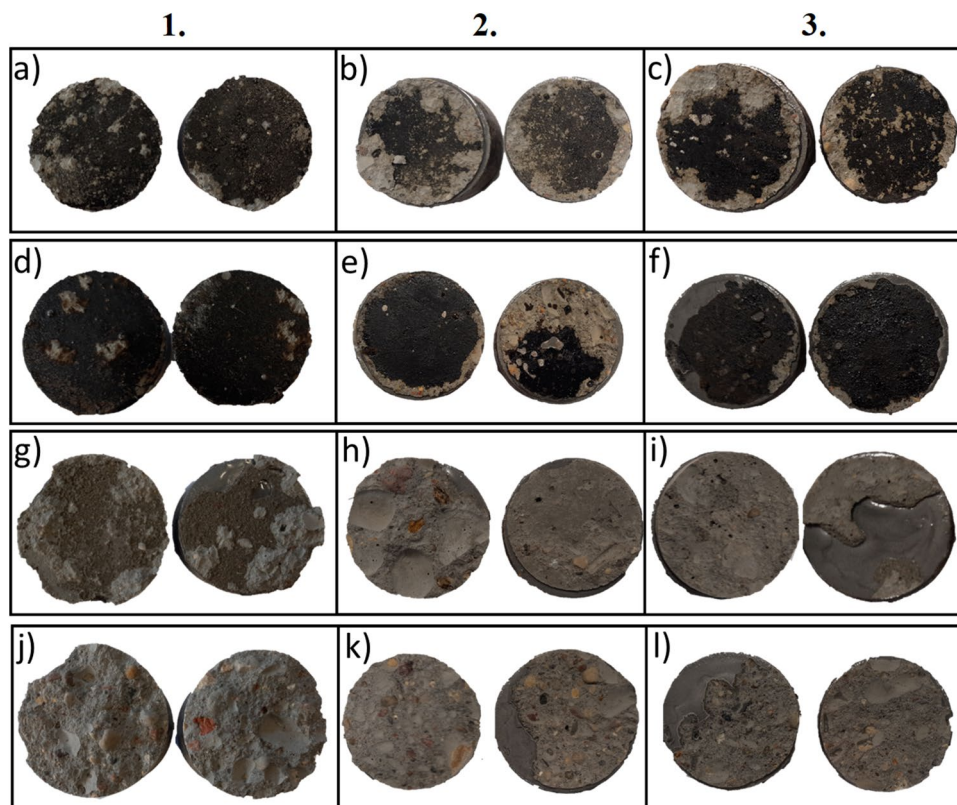
Figure 8. Pull-off adhesion failure types. (1) Samples before the aging process, (2) samples after the aging process and exposure to water, (3) samples after the aging process and exposure to urea—(a–c) BW, (d–f) BR, (g–i) MI, (j–l) EP.

Figure 8 showcases some examples of the failures encountered during this study. Column 1 presents the samples before the aging process, column 2 shows the samples after the aging process and exposure to water, and column 3 presents samples after the aging process and exposure to urea. In accordance with the failure

types defined in ASTM D 7234-21⁴⁰, all types of coatings exhibit adhesive failure [C] after the aging process and exposure to urea due. This can be attributed to the high contamination levels on the concrete surface caused by the urea components and the aging effects. Substrate failure, as depicted in (j), (k), (l), and (h), is the preferred mode of failure for coatings on concrete^{40,41}. However, it is important to note that the cases of substrate failure observed in Fig. 8b, c for BW cannot be considered valid due to their low adhesion values.

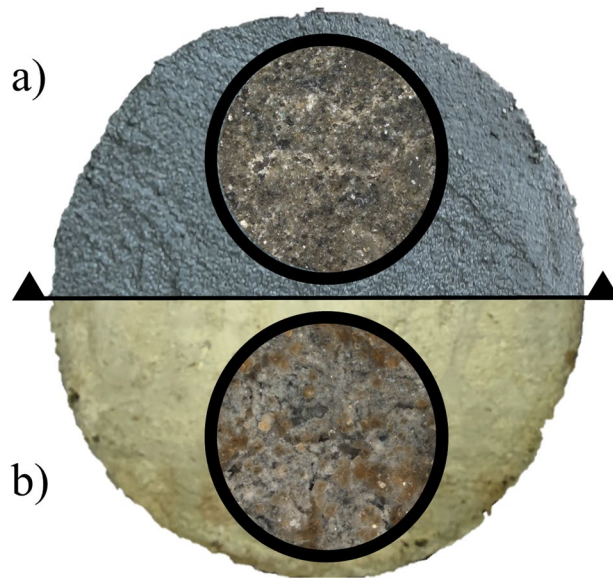
Figure 9. MI micrographs. (a) Before the aging process, (b) after the aging process.

For the MI coating, a noticeable accumulation of calcite crystal was observed after the aging process. This phenomenon can be attributed to the crystallization of urea on the concrete surface. similar results were reported by Ramakrishnan1 et al.⁴² in a study on the development of a self-repairing material able to remedy cracks and fissures in concrete using *Bacillus pasteurii*, *Sporosarcina* bacteria, and urea as a curing method. The study revealed the formation of calcite crystals accumulations on superficial cracks, which aided in filling them and reducing the infiltration of contaminants deeper into the concrete. Micrographs of the MI coating before and after the aging process with urea exposure are presented in Fig. 9, captured at a magnification of 10× (200 μm) under white light, clearly displaying the accumulation of calcite crystals.

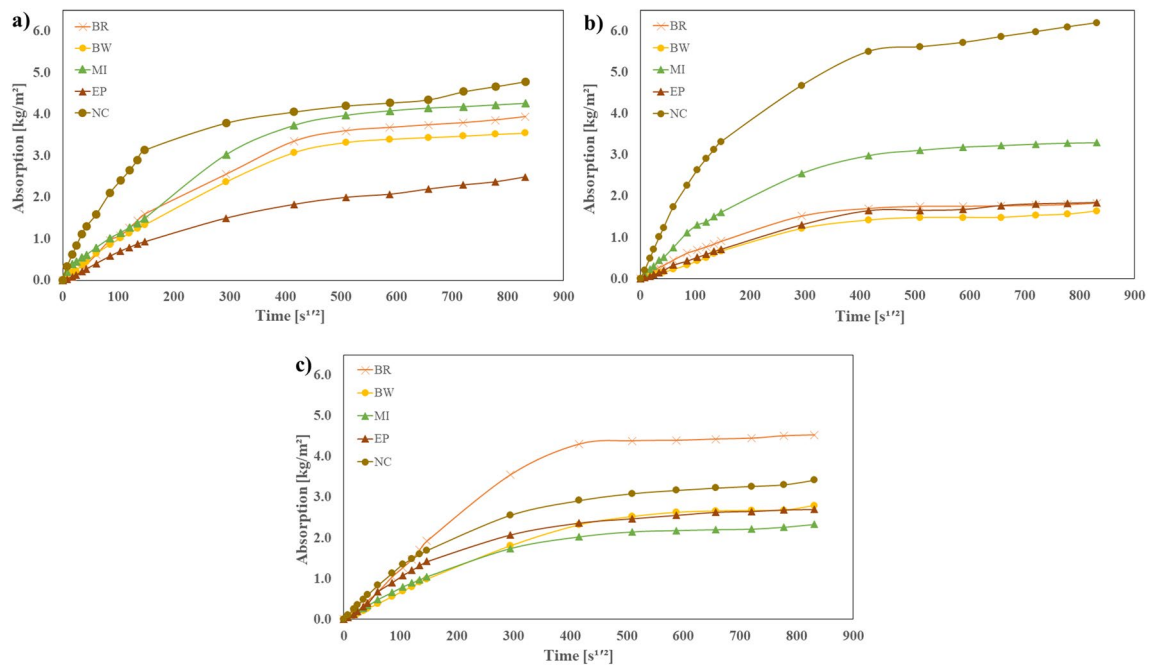
Figure 10. Water absorption rate (a) before the aging process, (b) after the aging process and saturation in water, (c) after the aging process and saturation in urea, 7%.

Water absorption rate. The results of water absorption rate for both coated and uncoated concrete samples before and after the aging process are illustrated in Fig. 10. All results comply with the ASTM C1585-20 Standard²⁷, where a linear relationship for the initial and secondary absorption was observed, with a correlation coefficient higher than 0.98. Figure 10a shows the absorption rate behavior of samples before the aging process, which aligns with a study conducted by Millan et al.⁴³. In their research, similar coating specimens were exposed to salt and regular water to assess their absorption properties. based on these findings, the MI coating exhibited the highest water absorption rate, followed by BR, BW, and EP coatings.

Figure 10b, c present the results of samples saturated with water and urea, respectively, and subsequently exposed to the aging process. These specimens presented a significant reduction in the absorption rate, primarily attributed to the aging process. The absorption rate of samples exposed to urea and protected with MI coating decreased due to the accumulation of salts in the coating surface, resulting in reduced permeability of

the protected concrete. Conversely, for BR and BW coatings, a noticeable reduction in the absorption rate was observed for samples saturated with water and urea. It is evident that the exposure to urea deteriorates the coatings, leading to an increased absorption rate of 146.73% for EP, 247.54% for BR, and 171.16% for BW compared to samples immersed in regular water.

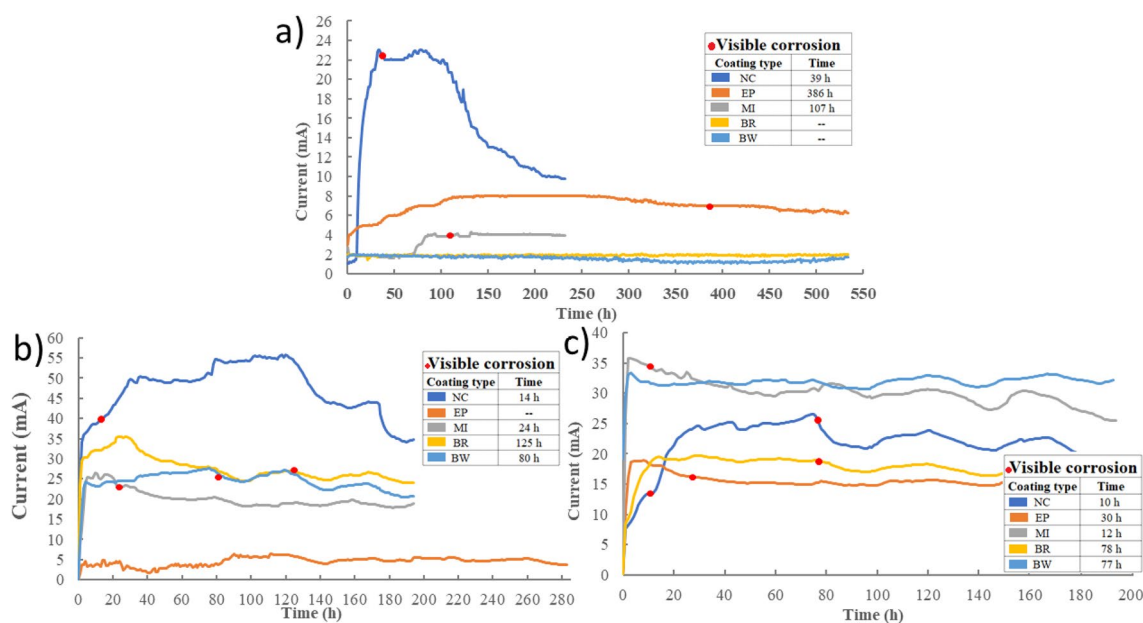
Figure 11. Current intensity curve, (a) before the aging process, (b) after the aging process and saturation in water, (c) after the aging process and saturation in urea, 7%.

Impressed voltage technique. The current intensity curves for samples before and after freeze–thaw cycles, saturated with regular water and urea, are presented in Fig. 11. Prior to the aging process, the maximum current for samples without coating protection was 23 mA, which was 58.18% lower than the samples saturated with regular water (55 mA). This increase indicates that the resistivity of the concrete surface has been compromised after the aging process, allowing for increased penetration of chloride ions into the concrete matrix. On the other hand, samples without coating protection and saturated with urea exhibited a current intensity 52.36% lower than samples saturated with water. This can be attributed to the presence of urea residues on the surface, which partially permeabilize the material and reduce the passage of chloride ions. Ramakrishnan1 et al.⁴².

MI, BR, and BW were the most affected materials by the freeze–thaw cycles. Before the aging process, these samples registered current values of 4.28, 2.08, and 1.98 mA, respectively. These values increased to 26.41, 35.54, and 27.73 mA for samples saturated in regular water and 35.78, 19.72, and 33.37 mA for samples saturated in urea

solution. In the case of samples protected with EP coatings, the highest current value of 18.93 mA was obtained in the samples exposed to urea, showing an increase of 235.10% before freeze–thaw cycles and 297.57% for samples saturated in water. These results align with previous findings by Aguirre et al.⁴⁶, where the highest current value for samples with epoxy coating was reported as 8 mA. Furthermore, it can be observed that, for all samples, the use of coating materials extended the appearance of corrosion products, thus protecting the concrete matrix in a chloride ion environment.

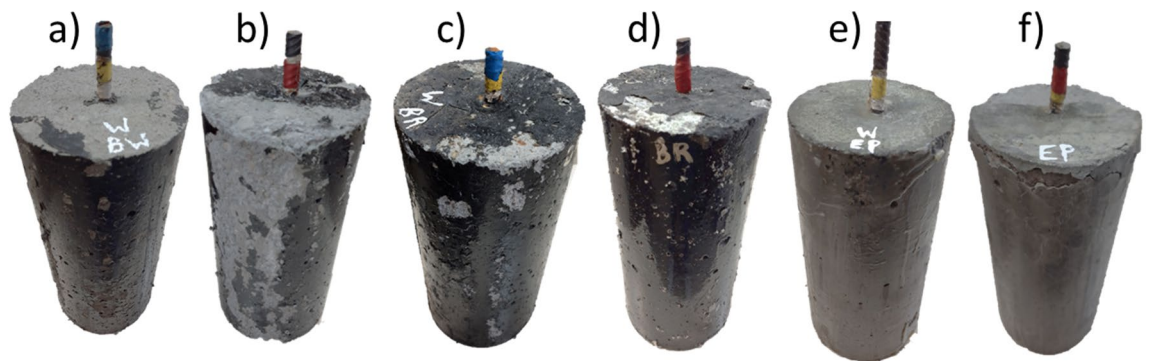
Figure 12. Concrete samples after the aging process. (a) BW water saturation, (b) BW urea saturation, (c) BR water saturation, (d) BR urea saturation, (e) EP urea saturation, (f) EP water saturation.

Figure 12 presents EP, BR, and BW concrete samples after the aging process, revealing visible physical damage in the coating materials. It is important to note that MI coating remained intact and undamaged throughout the aging process, regardless of exposure to water and urea. Similarly, EP samples exposed to water did not present any physical damage, effectively hindering the diffusion of chlorides into the concrete. However, EP samples exposed to urea, as well as BR, and BW samples exposed to water and urea, showed signs of physical damage. Among them, BW samples saturated with urea were the most adversely affected after the aging process.

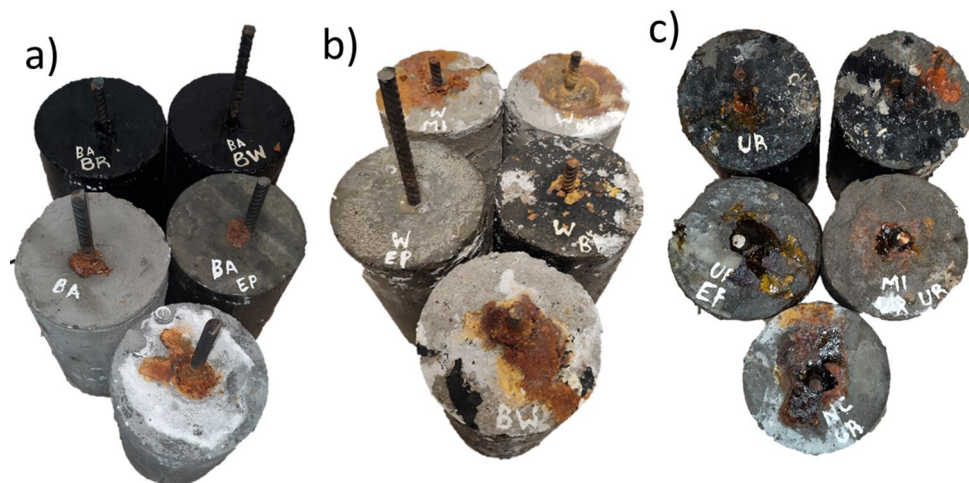
Figure 13. Concrete samples after the impressed voltage technique (a) before the aging process, (b) after the aging process and saturation in water, (c) after the aging process and saturation in urea, 7%.

Figure 13 presents the coated and uncoated reinforced concrete samples after the aging process and corrosion test. None of the specimens presented cracks on the concrete surface during the corrosion test, indicating that all laboratories were concluded once corrosion products became visible. After 22 days of testing, BW and BR samples did not present any corrosion on the concrete surface. In this case, the test was finalized, analyzing the materials' resistance to chloride ions. It is important to highlight that EP samples exposed to regular water did not present any physical damage before the impressed voltage technique. However, the presence of chlorides and the current that passes through the concrete deteriorated the coating material, leading to its fracture and physical damage.
