# Traces of the Strong Devastating Earthquakes in the Hansarai and Its Vicinity, Bakhchysarai, Crimea

**Abstract**—We study an ancient earthquake that significantly damaged the Hansarai (Khansarai) in Bakhchysarai, Crimea, at the end of the 17th century. However, to date, the traces of this catastrophic event can barely be found in the Khansarai walls. Our studies have shown that this is mainly due to the numerous repairs and restorations which have been continuously conducted at the monument. It is only due to the fact that one of the objects of the Hansarai (the “Eastern Building”) was plundered in 2013 that we were able to identify the internal structure of its walls and to reveal a clearly expressed seismogenic deformation of the brick arch which underwent a subsequent repair. In order to accurately date the seismic event, we carried out a search for the analogies, which revealed similar damage in the walls of the Eski-Durbe mausoleum, the monuments of the first palace of the Crimean khans in Salachik (Zincirli medrese and Hacı Giray durbe mausoleum) and the Great Kenassa of the Chufut-Kale fortress. By comparing the chronology of the Eastern Structure and other monuments and

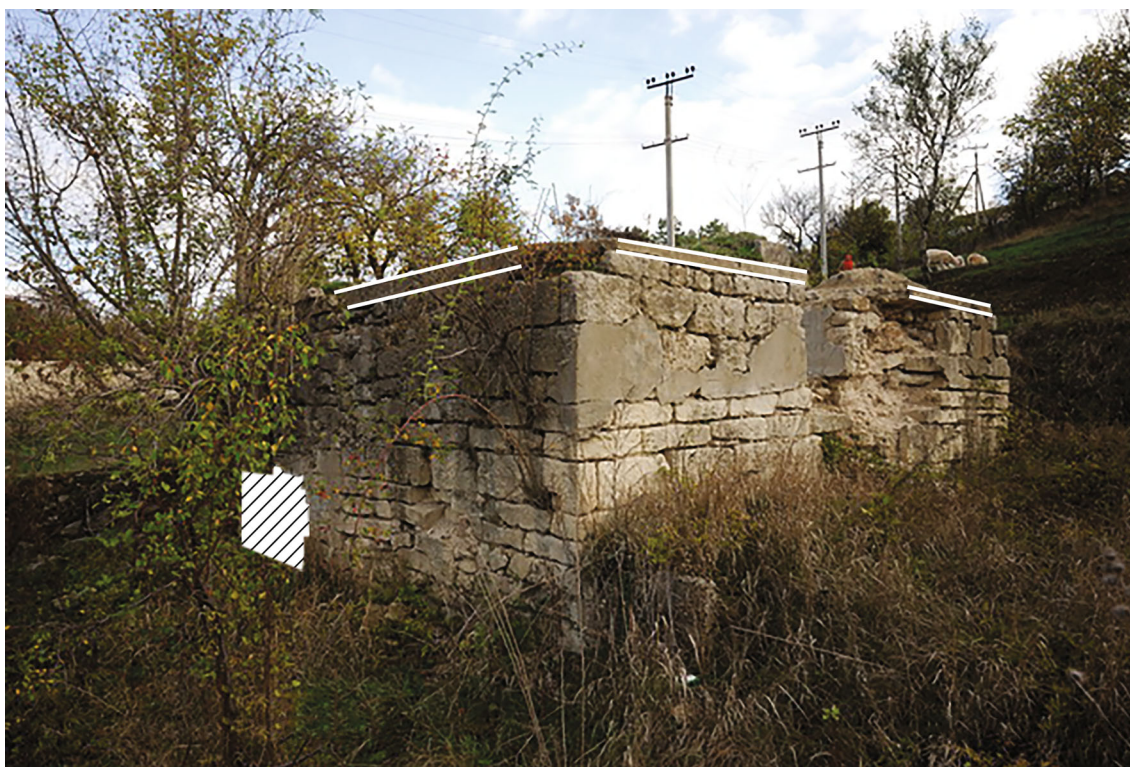
**Fig. 3.** Hansaray. Eastern structure of presumed Sahib Giray Divan Hall (northern wall) before loss of cladding of well-processed stone (after (Gaivoronskii, 2015)). Black shading on white background shows sub-rectangular entrance to building on northern face of structure. Concrete ceiling slabs are indicated by white lines.

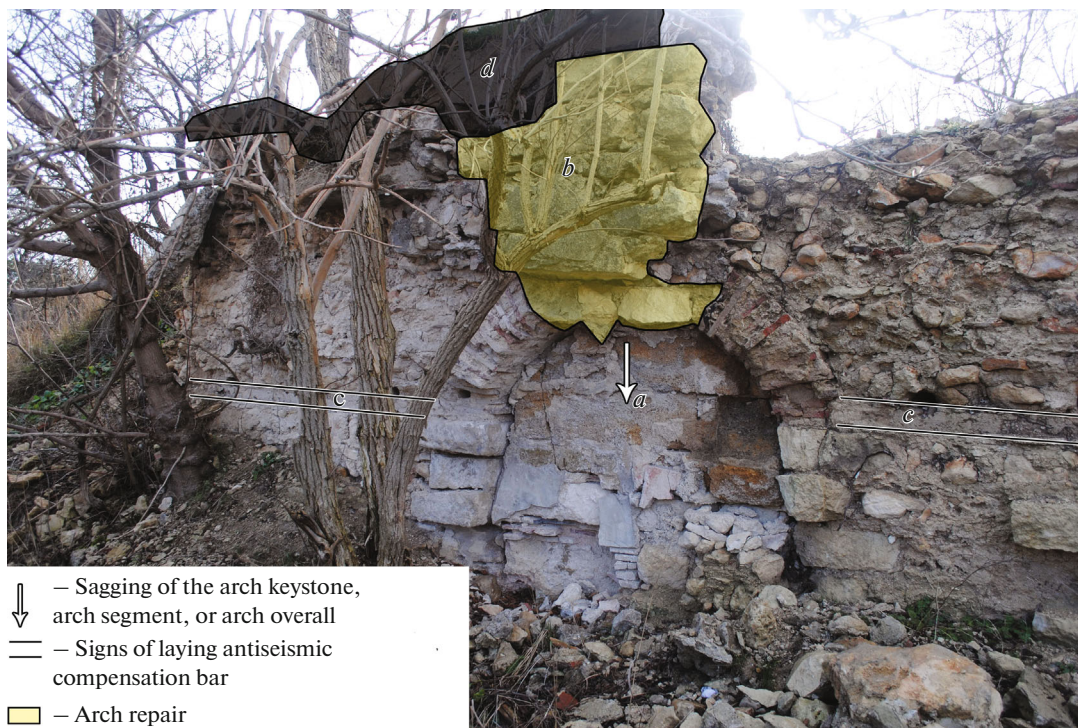
**Fig. 4.** Hansaray. Eastern structure of presumed Sahib Giray Divan Hall (northern wall). Seismic deformation of plinth-brick arch with a strike  $88^\circ$ : (a) loss of upper central part of plinth-brick arch; (b) plinth arch repair with rubble stone; (c) signs of laying antiseismic compensation bar, duvar-kushak technology; (d) modification of “eastern building” in Soviet period (concrete armored belt).

needs (Fig. 4). As a result of significant damaging of the cultural heritage object, the internal structure of the “eastern building” was exposed. The object was constructed using several antiseismic techniques: duvar-kushak<sup>1</sup> (Fig. 4, c) and opus mixtum<sup>2</sup> (Fig. 5, a). Obviously, the plundered outer cladding had a later age because the only rectangular doorway (Fig. 3, a) which led inward covered the plinth (brick) arch of the earlier passage. It was located in a wall of a strike of 89°. The arch had a clearly expressed seismogenic deformation (Fig. 4, a) manifesting itself by the loss of the upper central part of the arch structure. The arc was subsequently repaired and the loss filled with rubble (Fig. 4, b). During the period when the protection of the objects of cultural heritage in the territory of the Hansaray complex was weakened, the “eastern building” was reinforced by a concrete armored belt (Fig. 3d) and covered by reinforced concrete slabs (Figs. 3, b, and 5, b). The passage under the arch was laid with rubble using modern building material apparently at the same time.

Such a deformation of an arched structure is a spectacular example of the effect of an earthquake on ancient buildings. In order for the plinth-brick arch of the “eastern building” to obtain such a damage, seismic vibrations should propagate parallel or slightly obliquely to the strike of the structure (*Archeoseismology ...*, 1996, pp. 129–152; Korzhenkov and Mazor, 1999). The ground shaking intensity sufficient for producing this damage is at least  $I_1 = VII$  (MSK-64). However, the very design features of the building may suggest that the intensity estimate perhaps needs some correction. The “eastern building” was built using two antiseismic techniques: duvar-kushak and opus mixtum. Moreover, it is the duvar-kushak that was used to reinforce the arch that was damaged by seismic deformation (Fig. 4, c). Both these methods are systems with increased damping (Lipatov, 2006, p. 18). The most striking example of the use of these systems in a seismically active region can be observed in the Theodosian Walls or the Theotokos Pammacaristos Church—the Fethiye Cami Mosque, Istanbul. Despite having undergone numerous strong and devastating earthquakes (Khapaev, 2008, p. 97) there constructions have been fairly well preserved. The seismic stability assessment of the structures that were built using simultaneously the duvar-kushak and opus mixtum techniques indicates that the “eastern building” can be attributed to type B of the structures on MSK-64 scale and that the seismic intensity estimate for this building is higher,  $I_1 = VII$ – $VIII$  (MSK-64). The epicentral

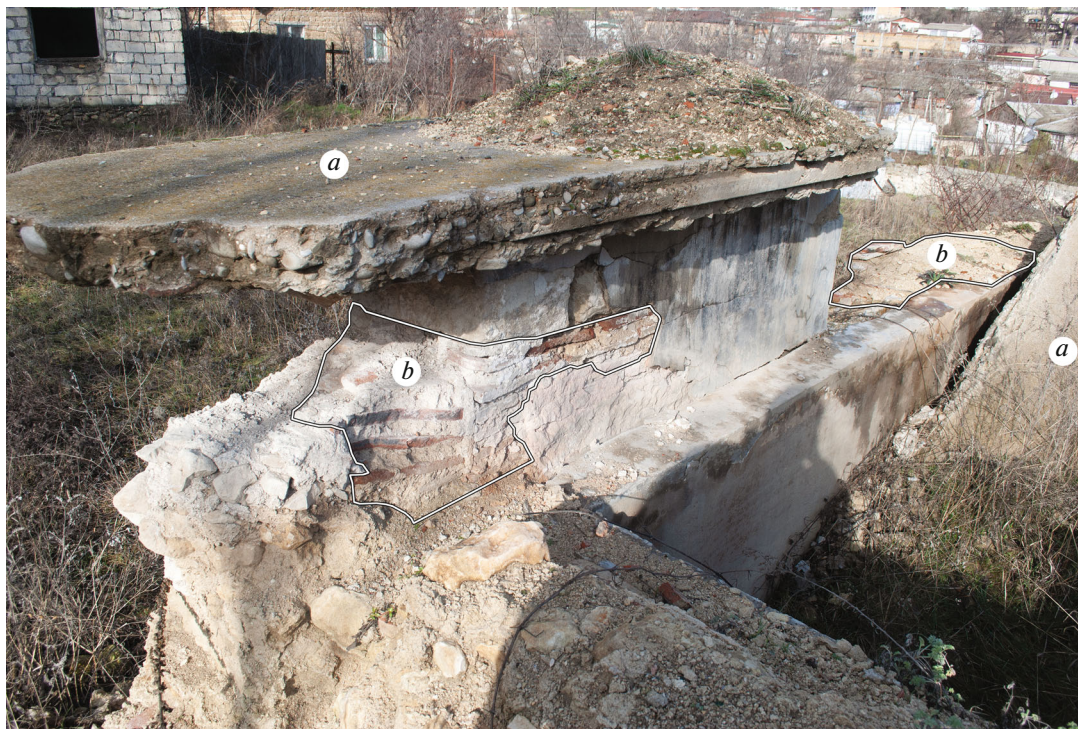
**Fig. 5.** Hansaray. East building, western wall, inside view: (a) concrete floor slabs; (b) opus mixtum masonry technique.

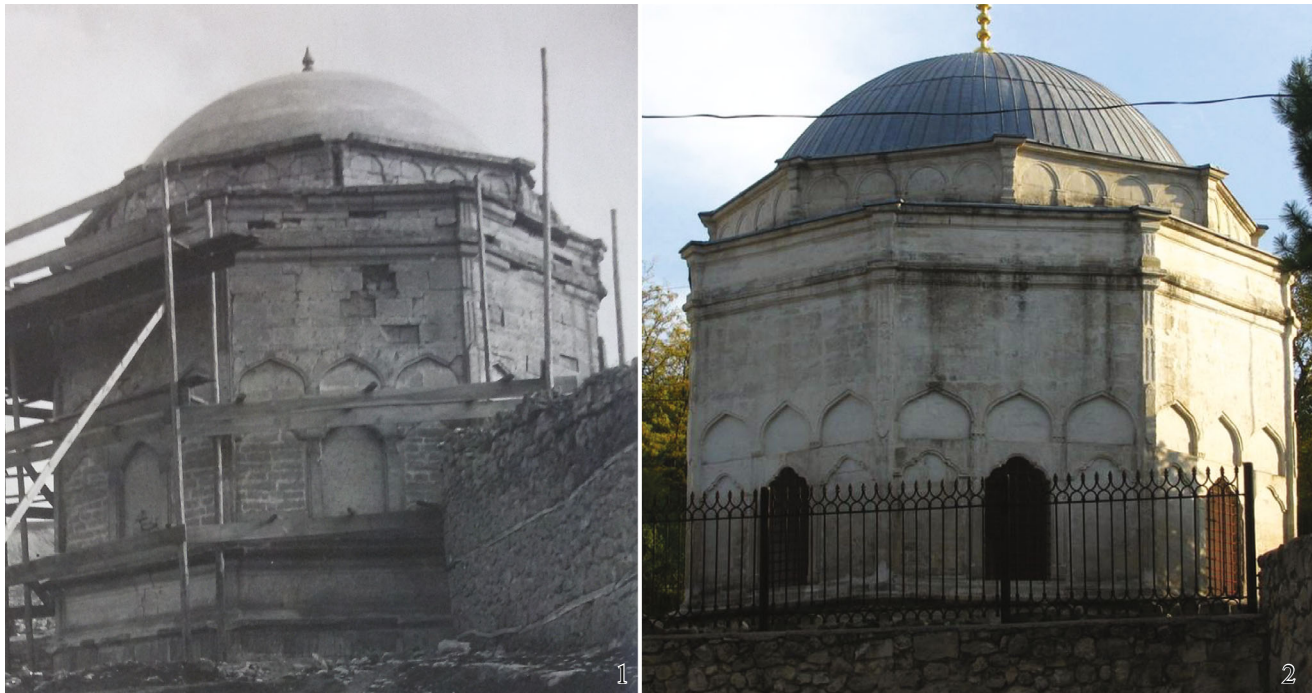
**Fig. 6.** Dilyary Bikech durbe of Hansaray complex. Face striking  $79^\circ$ . Photo: 1, monument restoration, 1914 (clearly visible are movements of stone blocks in durbe cladding above arches of laid windows, enhanced by skyscraper effect towards building's dome); 2, present state.

The spectacular example of how restorations and repairs of buildings obliterate traces of deformations is the Dilara Bikech durbe (Fig. 6). The durbe was built in 1763–1764 (Ibragimova, 2016, p. 175) but its condition at the beginning of the twentieth century called for repair and restoration work. In the photo taken in 1914 during the restoration, it can be clearly seen that the stone blocks move, are squeezed out, and experience rotations on the faces with the strikes  $37^\circ$  and  $79^\circ$ . The deformations in the building increase as the wall is raised. At present, the described damages in the facade of the durbe are absent (Fig. 6, panel 1). As of now, it is unclear what caused these deformations. Tracing their origin requires additional archival, historical, and archaeological studies. However, it is beyond question that the repair and restoration work can completely obliterate deformations in the walls of the Khansarai structures and other objects of the New Age in Crimea.

the effective solution is the constant repair and restoration work at the archaeological objects which obliterates seismic deformations. The Dilara Bikech durbe is a striking example. In other words, Bakhchysarai with its vicinity is a living urban organism. Its historical and cultural landscape is carefully protected and preserved as an object bearing the marks of universal cultural value. The almost complete, with rare exception, absence of the archaeological studies and their published results for the territory of both the palace complex itself and the Old town and its outskirts is another factor complicating the dating of seismogenic deformations.

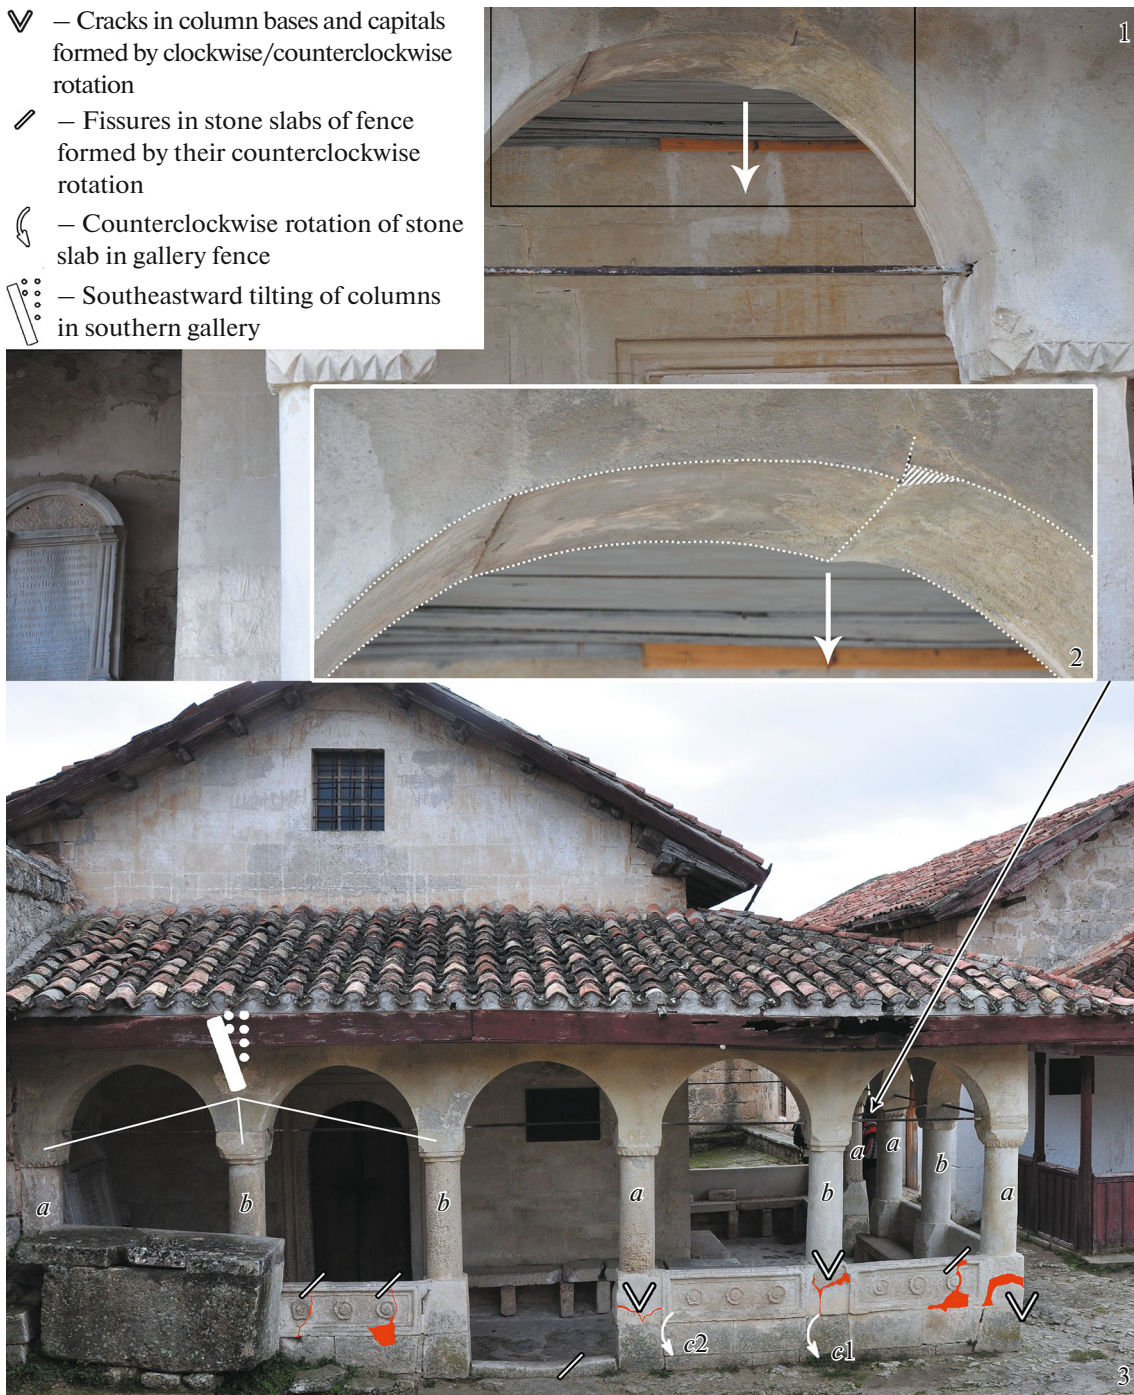
**Fig. 9.** Chufut-Kale Fortress. Big Kenassa: 1, southwestern gallery with strike 95°; 2, same, close-up view; 3, view of northeastern gallery (red filling shows fissures formed in column bases and fence stone slabs by their counterclockwise rotation): *a*, columns with stalactite echini on capitals; *b*, columns with echinus in form of round pillows and octagonal necks; *c1*, counterclockwise rotation of column base by 4° in gallery; *c2*, counterclockwise rotation of stone slab in gallery fence by 5°.

Next, the deformations are observed in the northwestern gallery. Here, an earthquake formed an ensemble of cracks in the stone slabs of the fence (Fig. 8, c1–c3; Fig. 9, 3), bases (Fig. 8, e; Fig. 9, 3) and capitals of the columns (Fig. 8, e1; Fig. 10, c) (event 2). The cracks resulted from the counterclockwise rotation of individual elements of the gallery. Besides, the threshold stone of the entrance to the northeastern gallery was cracked (Fig. 8, d). These damages could have been formed under strong seismic vibrations directed along or slightly obliquely to the strike of the damaged elements. The gallery fence slab immediately right of the entrance and the base of the second right column are rotated counterclockwise by 5° (Fig. 10, a1) and 4° (Fig. 10, a2), respectively. This indicates that the most intense seismic vibrations propagated from the west at a certain angle to the strike of the colon-

nade (Fig. 11, *e1–e2*). This also explains the through-going fissures in the fence slabs (Fig. 8, *c*; Fig. 9, 3). The difference is that in contrast to the intact slabs, the damaged ones were rotated counterclockwise only after the crack formation (it is clearly seen in the photo (Fig. 10, *a3*) that the slab sharply changes its strike after the appearance of the crack). A similar deformation was revealed in the capital of the corner column of the gallery (Fig. 10, *c*). Here, the counterclockwise rotation of the column around its axis resulted in the cracking of the capital itself and in a certain detachment of its southern corner. These deformations could have been produced by an earthquake (event 2) with intensity  $I_7 = \text{VII–VIII}$  (MSK-64) with the epicentral area west of the monument (Fig. 11, *e1–e2*).
