SHORT REPORT

# The risk of intra-urethral Foley catheter balloon inflation in spinal cord-injured patients: Lessons learned from a retrospective case series

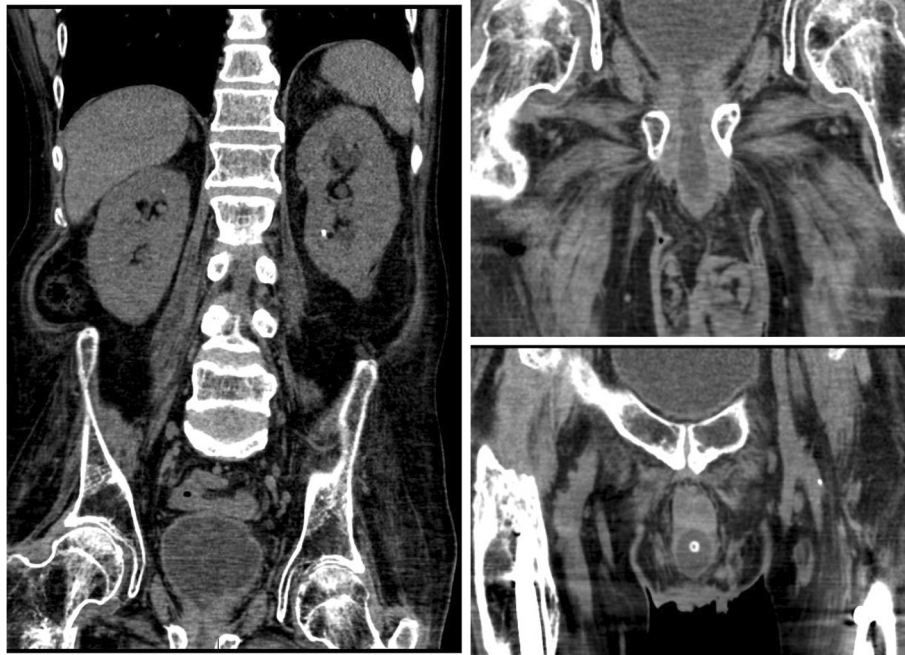
**Fig. 1** Case 1. Left panel: Coronal section of non-contrast CT of abdomen revealed full bladder; Foley catheter was not seen within the urinary bladder. Right Top panel: Coronal section of CT of pelvis showed fluid distension of the membranous and prostatic urethra. Foley catheter was not seen in bladder or in proximal urethra. Right bottom panel: Coronal section of CT of pelvis revealed balloon of Foley catheter in the proximal penile urethra

CT of pelvis was requested to locate the position of the balloon of Foley catheter. However, CT of abdomen was performed, which revealed full bladder. Foley catheter was not seen within the urinary bladder (Fig. 1 Left panel). This scan did not include pelvis; therefore precise location of the Foley balloon could not be ascertained. The patient was sent to radiology department again for scan of pelvis. CT of pelvis revealed fluid distension of the membranous and prostatic urethra (Fig. 1 Right Top panel); the balloon of Foley catheter was located in the proximal penile urethra (Fig. 1 Right Bottom panel).

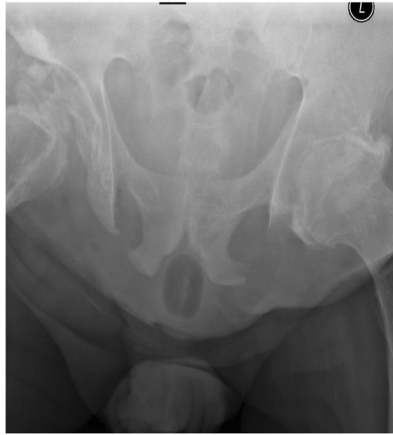
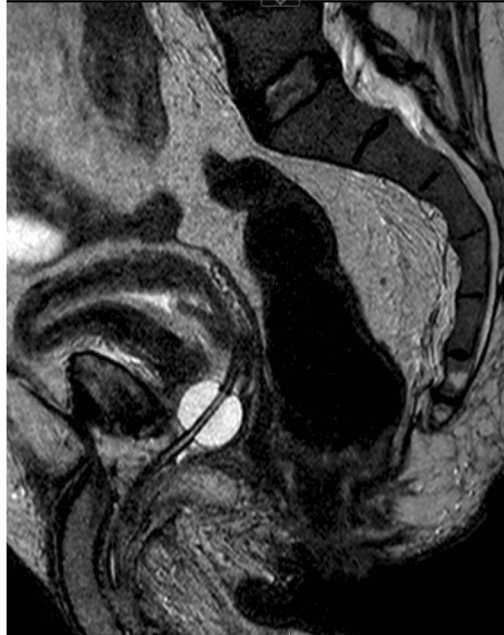
**Fig. 2** Case 3. Left panel: X-ray of pelvis taken after injecting air through the balloon channel of Foley catheter revealed that the balloon was located in urethra, well below ischiopubic ramus. Right panel: MRI of pelvis sagittal T-2 weighted image revealed balloon of Foley catheter in proximal urethra

therefore, 5 ml of air was injected into Foley balloon and X-ray of pelvis was taken. This X-ray revealed the balloon of Foley catheter in urethra (Fig. 2 Left panel). Urethral catheter was removed and another catheter was inserted ensuring that the catheter was located within the bladder. Subsequently, urethral catheter was changed in the community. This patient developed skin breakdown and a cavity in the perineum. Urine was dripping continuously into the open cavity. The balloon of Foley catheter could be seen in the base of the cavity. MRI of pelvis revealed balloon of Foley catheter in the urethra (Fig. 2 Right panel). Suprapubic cystostomy was performed using Seldinger technique (Medi Plus, Unit 7, The Gateway Centre, Coronation Road, Cressex Business Park, High Wycombe HP12 3SU, UK). Following suprapubic cystostomy, the catheter has been draining. The cavity in perineum had shrunk considerably in size. Urine leak continued albeit to markedly lesser extent.

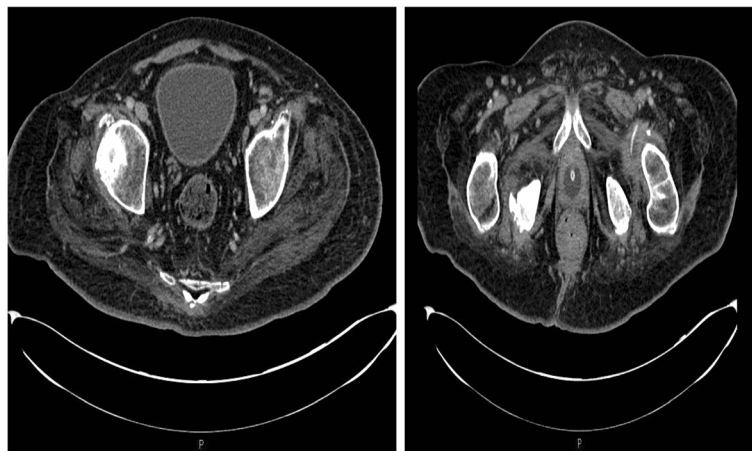
**Fig. 3** Case 4. Left panel: Axial section of CT of abdomen and pelvis revealed full bladder; no catheter was seen in the lumen of urinary bladder. Right panel: Axial section of CT of pelvis revealed balloon of Foley catheter in the proximal urethra within prostate

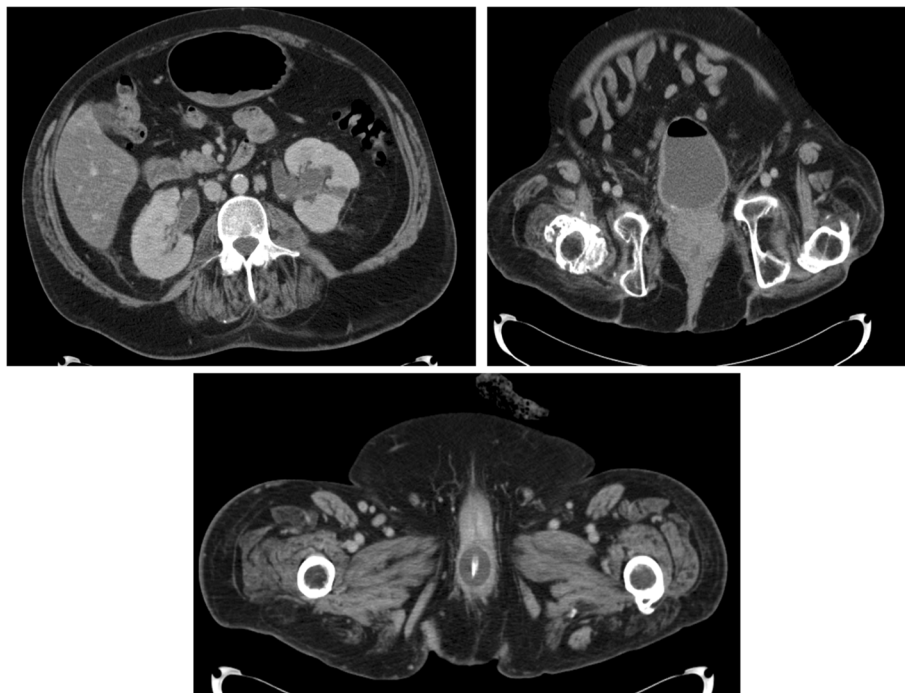
**Fig. 4** Case 5. Top Left panel: CT abdomen axial section revealed moderate left hydronephrosis and hydroureter, and mild right hydronephrosis and hydroureter. Top Right panel: CT of abdomen and pelvis, axial section: Urethral catheter was not present within the bladder. Bladder was of small capacity and contained urine and gas. Bottom panel: CT pelvis, axial section revealed balloon of Foley catheter in the membranous urethra

hydronephrosis. In 2015, he developed malaise, lower abdominal pain, back ache and nausea. He was treated for urine infection. CT abdomen revealed moderate left hydronephrosis and hydroureter, and mild right hydronephrosis and hydroureter down to the bladder (Fig. 4 Top Left panel). Transurethral catheter was not seen in the urinary bladder (Fig. 4 Top Right panel); tip of catheter was present in urethra; Foley balloon was seen in the membranous urethra (Fig. 4 Bottom panel). Most likely, the catheter has been pulled inadvertently. Flexible cystoscopy was performed and a size 16 French Foley catheter with a 20 ml balloon was inserted. Bypassing of catheter and urine leak decreased after inserting a 20 ml balloon Foley catheter per urethra. Subsequently, open suprapubic cystostomy was performed as percutaneous access to urinary bladder was unsuccessful because of his body status and small capacity urinary bladder.
