EDUCATIONAL REVIEW

Artefacts in contrast enhanced digital mammography: how can they affect diagnostic image quality and confuse clinical diagnosis?

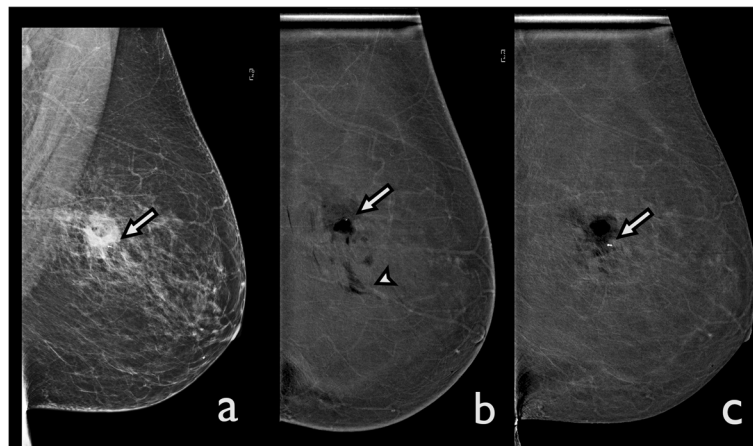
Fig. 1 Motion artefact. A ductal carcinoma in situ was diagnosed in the left breast after an ultrasound-guided core needle biopsy. CEDM was performed for preoperative staging. **a** The LE image shows a post-biopsy hematoma with a marker (arrow). **b** The recombined CEDM image demonstrates that the margins of the hematoma are blurred secondary to motion artefacts. Some black bands are visible (arrowhead), and the post-biopsy marker appears to be in a different position from the previous image (arrow). **c** A new recombined CEDM image was performed. Here, the motion artefacts are no longer visible, and the marker appears to be in the right position (arrow)

The current CEDM process, which involves a dual energy acquisition, was developed to overcome this limitation. It is characterised by two images acquired in rapid succession by applying X-rays of distinct energy, both after the administration of contrast media. Motion artefacts have been significantly minimised due to the brief interval of time between the two exposures. However, CEDM images are still more prone to motion artefacts compared to traditional mammography because dual-energy acquisition requires longer exposure and compression times. In the recombined images, motion artefacts appear as blurring of the margins of lesions (Fig. 1). Adequate compression can reduce motion artefacts both in FFDM and CEDM [8].

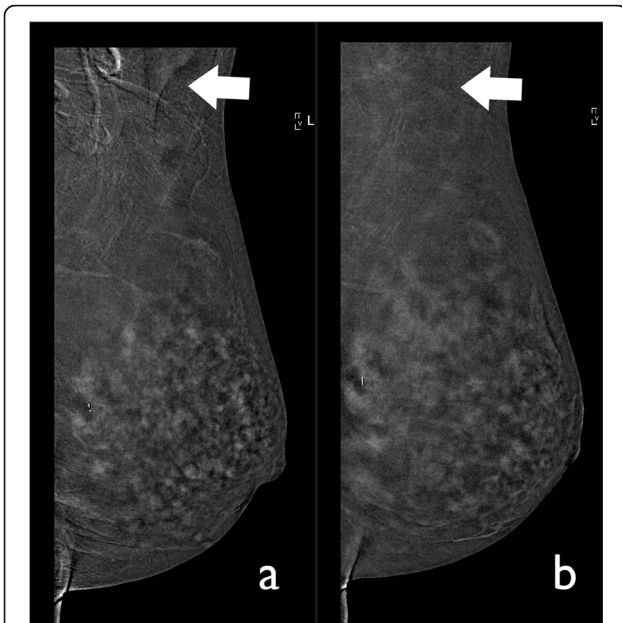
Fig. 2 Hair artefact. CEDM was performed for preoperative staging in a 51-year-old patient. **a** The recombined image shows several curvilinear lines related to the patient's hair (arrow). **b** Thus, we asked the patient to tie her hair before performing another acquisition. The artefact is no longer visible (arrow)

Jewellery, clothing and hair located in the field of view of the CEDM image can result in artefacts and obscure potential pathological findings (Fig. 2). Before carrying out the examination, it is important to remove any clothes and accessories that may be projected in the image and ensure the patients hair is pulled back and tied [9].

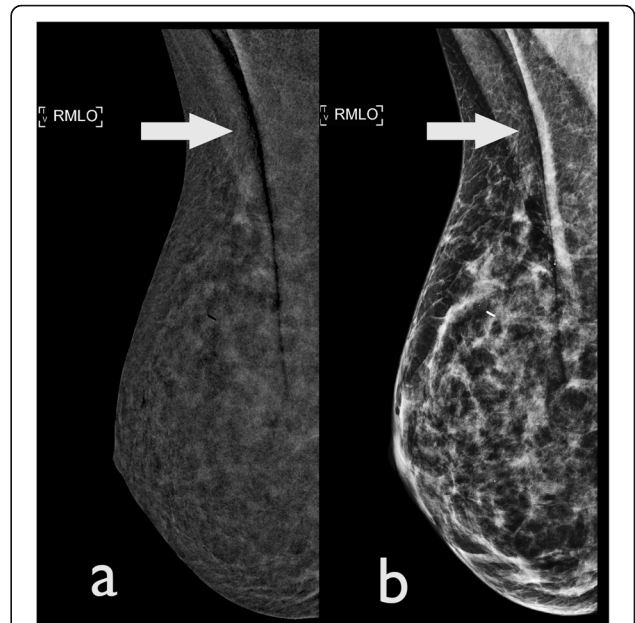
Fig. 4 Air trapping artefacts: A CEDM performed for problem solving in a 52-year-old woman, using a **(a)** CEDM-recombined image and **(b)** LE image. Both images demonstrate the presence of a vertical, black band (arrows) secondary to trapped air

Air trapping is a common artefact caused by partial contact between the skin and the detector or compression paddle [1]. This leads to the presence of air, which creates a dark artefact in the configuration of the area of incomplete contact, possibly hiding underlying abnormalities (Fig. 4).

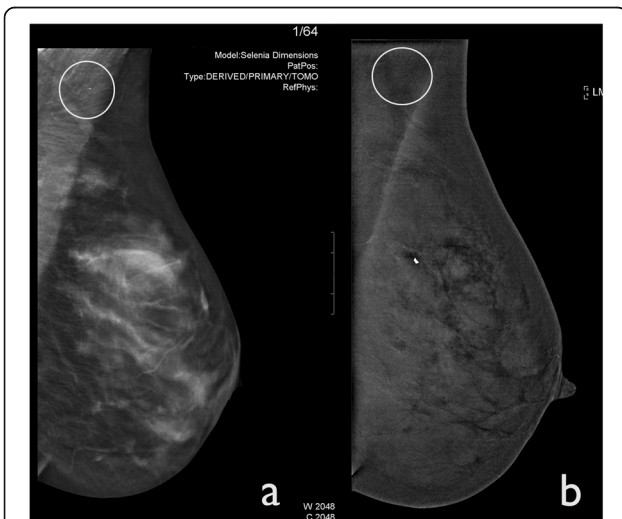
Fig. 3 Antiperspirant artefact. CEDM was performed for staging an IDC in the right breast of a 59-year-old woman. **a** Left MLO tomosynthesis shows a little white spot in the axillary region caused by the presence of the antiperspirant substance (circle). **b** The CEDM-recombined image demonstrates that antiperspirant is barely perceptible as a small, black dot (circle)

The active ingredients of antiperspirants are complex-aluminium-based; these substances produce radiopaque particles that can mimic microcalcifications in LE images. Usually, antiperspirant particles appear black on

CEDM recombined images (Fig. 3). It is important for technologists to recognise this artefact and to ask the patient to clean the axilla or skin folds before the subsequent image acquisition is performed.

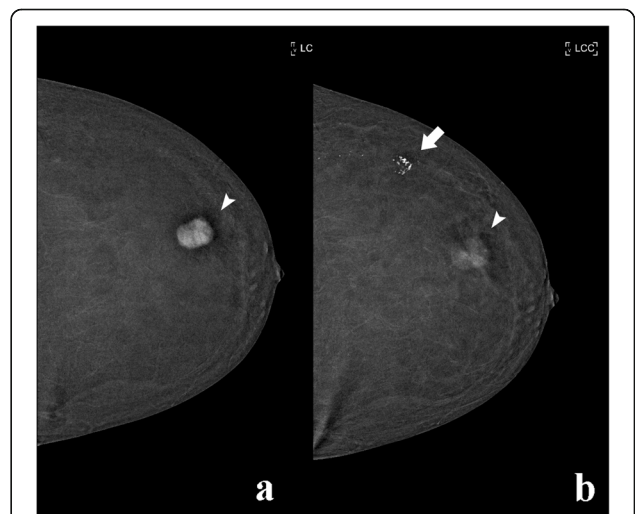
Fig. 5 Contrast splatter. CEDM was performed in a 55-year-old woman for preoperative staging. **a** The recombined image shows an avidly enhancing lesion in the outer quadrant (arrowhead). **b** A delayed acquisition was performed where contrast contamination of the skin is visible (arrow). Contrast washout is also demonstrated within the lesion (arrowhead)

It is critical to pay close attention to the technique during contrast administration to prevent contrast contamination. When detaching the tubing from the power injector, the contrast media may accidentally splatter onto the adjacent equipment or skin, resulting in the appearance of small white dots on recombined images, which may be confused with microcalcifications (Fig. 5).

administers the contrast media should not assist in patient positioning [10]. Carefully cleaning the region to be examined and the detector of the mammography unit prior to subsequent acquisitions can resolve this artefact.

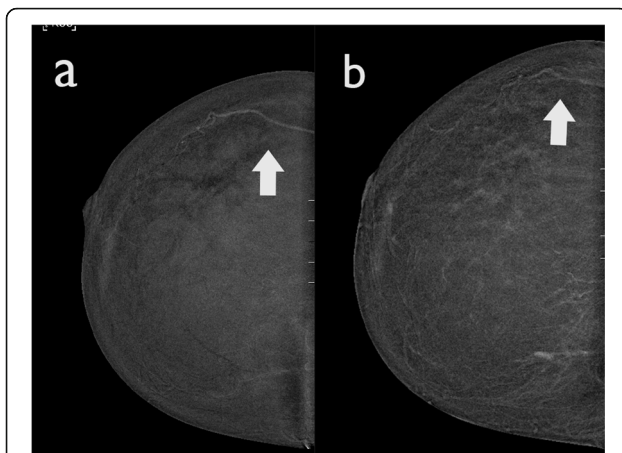
Fig. 6 Transient retention of contrast in blood vessels: a CEDM was performed in a 66-year-old woman to evaluate a suspicious finding in the left breast on mammography. **a** The right, recombined image shows a bolus of contrast within a blood vessel (arrows); **b** this artefact disappeared is less promiscuous in the following CEDM acquisition (arrow)

The retention of contrast media in the blood vessels is frequent. However, it does not compromise image quality (Fig. 6). This phenomenon is typically due to premature breast compression and it is not visualised in the subsequent image acquisition of the same breast.

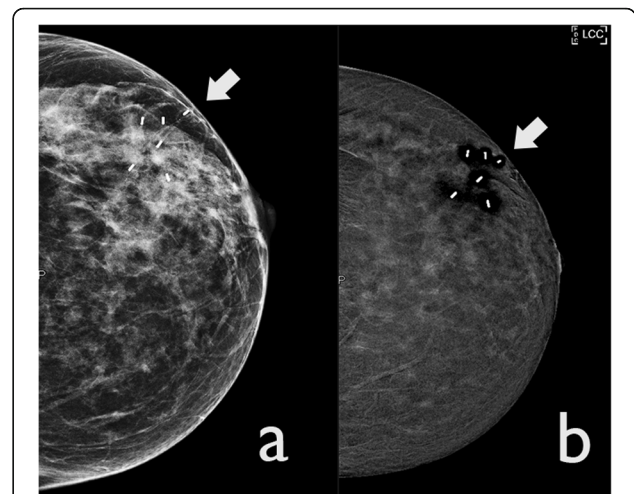
Fig. 7 Artefact due to the presence of post ultrasound guided biopsy markers: **a** LE CEDM image. There are some markers seen at the outer quadrant of the left breast (arrow); **b** in the recombined image, the markers are seen as high attenuation structures and they demonstrate a surrounding dark halo

Placing markers after breast biopsy is very common. Markers of different composition and materials can demonstrate a variable appearance. In our centre, titanium markers are inserted in case of vacuum assisted biopsy while zirconium-oxide markers are inserted during ultrasound-guided biopsy procedures. On the recombined CEDM images, all markers appear as high attenuation structures; however, a surrounding dark halo is occasionally seen with the zirconium oxide markers (Fig. 7).

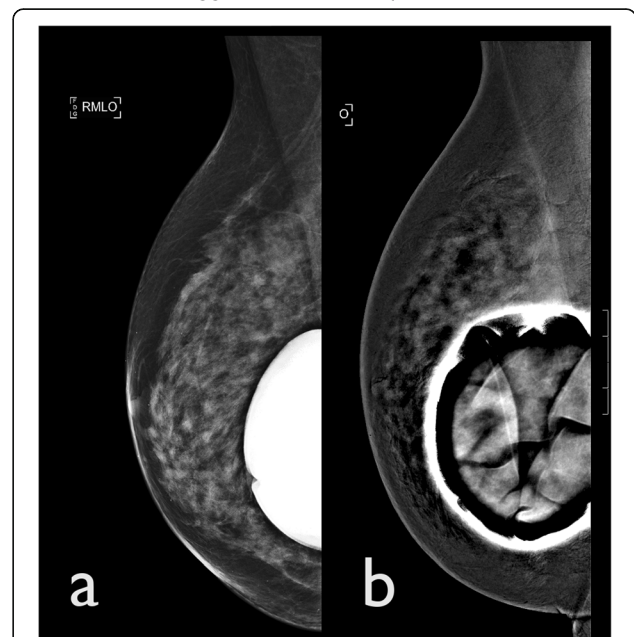
Fig. 8 Breast implant artefact. A CEDM was performed for suspected microcalcifications in a 55-year-old woman with a right breast implant. **a** LE CEDM image shows a breast implant in situ. **b** CEDM recombined image presents a significant post-processing artefacts secondary to the presence of the implants

Breast implant rupture can lead to either intracapsular or extracapsular involvement, which requires them to be removed and replaced. The sensitivity of MRI in assessing the integrity of breast implants is about 90% [11]. Breast implants tend to produce significant artefacts on CEDM recombined images, which may obscure an underlying pathology (Fig. 8). Therefore, MRI continues to be the imaging modality of choice in women with breast implants.

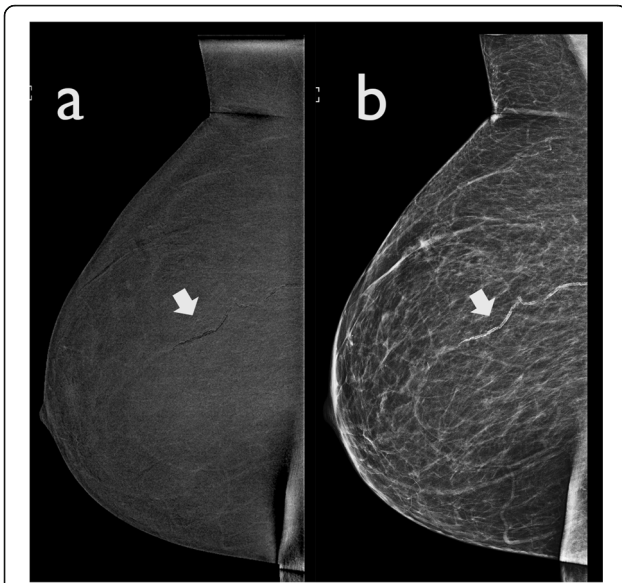
Fig. 9 Negative contrast enhancement. **a** CEDM recombined image presents an irregular, tubular structure (arrow), which is black in relation to the surrounding background. **b** In LE CEDM image, this wavy band corresponds to a calcified blood vessel (arrow)

In recombined CEDM images, cysts, large calcifications or post-biopsy hematomas demonstrate an area of rim enhancing hypodensity in relation to the surrounding background giving it a “negative contrast enhancement” appearance which is also referred to as the “eclipse sign” (Fig. 9). This phenomenon is actually not a true artefact, but is in fact a natural consequence of the acquisition technique.

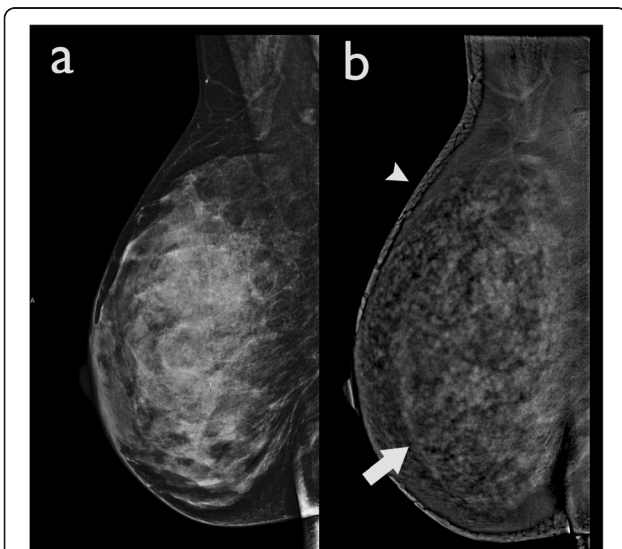
Fig. 10 Halo artefact in a 52-year-old woman. **a** The LE CEDM image demonstrates a dense breast with no show focal alterations, and **(b)** the recombined image presents an apparent “breast-within-a-breast” artefact (arrow). The skin artefact that is observed in the right breast (arrowhead) is caused by detector saturation in the skin region due to a high detector signal

This is a software-processing artefact also known as “breast-within-a-breast artefact” [5]. It occurs due to a rapid difference of scattered radiation between different breast thicknesses separating the central and peripheral regions causing the software-processing algorithm to create a false exaggerated boundary.

This artefact is characterised by a curved line of high density, parallel to the edge of the skin (Fig. 10). This artefact does not usually compromise image quality. However, in presence of prominent parenchymal enhancement, a small mass located parallel to this high-

density artefact may be obscured. This artefact appears to be vendor specific.

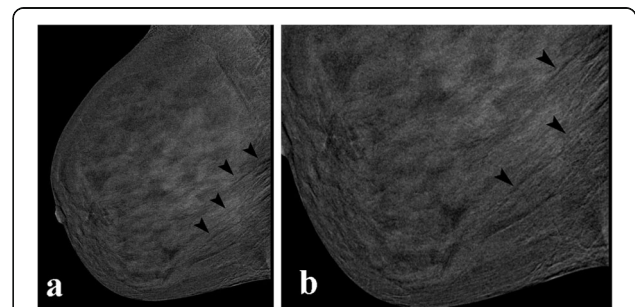
Fig. 11 Ripple artefact. CEDM performed for preoperative staging. The arrowheads are indicating the ripple artefact, which are seen as thin alternate dark and light lines in the recombined image **(a)**. The artefact is more visible in the magnified view **(b)**, arrowheads

Ripple artefacts are very commonly visible on recombined images as alternating black and white lines. They are mainly seen in the MLO projections (Fig. 11). Dromain et al. [12] suggested that this may be attributed to patient motion, due to the short interval between the low- and high-energy exposures. However, there are some authors [5] who attribute it to cardiac pulsations transmitted through the chest wall as it more commonly seen in the lower quadrants of MLO projections of the left breast. Reducing patient anxiety might reduce this artefact; however, it does not compromise the image quality.

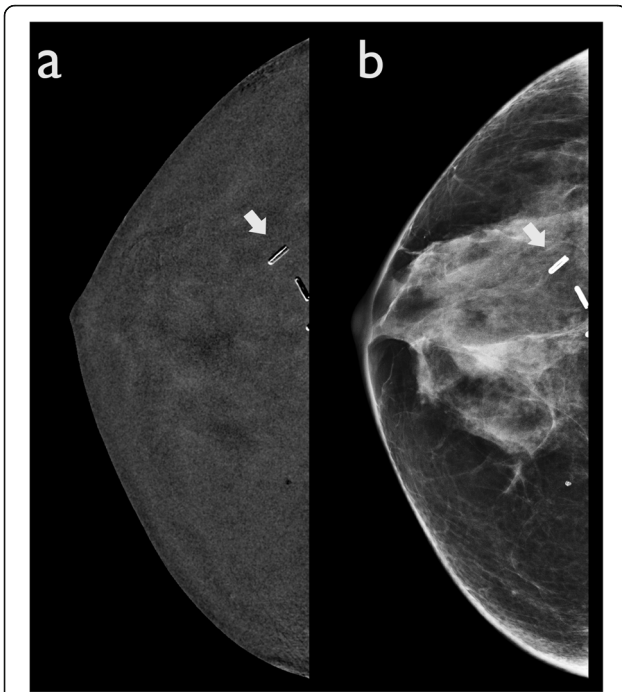
Fig. 12 Misregistration artefact. A woman with a history of previous right quadrantectomy. **a** CEDM recombined image shows post-surgical clips with alternating bright and dark lines (arrow). **b** The same clips are also visible in LE CEDM images (arrow)

Misregistration artefacts are commonly observed in relation to surgical clips, vessels and calcifications. It is seen as alternating bright and dark lines, illustrating a “zebra artefact” seen exclusively on recombined images (Fig. 12). Even minimal motion between the LE and HE images causes misalignment of the images, resulting in imprecise subtraction.

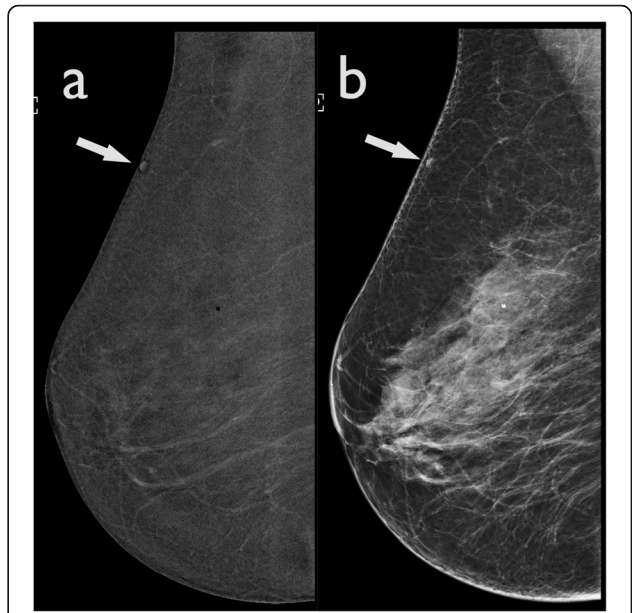
Fig. 14 Enhancement of skin lesions. **a** The recombined image demonstrates a small oval enhancing lesion in the upper quadrant of the right breast, which could mimic a small enhancing mass (arrow). **b** The LE CEDM image shows an oval hyperdensity formation in the upper quadrant. Evaluation of the patient's skin in this region confirmed the presence of a small skin angioma

Moreover, some vascular skin formations, such as skin angiomas, may show contrast enhancement, mimicking the presence of suspicious lesions (Fig. 14). A careful clinical examination of the patient’s skin may be necessary.

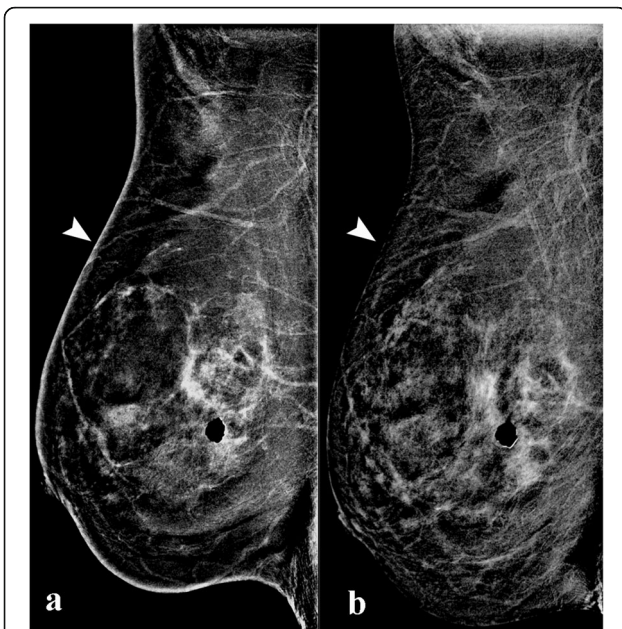
Fig. 13 Skin-line artefact. **a** The early-recombined image demonstrates a marked enhancement of the skin line. **b** The skin enhancement is not appreciated in the delayed recombined CEDM acquisition

The skin does not usually demonstrate enhancement in recombined images; however, it may show a thin rim of enhancement. This artefact may be caused by non-uniform scatter radiation and difference in skin thickness throughout the breast. This artefact is also known as “skyline artefact” (Fig. 13). It is necessary to check the skin thickness in the LE images, to verify that the skin is not truly affected by a disease.

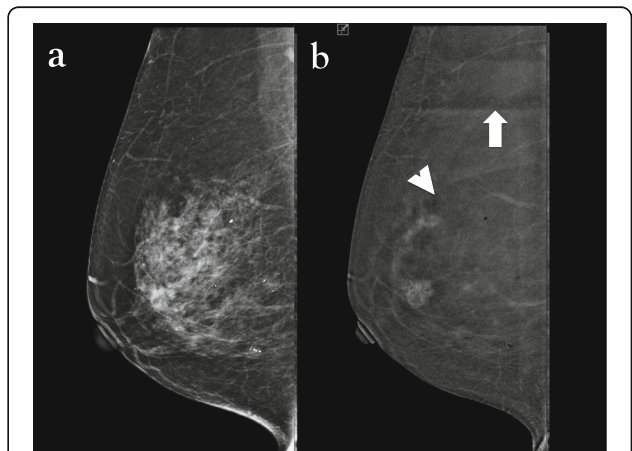
Fig. 15 Ghosting artefact: a 50-year-old woman presented with a right breast lump. **a** The LE CEDM image shows no obvious artefacts, and **(b)** ghosting of the latent CC view (arrowhead) of the previously imaged breast is projected within the MLO image and an axillary line artefact (arrow) is also evident in this image

This artefact occurs when a previous image acquisition remains latent and overlaps with the subsequent image. In CEDM, rapid transitions between acquisitions can be the cause of a persistent latent signal that overlaps the new acquisition (Fig. 15). This artefact is not commonly seen and recalibrating the machine to remove the memory of the previous image can rectify this complication.
