An approach for the reconstruction of a traditional masonry-wooden building located in an archeological area. Part I: Methodology

Cemil Akçay¹, Nail Mahir Korkmaz² and Baris Sayin^{3*}

Abstract

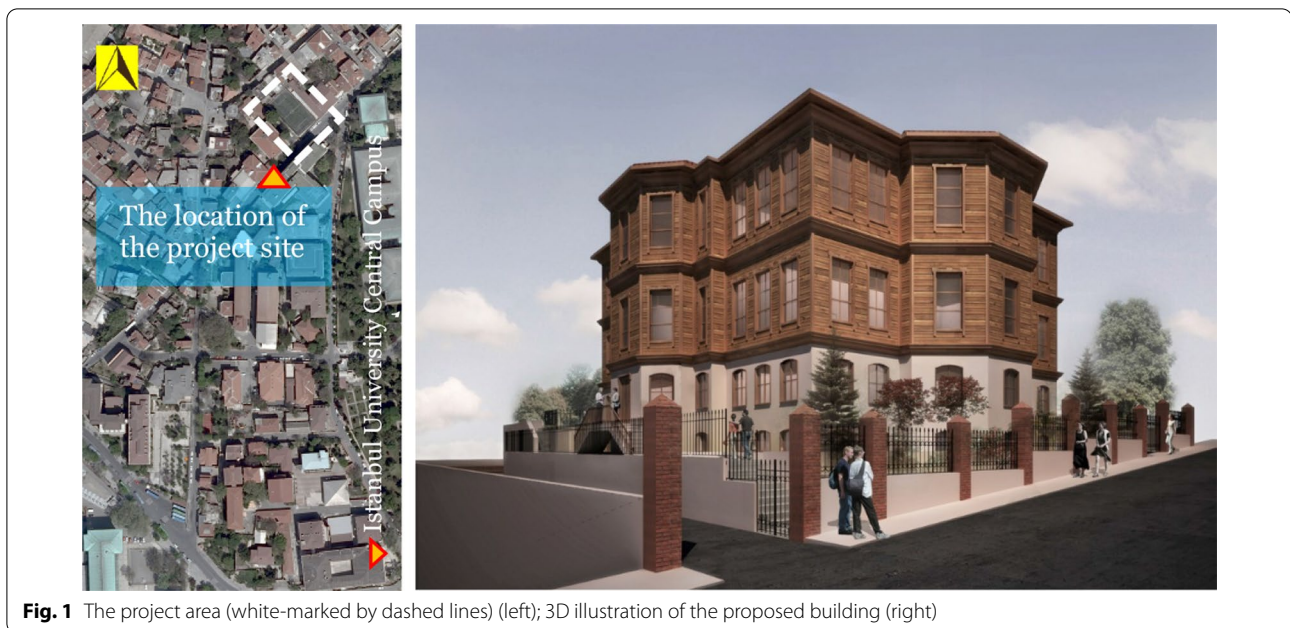
Fig. 1 The project area (white-marked by dashed lines) (left); 3D illustration of the proposed building (right)

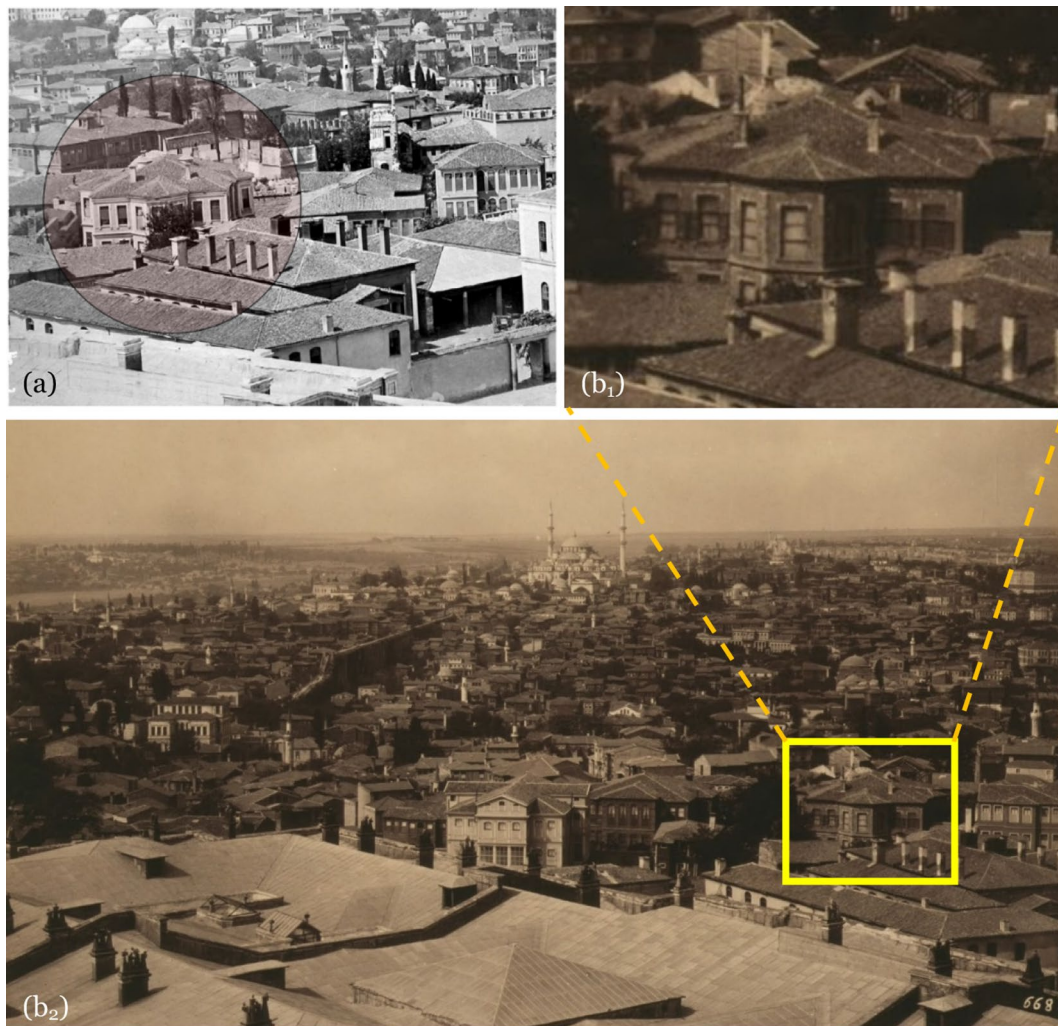
Fig. 6 The view of the mansion building in the 1880s from (a) DAI [52] and the (b1, b2) Abdulhamid II Collection [53]

of the German Archeology Institute and the Abdulhamid II Collection, we concluded that the examined building was constructed in the 1880s. The building is described as a secondary school on the German Blue Maps from 1913, the Pervititch maps of 1935 and the Istanbul aspect map of 1945. The building is absent from a photograph dated 1948 (Figs. 7 and 8), leading us to conclude that the building was demolished some time between 1945 and 1948. In photographs dated 1950 and 1966, in the decades following the demolition of *İbrahim Efendi Konağı*, two buildings can be seen on the site (Fig. 9a, b), while a 1982 photograph shows the site to be empty (Fig. 9c), and no construction has taken place since.

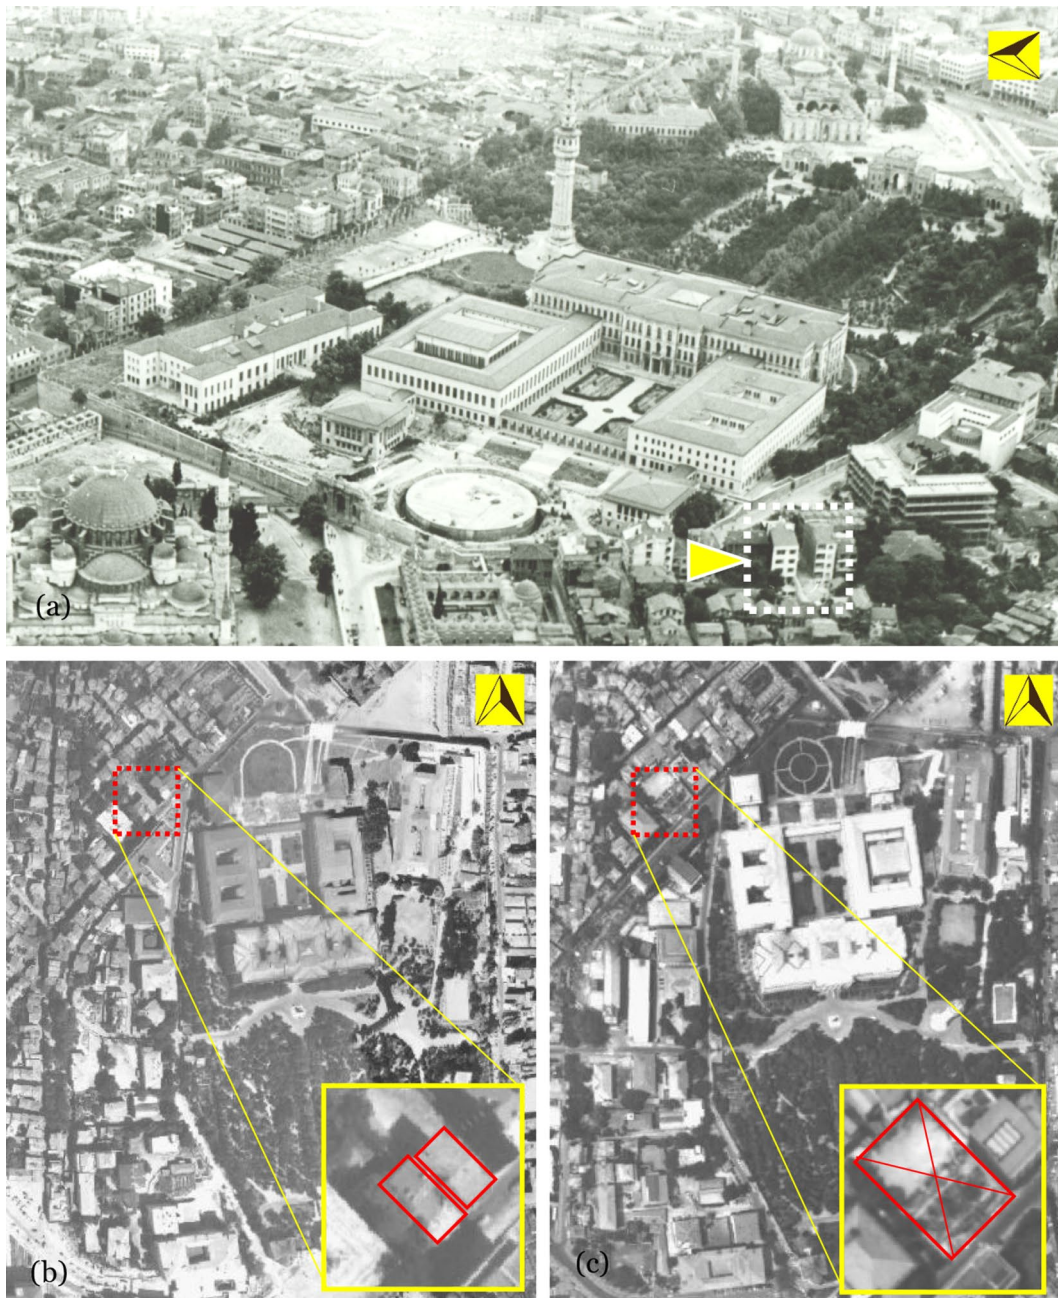
Fig. 9 Views of the area: **a** 1950 [58], **b** 1966 [51], **c** 1982 [51], (marked by dashed lines)

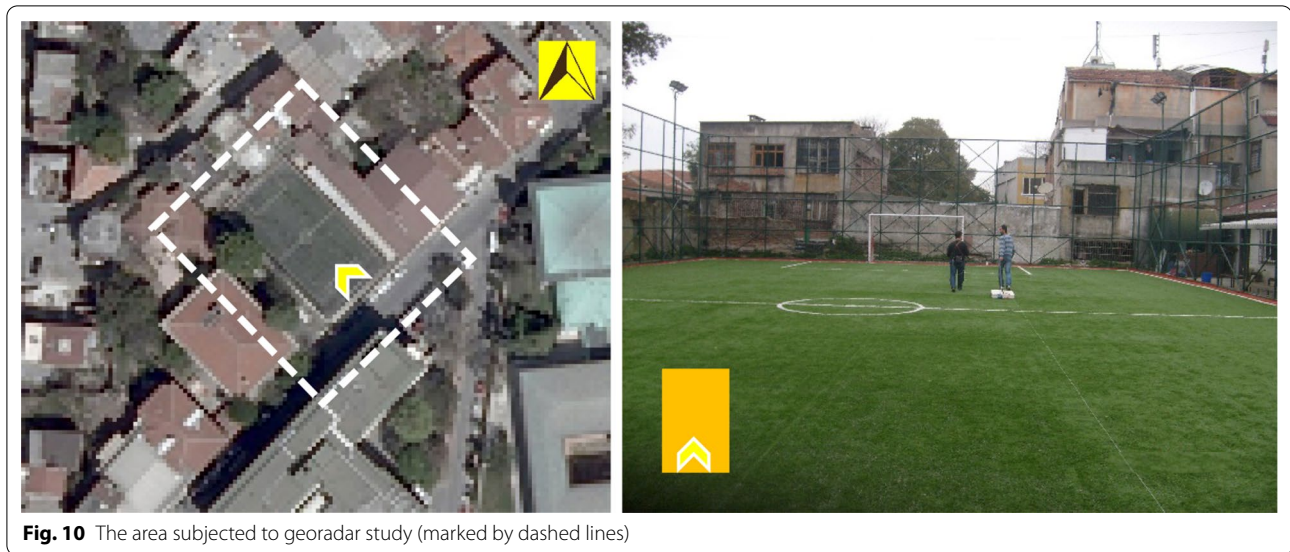
Fig. 10 The area subjected to georadar study (marked by dashed lines)

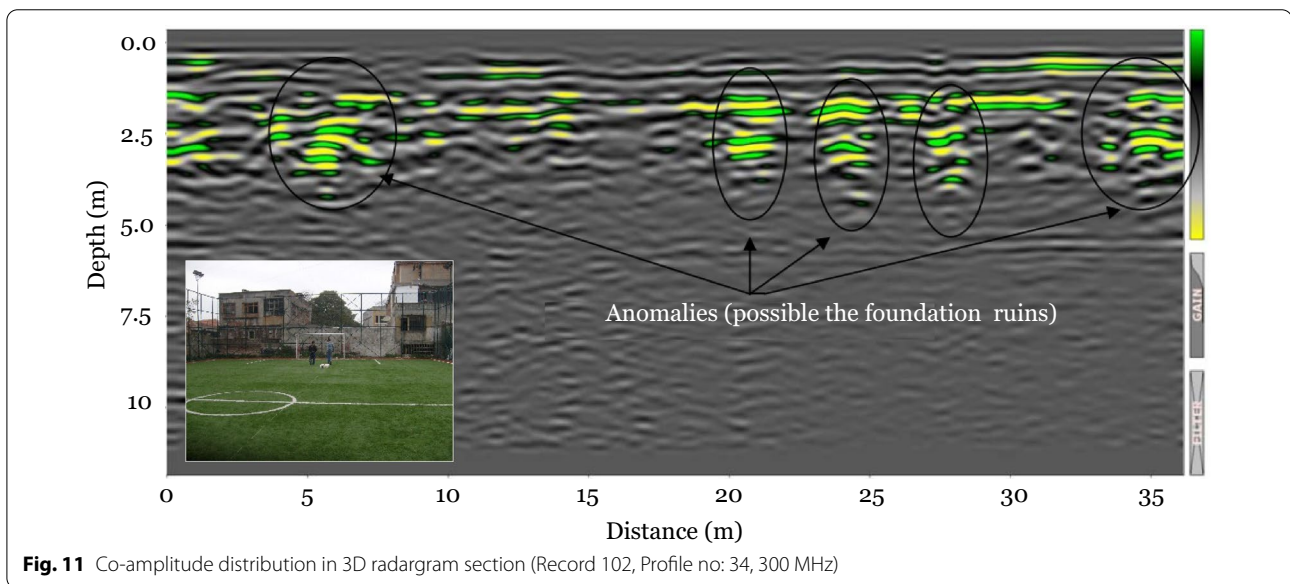
Fig. 11 Co-amplitude distribution in 3D radargram section (Record 102, Profile no: 34, 300 MHz)

continuous form measurements along with parallel profiles, and any anomalies detected on the radargrams were transferred to radargram diagrams. Using 2D radargram sections and 3D radargram block diagrams, the anomaly distributions were specified, and the anomaly images were thought to indicate the foundations of the original *İbrahim Efendi Konağı* (Figs. 11, 12). In the 3D radargram sections, the distribution of anomalies below ground was determined in 3D sections prepared by selecting the equivalent amplitude distributions (Fig. 13).

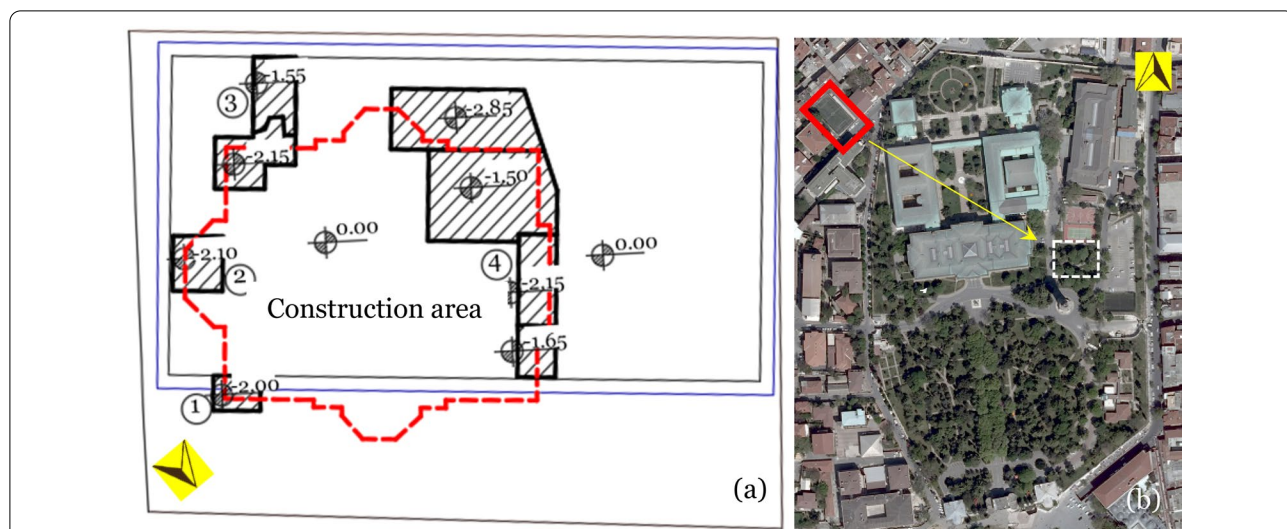
Fig. 14 a Archeological excavation points (1 to 4) in the construction area, b The site of the relocated architectural fragments (marked by dashed lines)

Based on the findings of the georadar surveys, archeological excavations were carried out to identify any existing foundation ruins and to any ancient findings in the construction area. The excavation locations are given in Fig. 14a. A total of four boreholes were drilled for excavation analysis: Borehole no. 1, measuring 3.1 m × 2.3 m, was made in the eastern corner of the plot, while borehole no. 2, measuring 3.3 m × 3.6 m, was in the southeast of the area. During the excavations carried out in these locations, various marble items were found at different depths, the geometric and material properties of which are presented in Table 1. The finds were relocated to a place within the Central Campus of Istanbul University, where other fragments were also collected (Fig. 14b).

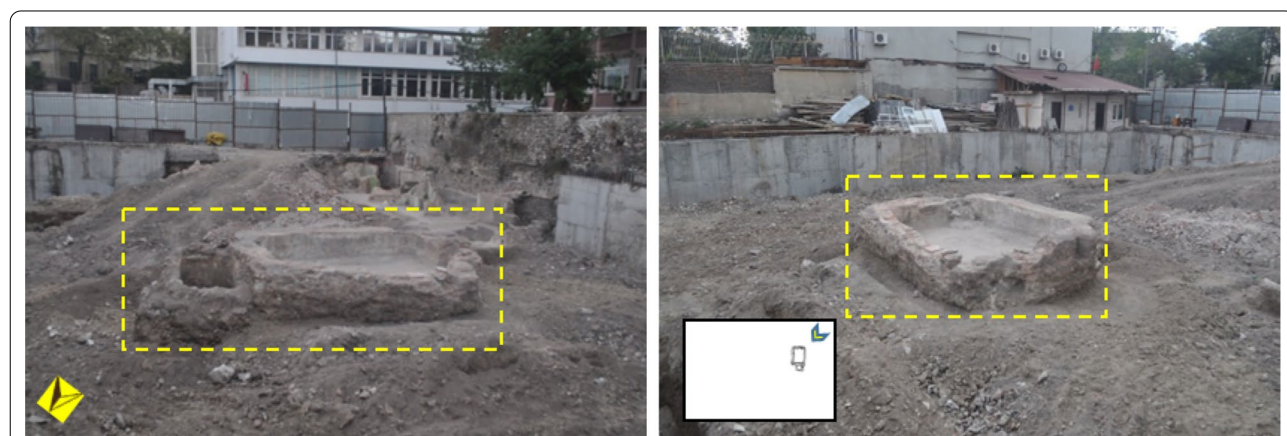
Fig. 15 Views of the cistern on the project site

Borehole no. 4 in the center of the site produced a remnant of which the formal features and architectural characteristics were unclear (Fig. 15). An examination of the general appearance and the construction technique applied to the item suggested that it came from a cistern (reservoir, water tank) that was probably built in the Late Ottoman era (the 18th or nineteenth centuries). The mass of the item was around 400 kN, and in situ observations and examinations showed that material deterioration had occurred in some structural materials, such as brick, stone, joints, fillings and plaster mortars. Furthermore, another small reservoir with relatively weak joints and grouts was identified in the northern part of the first construction area. In parallel to this, it was understood that the mortar on the architectural find had significantly lost its binding properties. The Cultural Assets Preservation Board decided that the finding had no architectural or historical value, and could thus be removed from the

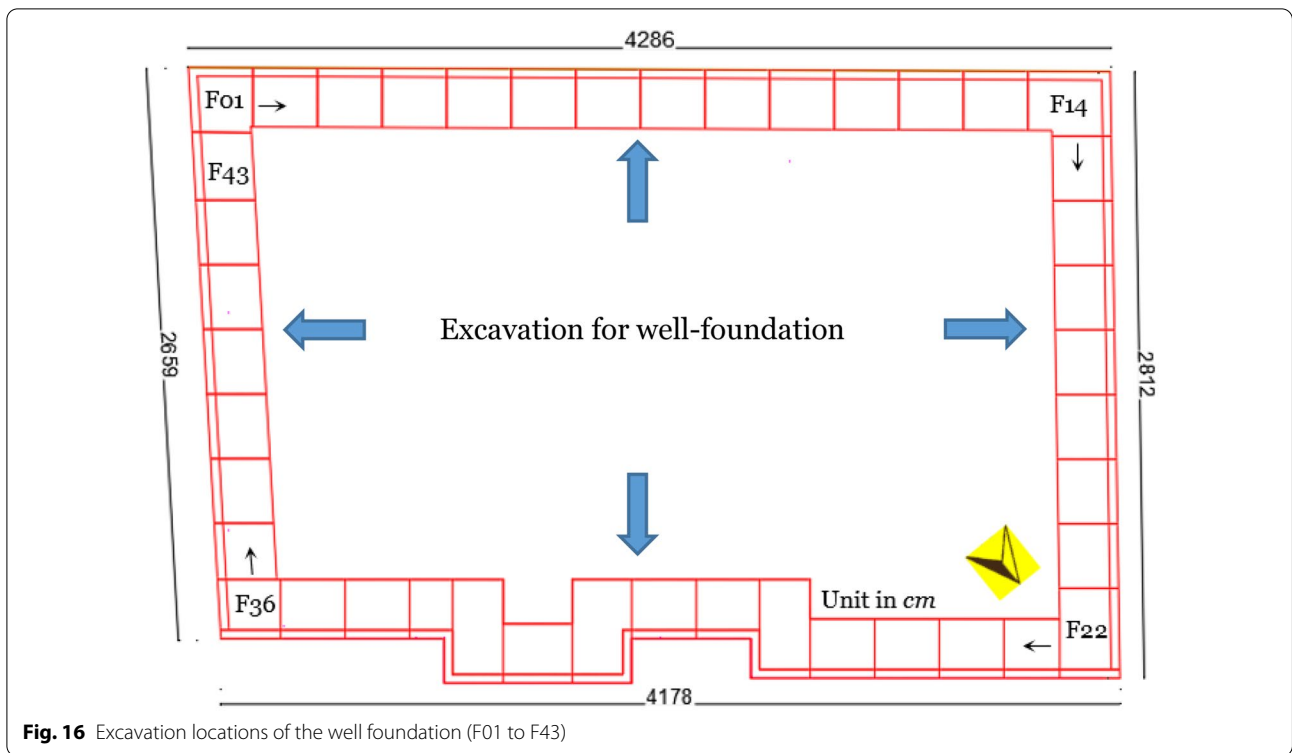
Fig. 16 Excavation locations of the well foundation (F01 to F43)

An excavation was also carried out for the well foundation-shear wall on all sides of the construction area (Fig. 16). Soil embankments were identified during excavations on the north, west and eastern edges of the site, while the remains of a stone wall at a depth of 2 m were determined during the excavations to the southwest part. The wall, which was built using a mud and sand mortar, measured 0.6 m high and 0.26 m wide, and ran in a northwest-southeast direction, and three cut stones were found behind it, side-by-side, at a depth of -1.85 m, that were determined to be unconnected. In another

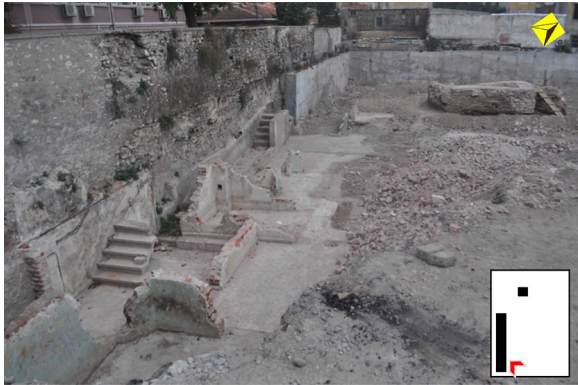
Fig. 18 Remains uncovered in the well foundation excavation on the southwest side of the area

excavation carried out in the southwest of the site, foundations from the Turkish republic era were identified that were assumed to belong to buildings constructed following the demolition of *İbrahim Efendi Konağı* in 1948 (Figs. 17, 18).

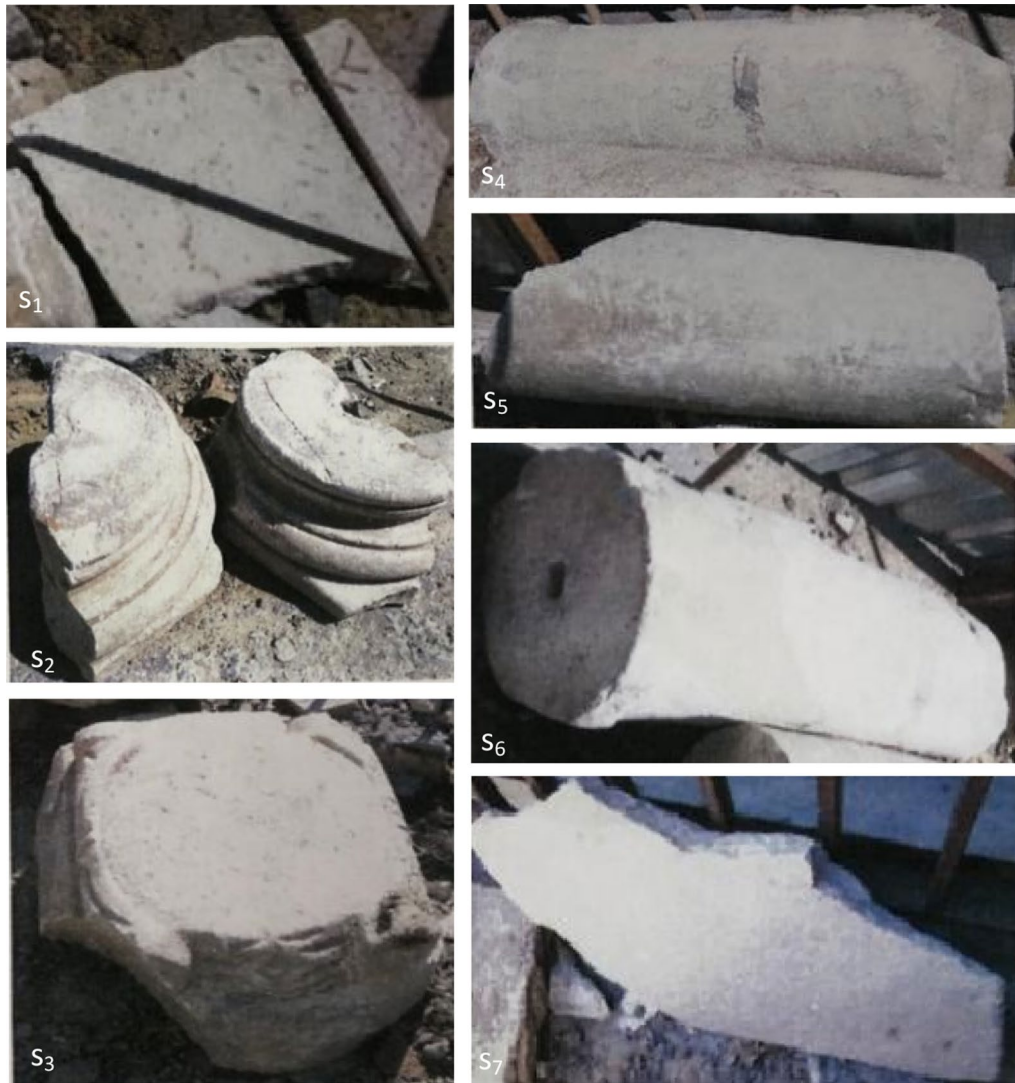
Fig. 19 Archeological finds during excavations for the well foundation

During the excavations for the construction of the well foundation, marble finds of various types and dimensions were identified at different depths (Fig. 19), the geometric and material properties of which are given in Table 2. It was decided to carry out an excavation work of the entire area under the supervision of the Directorate of Istanbul Archeology Museums, since it was believed that more unearthed remains could exist across the construction area [59], although no such cultural assets, whether movable or immovable, were found during these excavations. All remains were documented with survey reports and photographs and were removed from the site [60]. Thus,

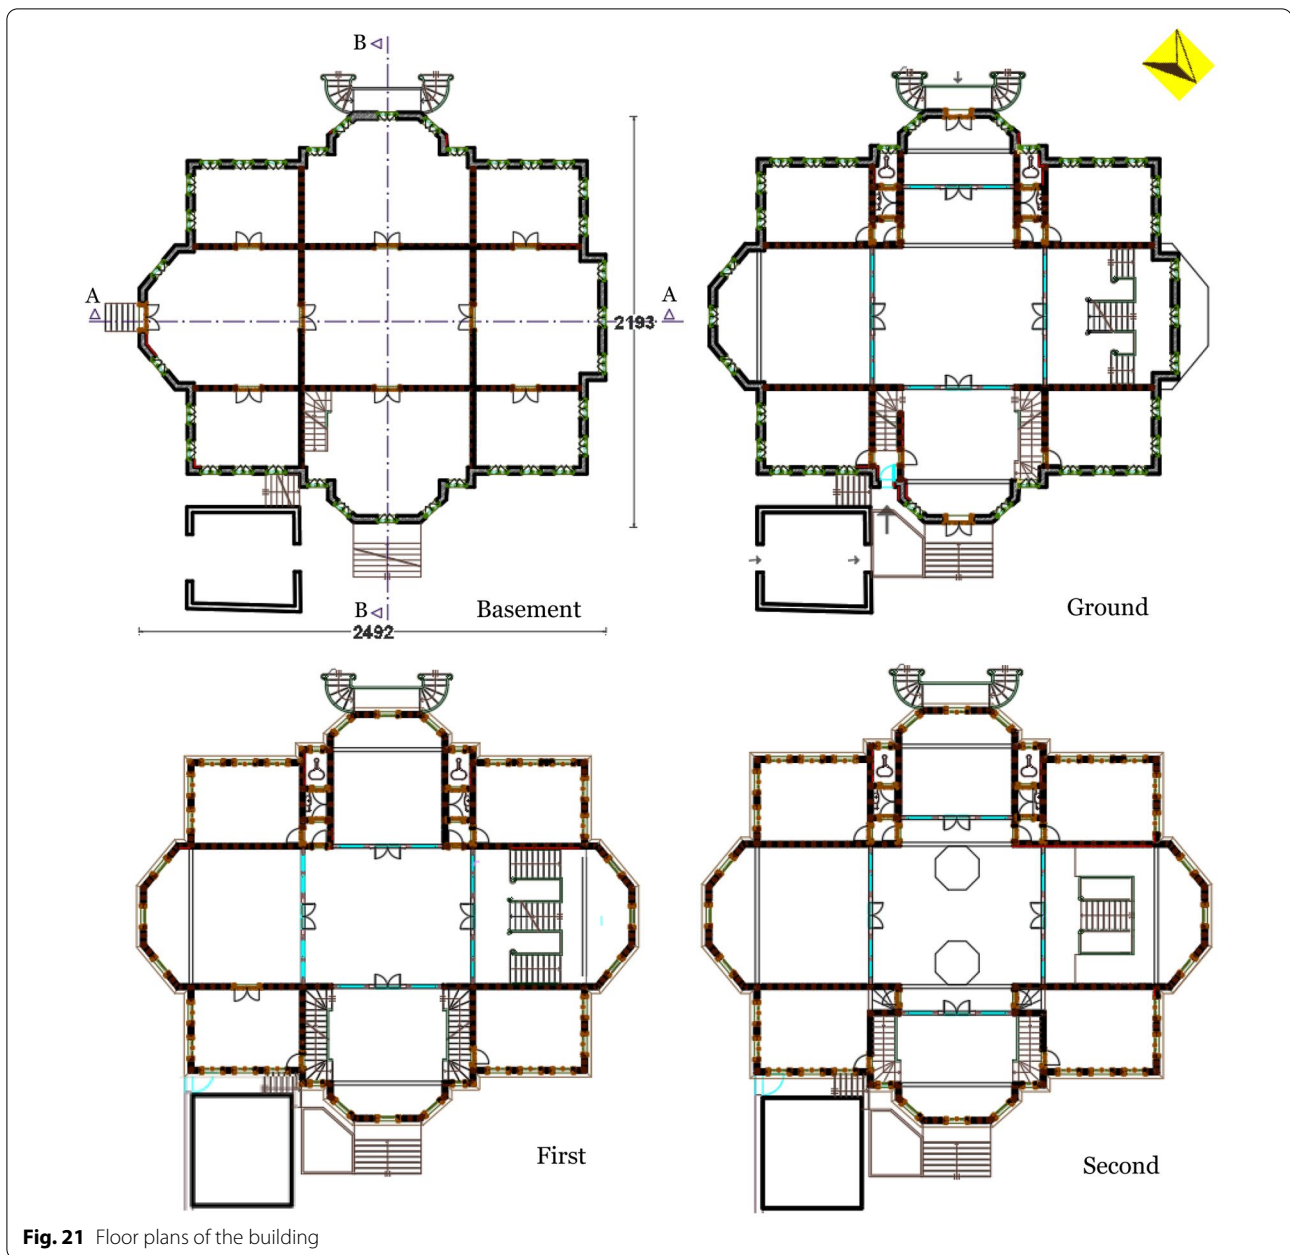
Fig. 21 Floor plans of the building

façade of *İbrahim Efendi Konağı* were garnered from historical maps, photographs and old documents. The internal organization of the spaces was based on the typology of the building and from references obtained from the façades. In the light of all this information, in addition to the floor and roof plans prepared for the building, the estimated sectional elevations and façade views are presented in Figs. 21, 22, 23, 24.

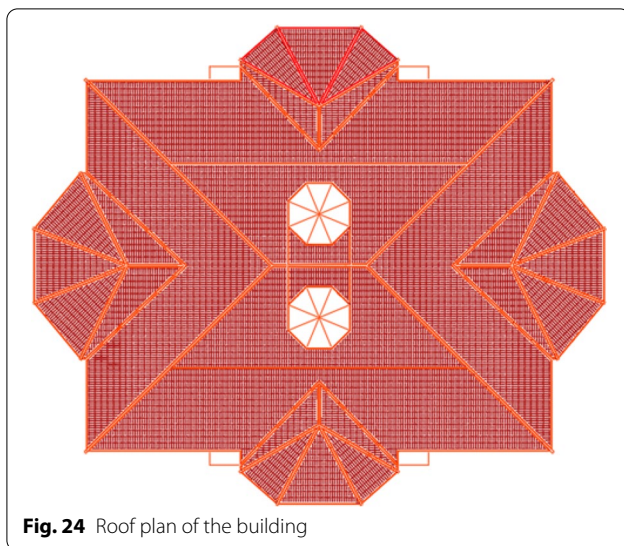
Fig. 24 Roof plan of the building
