RESEARCH ARTICLE

The geotechnical characteristics of landslides on the sedimentary and metamorphic terrains of South-East Nigeria, West Africa

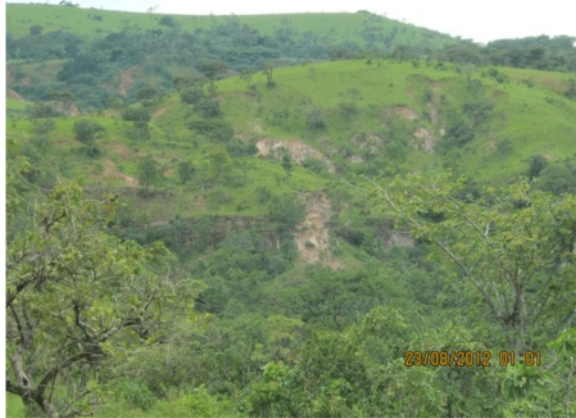
Figure 3 Shallow slides at the sedimentary terrain in Enugu (photo by Igwe).

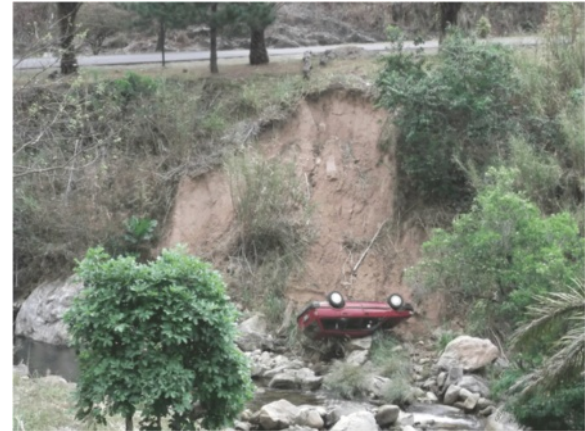
Figure 5 Some of the casualties of the Obudu landslide were the occupants of a car that tumbled when a slope near the road failed (photo by Igwe).

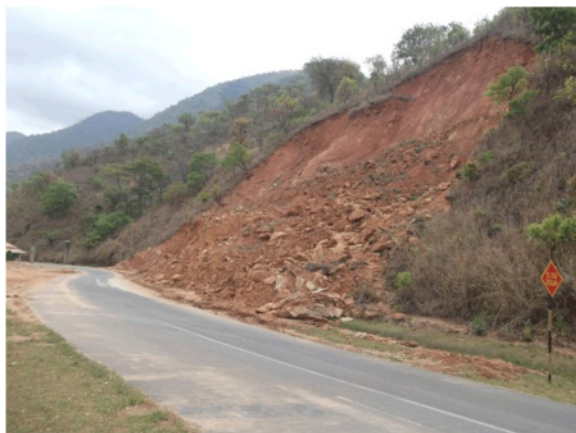
Figure 4 A landslide on the metamorphic terrain in Obudu Calabar (photo by Igwe).

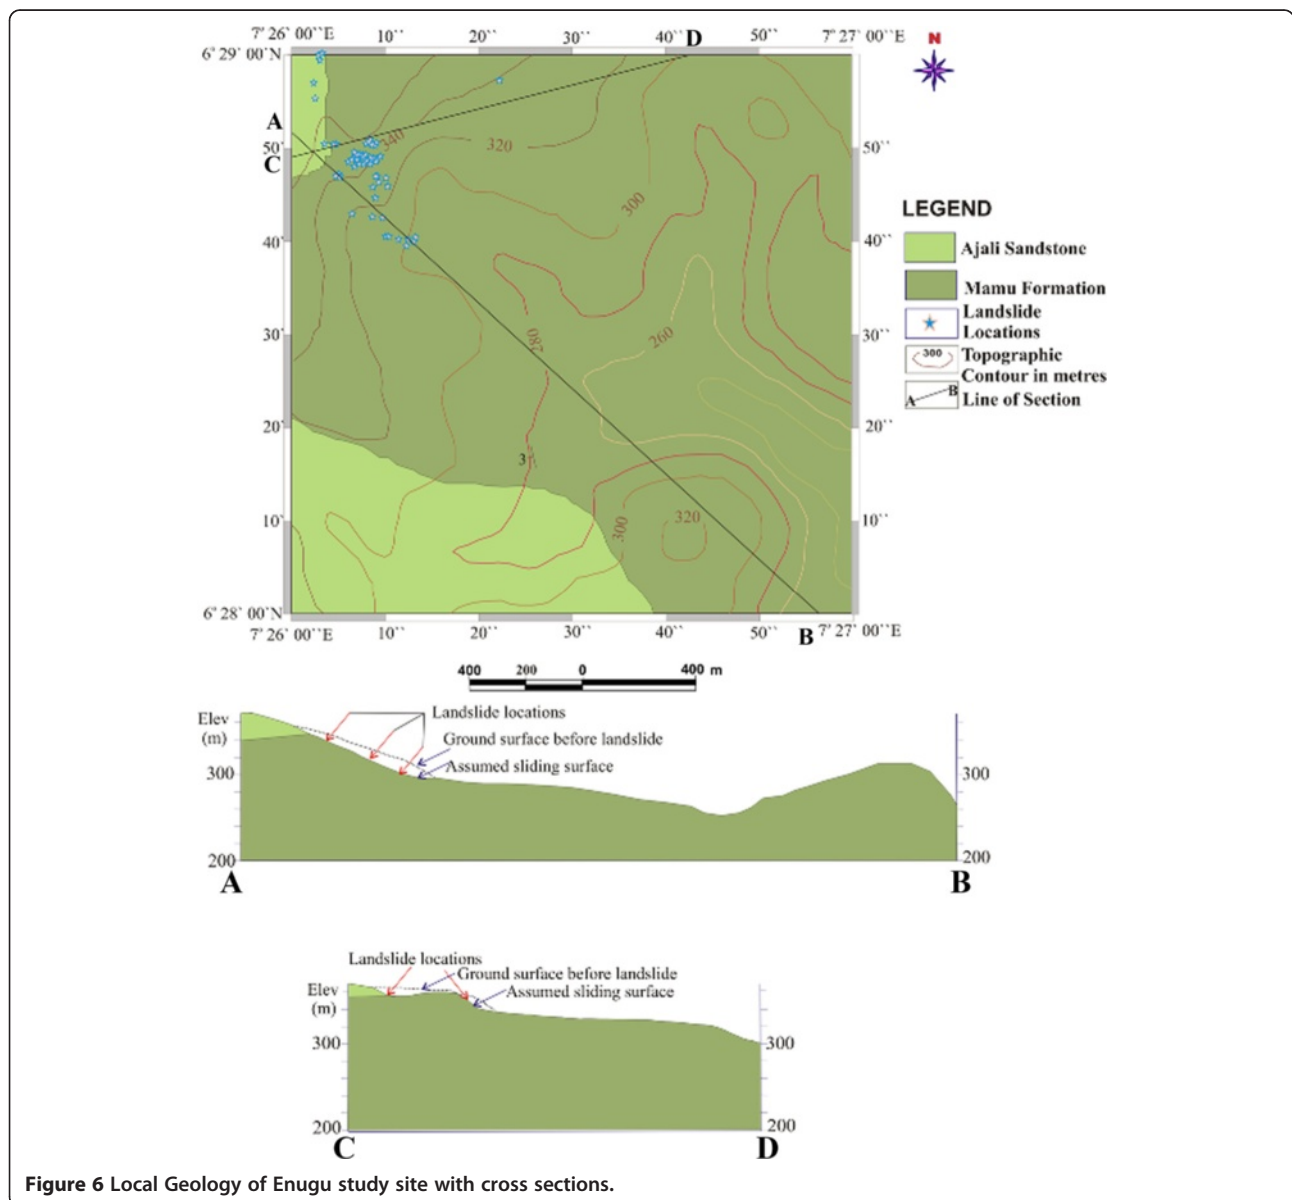
Figure 6 Local Geology of Enugu study site with cross sections.

The dominant rock types in Enugu area are sandstone siltstone and shale (Figure 6) that range from the Campanian

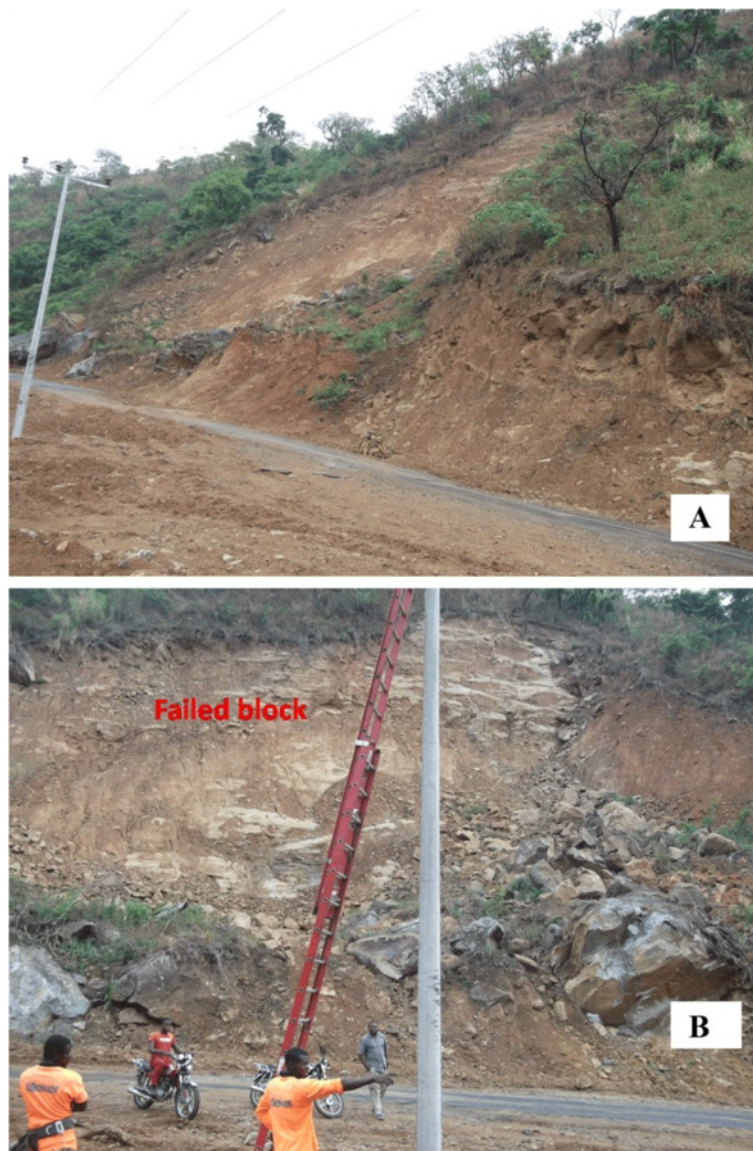
Figure 9 The landslide debris initially covered the road before being cleared in (A) and damaged power cables prompting the erection of a new power line in (B) (photo by Igwe).

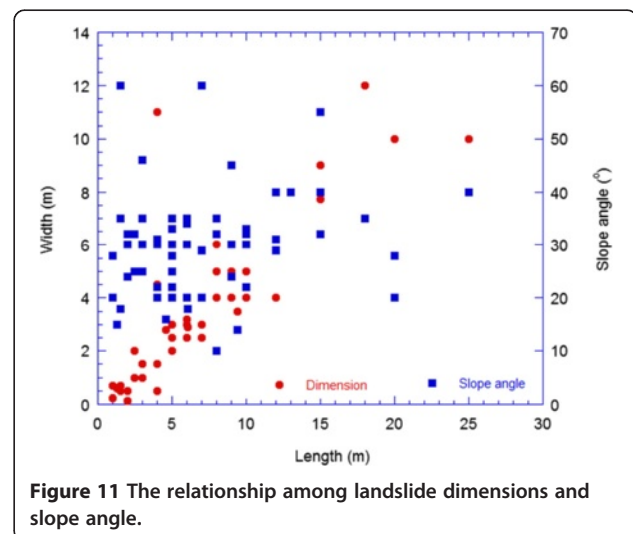
Figure 11 The relationship among landslide dimensions and slope angle.

which angles are between 30° and 35° (Figures 11 and 12). The trend appears to show that most of the landslides with bigger width also have larger length, and occur more on slopes with angles greater than 30° but less than 40°, which may be related to the triggering mechanism. It can be predicted therefore that the Enugu area is more prone to smaller slides than those with bigger dimensions. At every landslide width, the length could be determined, and vice versa. The prediction of potential landslide displacement and size should be a critical component of an early

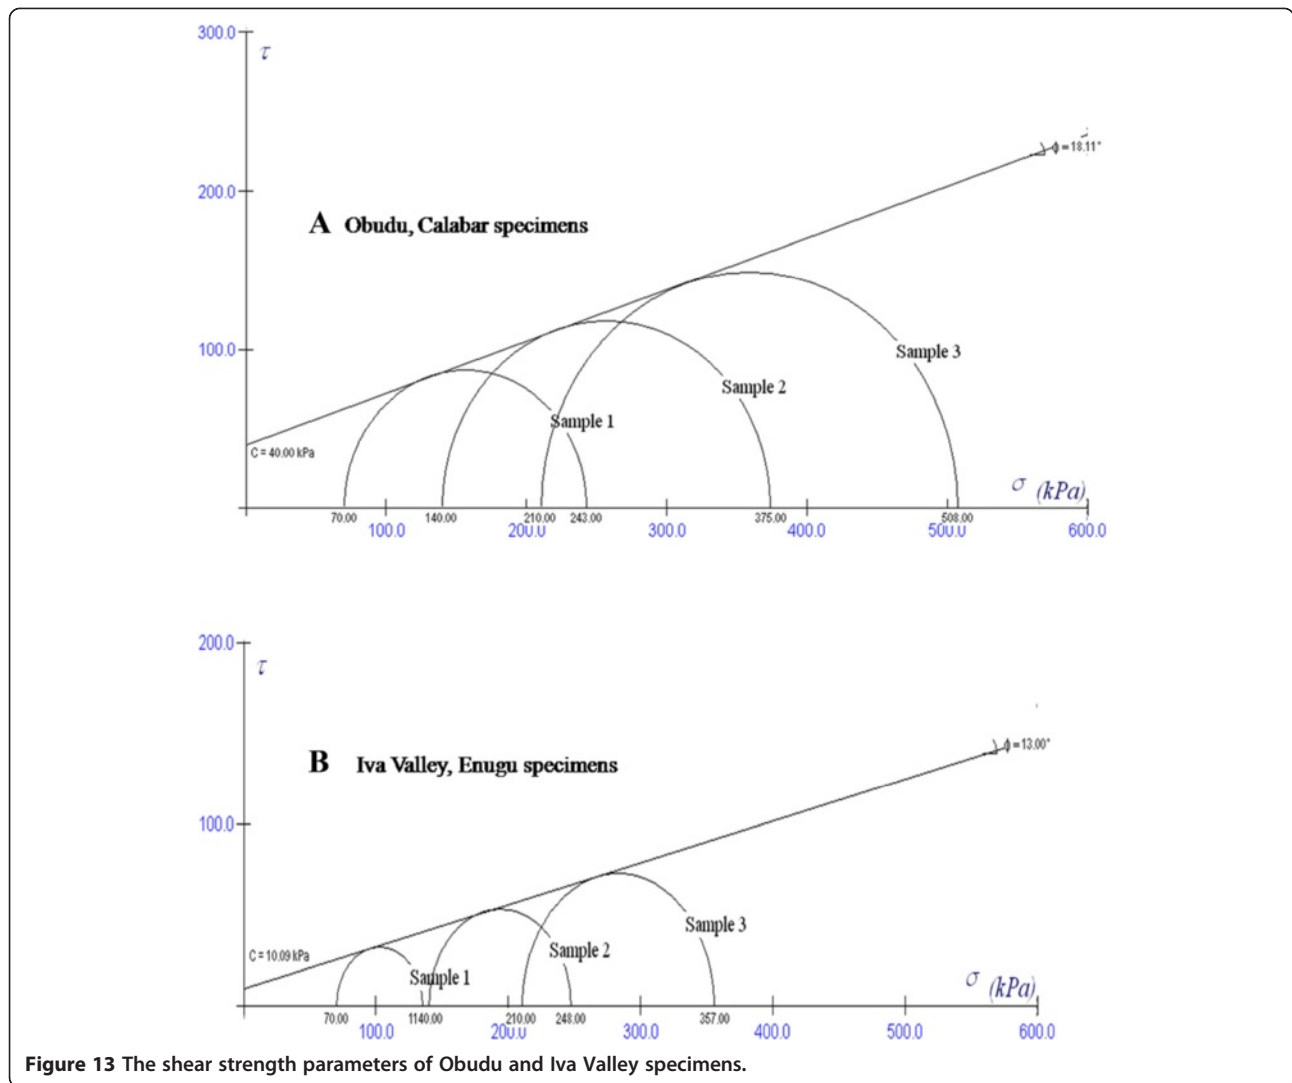
Figure 13 The shear strength parameters of Obudu and Iva Valley specimens.
