# Investigation of rainfall-induced shallow landslides on the northeastern rim of Aso caldera, Japan, in July 2012

Hufeng Yang<sup>1\*</sup>, Fawu Wang<sup>1</sup>, Vít Vilímek<sup>2</sup>, Kiminori Araiba<sup>3</sup> and Shiho Asano<sup>4</sup>

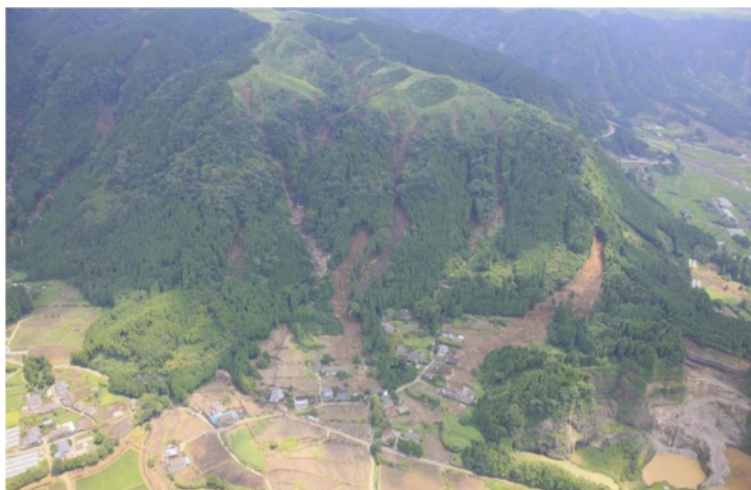
**Fig. 1** Shallow landslides on the northeastern rim of Aso caldera (image courtesy of Kokusai Kogyo Co., Ltd, Japan)

The Northern Kyushu area of Japan experienced high-intensity rainfall from 11 to 14 July, 2012. This heavy rainfall triggered many shallow landslides, especially on the northeastern rim of Aso caldera (Fig. 1). These shallow landslides, as the resource for debris flows, occurred on the upper slopes, at the inner rim of caldera. Trees growing along the gullies on the middle slopes were carried away by the debris flows. Many sabo dams (i.e. check dams) in the path of the debris flows were destroyed. The debris flows affected many villages and local settlers. The debris flows claimed 30 lives, with another two people remaining unaccounted for, and 13,263 houses were completely or partially damaged (Fire and Disaster Management

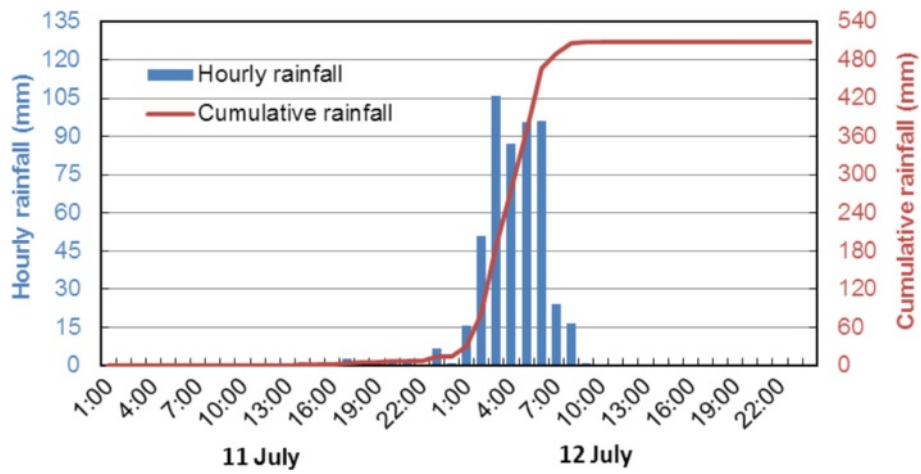
**Fig. 6** Hourly and cumulative rainfall at study area on 11 and 12 July, 2012

record. The rainfall data shows that the maximum hourly rainfall was 108 mm in the early morning of 12 July, and the cumulative rainfall over the two days was 508 mm (Fig. 6). This rainfall is the highest recorded at the Otohime Meteorological Observatory over the last decade. Obviously, heavy rainfall was the main triggering factor for this geo-disaster.

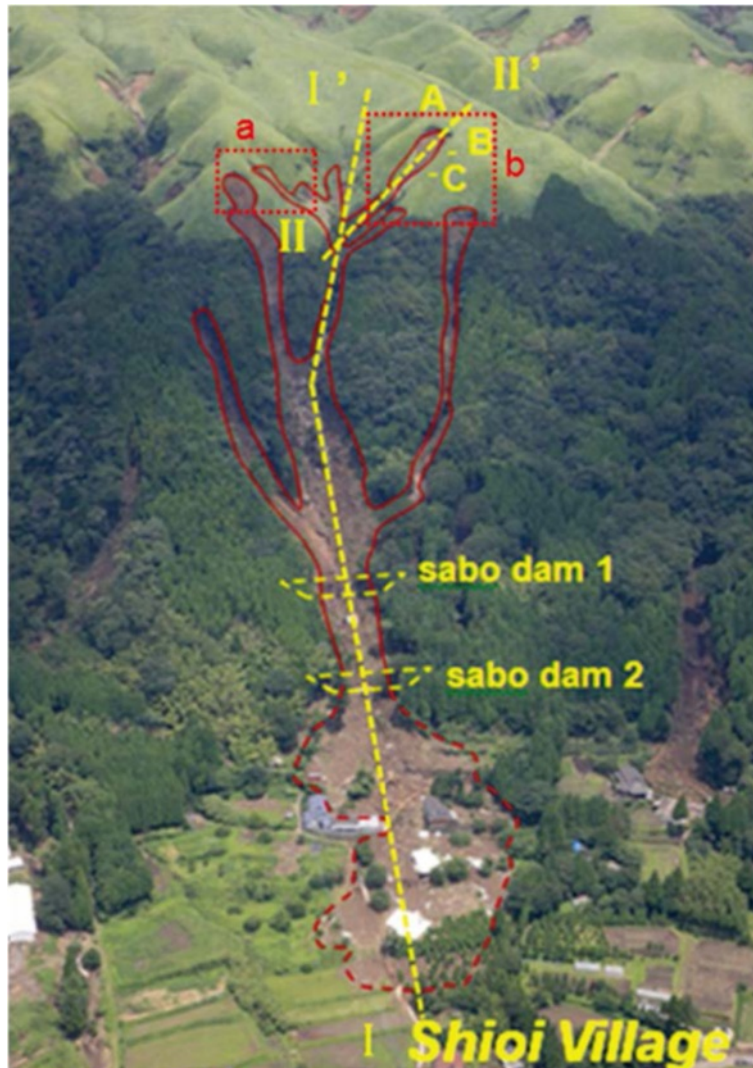
**Fig. 7** Photograph of the slope at Shioi Village, Ichinomiya, after failure (image courtesy of Kokusai Kogyo Co., Ltd, Japan)

A representative shallow landslide at Shioi Village in Ichinomiya, Kumamoto Prefecture (Fig. 2) was selected to study the initiation mechanism of shallow landslides on the steep slopes during heavy rainfall. Figure 7 shows the slope after failure. Several shallow landslides occurred in grassland at the rim of Aso caldera (Fig. 8). These shallow landslides were the source of debris flows in the gully. Field investigations were conducted on the

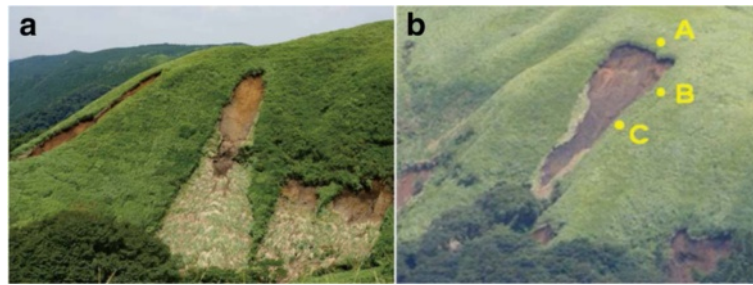
**Fig. 8** Shallow landslides in the grassland (locations of (a) and (b) are shown in Fig. 7; Points A, B and C in (b) show the locations of portable dynamic cone penetration tests)

shallow landslide shown in Fig. 8b. Longitudinal profiles were measured to illustrate the terrain of the gully and slope. Soil samples were collected from the main scarp of the shallow landslide for laboratory investigations. Three portable dynamic cone penetration tests were conducted to determine the thickness of the soil layer. In order to measure the hydraulic coefficient of the soil, in-situ infiltration tests were conducted in hand-drilled boreholes of varying depth, above the top of the main scarp of the shallow landslide.

The test locations are shown in Fig. 8b. During the dynamic cone penetration tests, a 5 kg hammer was dropped (free fall) from a height of 50 cm. The number of drops ( $N_d$ ) was recorded for each 10 cm penetration depth of the cone tip (Qureshi et al. 2009). The thickness of the soil layer and its boundaries could thus be determined, due to the differing strength of the potential sliding bed.

The test locations were located above the main scarp of the shallow landslide, near point A in Fig. 8b. A portable

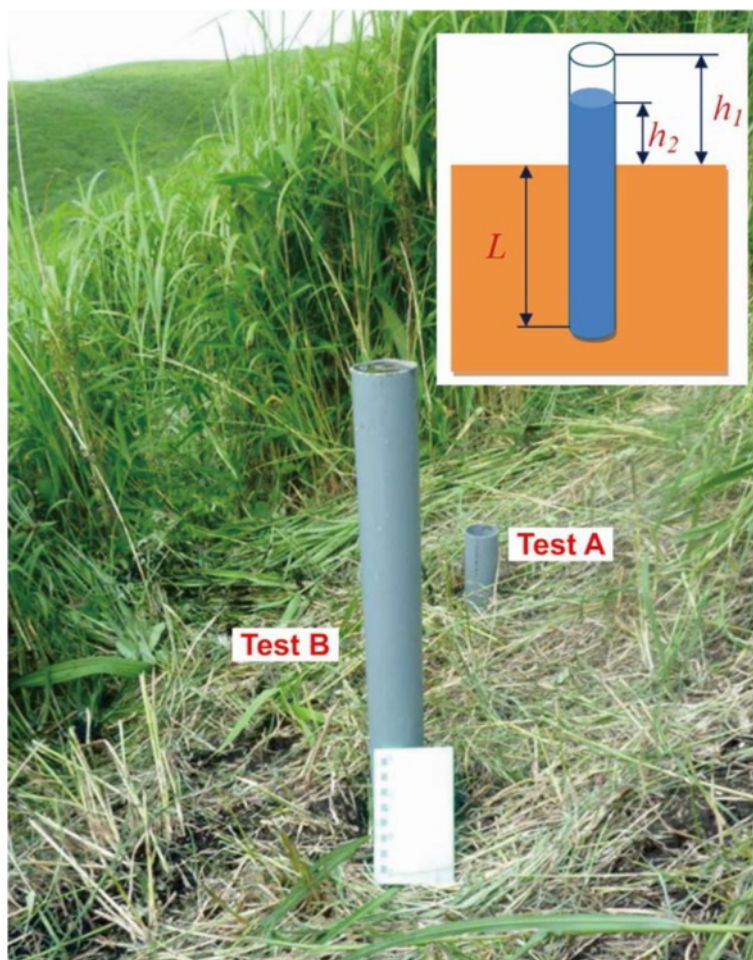
**Fig. 9** In-situ infiltration tests

twist drill was used to drill a 0.25 m deep borehole. A PVC tube was then inserted into the borehole until the bottom was reached. The tube was then filled with water, and the initial water level and start time of water infiltration were noted. The final depth of the water level was measured after a given time interval. A second borehole with a depth of 0.75 m was drilled near the first borehole (Fig. 9) to determine the variation of soil permeability with increased depth. The same test process was used for the second borehole. Tests were carried out twice in each borehole to obtain an average value. The hydraulic coefficient ( $k$ ) was calculated using Eq. 1 (Lambe and Whitman 1969);

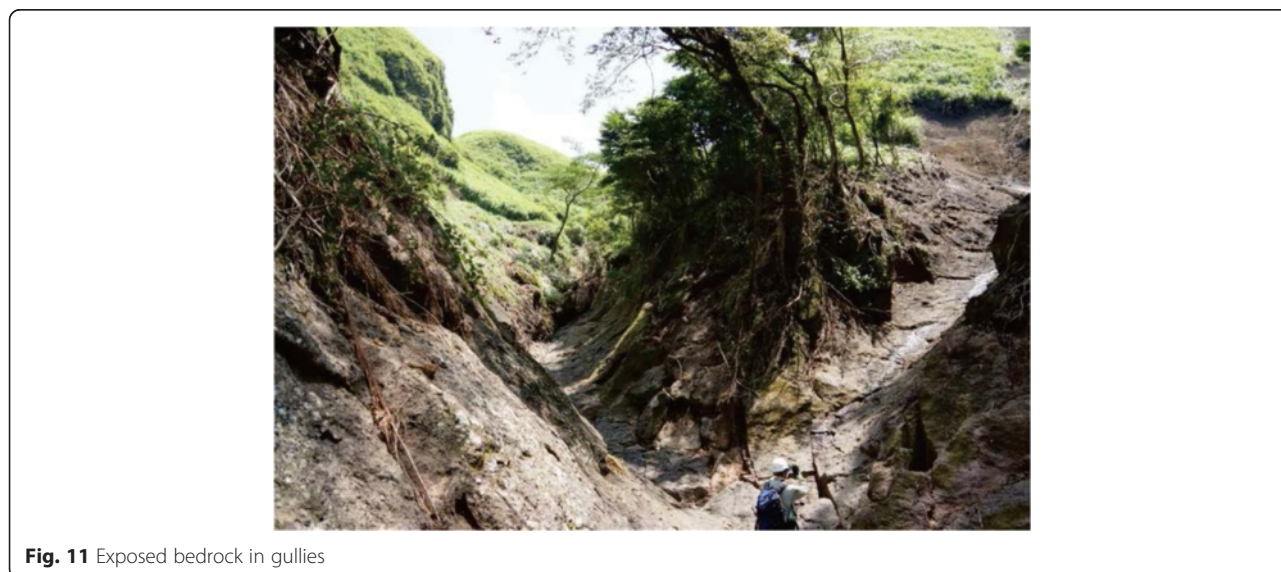
**Fig. 11** Exposed bedrock in gullies

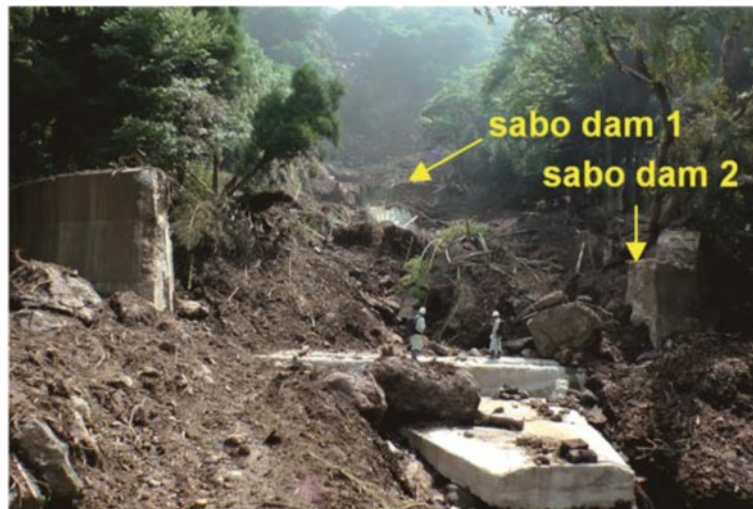
**Fig. 12** Sabo dams destroyed by debris flow

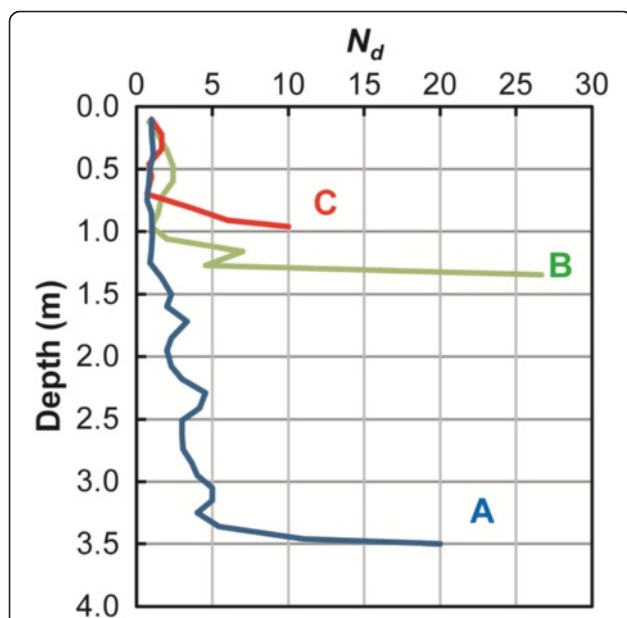
**Fig. 13** Results of three portable dynamic cone penetration tests

The results of the portable dynamic cone penetration tests show that the soil layer is about 3.5 m thick at the upper slope (Fig. 13). The soil layers gradually become thinner (about 1 m) from the upper to the lower slope. In general, soils in the lower parts of hillsides are thicker than in their upper part, due to soil erosion in the upper parts, and deposition in the lower parts. Consequently, the characteristics of the slope at the rim of Aso caldera differ from the general condition. This may be because that erosion on the lower slope is more severe than on the upper slope due to surface run-off during heavy

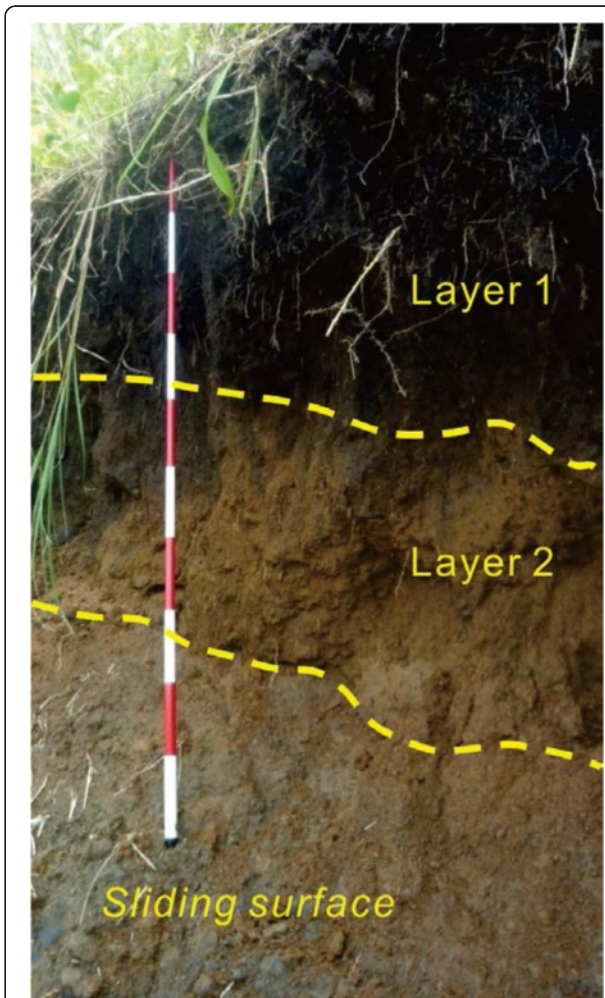
**Fig. 14** Main scarp of the shallow landslide

The soil in the main scarp of the shallow landslide can be divided into two layers based on the appearance features (Fig. 14). Layer 1, the black uppermost layer, is composed of volcanic ash, humus and plant roots. Coarse sand and gravels occur in the underlying layer 2. Particle size gradually increases downward, reaching maximum particle diameter of about 20 mm. The sliding zone of the shallow landslide is located at the base of layer 2, which is underlain by a basal gravel layer. Sliding surfaces were observed on the surface of the basal gravel layer. Grain size analysis (sieve and hydrometer analysis) of soil samples from each layer was conducted to determine their grain size distribution (Fig. 15). Fine particles (grain size less than 0.075 mm) form around 45 % of the soils in layers 1 and 2. After the occurrence of shallow landslides, on steep slopes these fine materials can easily transform into debris flows during heavy rainfall. According to the Unified Soil Classification System (USCS), layer 1 is composed of poorly graded tephra clay. Layer 2 is composed of clay with coarse sand gravels.

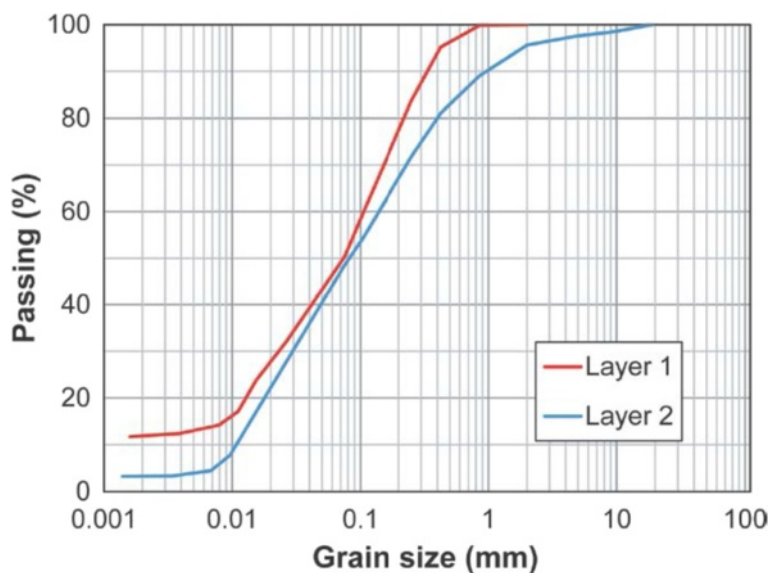
**Fig. 15** Grain size distributions of soil samples from different layers

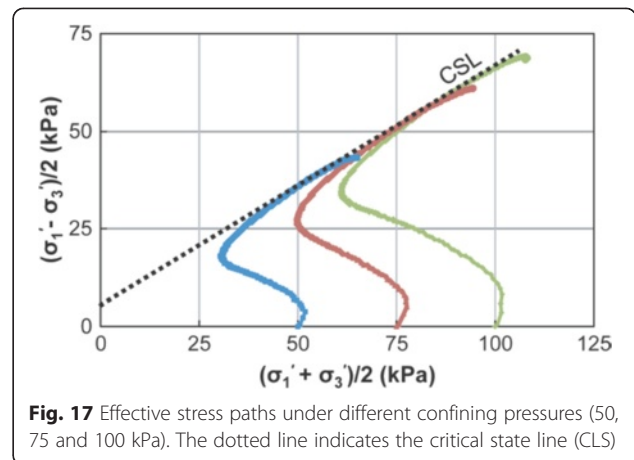
**Fig. 17** Effective stress paths under different confining pressures (50, 75 and 100 kPa). The dotted line indicates the critical state line (CLS)

from its maximum value as the strain increases continuously, and finally reached a minimum value at the end of the tests. The initial buildup of the pore-water pressure suggests that the specimens exhibit contractive behavior. The reduction in the pore-water pressure after the peak indicates that the specimens change from contractive to dilative behavior during shear, as illustrated by the effective stress paths shown in Fig. 17.

All the effective stress paths show a similar trend. Each path moves toward the right initially (increasing  $(\sigma'_1 + \sigma'_3)/2$ ), and then moves to the left (decreasing  $(\sigma'_1 + \sigma'_3)/2$ ) until reaching a turning point, after which they turn right, before reaching the critical state line (CSL) at the end of the test. The critical states of saturated specimens can be represented by the CSL in the stress plane. The gradient of the critical state line is 0.6, which corresponds to a critical state line of effective friction of  $36.9^\circ$  and cohesion of 6.3 kPa. In published results of soil shear strength, it was observed that the effective friction angle was about  $35^\circ$ , and cohesion varied between different soil layers (Paudel et al. 2008). The

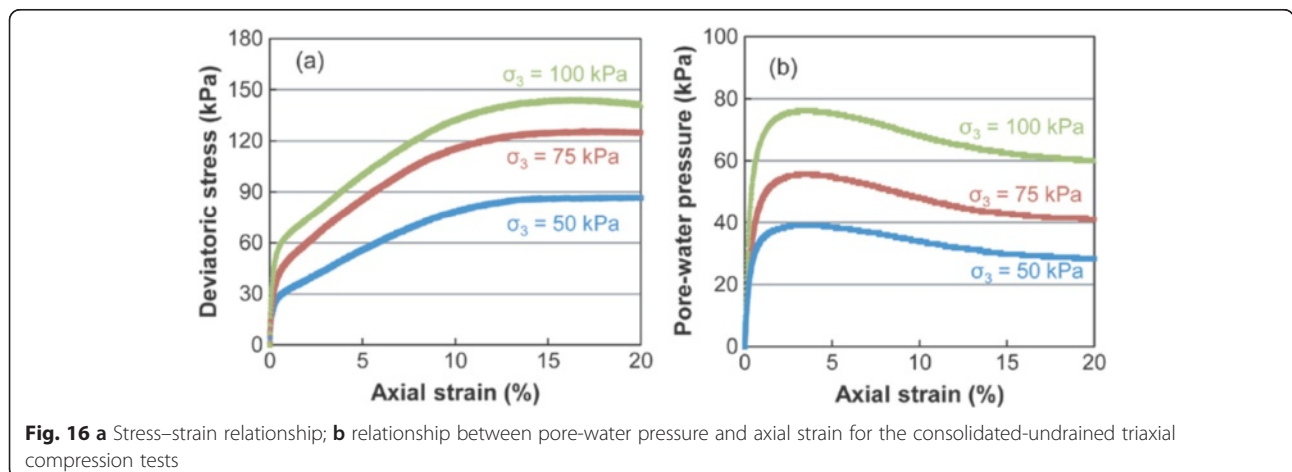
**Fig. 16 a** Stress–strain relationship; **b** relationship between pore-water pressure and axial strain for the consolidated-undrained triaxial compression tests

The stress–strain relationship of the consolidated-undrained tests on the saturated specimens (Fig. 16a) shows that the deviatoric stress increases with the axial strain. The stress–strain curves provide evidence for stress hardening. When the shear strain is over about 13 %, the deviatoric stress begins to flatten. For the specimen with high confining pressure (100 kPa), stress softening was observed at the end of the test. Critical state was reached for all three tests with a high axial strain (Fig. 16a).

The relationship between excess pore-water pressure and the axial strain of consolidated-undrained tests on the saturated specimens is shown in Fig. 16b. Positive pore-water pressure was recorded in all three undrained tests. In all soil specimens, pore-water pressure increased to a peak at low strain (about 3 %), declines

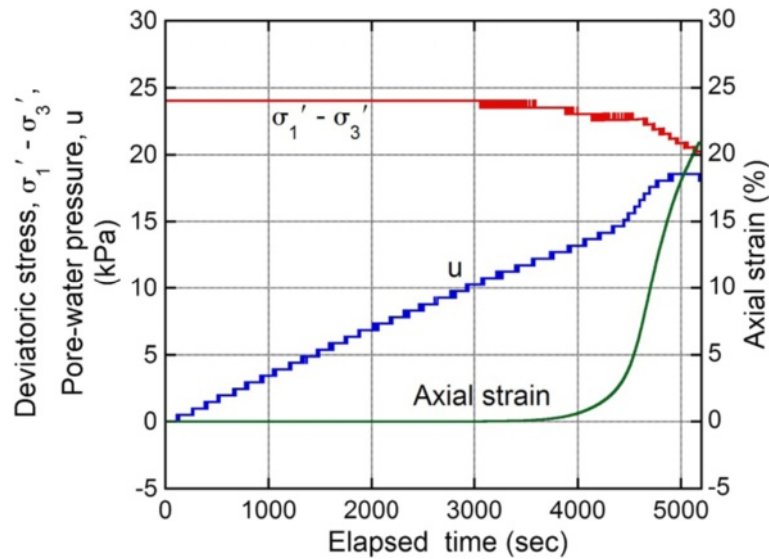
**Fig. 18** Relationships between deviatoric stress, axial strain and pore-water pressure for the pore-water pressure controlled triaxial test

The relationships between deviatoric stress, axial strain and pore-water pressure were obtained through the pore-water pressure controlled triaxial test (Fig. 18). The results show that when the pore-water pressure increased to about 12 kPa, the deviatoric stress started to decrease, while the axial strain increased. With the continuous increase of pore-water pressure, the major failure of the soil occurred when the pore-water pressure increased to near 15 kPa. At this time, high excess pore-water pressure was generated in the soil, causing the obvious decrease of effective stress. In a short time, the axial strain increased rapidly, and exceeded 20 %. This soil behavior in response to increase in pore-water pressure can explain the initiation mechanism of the shallow landslides on the slopes. During heavy rainfall, continuous rainfall infiltration can generate a wet front in the soil layer, and in turn forms a saturated zone above the potential sliding surface. The saturated zone will move gradually upwards in relation to the slope surface, and the pore-water pressure acting on the potential sliding surface will increase. Based on the results, it is evident that failure in the soil specimen will not occur, even with high pore-water pressure (less than 12 kPa). It also means that the slope can maintain stability when the rainfall is not so heavy. However, if the pore-water pressure exceeds the critical value as a result of heavy rainfall, a shallow landslide will be triggered.
