# In-plane cyclic behaviour of unfired clay and earth brick walls in both unstrengthened and strengthened conditions

**Abstract** This article presents the outcome of a series of in-plane shear tests on non-traditional masonry walls under unstrengthened and strengthened conditions. The uniqueness of the experiments arises from the testing of unfired clay and earth (adobe) bricks, which are typical for numerous historical buildings and which have significantly different mechanical properties in comparison with the nowadays commonly used fired bricks, concrete blocks, etc. The applicability and suitability of two different strengthening techniques, which do not require significant structural intervention, were investigated with the use of two evaluation procedures. The first technique was realised using steel wire ropes that were mechanically fastened to the wall and arranged in an X shape. The other technique comprised of the application of a geo-net to the surface of the wall,

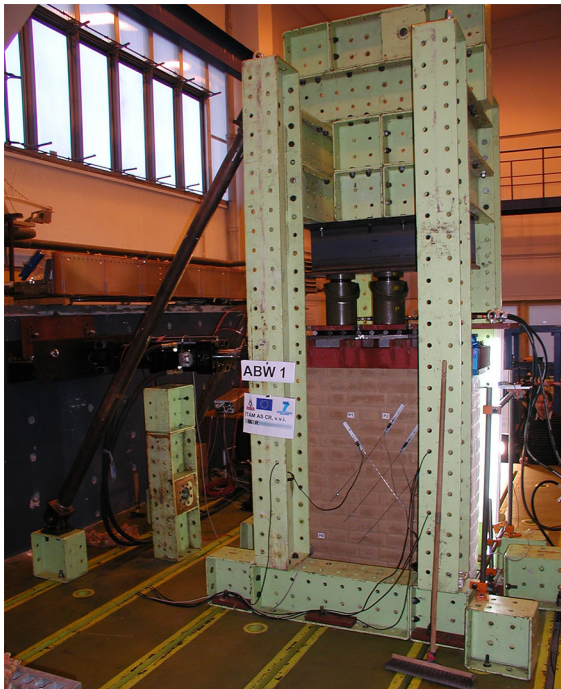
Fig. 3 Testing rig with the specimen

The masonry specimens were mounted into a special testing rig that simultaneously enabled uniform compression and cyclic horizontal loading on the top of the tested wall; see Fig. 3.

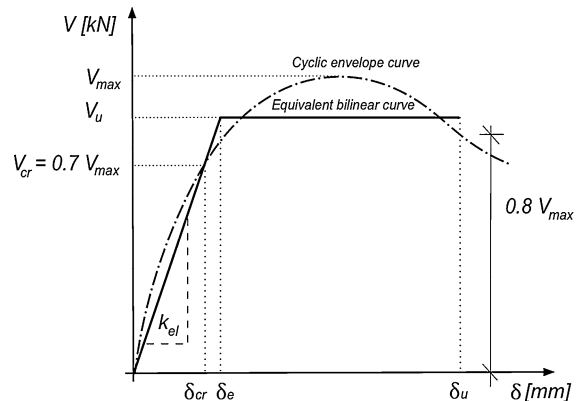
Fig. 5 Hysteresis envelope and its bilinear idealisation

The actual hysteresis behaviour of a masonry wall, subjected to the combination of constant vertical load and a sequence of lateral loads, can be interpreted by the commonly used bilinear curve, see [23, 24] or [25] and Fig. 5.

The construction of a cyclic envelope of the hysteresis loops was carried out first. In the present case, the hysteresis loop represents a dependence of the horizontal force  $V$  (force of the actuator) on the top wall displacement  $\delta$  (actuator displacement) for one cycle of the loading step. The characteristic value of the maximum force and the displacement were taken as averages of their maxima relative to the positive and negative loading directions. Three envelope curves, each corresponding to individual cycles, were constructed.

The parameters of the bilinear curve were determined using the following procedure. The first step was the evaluation of the elastic stiffness. The elastic stiffness  $k_{el}$  was obtained by drawing the secant to the experimental envelope at 70 % of  $V_{max}$  relative to the displacement  $\delta_{cr}$  for which the development of the first cracks was expected:

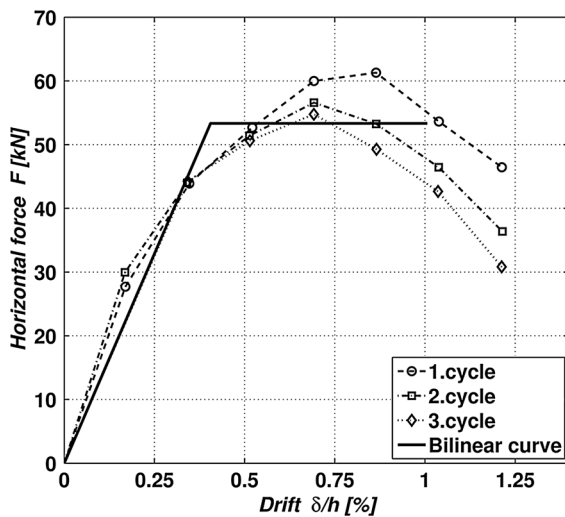
**Fig. 8** Bilinear curve and envelope curves of the individual cycles of an unstrengthened adobe wall

The graph in Fig. 8 represents the envelope of the loops for each loading cycle together with their approximation to an idealised bilinear curve. The differences between the points on the envelope curves, corresponding to the same drift, pointed out a horizontal force degradation. In general, the force necessary to achieve the same drift decreased with the recurrence of the loading cycle. When the differences in the drift start to increase, this can be considered as

the starting point of significant structural change, i.e. the first damage. Even though adobe is in general a brittle material, the horizontal part of the resulting bilinear curve demonstrated a slightly ductile behaviour.

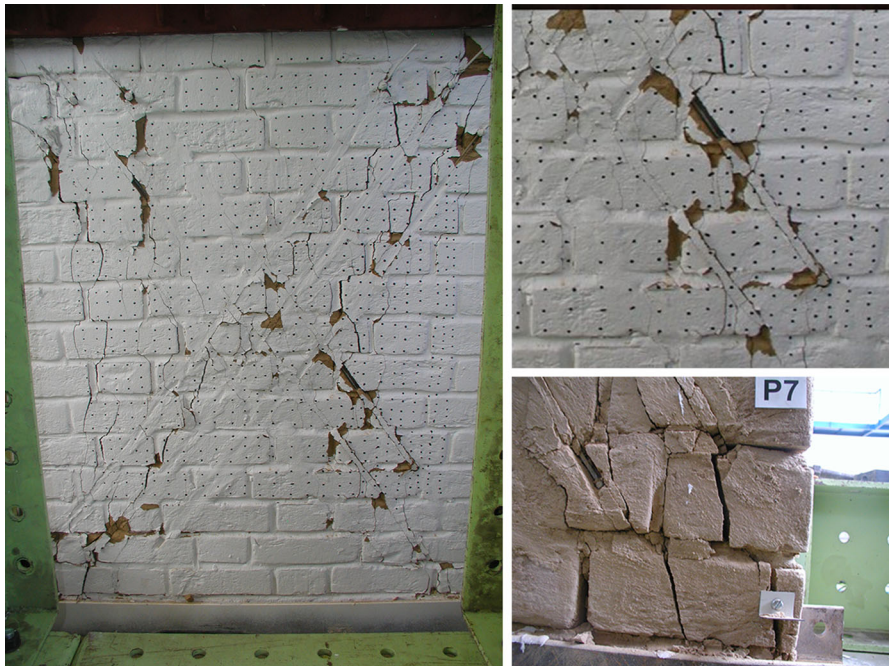
**Fig. 11** Crack pattern (left), the out-of-plane deviation of the steel wire ropes (top right) and the damage of the corner (bottom right) near the rope anchor of a strengthened adobe brick wall

of the ropes away from their grooves (as can be seen in Fig. 11), thereby decreasing the area of the cross-section of the wall withstanding the load. The occurrence of this phenomenon decreased the effective thickness of the wall and promoted the development of the major shear cracks along the diagonals. Although the ropes are still partially active, the mechanism of the transfer of forces is changed and the main stresses are transferred back onto the wall itself, following its diagonals. This, together with its decreased effective thickness—taking into account the empty grooves—initiated the development of the major diagonal shear cracks. The process of out-of-plane movement of the ropes and the above mentioned

weakening also contributed to the rapid failure of the whole specimen.

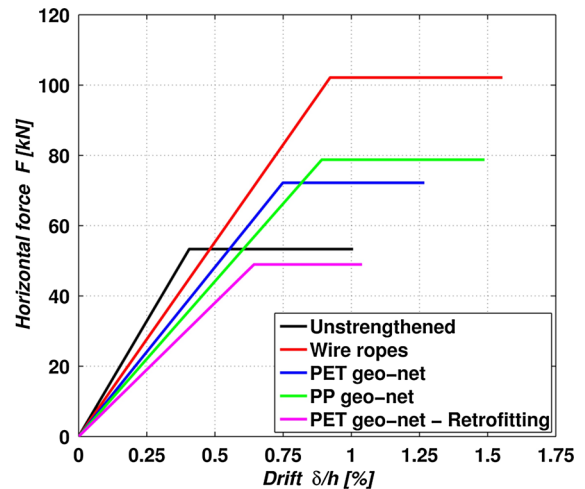
**Fig. 15** Comparison of bilinear curves of all adobe walls

Figure 15 compares the bilinear curves of all tested adobe walls, showing the efficiency and the impact of each particular intervention on the elastic as well as the plastic region.

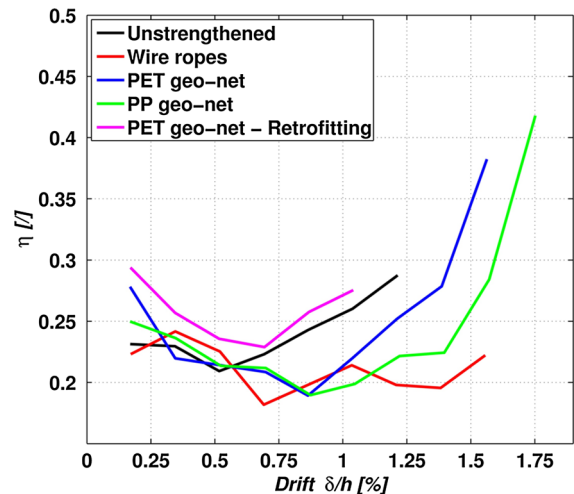
**Fig. 17** Loss factor  $\eta$  of adobe walls as a function of drift

The loss factors  $\eta$  of all tested walls, representing damping capacity per unit angle of the cycle, showed similar trends with increasing top wall drift, see Fig. 17. The loss factor decreased slightly until the first significant damage occurred. Subsequently the damping increased, especially due to the friction in the cracks. This characterised the whole loading process until the total collapse of the specimens. The only

exception was that of the intervention using steel ropes, for which the loss factor remained almost constant during the whole loading process due to a more effective redistribution of the tension forces in the wall body. In this case the tension forces were transferred to the ropes and fewer cracks (i.e. friction surfaces) were generated before the sudden collapse. As a result, the damping was lower than that of the unstrengthened specimen even after suffering the first considerable damage. The application of the geo-nets ensured integrity even after significant damage had occurred and thus achieved higher values of the loss factor at higher drifts. The geo-nets shifted the origin of the damping increase as well as the occurrence of the first visible damage, when compared with the unstrengthened wall, to a higher top wall drift values. The damping of the retrofitted wall with PET geo-nets was, for all drifts, higher than for the unstrengthened wall. The differences in lost factor were significant up to a drift of 0.75 %. Beyond this value, the loss factor was approximately equal to the factors of the unstrengthened state.

The trend of loss factor of all strengthened unfired clay brick walls follows trend of their counterparts from adobe, see Fig. 21 and compare with Fig. 17. Also in this case the application of the geo-nets ensured better integrity of the damaged wall and thus achieved higher values of the loss factor at higher drifts. The factor of the wall strengthened using wire ropes was also almost constant and was lower than for the unstrengthened specimen.

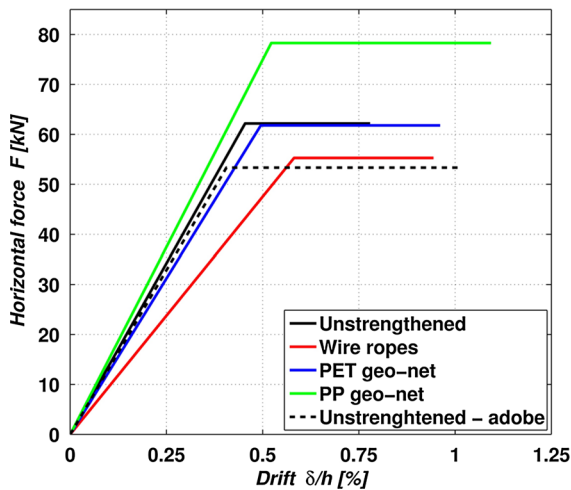
**Fig. 18** Comparison of bilinear curves of all unfired clay brick walls

comparison with the unstrengthened adobe wall, see Fig. 18. This supports the assumption of the adobe being a more plastic or ductile material. The construction of the bilinear curve from envelope curves is displayed in Fig. 19. Additionally, the actual stiffness of the unfired clay brick wall, obtained from the slope of the hysteresis loops, decreased with increasing top wall drift, see Fig. 20. The actual stiffness was almost the same as of the adobe wall.

The tests on the walls with PET geo-nets and wire ropes have revealed the shortcomings of these strengthening systems. The importance of a secure connection between the inserted or attached strengthening elements and the wall was confirmed. The intervention using PET geo-nets proved to be inefficient due to an insufficient number and the weak anchorage of the steel staples. During the loading process, the PET geo-nets and the plaster detached easily and quickly from the surfaces of the masonry wall and prevented the transfer of the load to the geo-nets. The behaviour of the wall under loading remained the same as in the unstrengthened case, however, the plastic range of the bilinear curve subtly increased, see Fig. 18.

compression, causing not only an inefficiency of the intervention technique but also the weakening of the cross section of the wall which resisted the loading. This resulted in a decrease of the load-carrying capacity of the wall even below that of the unstrengthened specimen, see Fig. 18.

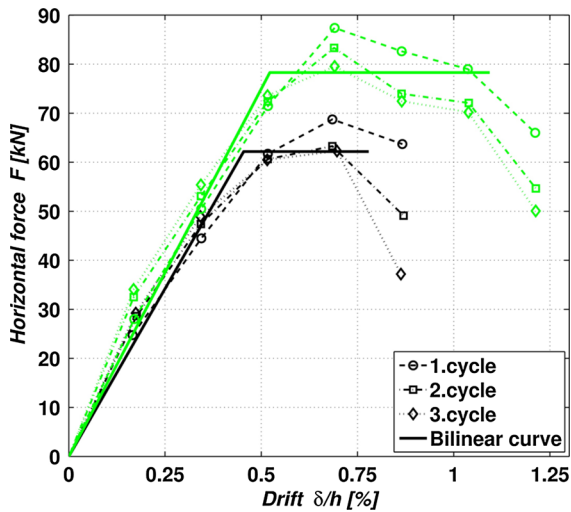
**Fig. 19** Bilinear curve and envelope curves of the individual cycles of unstrengthened (black) and strengthened (green) unfired clay brick walls using PP geo-nets. (Color figure online)

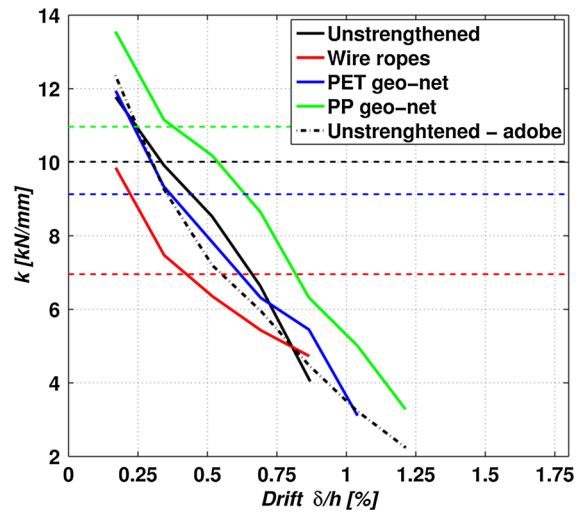
**Fig. 20** Decrease of actual stiffness of tested unfired clay brick walls with increase of their drift (*horizontal dashed lines*—the equivalent elastic stiffness of bilinear curves of these unfired clay brick wall)
