# Structural behavior of corroded RC beams with/without stirrups repaired with CFRP sheets

**Abstract** Strengthening/repair of existing reinforced concrete structures has become one of the important issues in the field of civil engineering. In reinforced concrete structures located in hot and humid areas, steel reinforcement is generally vulnerable to deterioration due to corrosion. Corrosion of reinforcement in many cases is considered the main cause of concrete structures deterioration which in turn requires large budgets for repair and maintenance. This paper presents the experimental results of damaged/repared reinforced concrete beams. The experimental program consisted of testing 12 reinforced concrete rectangular beam specimens with/without shear reinforcement and exposed to accelerated corrosion. The corrosion level was varied between 5 and 7.5 % which represents mass loss of the longitudinal steel reinforcement on the tension side. Corroded beams without shear reinforcement were repaired by bonding longitudinal carbon fiber reinforced polymer (CFRP) sheets to the tension side in addition to external U-shaped CFRP sheets to restore the strength loss due to corrosion. Corr

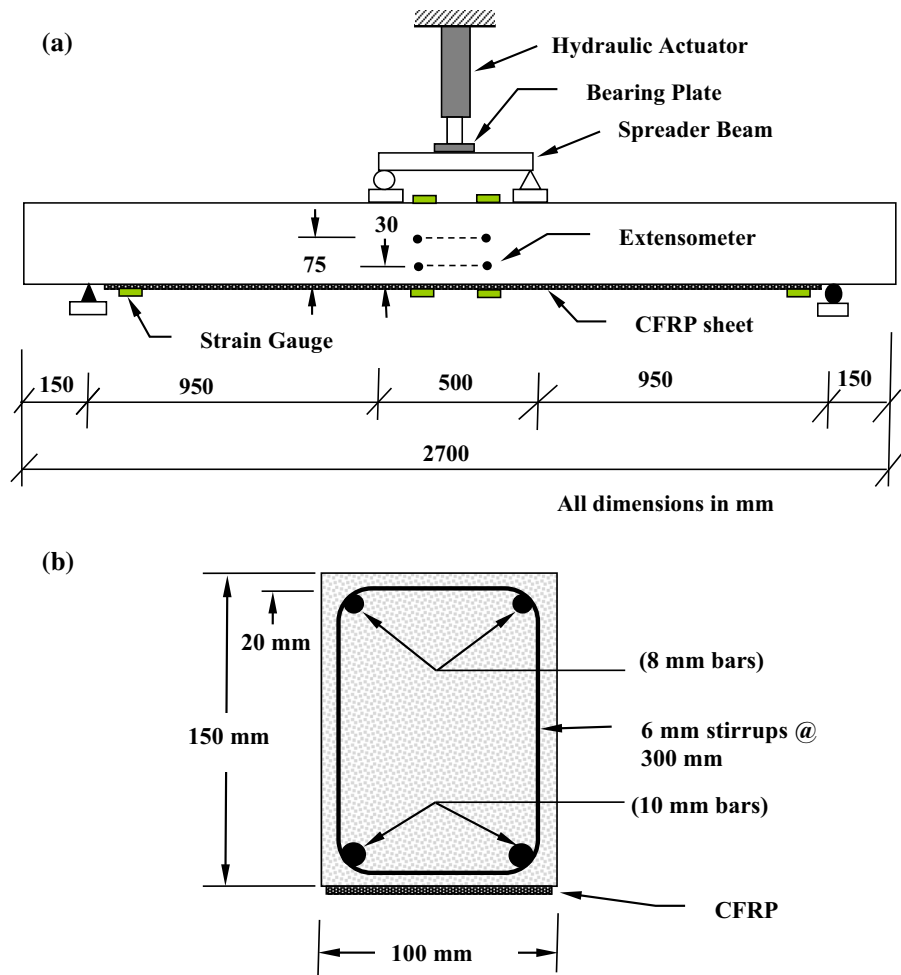
**Fig. 2** a Test setup for beams with stirrups, b cross section details

The second group (Group B) consisted of 5 reinforced concrete beams with stirrups as summarized in Table 1. All beams were reinforced with two straight 10 mm diameter bottom bars (tensile reinforcement) and two 8 mm diameter top bars to hold the stirrups as shown in Fig. 2. The clear concrete cover was 20 mm on all sides of the cross section. For stirrups, 6-mm diameter epoxy coated plain bars spaced at 300 mm c/c were used within the shear span. The stirrups were epoxy coated to insure they will not get corroded during accelerated corrosion process of the tensile reinforcement. In Group B, Beam BC0 was a control beam with no corrosion, while beams BC5 and BC7.5 were subjected to accelerated corrosion with 5 and 7.5 % corrosion (mass loss in tensile reinforcement). Beams BS5 and BS7.5 were strengthened by applying CFRP sheet at the bottom of the beam only.

All specimens were loaded in four-point loading (see Figs. 1 and 2). The load was applied using a 250 kN hydraulic actuator through a spreader steel beam to the specimen. Four linear variable displacement transducers (LVDTs) with a range capacity of 100 mm were used to measure the quarter lines and mid-span deflections of the beam during testing; two electrical strain gauges (60 mm long) at the top of the beam to measure the concrete strain and two extensometer of gauge length of 200 mm and range capacity of  $\pm 5$  mm was used to measure the side strain of concrete. For beams strengthened with longitudinal CFRP sheets four electrical strain gauges (6 mm long) were installed along the centerline of CFRP sheet.

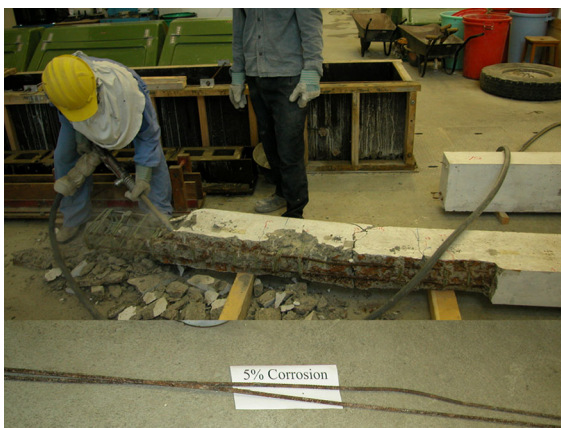
**Fig. 4** Extracting the corroded bars after the test for evaluation of the actual mass loss

Following the experimental tests of the beams, the actual mass loss due to steel reinforcement corrosion was measured using bars that were extracted from the corroded beams (see [Fig. 4](#)). The procedure given in ASTM standard G1, designation C.3.5, was used for the mass loss analysis [31]. Six bar coupons 250 mm in length were taken from the corroded bottom bars of each corroded beam. The coupons were taken at random from both of the corroded bars in each beam since the corrosion was assumed to be uniform along the entire length of the beam. Bar coupons from the control beams were used as a reference. [Table 2](#)

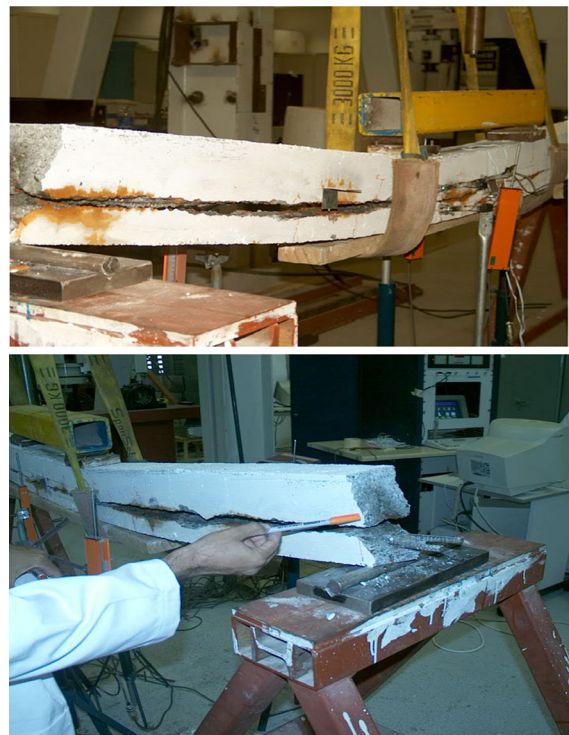
**Fig. 6** Bond failure of beam AC5&AC7.5

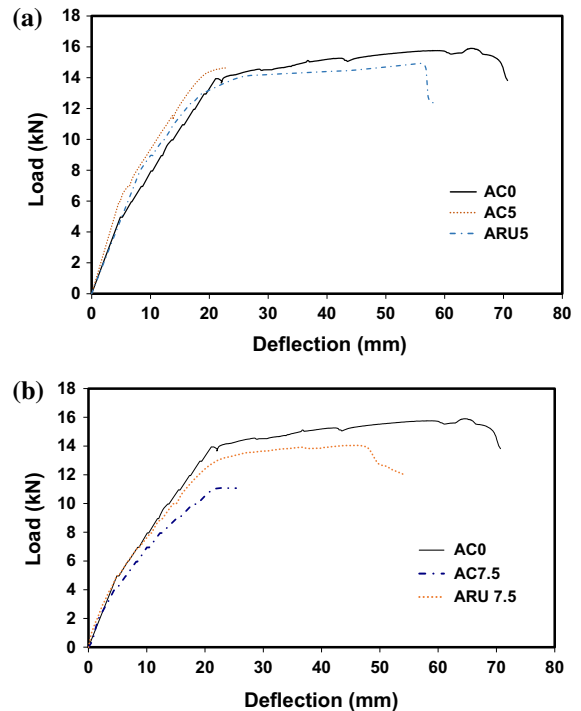
**Fig. 8** Effect of CFRP U-wrap strips on beams without stirrups. **a** Beams with 5 % corrosion. **b** Beams with 7.5 % corrosion

Attaching U-shaped CFRP strips on corroded beams without stirrups changed the mode of failure of the repaired beams. Figure 8 illustrates the effect of U-shaped CFRP repair on the corroded beams without

stirrups. Adding U-shaped sheets improved the strength by attaining higher ultimate load and improved ductility indicated by higher maximum deflection at failure. This is observed from the response of beams ARU5 and ARU7.5 which failed by crushing of concrete compared to a brittle failure observed in beams AC5 and AC7.5. The maximum deflections were increased by 59 % and by 48 % in beams ARU5 and ARU7.5 compared to beams AC5 and AC7.5, respectively due to the CFRP repair. Figure 9 shows locations of U-shaped CFRP sheets and corresponding locations of strain gauges. Strain was measured along the U-shaped CFRP sheet (i.e. transverse the beam axis). The change of strain in the U-shaped CFRP sheets in beam ARU5 is shown in Fig. 10; strain in FRP2 is higher than in FRP1 since FRP2 sheet is located in the shear span where stirrups are needed most. FRP2 sheet provided the anchoring force as observed from the increase in the strain at higher applied loads indicating the effectiveness of externally attached CFRP U-shaped strips. FRP3 was located next to the support and as such was subjected to minor strain since the deformations are small near

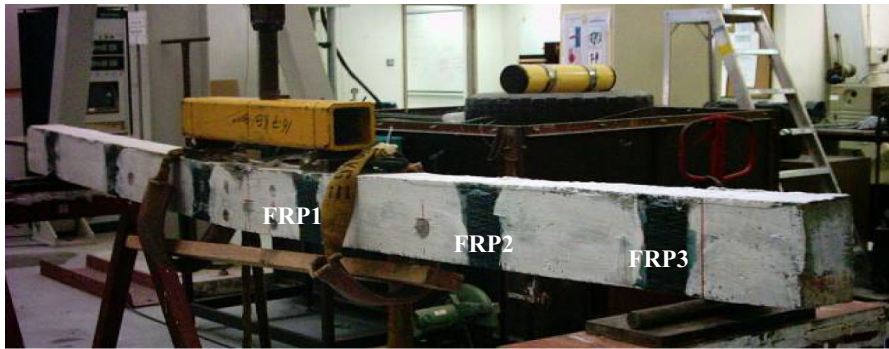
**Fig. 9** Locations of strain gauges in the U-shaped CFRP sheets

Strain gauges were also installed at the mid-height of the U-shaped CFRP sheets along the vertical direction (i.e. transverse to the beam axis). All beams were tested to failure using displacement control with a rate of 0.3 mm/min.

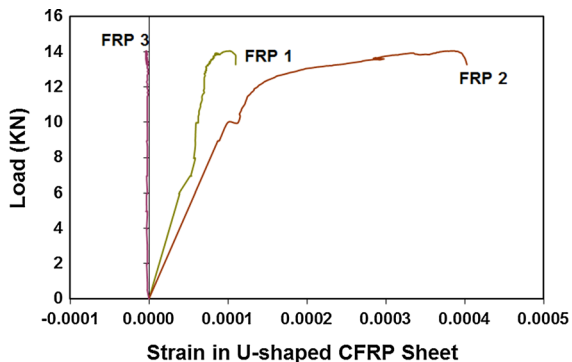
**Fig. 10** Strain in the U-shaped CFRP sheets in beam ARU5

the support and also the compressive force provided by the support reaction provided an anchoring action which reduced the stress from the U-shaped CFRP sheet near the supports.

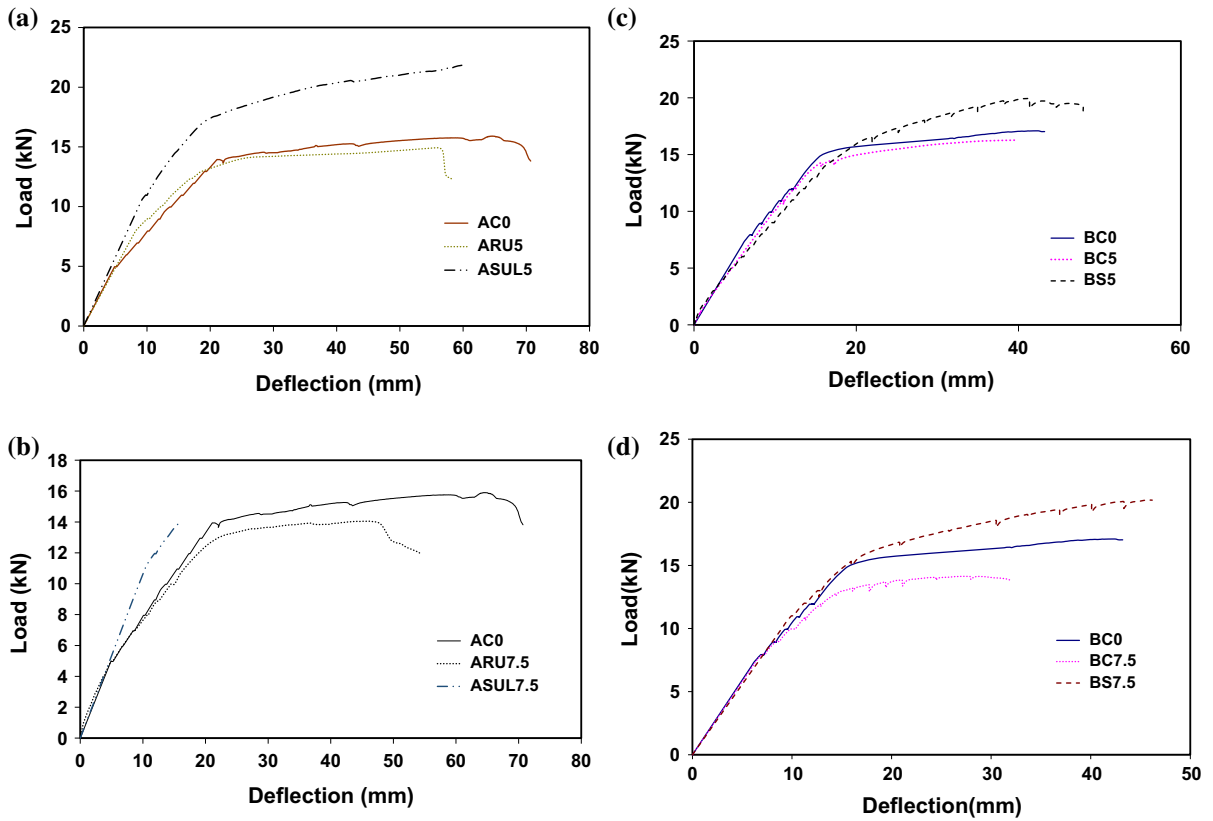
Fig. 11 Effect of CFRP sheet strengthening: a, b beams without stirrups; c, d beams with stirrups

The load deflection curves for strengthened beams without stirrups are shown in Fig. 11a, b, while strengthened beams with stirrups results are shown in Fig. 11c, d. Adding CFRP sheet and U-shaped sheets to strengthened corroded beams without stirrups increased both ultimate load and stiffness of the repaired beam. The ultimate load of beam ASUL5 was increased by about 37 and 47 % compared to the uncorroded control beam AC0 and the corroded beam ARU5, respectively. Adding the CFRP sheet delayed the cracking of the concrete and enhanced the stiffness of the beam as may be

observed from the load vs. deflection curve shown in Fig. 11a. An increase in stiffness by about 25 % in beam ASUL5 compared to the control uncorroded beam AC0. Beam ASUL5 failed by crushing of concrete after a large deflection beyond the yielding load.

Strengthened beams with stirrups (Fig. 11c, d) attained higher ultimate loads compared to the corroded and control beams, but the stiffness was almost unchanged. Beam BS5 strengthened by CFRP sheet at the tension side was able to sustain load higher than beam BC0 and beam BC5 by 3 and 9.5 %, respectively. The yield load was also higher in the strengthened beam BS5 than both control beams (BC0 & BC5). Beam BS5 failed by CFRP rupture at mid-span which was mainly due to the opening of the horizontal corrosion crack that pushed the cover concrete against the CFRP sheet creating concentration of stresses on the CFRP

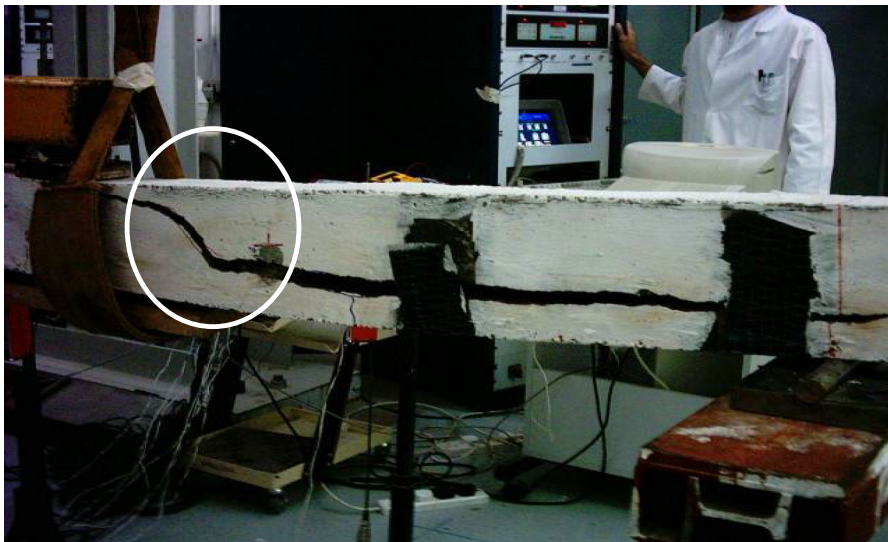
Fig. 12 Bond-shear failure of beam ASUL7.5

Following the accelerated corrosion phase, Beam ASUL7.5 was severely cracked along the reinforcement on the side where the rebars were connected to the voltage source. It is believed that more moisture penetrated the beam through the cracks from the partially immersed bar ends. This produced higher concentration of corrosion on one side of the beam. This beam failed prematurely in a brittle manner as one of U-shaped sheets debonded, the crack along the beam opened up and finally failed in bond-shear mode as shown in Fig. 12. Even though beam ASUL7.5 failed prematurely, it is observed that within the elastic range the stiffness was improved compared to beams AC0 and ARU7.5.

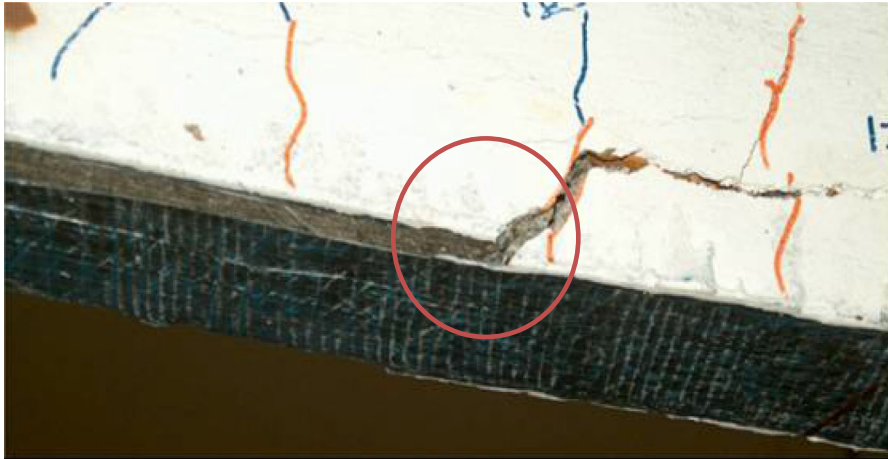
**Fig. 13** Separation of concrete cover and CFRP in beam BS7.5

sheets. The ultimate load of beam BS7.5 reached 20 kN which is 18 and 43 % higher than ultimate loads of beams BC0 and BC7.5, respectively. Failure of beam BS7.5 was initiated by the separation of concrete cover where flexural cracks (vertical) crossed the corrosion cracks (horizontal) along the reinforcing bars. The CFRP sheet was pushed away from the beam surface (partial debonding), but finally failed by rupture at the tip of the cracked area (see Fig. 13).
