Failure of Large-Diameter Steel Pipe with Rolling Scabs

V. N. Shinkin

Moscow Institute of Steel and Alloys, Moscow

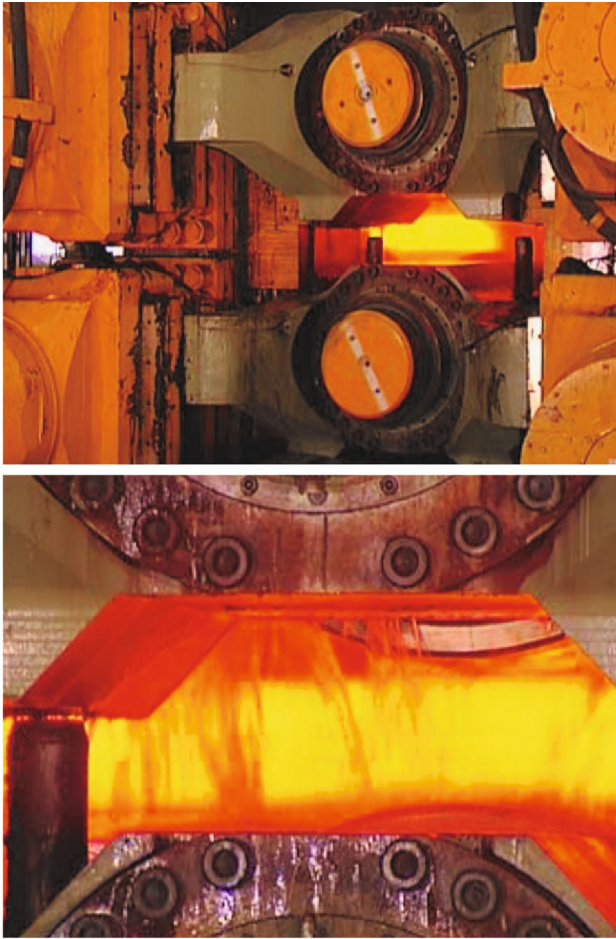
Fig. 1. Hot steel strip between rollers in a mill.

A scab is a surface defect of steel sheet in the form of an irregular dark spot produced by the rolling of a metal fragment welded to the slab on account of a casting error or adhesion during hot rolling (Fig. 1) [12, 17].

deformed in hot rolling together with the sheet (Fig. 1).

In our view, the dimensions and shape of the hole running through the wall of the ruptured pipe indicate that the scab and scratch may be formed when a hexagonal M12 nut (State Standard GOST 5915–70; width 19 mm; diagonal 21.94 mm; thickness 10 mm) or M14 nut (State Standard GOST 5927–70; width 21 mm; diagonal 24.25 mm; thickness 11 mm) falls onto the surface of the steel sheet in hot rolling (Fig. 1).

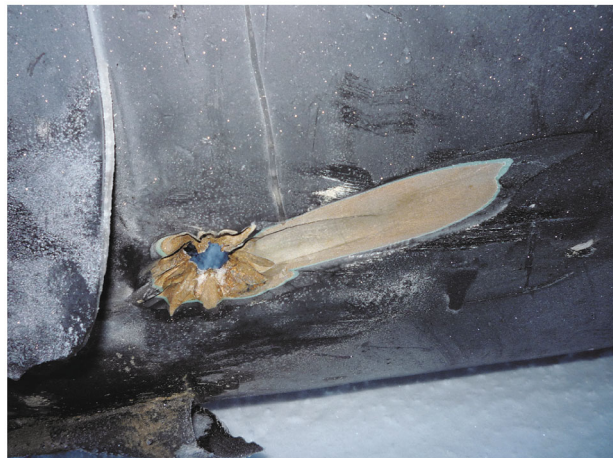
In Fig. 3, we show a steel pipe from a transfer pipeline with a defect that passes through the entire exterior wall. The working pressure when the accident occurred was $p^{ru} = 4.4$ MPa (59% of the design pressure of 7.5 MPa). The characteristics of the pipe are as follows: strength class K60; diameter 720 mm; wall thickness 11 mm; length 11.59 m; and mass 2.251 t. The pipe has a three-layer external insulating coating. The steel sheet for the pipe was produced by controlled rolling.

Fig. 3. Scab on the outer surface of a pipe.

Given that the working gas pressure of the pipe at rupture was 4.4 MPa ($4.4/20.9 = 21\%$), while the defect was so large as to be visible to the naked eye (110×50 mm), we conclude that ultrasonic monitoring and hydraulic testing of the pipe at the manufacturing plant must be improved.

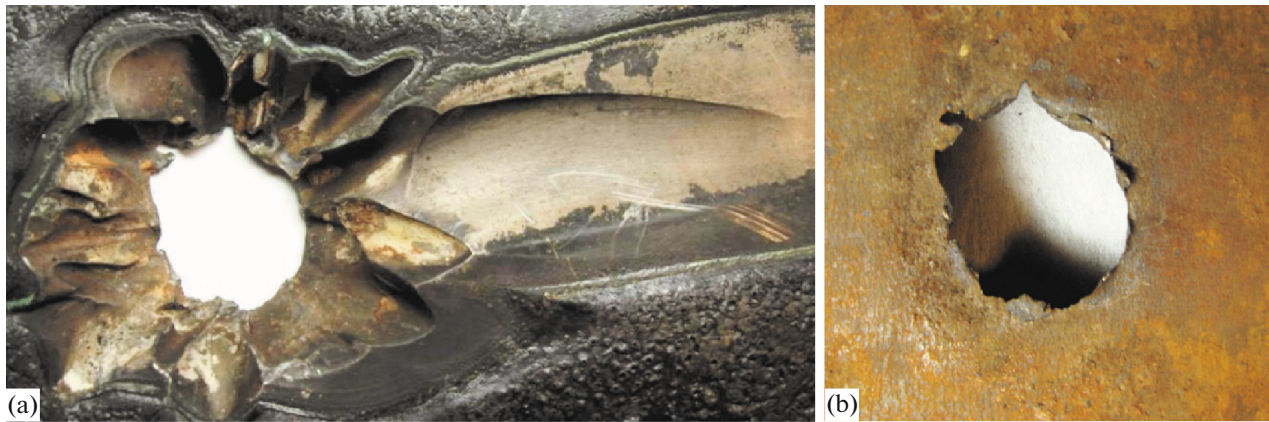
The scab and scratch correspond to local thinning of the pipe wall (dimensions 110 × 50 mm). With loss of sealing of the pipeline, the scab falls out, to form a hole passing through the entire wall (dimensions 20 × 25 mm), as shown in Fig. 4. The lost material has not been found. The smooth and undulatory surface of the defect shows that it is formed at a temperature comparable with the melting point of the sheet and is

Fig. 4. Failed pipe: scab on external surface (a) and hole penetrating the wall to the inner surface (b).

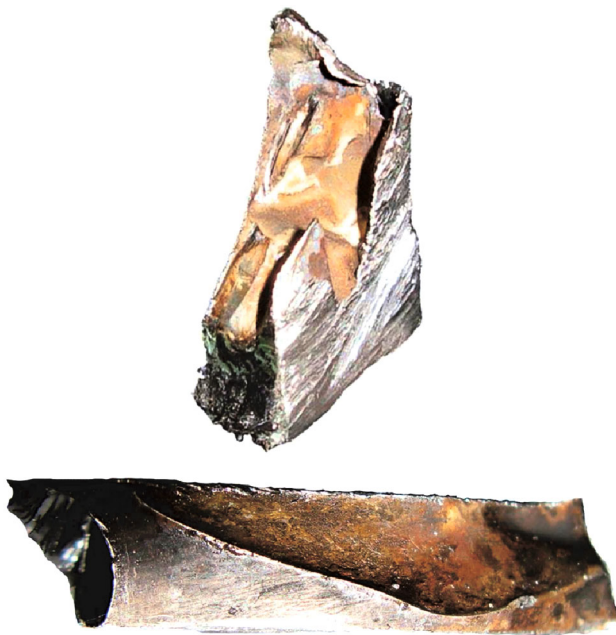
The first sample is cut at the defect site in the plane transverse to the rolling direction (Fig. 5). The banding of the pearlite over the sample cross section is non-uniform. Local distortion of the pearlite banding is observed at the sample surface adjacent to the defect. Such structural distortion indicates that the defect was formed in hot deformation in the course of rolling. In view of the lack of pronounced bending over the length of the defective section and also its shape, we conclude that the defect is deformed in rolling together with the sheet.

The second sample is cut at the defect site in the plane parallel to the rolling direction (Fig. 5). Local distortion of the pearlite banding is observed.

Fig. 5. Samples cut at the defect site, transverse (top) and parallel (bottom) to the rolling direction of the steel sheet.
