A Microstructural Study of the Thermal Fatigue Failures of 60Sn-40Pb Solder Joints

D. FREAR,* D. GRIVAS,** J. W. MORRIS, JR**

Key words: Sn-Pb solder, microstructure, low cycle thermal fatigue

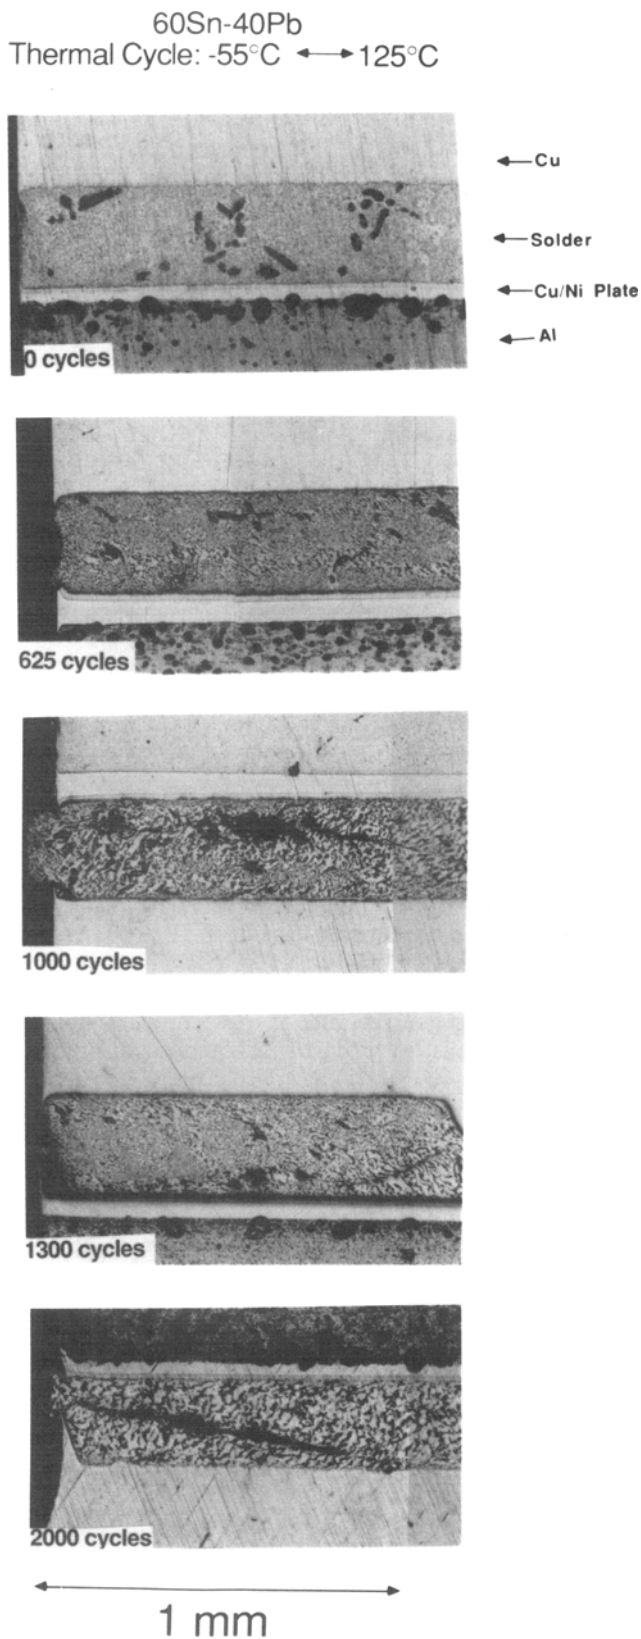
Thermal fatigue specimens, shown in Fig. 1 with 10 mil thick 60Sn-40Pb joints, were thermally cycled between $-55°$ and $125°$ C up to 2000 cycles. The optical microstructure of these joints as a function of number of cycles is shown in Fig. 3. An interesting development in the microstructural evolution was found to occur after 625 cycles, the microstructure in the bulk solder heterogeneously coarsens parallel to the direction of shear in the regions of high shear strain at the ends of the specimen. This is shown clearly in Fig. 4 which is a specimen after 684 thermal cycles. Both the Pb and Sn-rich phases coarsen. The coarsened Pb-rich phase is devoid of Sn precipitates. The coarsening is not associated with the Cu/solder interface, heterogeneous coarsened regions occur anywhere from near the interface to the center of the joint. The coarsened regions show no preference to form either on the Cu or Al side of the joint. The coarsened regions initially are very thin but gradually increase in width as the number of cycles increases.

After 1000 cycles cracks develop in the heterogeneous coarsened region of the solder, Fig. 3. These cracks are found to occur only within the hetero-

Fig. 3 — Optical microstructure cross sections of 60Sn-40Pb/Cu joints as a function of the number of cycles between −55° and 125° C.

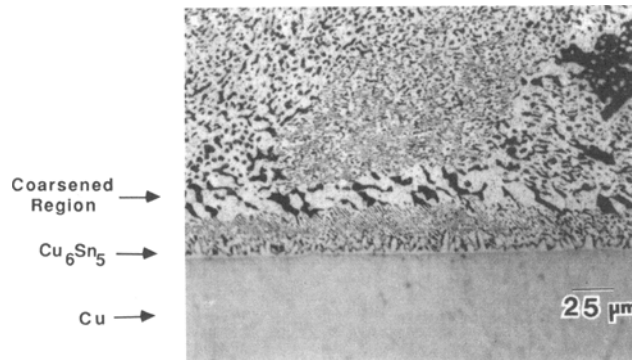
Fig. 4 — Optical microstructure cross section of a 60Sn-40Pb/Cu joint after 684 cycles between −55° and 125° C revealing the heterogeneous coarsened region.

The cause of the initial heterogeneity appears to be associated with the boundaries between the eutectic Sn-Pb colonies within the solder joint. The boundary between the colonies consists of Sn and Pb-rich phases that are initially, on solidification, coarser than the rest of the microstructure. Therefore the boundaries are the weakest portion of the microstructure and the strain concentrates there. Further coarsening is also facilitated because the regions adjacent to the coarsening are fine and redistribution of Pb and Sn is easy, Fig. 4.

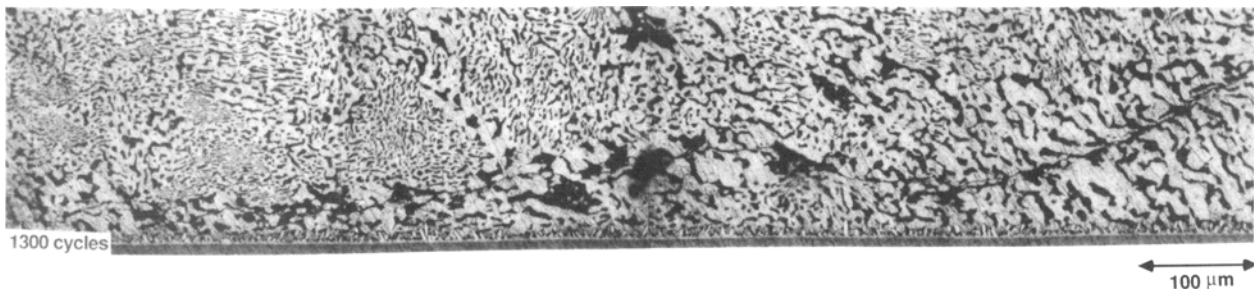
geneously coarsened regions of the solder joint, as shown in Fig. 5. The crack follows the coarsened region as it tails down from right to left across the joint. The cracks occur through the Sn-rich regions or at the interface between the Sn-rich and Pb-rich regions. This is clearly shown in the polarized optical micrographs in Fig. 6 of the specimen after 1300 cycles. The cracks occur though the Sn-rich regions at Sn-Sn grain boundaries. In polarized light different Sn grains show variations in contrast and cracks are observed between these variations in contrast. The crack propagate through Pb-rich regions so as to join failed Sn-rich regions. The Sn grains observed in the polarized micrographs are about 3 µm in diameter. The Sn grain size of the as-solidified solder is 0.44 µm, shown in the TEM micrographs of Fig. 7. The Sn grain size for bulk solder aged at 125° C for 167 hrs (which is equivalent to 2000 cycles with a 5 min hold time) coarsened to 1.3 µm, as shown in the TEM micrograph of Fig. 8. The Sn grains in the highly strained coarsened regions therefore grow larger than expected for thermal aging alone.

Fig. 5 — Optical microstructure cross section of a 60Sn-40Pb/Cu joint after 1300 cycles between −55° and 125° C showing a crack in the coarsened region.

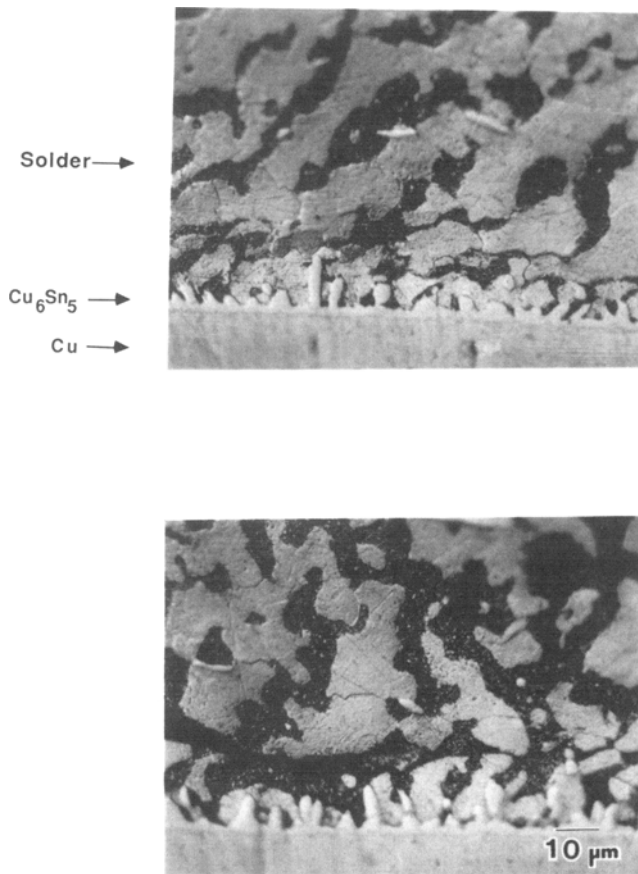
Fig. 6 — Polarized optical microstructure cross section of a 60Sn-40Pb/Cu joint after 1300 cycles. Intergranular cracks through the Sn rich phase are shown.

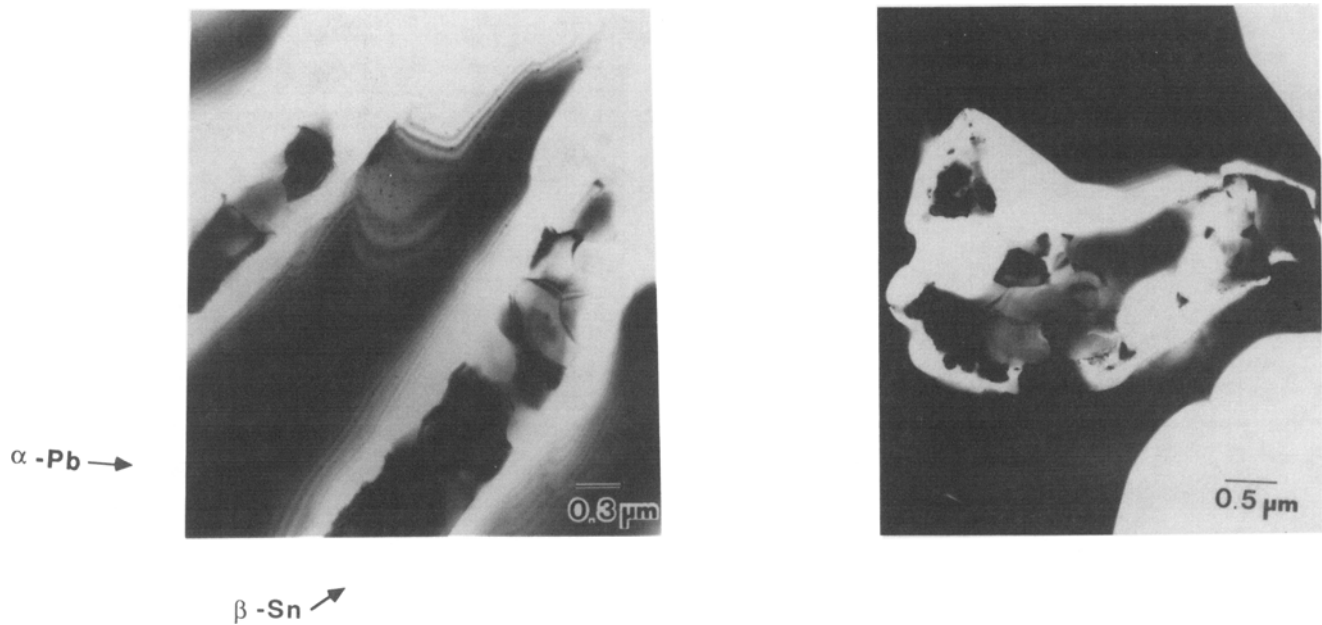
Fig. 7 — TEM bright field image of polygranular β-Sn in lamellar and globular regions in 60Sn-40Pb.

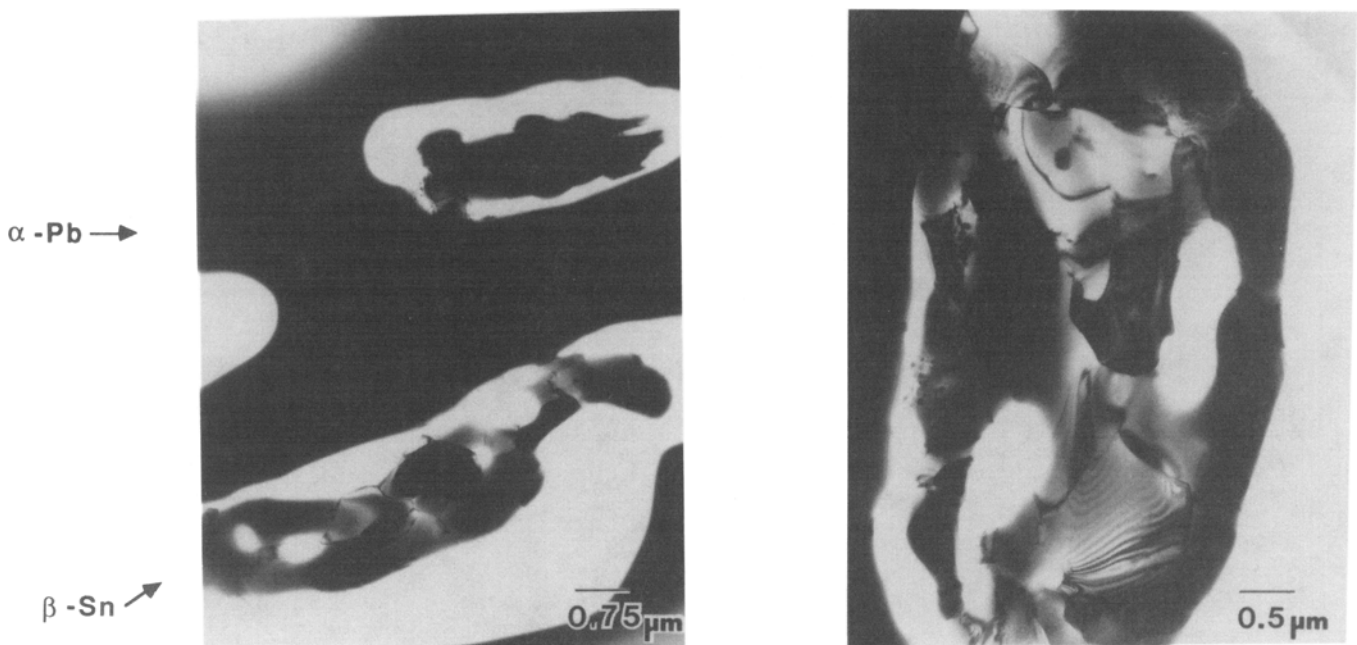
Fig. 8 — TEM bright field image of polygranular β-Sn after 167 hours at 125° C illustrating Sn grain growth.

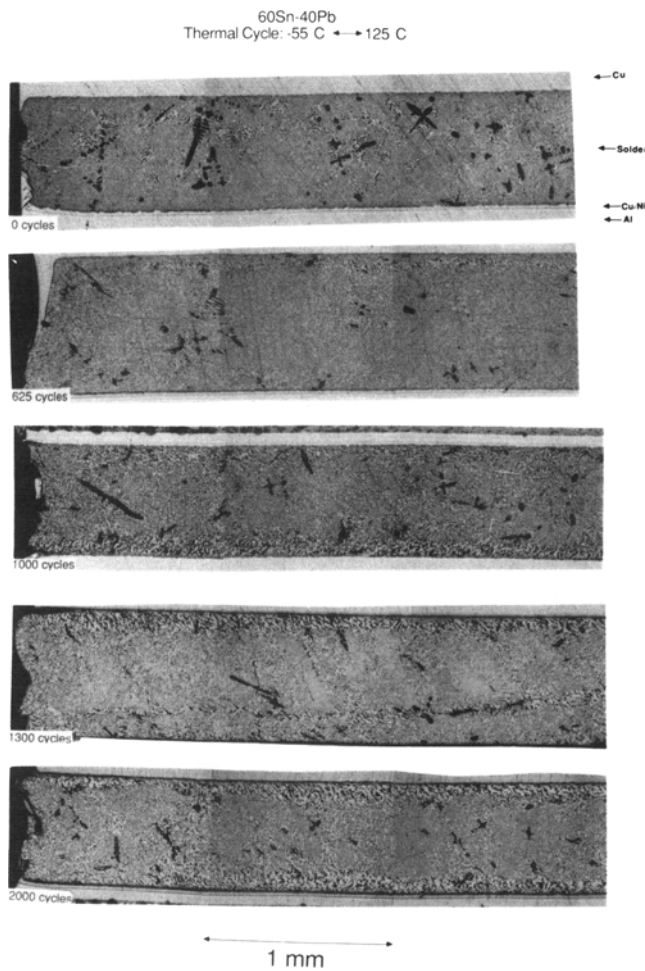
To determine the effect of joint thickness 60Sn-40Pb solder joint specimens of 20 mil thickness were also thermally cycled between −55 and 125° C. By doubling joint thickness the shear strain was halved to 10%. The results of this experiment are shown in Fig. 9. Again heterogeneous coarsened regions develop throughout the solder. After 1000 cycles multiple coarsened regions occur parallel to the shear direction. More than one heterogeneous region was observed in each sample. Despite the halved strain the joints fail, through the coarsened region, after 1000 cycles. This is the same as for the 19% shear strained samples. The failures again occur through the Sn-rich regions in an intergranular fashion.

Fig. 9 — Optical microstructure cross section of a 20 mil (0.51 mm) thick 60Sn-40Pb/Cu joint as a function of the number of thermal cycles between −55° and 125° C.

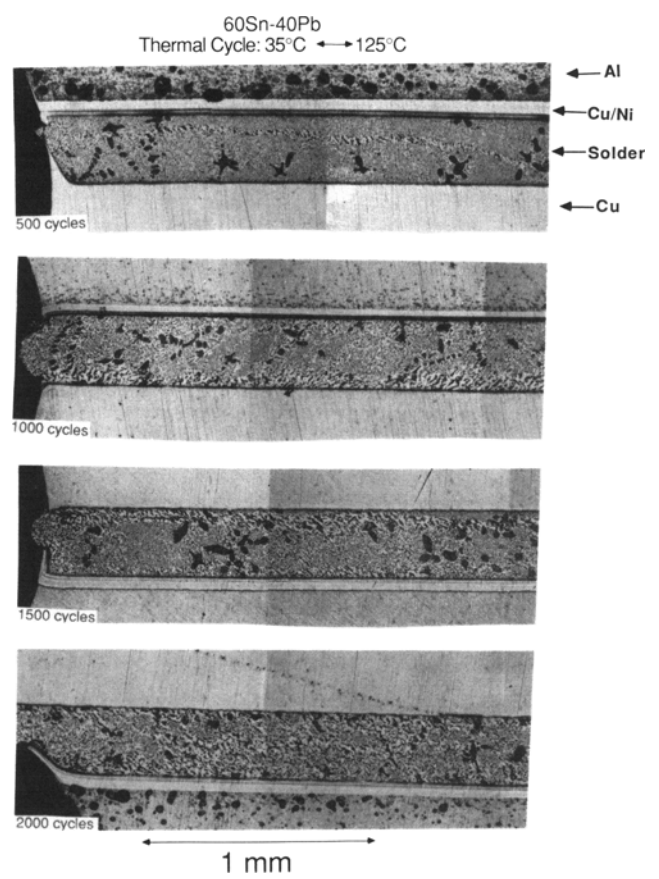
The optical microstructure of the 60Sn−40Pb joints as a function of the number of cycles between 35 and 125° C is shown in Fig. 10. After 500 cycles the heterogeneous coarsened region develops in the center of the solder joint, in a fashion identical to that found for the full −55 to 125° C thermal cycle.

Fig. 10 — Optical microstructure cross sections of 60Sn-40Pb/Cu joints as a function of the number of cycles between 35° and 125° C.

Both high (35 to 125° C) and low (−55 to 35° C) temperature thermal cycles were detrimental to the fatigue life of 60Sn-40Pb solder joints. The high temperature cycling coarsened and failed in a manner identical to that for the full −55 to 125° C cycle, Fig. 10. This indicates that the coarsening and fail-

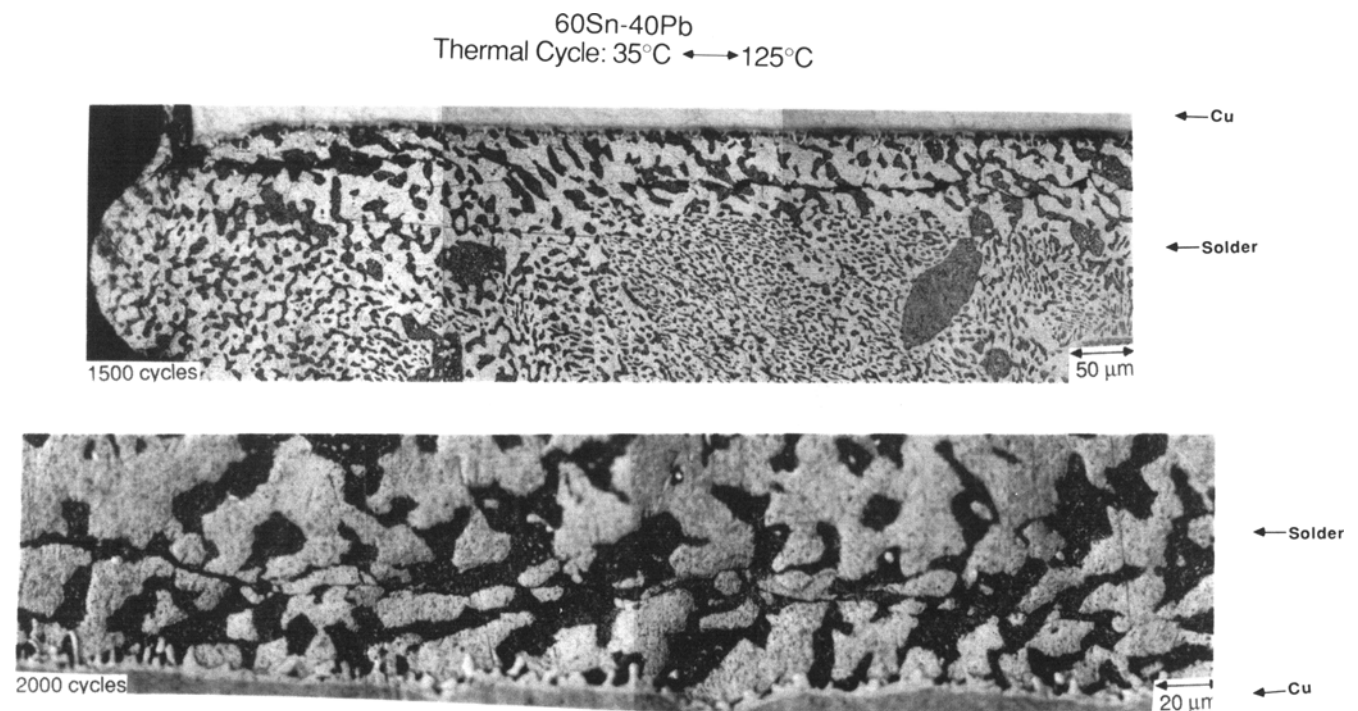
cycles. A higher magnification of these cracks is shown in Fig. 11. The cracks preferentially occur through the Sn-rich phase or at the interphase boundaries. Cracking occurs in the Pb-rich phase only when a path through the Sn is not available. The similarities between the full thermal cycle and the high temperature cycle indicate that coarsening and cracking is dependant on strain at elevated temperatures.

Fig. 11 — Optical microstructure cross sections of 60Sn-40Pb/Cu joints after 1500 and 2000 cycles between 35° and 125° C revealing cracks through the coarsened regions.

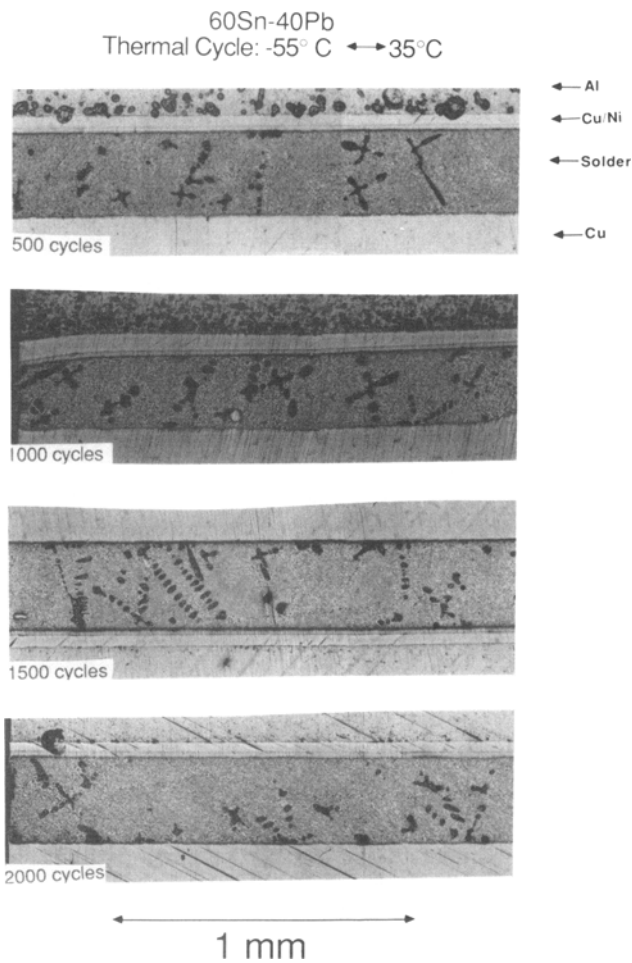
• *−55° C to 35° C.* Cycling between −55 and 35° C examined the behavior of the solder joint at the low temperature portion of the thermal cycle. Figure 12 shows the optical microstructure of the joint as a function of cycles between −55 and 35° C. Heterogeneous coarsening is not as extensive for this low temperature cycling. However, a very thin heterogeneously coarsened region in the solder does develop after 1500 cycles. This coarsening is shown clearly in Fig. 13 for the sample after 1500 thermal cycles. A coarsened region develops both parallel to the shear direction and between columnar cells of the solder. Cracks develop in the thin coarsened regions, after 1500 cycles, and the cracks run through the Sn-rich regions or at interphase boundaries. Cracks were only observed within the coarsened regions.

Fig. 12 — Optical microstructure cross sections of 60Sn-40Pb/Cu joints as a function of the number of cycles between −55° and 35° C.

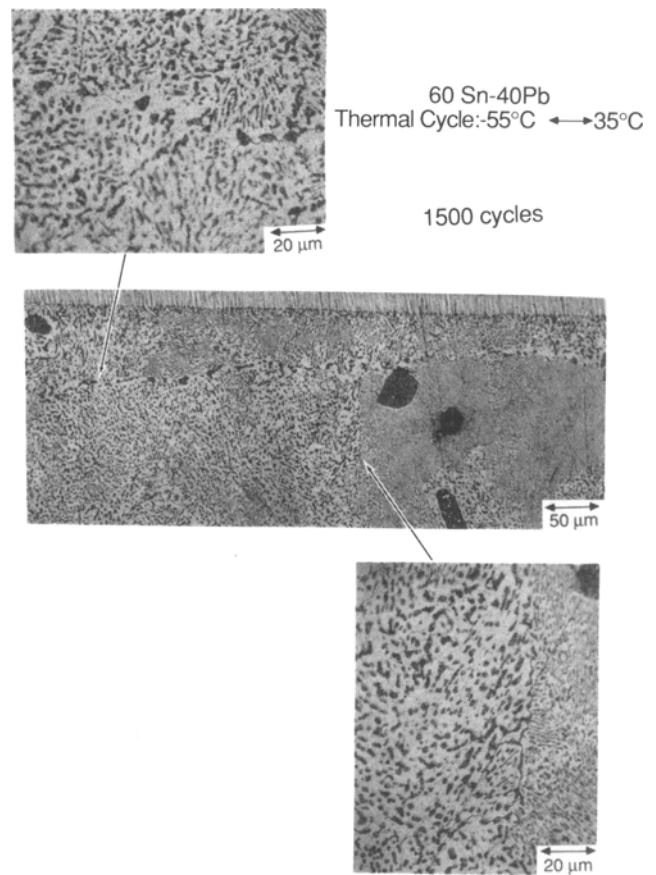
Fig. 13 — Optical microstructure cross section of a 60Sn-40Pb/Cu joint after 1500 cycles between −55° C and 35° C revealing a thin coarsened region and cracks propagating through the Sn-rich phase in this region.

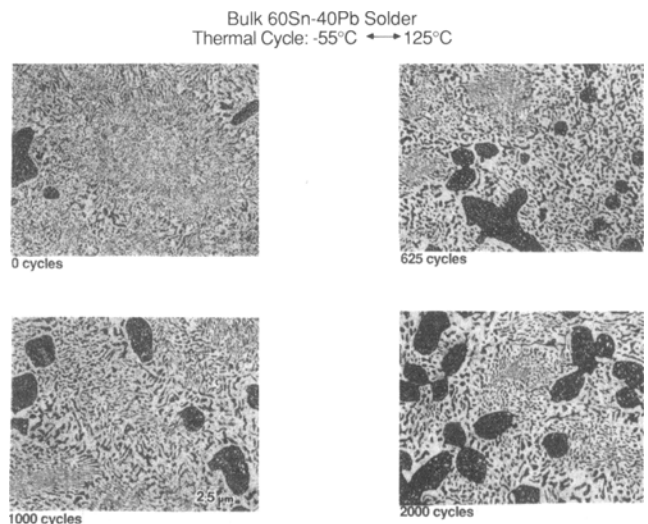
Unconstrained bulk 60Sn-40Pb solder was cycled between −55 and 125° C to observe coarsening behavior as a function of temperature alone. Optical micrographs of the solder are shown in Fig. 14 as a function of the number of cycles. Coarsening was observed to develop as the number of cycles increase. The coarsening was homogeneous in nature, both the Pb and Sn regions coarsened throughout the solder. The Sn grain size was found to be 1.3 μm from the TEM micrographs shown in Fig. 8. The Pb-rich regions remain heavily decorated with Sn precipitates ranging from 0 cycles to 2000 cycles. In heterogeneous coarsening, described previously, the

Pb-rich regions were denuded of precipitates. No cracking was observed to occur anywhere within the solder for any number of cycles. The heterogeneous coarsening and cracking is therefore a function of temperature and applied strain.

Fig. 14 — Optical microstructure of unconstrained 60Sn-40Pb bulk solder as a function of the number of cycles between −55° and 125° C.

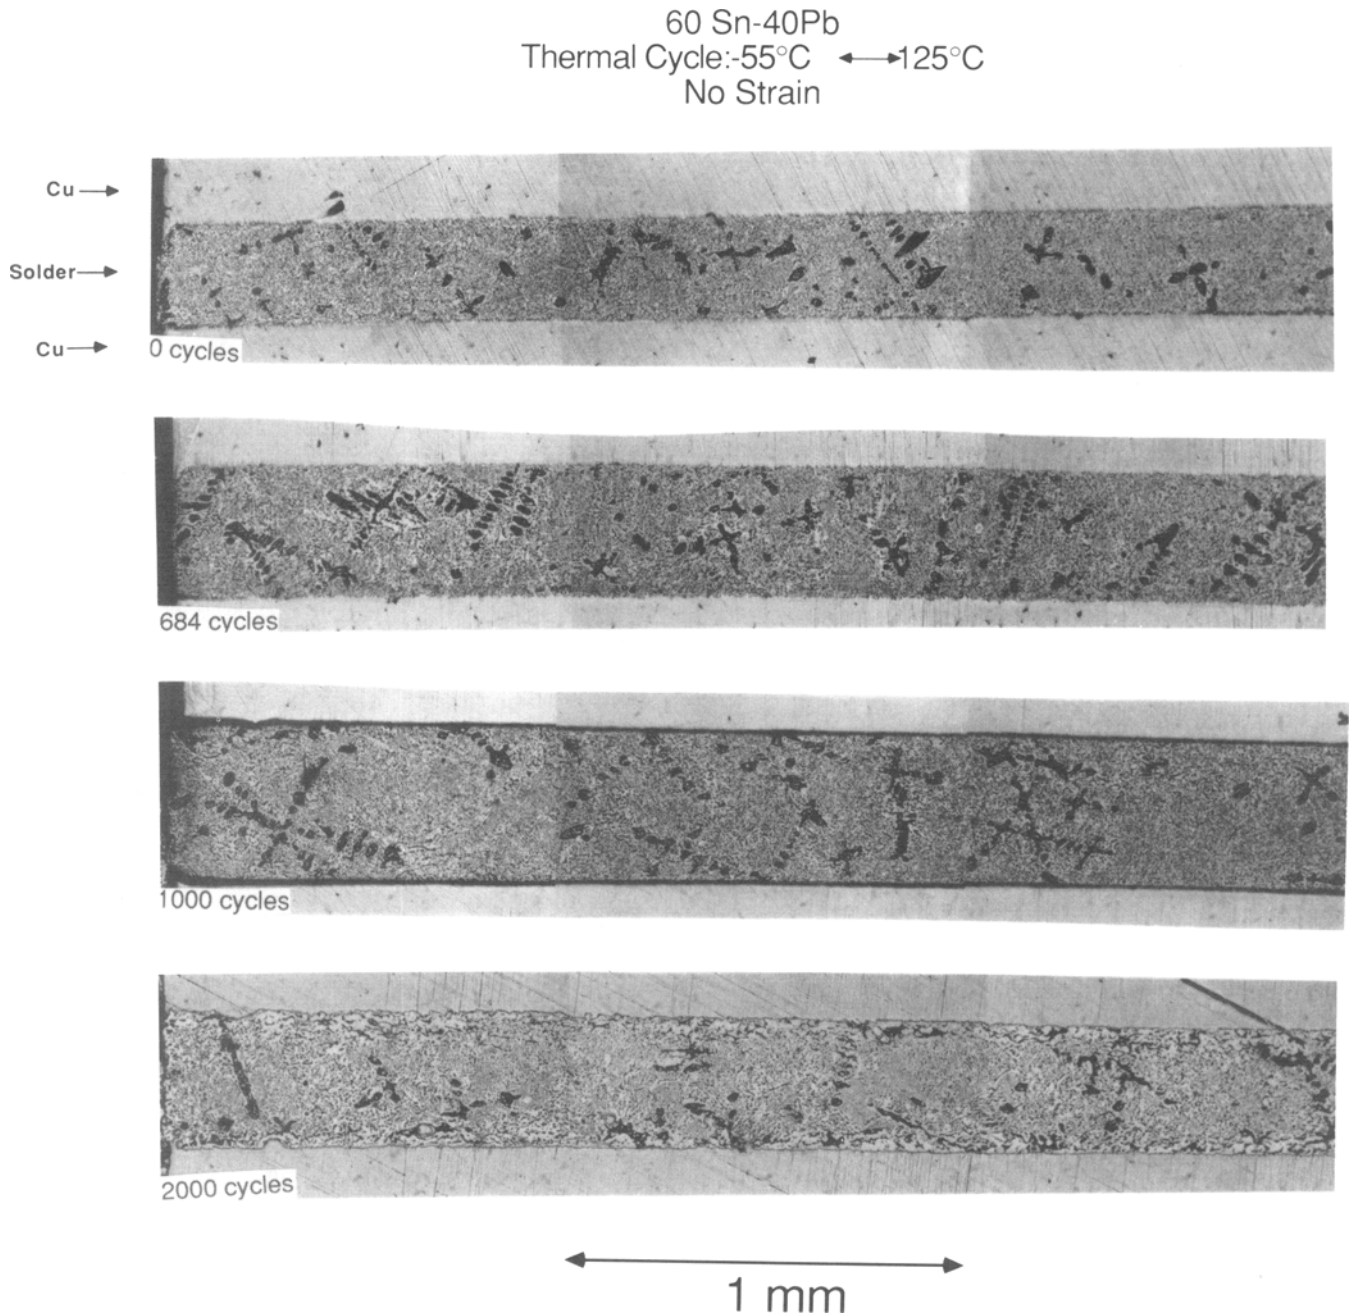
Optical micrographs of the Cu/Solder/Cu joints as a function of the number of thermal cycles is shown in Fig. 15. Heterogeneous coarsening does occur but only begins after 2000 cycles. The experiment ended after 2000 cycles and no cracks were observed anywhere within the joint. (The dark interfacial regions in the sample after 1000 cycles is

a polishing artifact of the height difference between the solder and Cu.) It is expected that cracking would eventually occur in the coarsened region given enough thermal cycles. This indicates that the difference in expansion between solder and Cu is significant to the thermal fatigue failure of solder joints. However, this effect is not as prevalent as when an externally applied strain is present (*i.e.* when the joint is constrained between Cu and Al).

Fig. 15 — Optical microstructure cross sections of Cu/60Sn-40Pb/Cu specimens as a function of the number of cycles between −55° and 125° C. Heterogeneous coarsening is found at 2000 thermal cycles.

One suggestion for eliminating thermal fatigue failures in 60Sn-40Pb joints is to match the thermal expansion coefficients of the materials joined by the solder. Besides being an expensive proposition, matching the materials only slightly delays failures. The optical micrographs in Fig. 15 show that even the difference in thermal expansion between Cu and 60Sn-40Pb solder causes heterogeneous coarsening to occur. Eventually cracks will form in the coarsened region leading ultimately to failure.
