Arch bridges subject to pier settlements: continuous vs. piecewise rigid displacement methods

Marialaura Malena · Maurizio Angelillo · Antonio Fortunato · Gianmarco de Felice [ORCID] ·
Ida Mascolo

Keywords Masonry · Arch bridge · Piecewise rigid displacement method · Finite element method

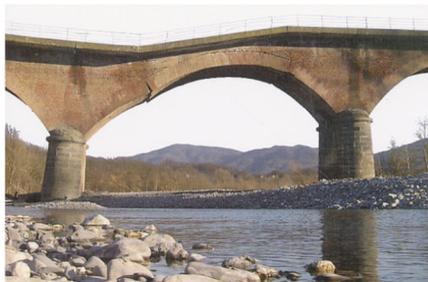
(a) Scrivia river bridge (IT, 2002) Cortesy of Camilla Torre [29]

(b) Trigno (IT, 2003) [10]

(c) Cesano river bridge (IT, 2011) [30]

(d) Rubianello bridge (IT, 2013) [12]

(e) Ballynameen Bridge (UK, 2015) [28].

(f) Bishopsford Road Bridge (UK, 2019)

Fig. 1 Recent worldwide masonry bridge failures under scour-induced settlements

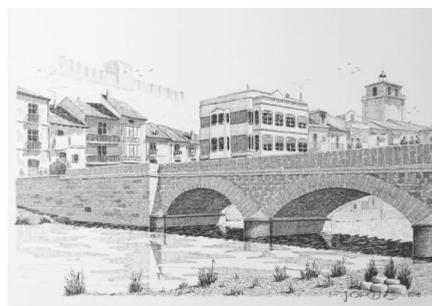
– **1883**: a big doline (i.e. a natural hollow) appeared in the riverbed leaving a significant part of the foundation poles timber unprotected and causing the settlement of the first and second piers on the side of Deba (right bank). Therefore, the foundation of the bridge piers were armored with rock rip-rap in the hope of stopping the slow, but nevertheless relentless, sliding and settlement of the piers and protect them from hydraulic stresses, and further erosion (Fig. 4). This interventions had not the expected effects (Fig. 5).
– **1892**: the first pier on the side of Deba suffered again a settlement of the foundation (0.34 m on the

Fig. 3 Historical photos of XIX century masonry bridge in the Gipuzkoa province: **a** Deba Bridge (Gipuzkoa); **b** Leona bridge (Penafiel)

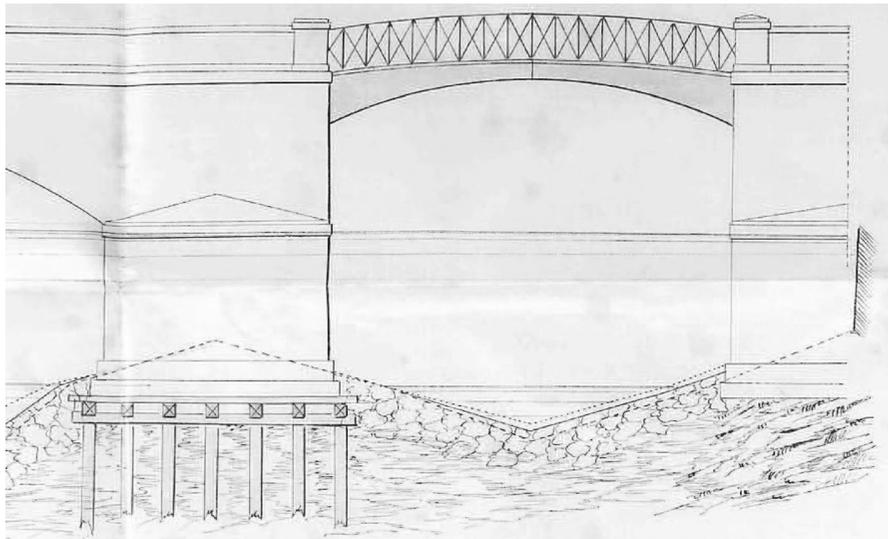
Fig. 4 Detail of the elevation drawing (from the original reparation design dated back to 1892 − 1893)

sea up side and $0.14\ m$ on the other side), with dislocations and damages in the bridge parapets and timpani. Inocencio Elorza examined the problem thoroughly. Under his leadership, it was decided to armor the piers foundations by exploiting the pre-existing breakwater rocks, forming a concrete base in the form of inverted vaults. These activities were articulated through a two-phase strategy. During the first phase, in 1892, maintenance activities were carried out, using about

110 m^3 of hydraulic cement and 180 m^3 of crushed stone. In the second phase, in 1893, the reparation of the bridge damages, and missing parts were performed.

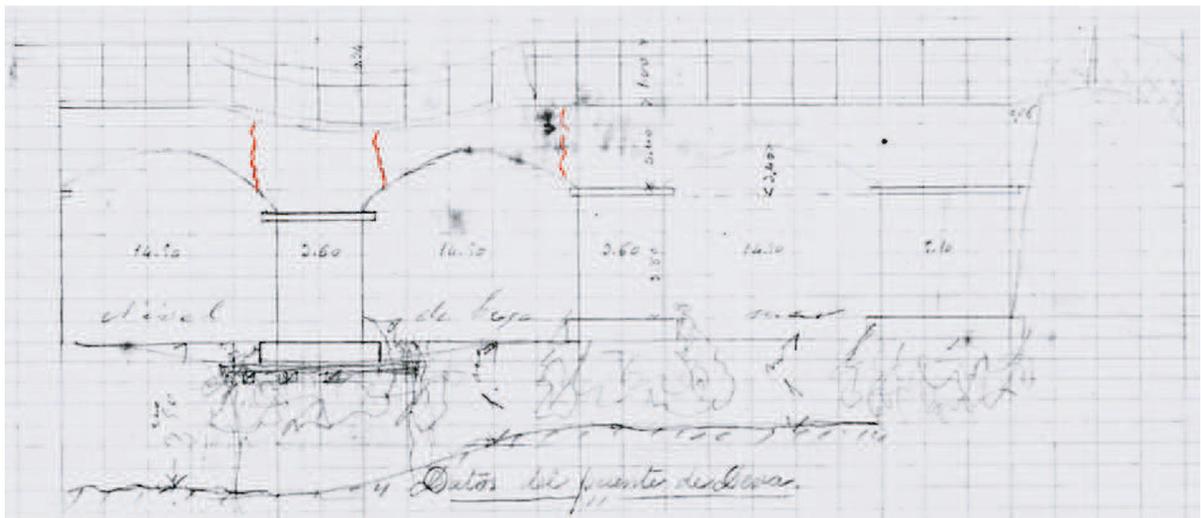
Fig. 5 A schematic representation of the 1892 bridge failure (Souce: Archivo histÃ³rico municipal-Libro de actas del Ayuntamiento de Deba: 1891 − 1895 (Signatura 65))

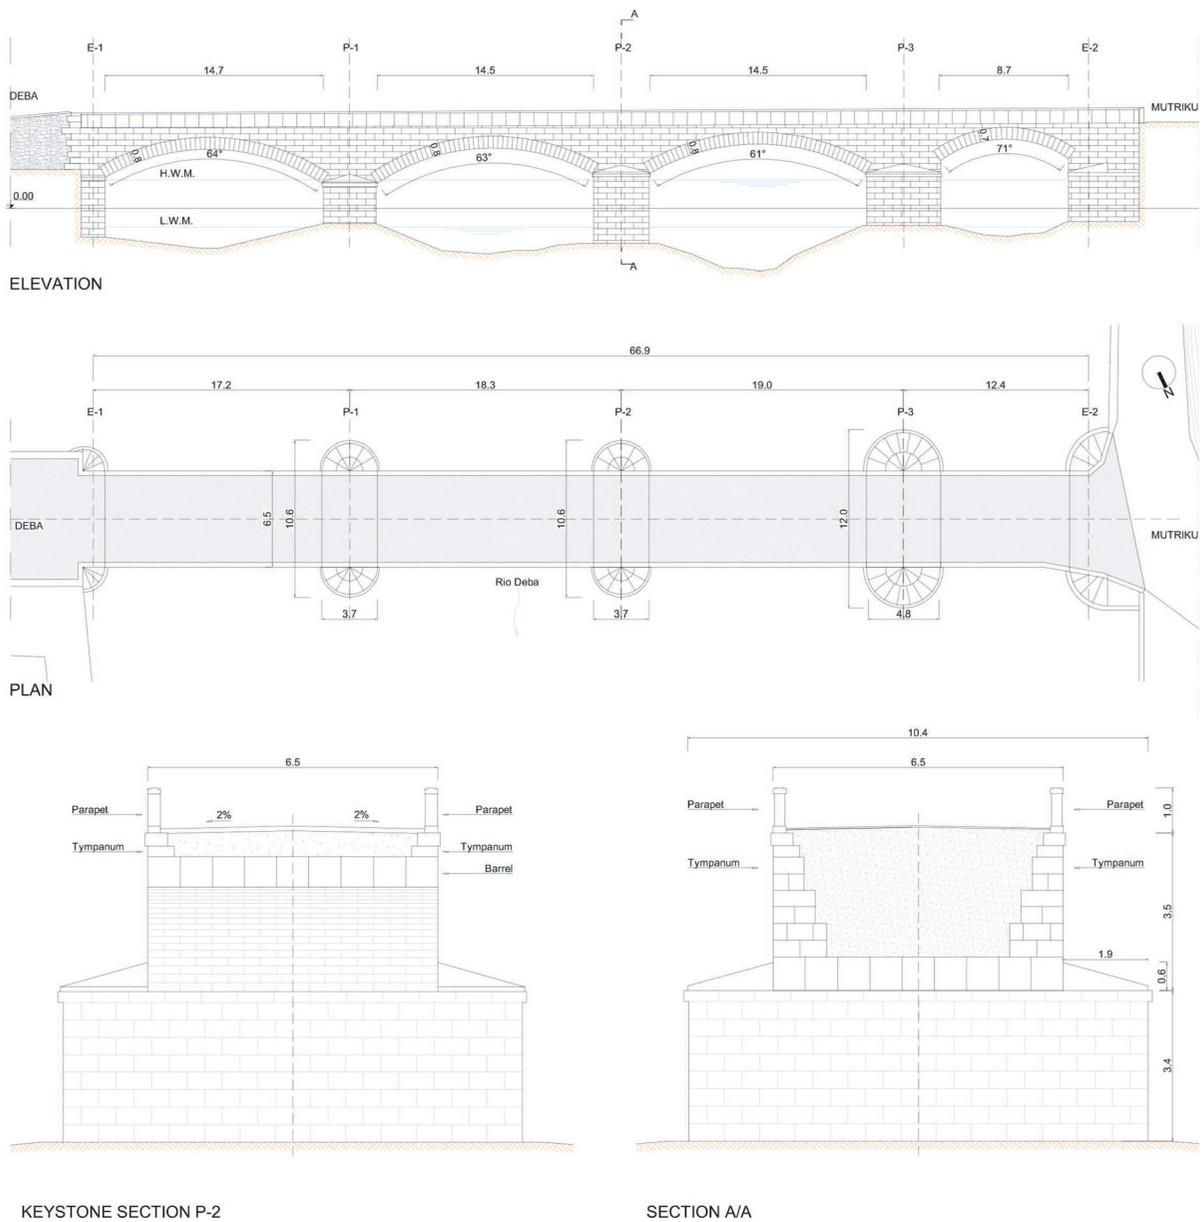
The bridge arches rest on three equal rectangular piers and two abutments with semicircular rostra. The outer dimensions are 10.60 × 3.70 m for all piers with the only exception of the last pier on the Mutriku side that is wider, 4.80 m, to compensate the stresses that the near bank of Mutriku causes to the pier. Then, the span to width ratio for the two piers on the Deba side is about 4, that is a typical value for masonry bridges of *XIX* century. The piers rest on timber poles with maximum length of 5.00 m and average diameter of 0.30 m. They are hammered into the soil with a pitch of about 0.40 ÷ 0.6 m. Fig. 7 reports detail drawings of elevation, plan and sections of the bridge before the 2018 failure. They are extrapolated from the data and original drawings provided by the FHECOR engineer Isabel Lorenzo Pérez.

The foundations of the Deba bridge on the east side (Deba) lie in muddy ground mixed with sand and gravel and are made with 117 oak poles on which lays a large wooden raft that holds together the stone blocks foundations. Each pole is five meters long and at least twenty centimeters in average diameter. They were driven to refusal and their heads has been cut off in the

Fig. 7 Elevation, Plan and Sections of Deba Bridge before the 2018 failure. Modified from an original drawing by FHECOR Ingenieros Consultores, www.fhecor.com

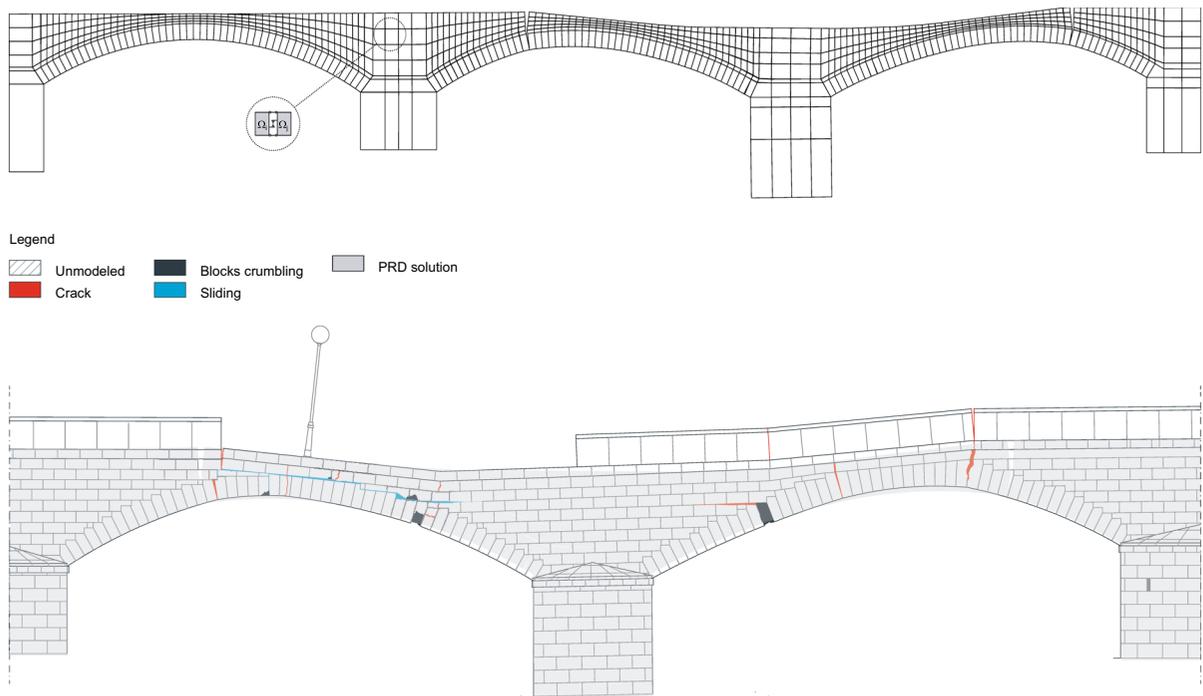
Fig. 10 PRD numerical results (top) and their superposition with the 2018 failure geometrical survey (bottom)

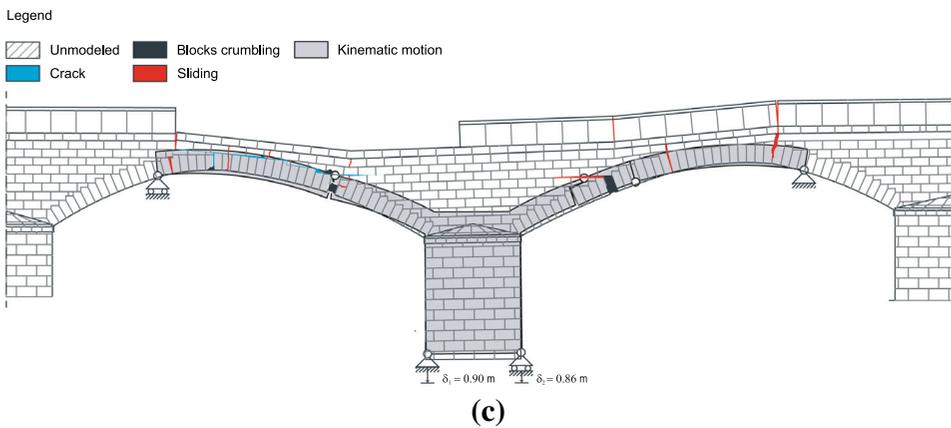
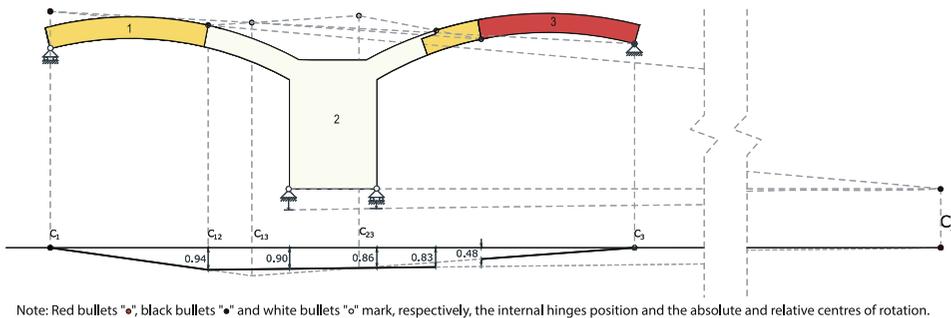
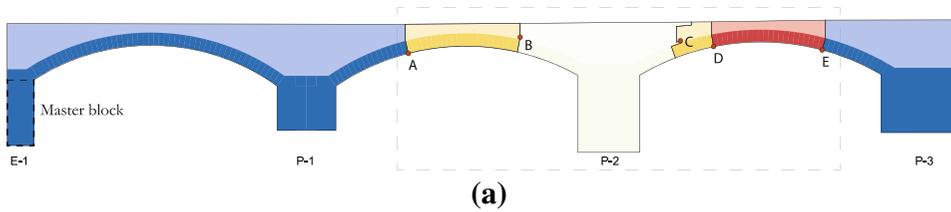
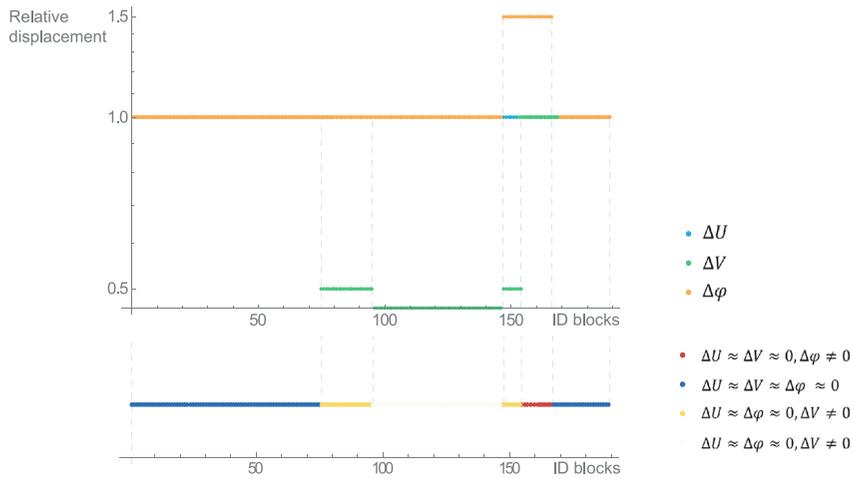
This allows to identify a cluster of about six rigid macro-blocks, hereafter marked with blue color, macro-blocks with about zero roto-translation, light and dark yellow colors, macro-blocks with non-zero vertical translation and red color, macro-blocks with non-zero rotation.

Fig. 11 a Numerical results obtained via PRD method: diagram of the relative kinematic of the blocks constituting the structural part of the bridge on a logarithmic scale (top) and resultant rigid macro-block partition of the bridge model (bottom); **b** kinematic motion of the bridge under imposed settlements; **c** superposition of kinematic motion of the bridge with the 2018 failure geometrical survey

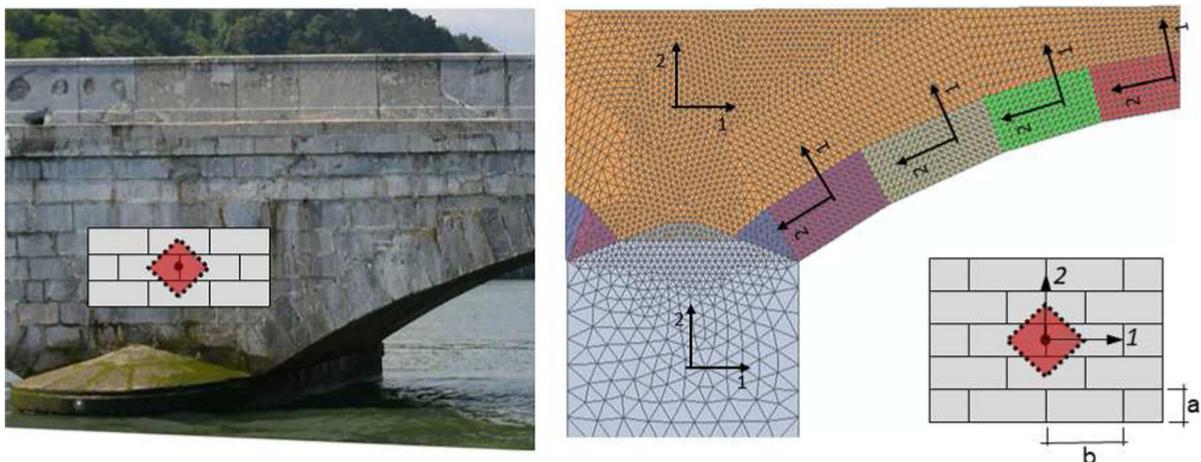
**Fig. 12** Material orientations

According to Eqs.13 the strength condition for masonry is simply defined by the dimensions of the blocks $a = 25$cm and $b = 40$cm, obtained from the geometric survey of the bridge, by the friction angle ϕ, assumed equal to $31°$ and by the orientation of the joints, according to Fig. 12. The elastic properties are defined based on the normal $K_n = 30.6$ N/mm^3 and the shear stiffness $K_t = 12.8$ N/mm^3 of the joints, and by the Young modulus $E_b = 3.18$ GPa and the Poisson's coefficient $v_b = 0.23$ of the blocks. The elastic parameters only influence the elastic branch of the global load-displacement curve (Fig. 15), but do not

It is worth noting that, the finite element model correctly describes the stone masonry pattern, following texture orientation by assigning a proper rotation to the elementary masonry cell, as described in Fig. 12.

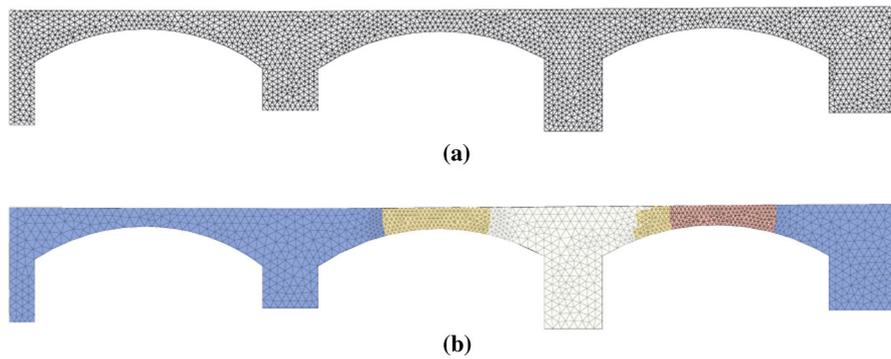
Two FE meshes were adopted for numerical analyses: the first one was obtained by setting a constant mesh size over the whole geometry (Fig. 13a), the second one was defined by mean of the numerical results of the PRD model (Fig. 13b). In the latter case, a mesh size equal to the previous one was adopted in the areas affected by the cracks, while a coarse mesh with double sized element was adopted in the areas where no cracks were detected. This allowed an optimization of the computational cost, limiting the number of degrees of freedom of the problem. The first mesh was composed of 2009 nodes and 3548 elements, while the optimized one was made of 1273 nodes and 2178 elements.

Fig. 13 FE Mesh: fine mesh **a** and optimized mesh derived from the overlap with the rigid macro-block partition **b**

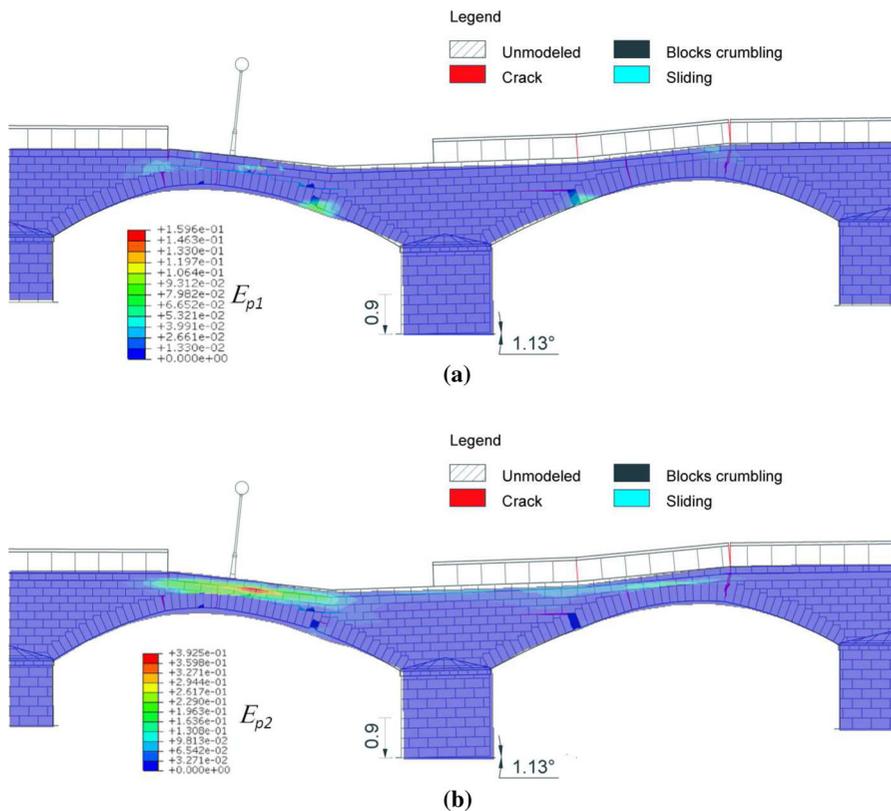
Fig. 14 Numerical result vs schematic representation of 2018 failure: **a** plastic strain concentration in horizontal direction and **b** plastic strain concentration in vertical direction

There is a good correspondence between the numerical results and the geometric survey of the damage as shown in Fig. 14: the model is able to reproduce the development of the four hinges in the bridge and the failure of the horizontal joints in the central portion of masonry above A-2 arch.

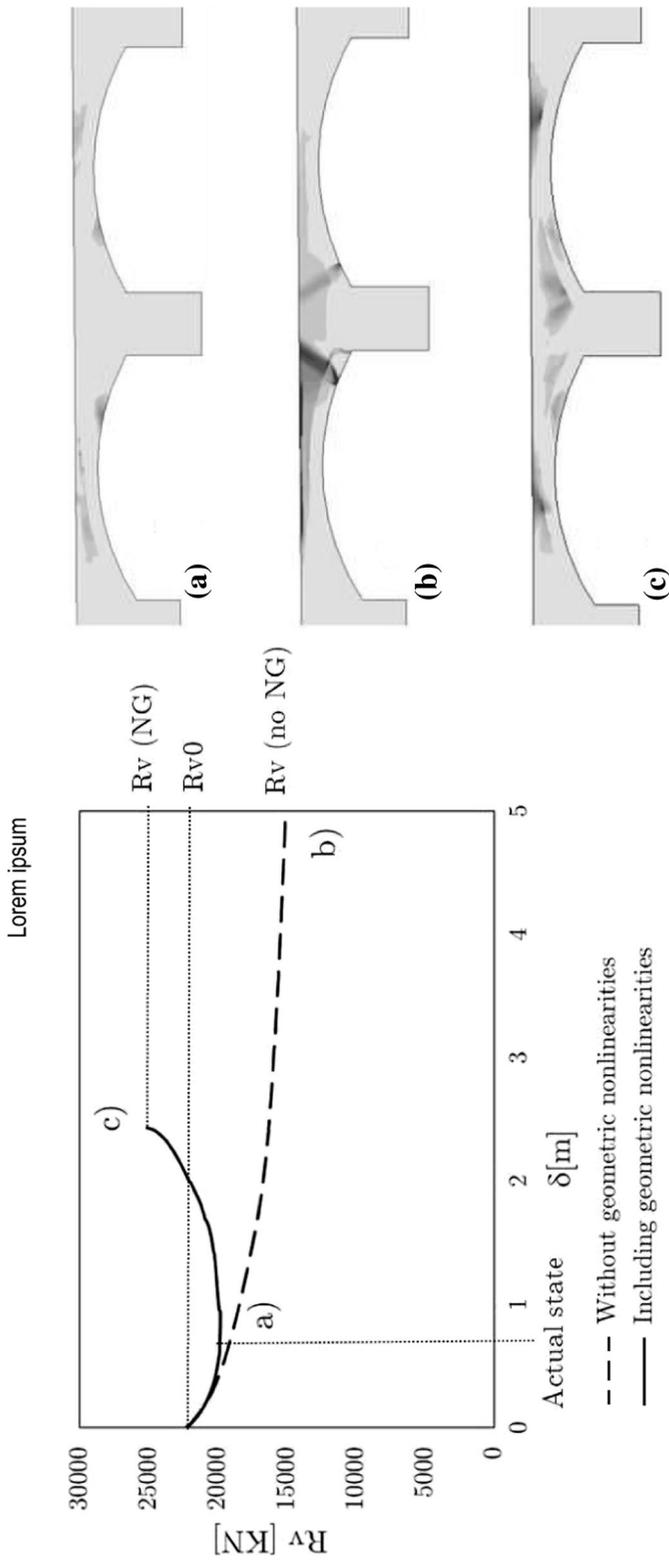
Fig. 15 Vertical reaction of the P-2 pier R_v under increasing settlement δ and corresponding inelastic deformation pattern over the bridge: **a** actual state, **b** final state under assumption of linearized kinematics and **c** final state considering geometric nonlinearities

The numerical analysis was pushed until the bridge collapsed, also taking into account the effect of geometric nonlinearities. In Fig. 15, the trend of the vertical reaction R_v at the basis of the P-2 pier versus the vertical displacement δ applied at the same pier is represented for linearized kinematics and geometric non-linearity conditions. The figure also shows the configuration of the bridge in its current state, i.e. for a vertical displacement of 0.9m, and at the end of the settling process.

The same mechanism that is found in the current state persists, with a wider spread of plastic strain. The analysis also reveals that the vertical reaction has reached the minimum value in the current state and would then grow again as the settlement increases, since the displacement does not allow an upper arch to form above the pier.
