Chapter 4: Conservation Approaches, Applications, Case Studies

THE DIFFICULT CHOICE OF MATERIALS FOR THE RECONSTRUCTION OF THE CATHEDRAL OF NOTO

Luigia Binda, Giuliana Cardani, Claudia Tiraboschi

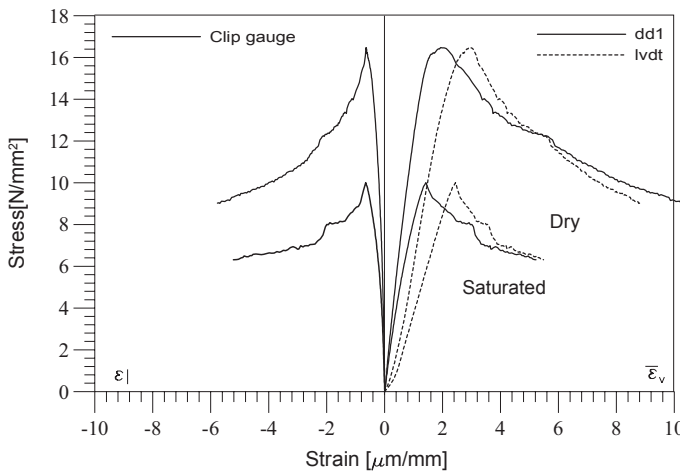
The calcarenite used for the external leaf of the pillars is characterized by a fairly good strength when tested dry up to constant mass (18.0 average N/mm² in compression, 2.2 N/mm² in tension for cylinders of 50 mm diameter and 100 mm height) and by a much lower strength when tested saturated up to constant mass (11.6 N/mm² in compression and 1.3 N/mm² in tension),

as showed in Figure 6. This means a reduction of 35.5% in the compressive strength and of 39% in the tensile one. The “travertine” used in the core of the pillars and in the external leaf above the base has a much lower strength than the calcarenite (5.2 N/mm² in compression as an average value measured on dry prisms of 100x100x200 mm dimension). The different mechanical characteristics of the two stones were also detected by sonic tests in laboratory and on site³. The other type of stone, very light, called “giuggiolena” was used for the construction of the arches and dome. This stone also shows a different behaviour when tested dry or saturated: 5.3 N/mm² in compression and 1.0 N/mm² in tension, when dry, 5.05 N/mm² in compression and 0.8 N/mm² in tension, when saturated.

Figure 6. Stress-strain plots of compression tests on saturated and dry calcarenite specimens.

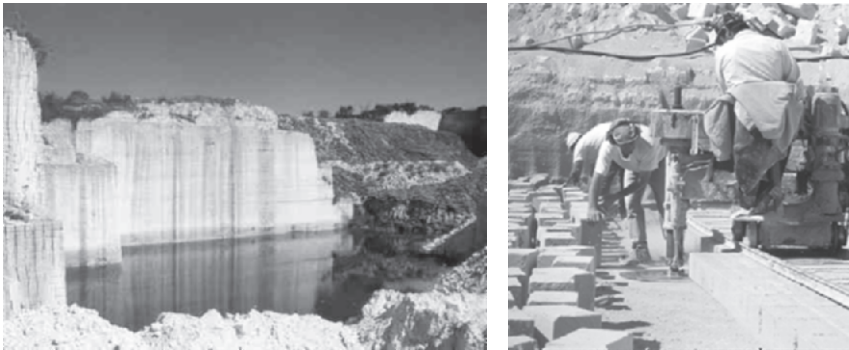
Six quarries situated in the area of Noto were visited by the authors and by the designers (Figure 7). The stones sampled from the quarries were sent to the DIS-Laboratory in Milan for characterization. As to the quarries, the stones were named E, N, D, Dg, S, B, I (D and Dg come from the same quarry). Cylinders were cored from the stones, of 50 mm diameter and 100 mm height. The dimensions are not always representative of the stone structure, but they were chosen for uniformity allowing comparing the results of the tests to those of the original stones. Physical and mechanical tests were carried out after mineralogical identification of the material^{1,4}.

Figure 7. Limestone quarries.

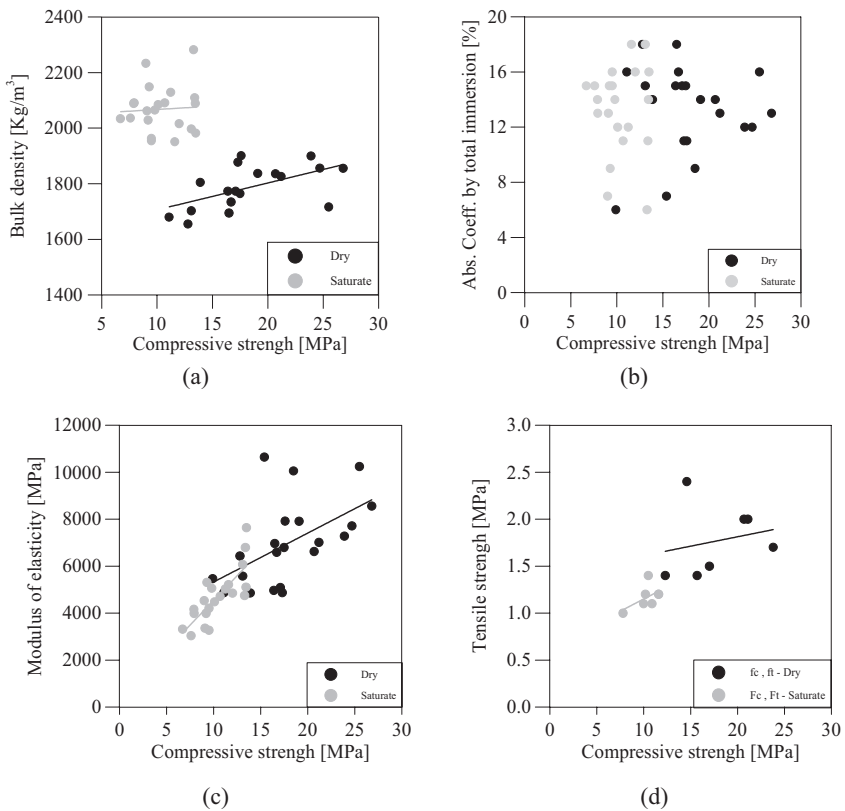
In order to verify the performance of the stones and choose the right quarry, the values of bulk density, absorption by total immersion, Young's modulus and tensile strength were reported against the compressive strength of dry and saturated specimens (Figure 8(a,b,c,d)). Even though the number of specimens was low and statistically not representative, it was possible to find some linear correlation.

Figure 8. Tentative correlations between compressive strength (a) and, respectively bulk density, absorption coefficient for total immersion (b), Young's modulus (c) and tensile strength (d) for dry and saturated specimens.

Minimum values for the compressive and tensile strength were specified for the contractor involved in the reconstruction, respectively, as 16.5 N/mm^2 dry, 9.5 N/mm^2 saturated in compression and 1.45 N/mm^2 dry, 0.95 N/mm^2 saturated in tension on cylinders cored from the stone blocks with dimensions:

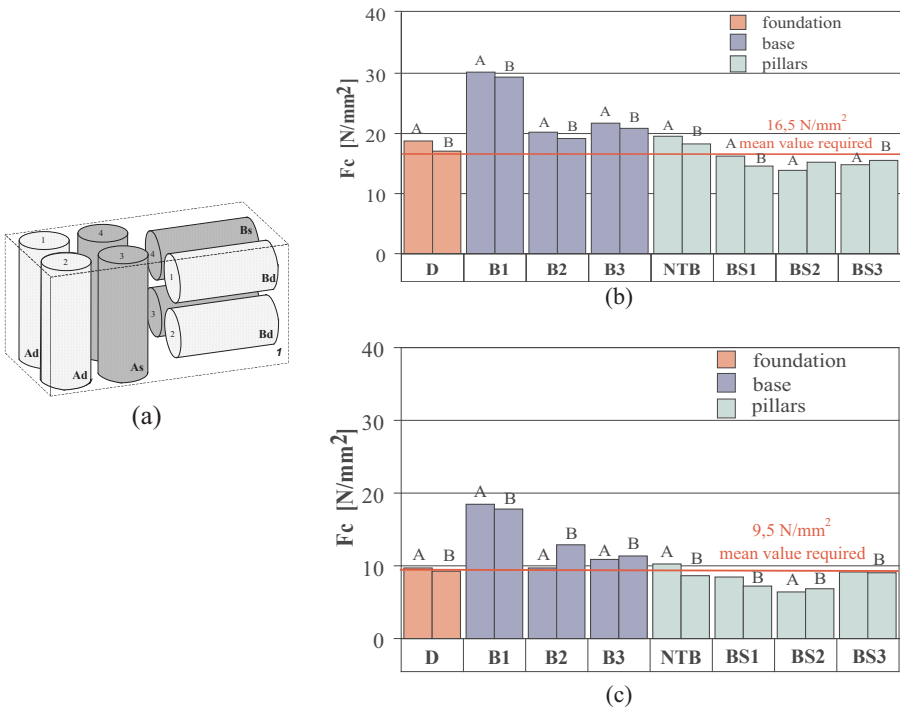
The cylinders were cored from each block in two directions A (rift plane) and B (perpendicular to rift plane) in order to characterize the eventual anisotropy of (Figs.9a and 10a). In Figures 9(b,c) the results of the compressive tests and in Figures 10(b,c) the results of the tensile strength carried out on stone cylinders in the state dry and saturated during subsequent testing campaigns are presented, compared to the strength limits required by the contractors; they show the variability in strength of the different types of stones and how the quality of the stones tended to decrease at each delivery.

The difference between the two directions A and B is not so evident, indicating low anisotropy. Subsequent deliveries of stone blocks show a decrease of compressive strength values below the requested one, while the indirect tensile strength varies according to the stone type. Large difference in strength shown by dry and saturated specimens was also clear. Saturation of the stones always induces a reduction in compressive strength of about 40%.

The values obtained for the original limestone seemed to be more homogeneous around an average value of 17.89 N/mm². If the designers wanted to

Figure 9. (a) Scheme of the stone specimen coring; (b) compressive strength in two directions of dry cylinder type D, B, NTB, BS at various times (numbers after letters indicate different supplies) and (c) compressive strength in two directions of saturated cylinder type D, B, NTB, BS at various times.

use a stone with similar strength as the original one then the S stone should be used. As a slightly higher strength was needed, stones B or Dg were employed. It is in any case better to use a quarry, which gives stones with less scattering in strength.

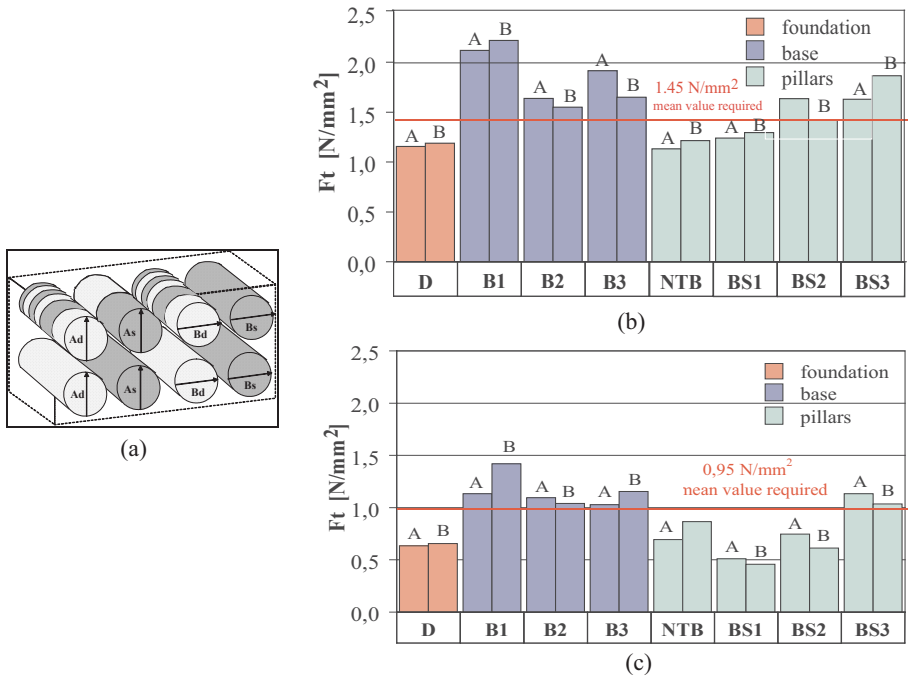
Figure 10. (a) Scheme of the stone specimen coring. (b) tensile strength in two directions of dry cylinder type D, B, NTB, BS at various deliveries (numbers after letters indicate different supplies) and (c) tensile strength in two directions of saturated cylinder type D, B, NTB, BS at various deliveries.

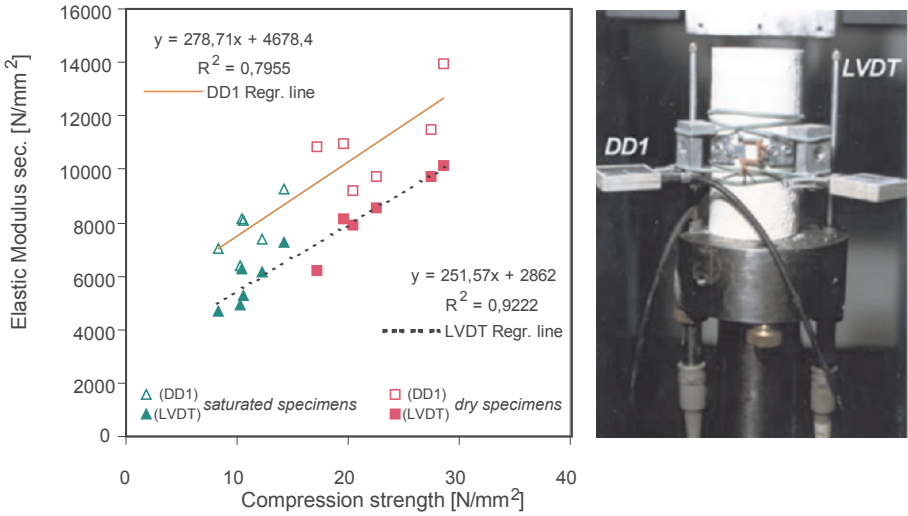
Figure 11 shows the elastic modulus against the compressive strength of the stones from quarry B, achieved by two different strain measurement devices. There is a good correlation between the values, in particular with the measurements made with the instrument LVDT positioned between plates, while measurements made with DD1 directly applied on the specimens are more scattered. The lower strength values are referred to saturated specimens and the higher to the dry specimens. This behaviour is quite similar for all the analysed stones as shown in Figure 12.

Figure 11. Correlation among the compressive strength values and the elastic secant modulus for the calcarenite B with different measurement devices.

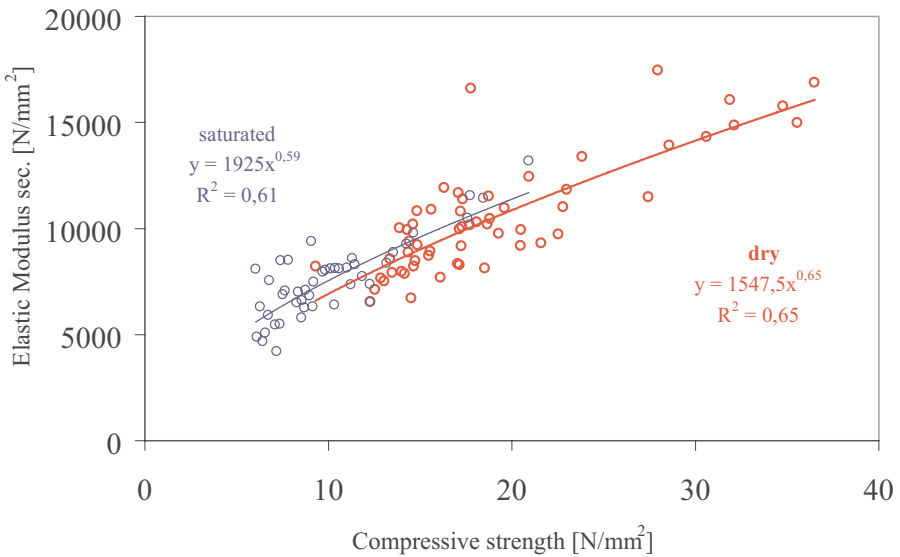
Figure 12. Compressive strength against elastic secant modulus of all the different types of characterised stones distinguished between saturated and dry specimens.
