Vulnerability of Architectural Heritage in Seismic Areas: Constructive Aspects and Effect of Interventions

Maria Rosa Valluzzi and Luca Sbrogiò

Abstract In this chapter, the effects of past interventions applied to historical city centers struck by a series of earthquakes over time are analyzed in terms of local and overall damage. Three villages in central Italy, Castelluccio di Norcia, Campi Alto di Norcia and Castelsantangelo sul Nera, containing overall about 150 buildings, are examined here. Classification of damage was based on the European Macroseismic Scale. The study provided vulnerability maps detailing the influence of interventions on buildings in historical city centers, which may contribute to better evaluation of damage scenario and maintenance plans.

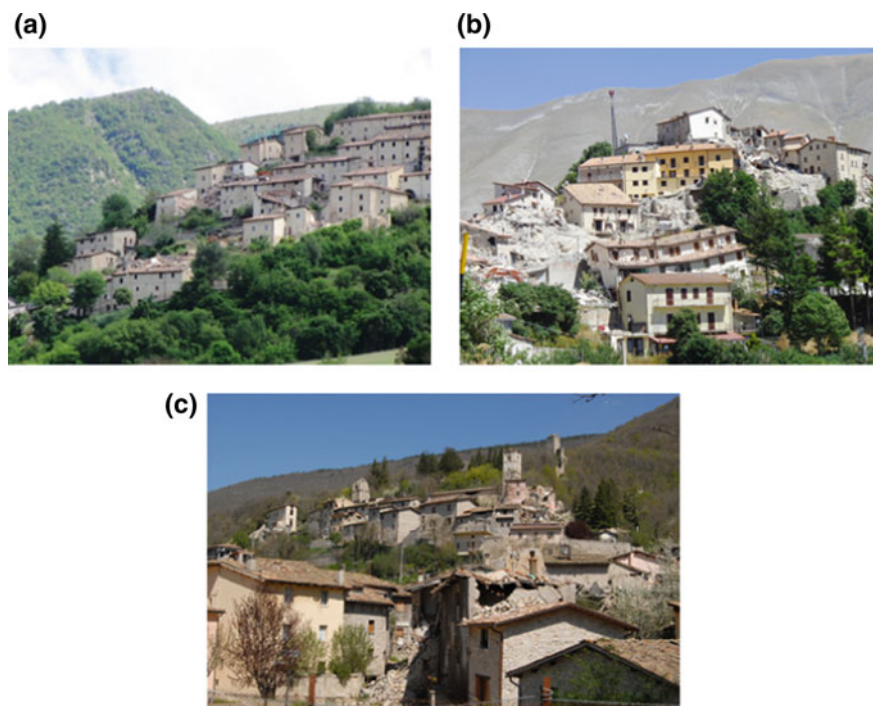
Campi Alto di Norcia and Castelsantangelo sul Nera have a similar layout: an egg-shaped boundary wall built on slope with terraced houses on the lower half, and a tower and church at the top. Instead, Castelluccio di Norcia is built on a small cliff overlooking the surrounding plain with a curtain wall at its base. Over the centuries, these ‘castles’ have been abandoned because of the development of *extra moenia* suburbs, closer to the road systems, like for Castelluccio di Norcia and Castelsantangelo sul Nera. Campi Alto di Norcia, being further from the valley road, is now almost completely abandoned (Fig. 6).

Fig. 6 View of three towns surveyed after 2016 seismic sequences: **a** Campi Alto di Norcia (PG); **b** Castelluccio di Norcia (PG); **c** Castelsantangelo sul Nera (MC)

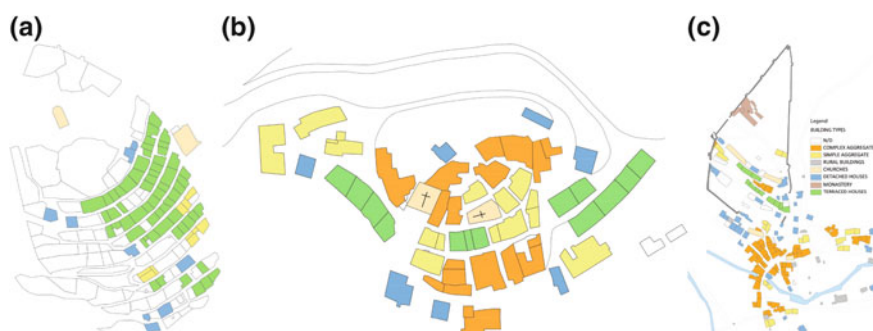
The new procedure collects data on interventions, both architectural (e.g., changes in plans’ layouts of openings distribution) and structural, with reference to vulnerability assessments and damage states available over the last 40 years (i.e., from 1979 onwards), according to building types existing in the three centers (Fig. 7).

Fig. 7 Building types in **a** Campi Alto di Norcia (PG), **b** Castelluccio di Norcia (PG), **c** Castelsantangelo sul Nera (MC)

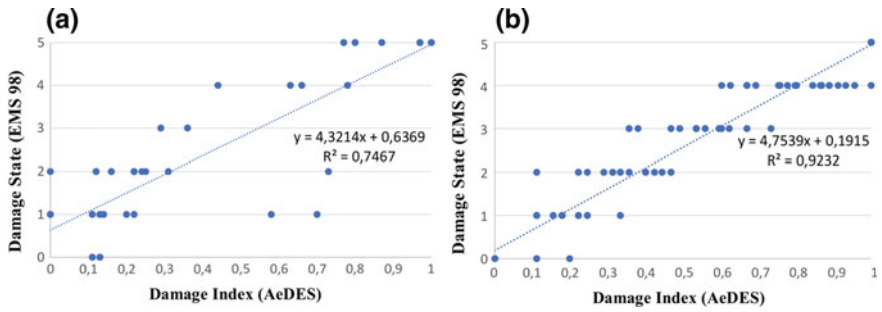
Fig. 11 Distribution of EMS 98 damage states in 2016: Campi Alto di Norcia (a) and Castelsantangelo sul Nera (b)

Comparisons among the resulting Id to damage states according to EMS 98 show a significant correlation between indexes (Fig. 11). Instead, when Id is compared with a vulnerability estimator such as the GNDT index (Iv), almost no correlation is found (Fig. 12): that is, vulnerability factors identified by the procedure were either wrongly judged or ill-defined, again presumably because of structural interventions.

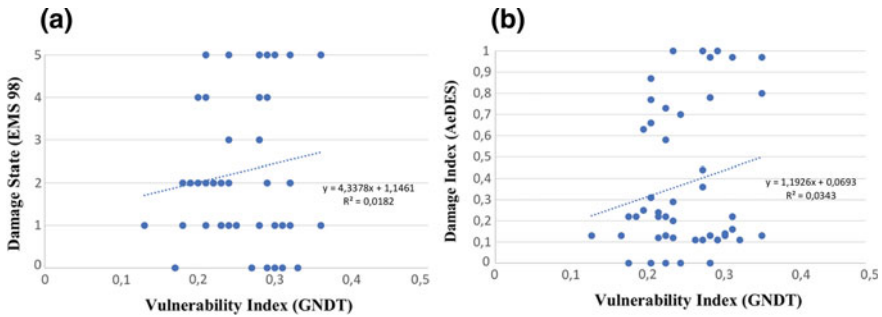
Fig. 12 Campi Alto di Norcia, correlation between vulnerability index (GNDT II level method) and EMS 98 damage state (a) and AeDES damage index (b), both showing very little correlation. Iv scale is limited to 0,5, to distinguish among points (max Iv = 1)
